APPENDIX B

BUILDING FUNCTIONAL ASSESSMENTS

DATE: NOVEMBER 2021

A. FACILITIES ASSESSMENT - FUNCTIONAL CONDITIONS

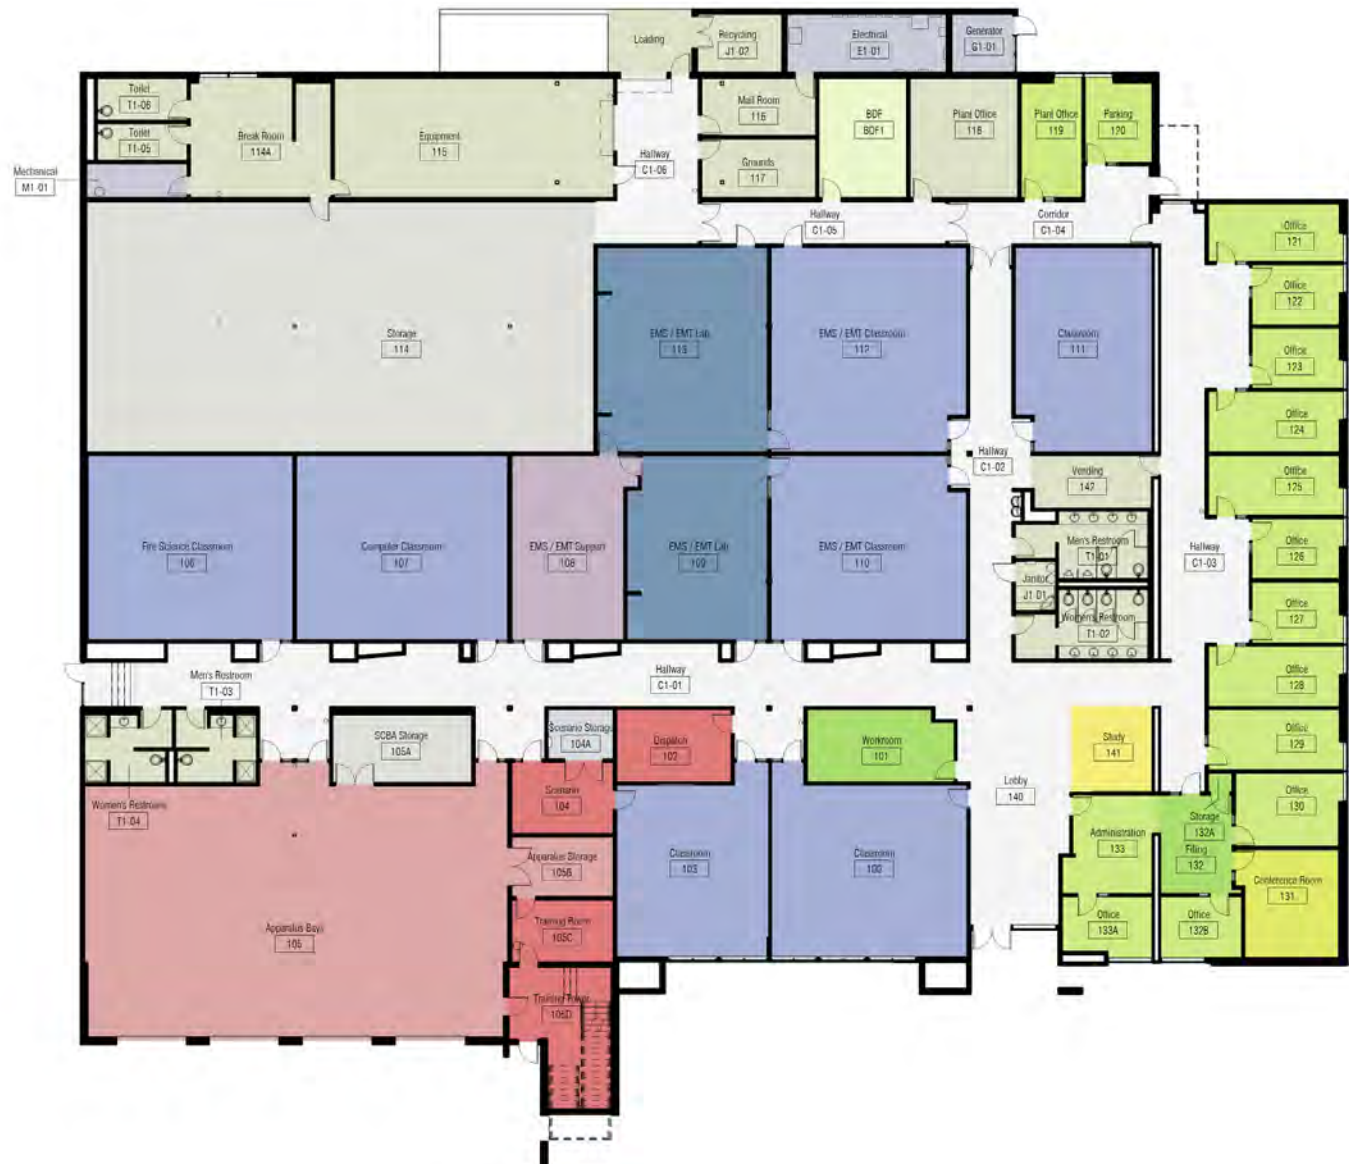
Level 1

- Classrooms on interior lack access to daylight
- Offices on building perimeter have good access to daylight but this limits the ability for more than two classrooms to have good daylight
- Significant space for facilities maintenance limits academic functions in the building.
- Access to faculty offices by students is not immediately clear.
- Enough individual bathrooms to accommodate gender inclusive use.
- Little engagement with outdoor spaces except for the potential through existing truck bay doors.
- Without Fire Protection, the footprint is large and inefficient for the amount of academic space it houses, particularly at this location where academic uses would be beneficial to the campus.

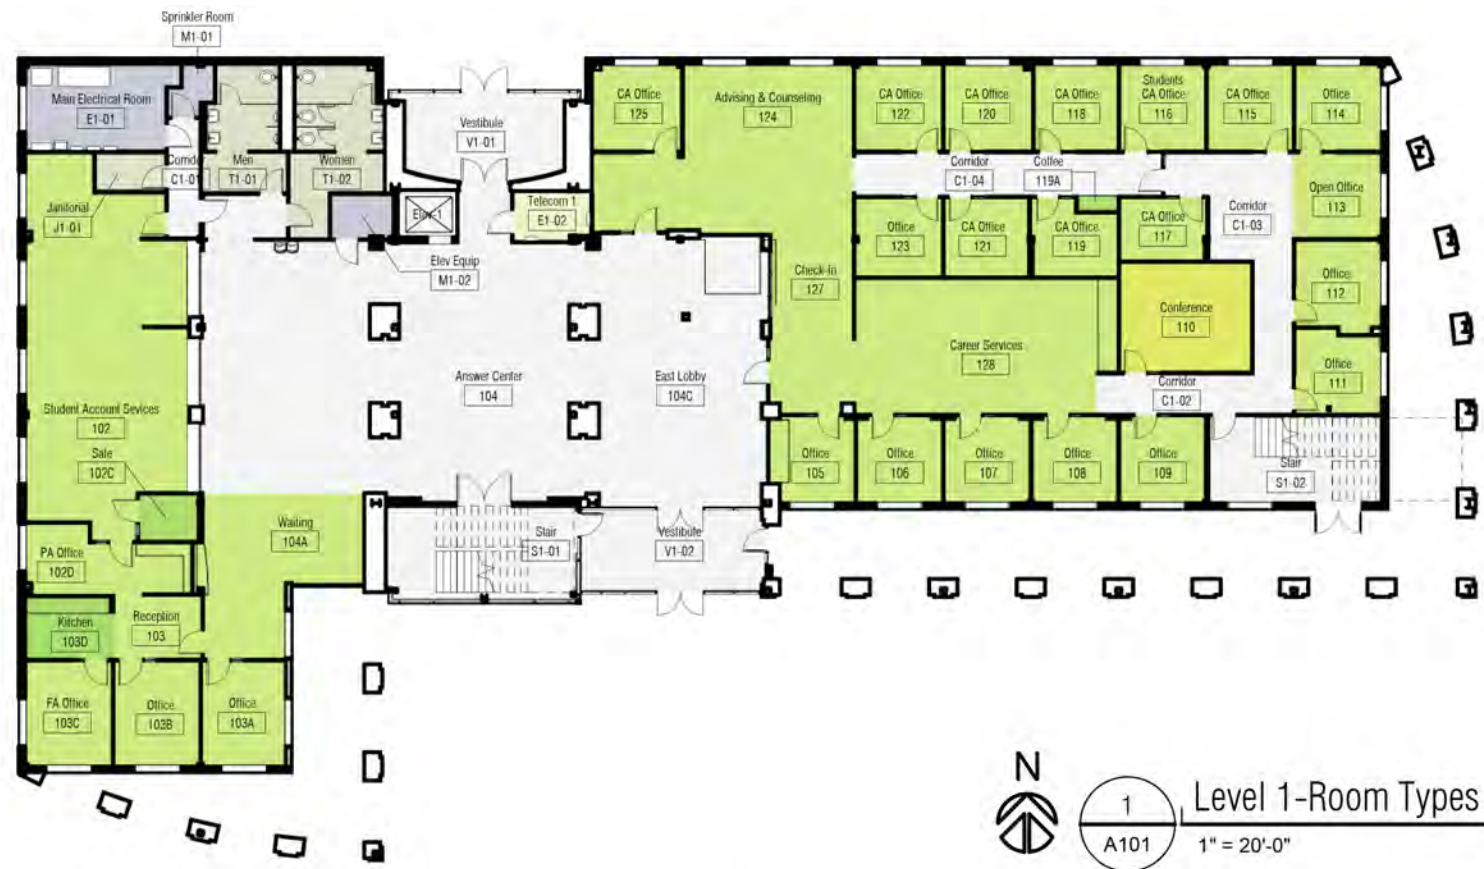
Level 1

- Upon entering through the two main entrances, orientation is difficult with large columns obstructing views and with entrances offset from each other.
- Central Answer Center has very limited access to daylight.
- Absence of gender inclusive restrooms.
- The building configuration helps to frame campus central spine.
- Some connection visually and physically to the outdoor plaza space but most of the windows are for individual offices.
- With three stories of occupiable space, building makes good use of its footprint.

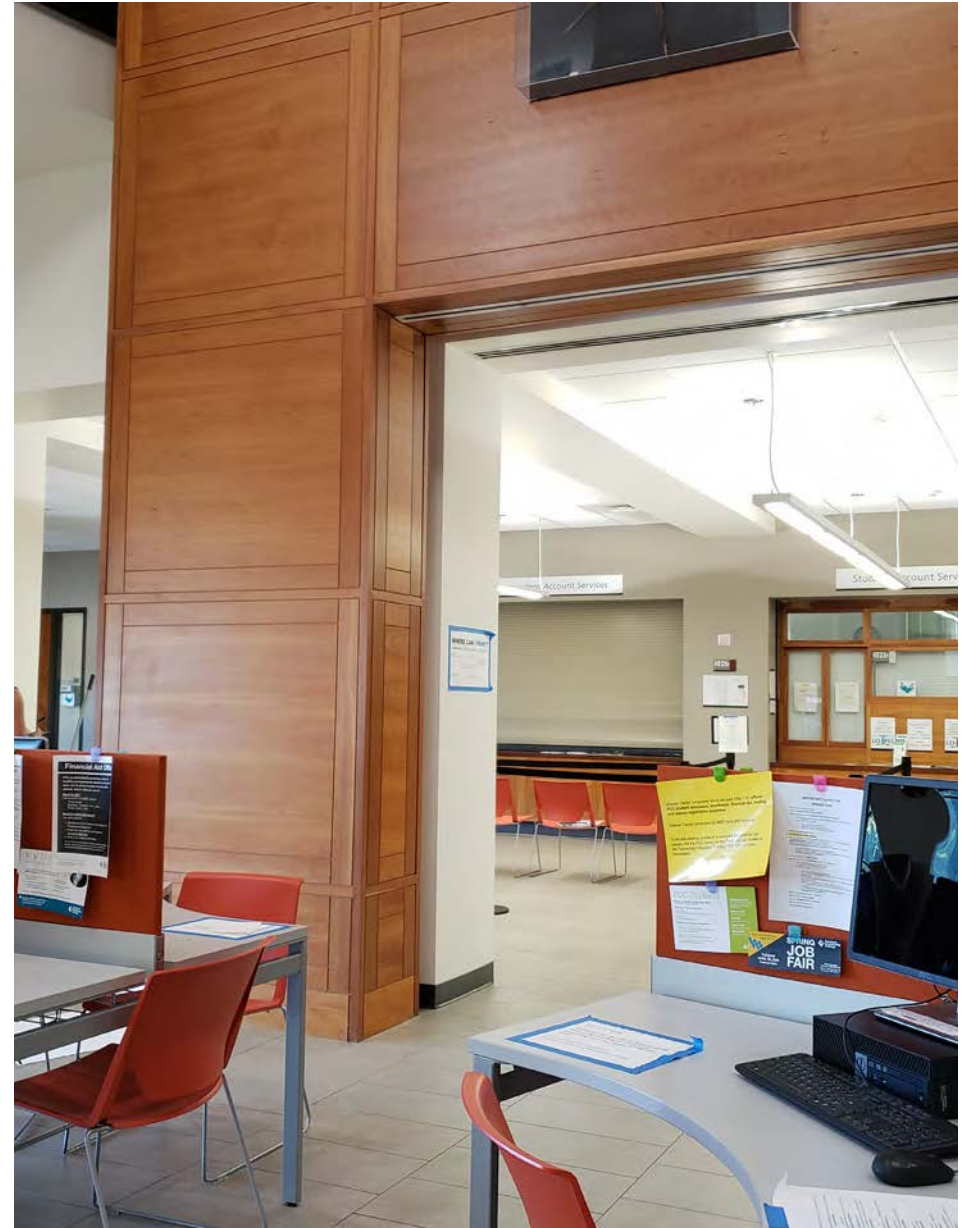
Answer Center with mezzanine above
