FACILITIES PLAN TECHNICAL REPORTS

Utilities Assessment

Portland Community College

April 2018

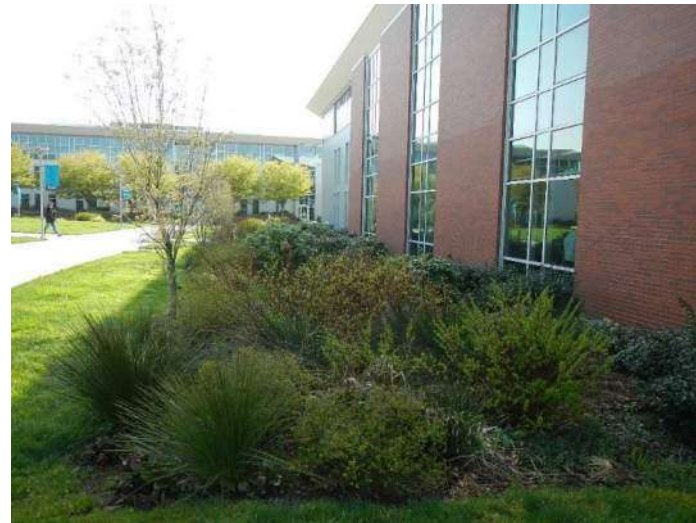
Southeast WQ #17: West water quality facility #17

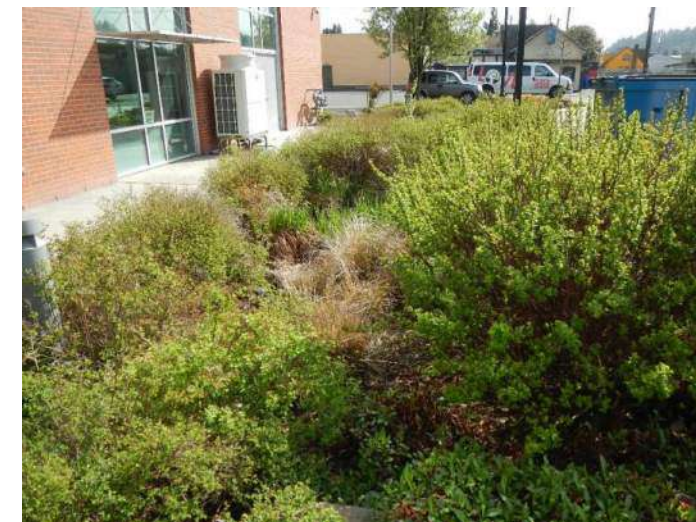
Southeast WQ #20: East water quality facility #20

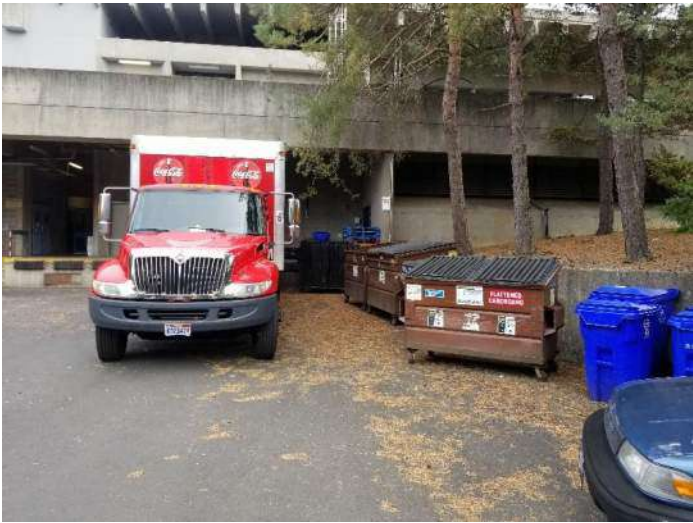
Sylvania 4: FDC for CC building
