FACILITIES PLAN TECHNICAL REPORTS

# Civil Site Accessibility and Utilities

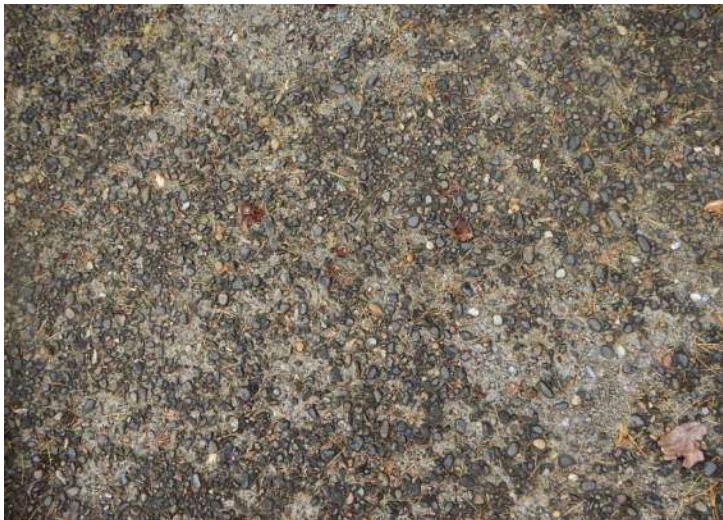
**Cascade 3**  
Keynote 7 - [Table 2](#)  
Hole 4 - [Table 4](#)

Obstruction Number	Type of Non-Compliance	Description	Severity
H2	Hole	½" Hole at Joint <a href="#">Photo: Cascade 10</a>	A
H3	Hole	Hole from cracking in concrete <a href="#">Photo: Cascade 26</a>	A
H4	Holes	Caused by exposed, rough aggregate <a href="#">Photo: Cascade 3</a>	B

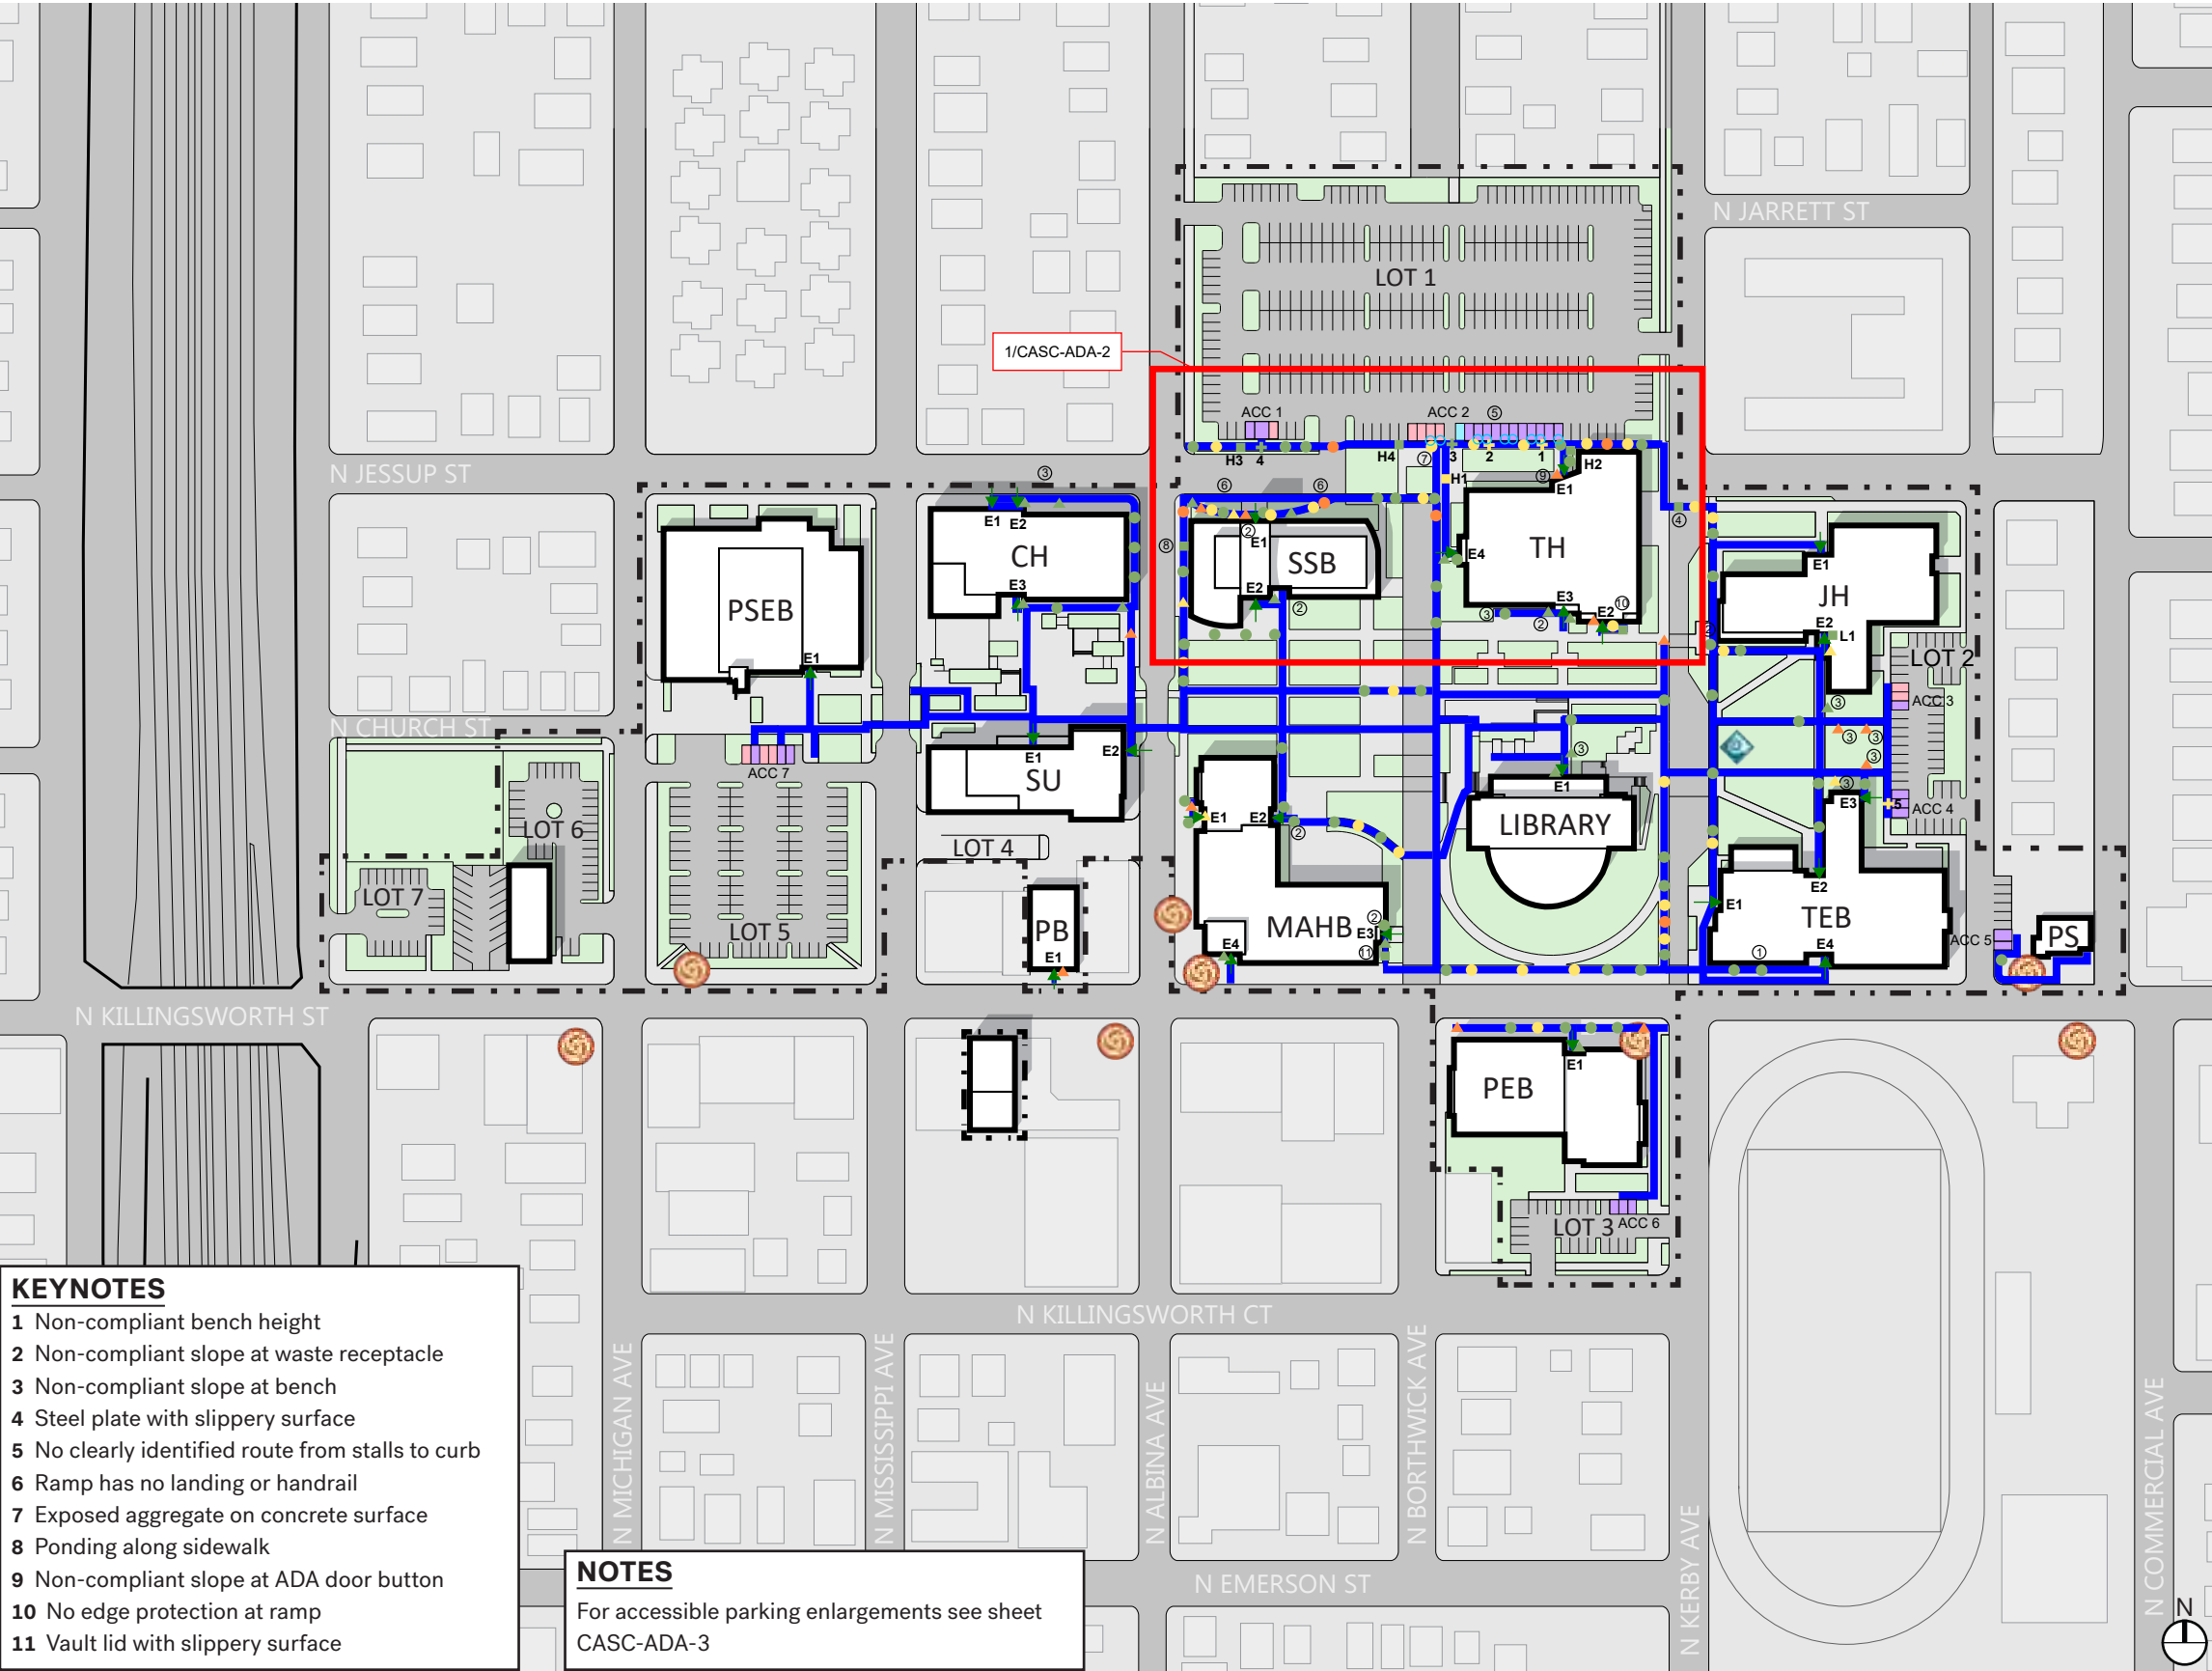
# SEVERE NON-COMPLIANT CURB RAMP

1 Non-compliant bench height

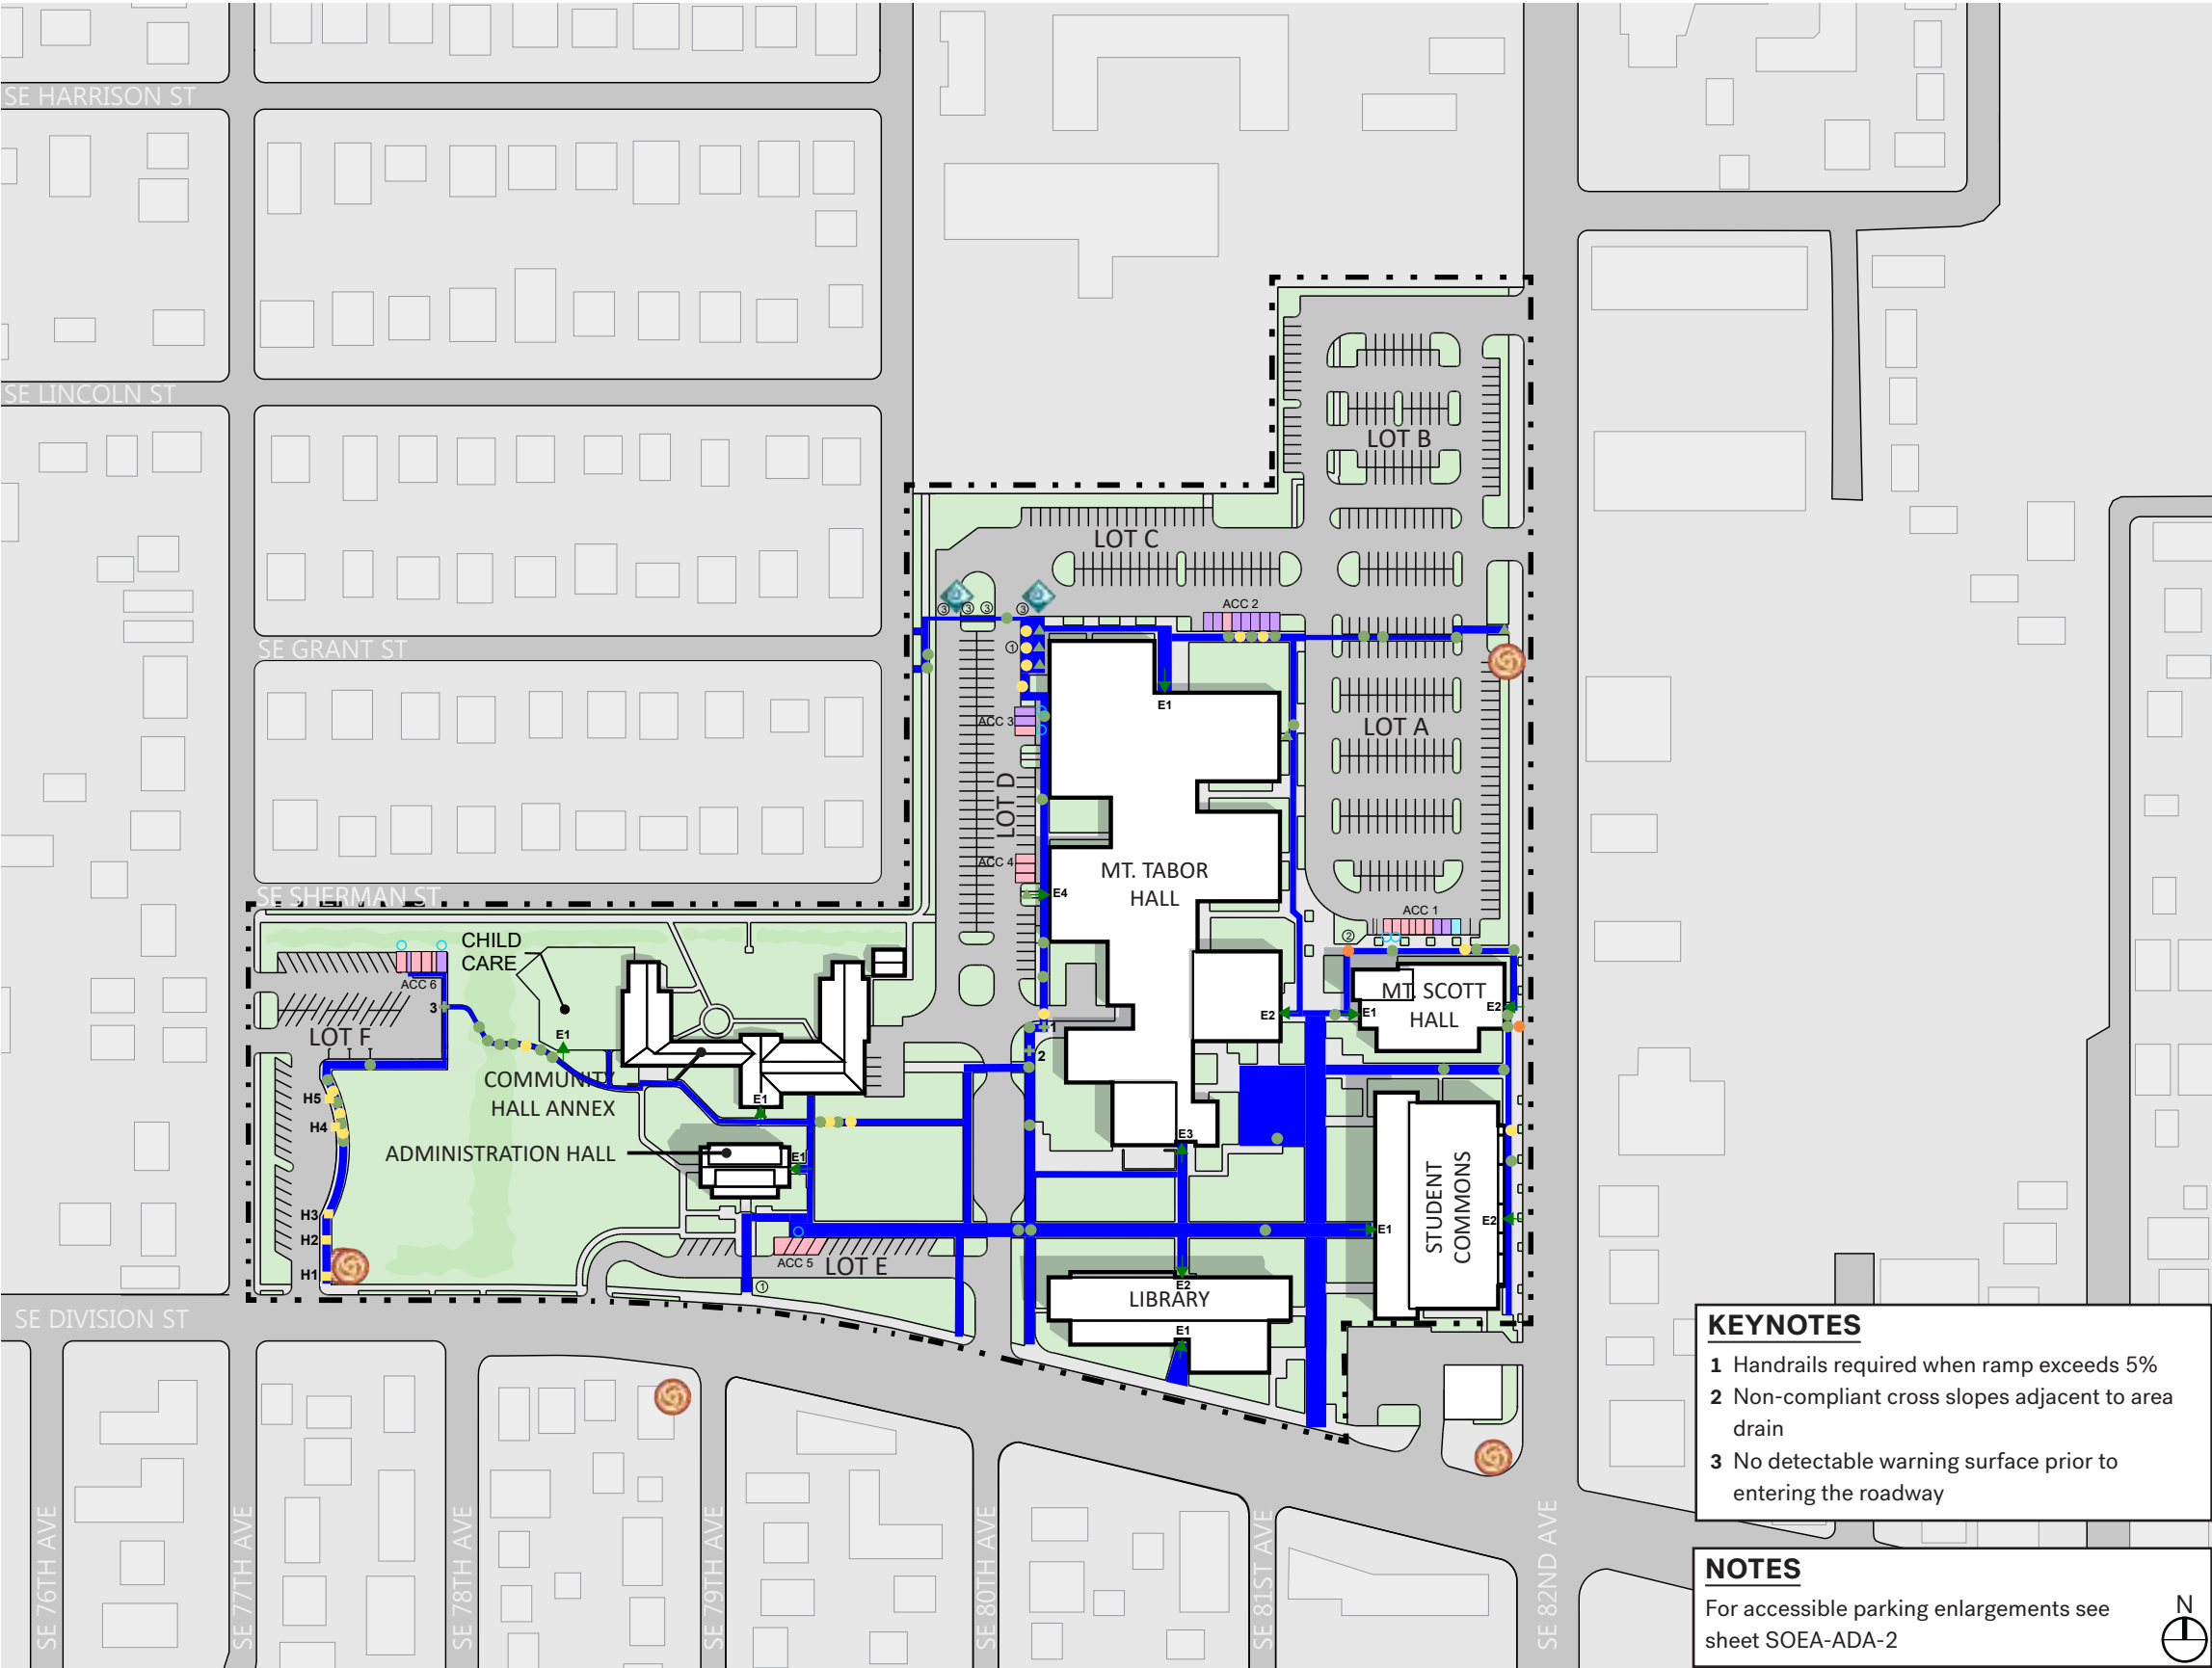
1 Handrails required when ramp exceeds 5%

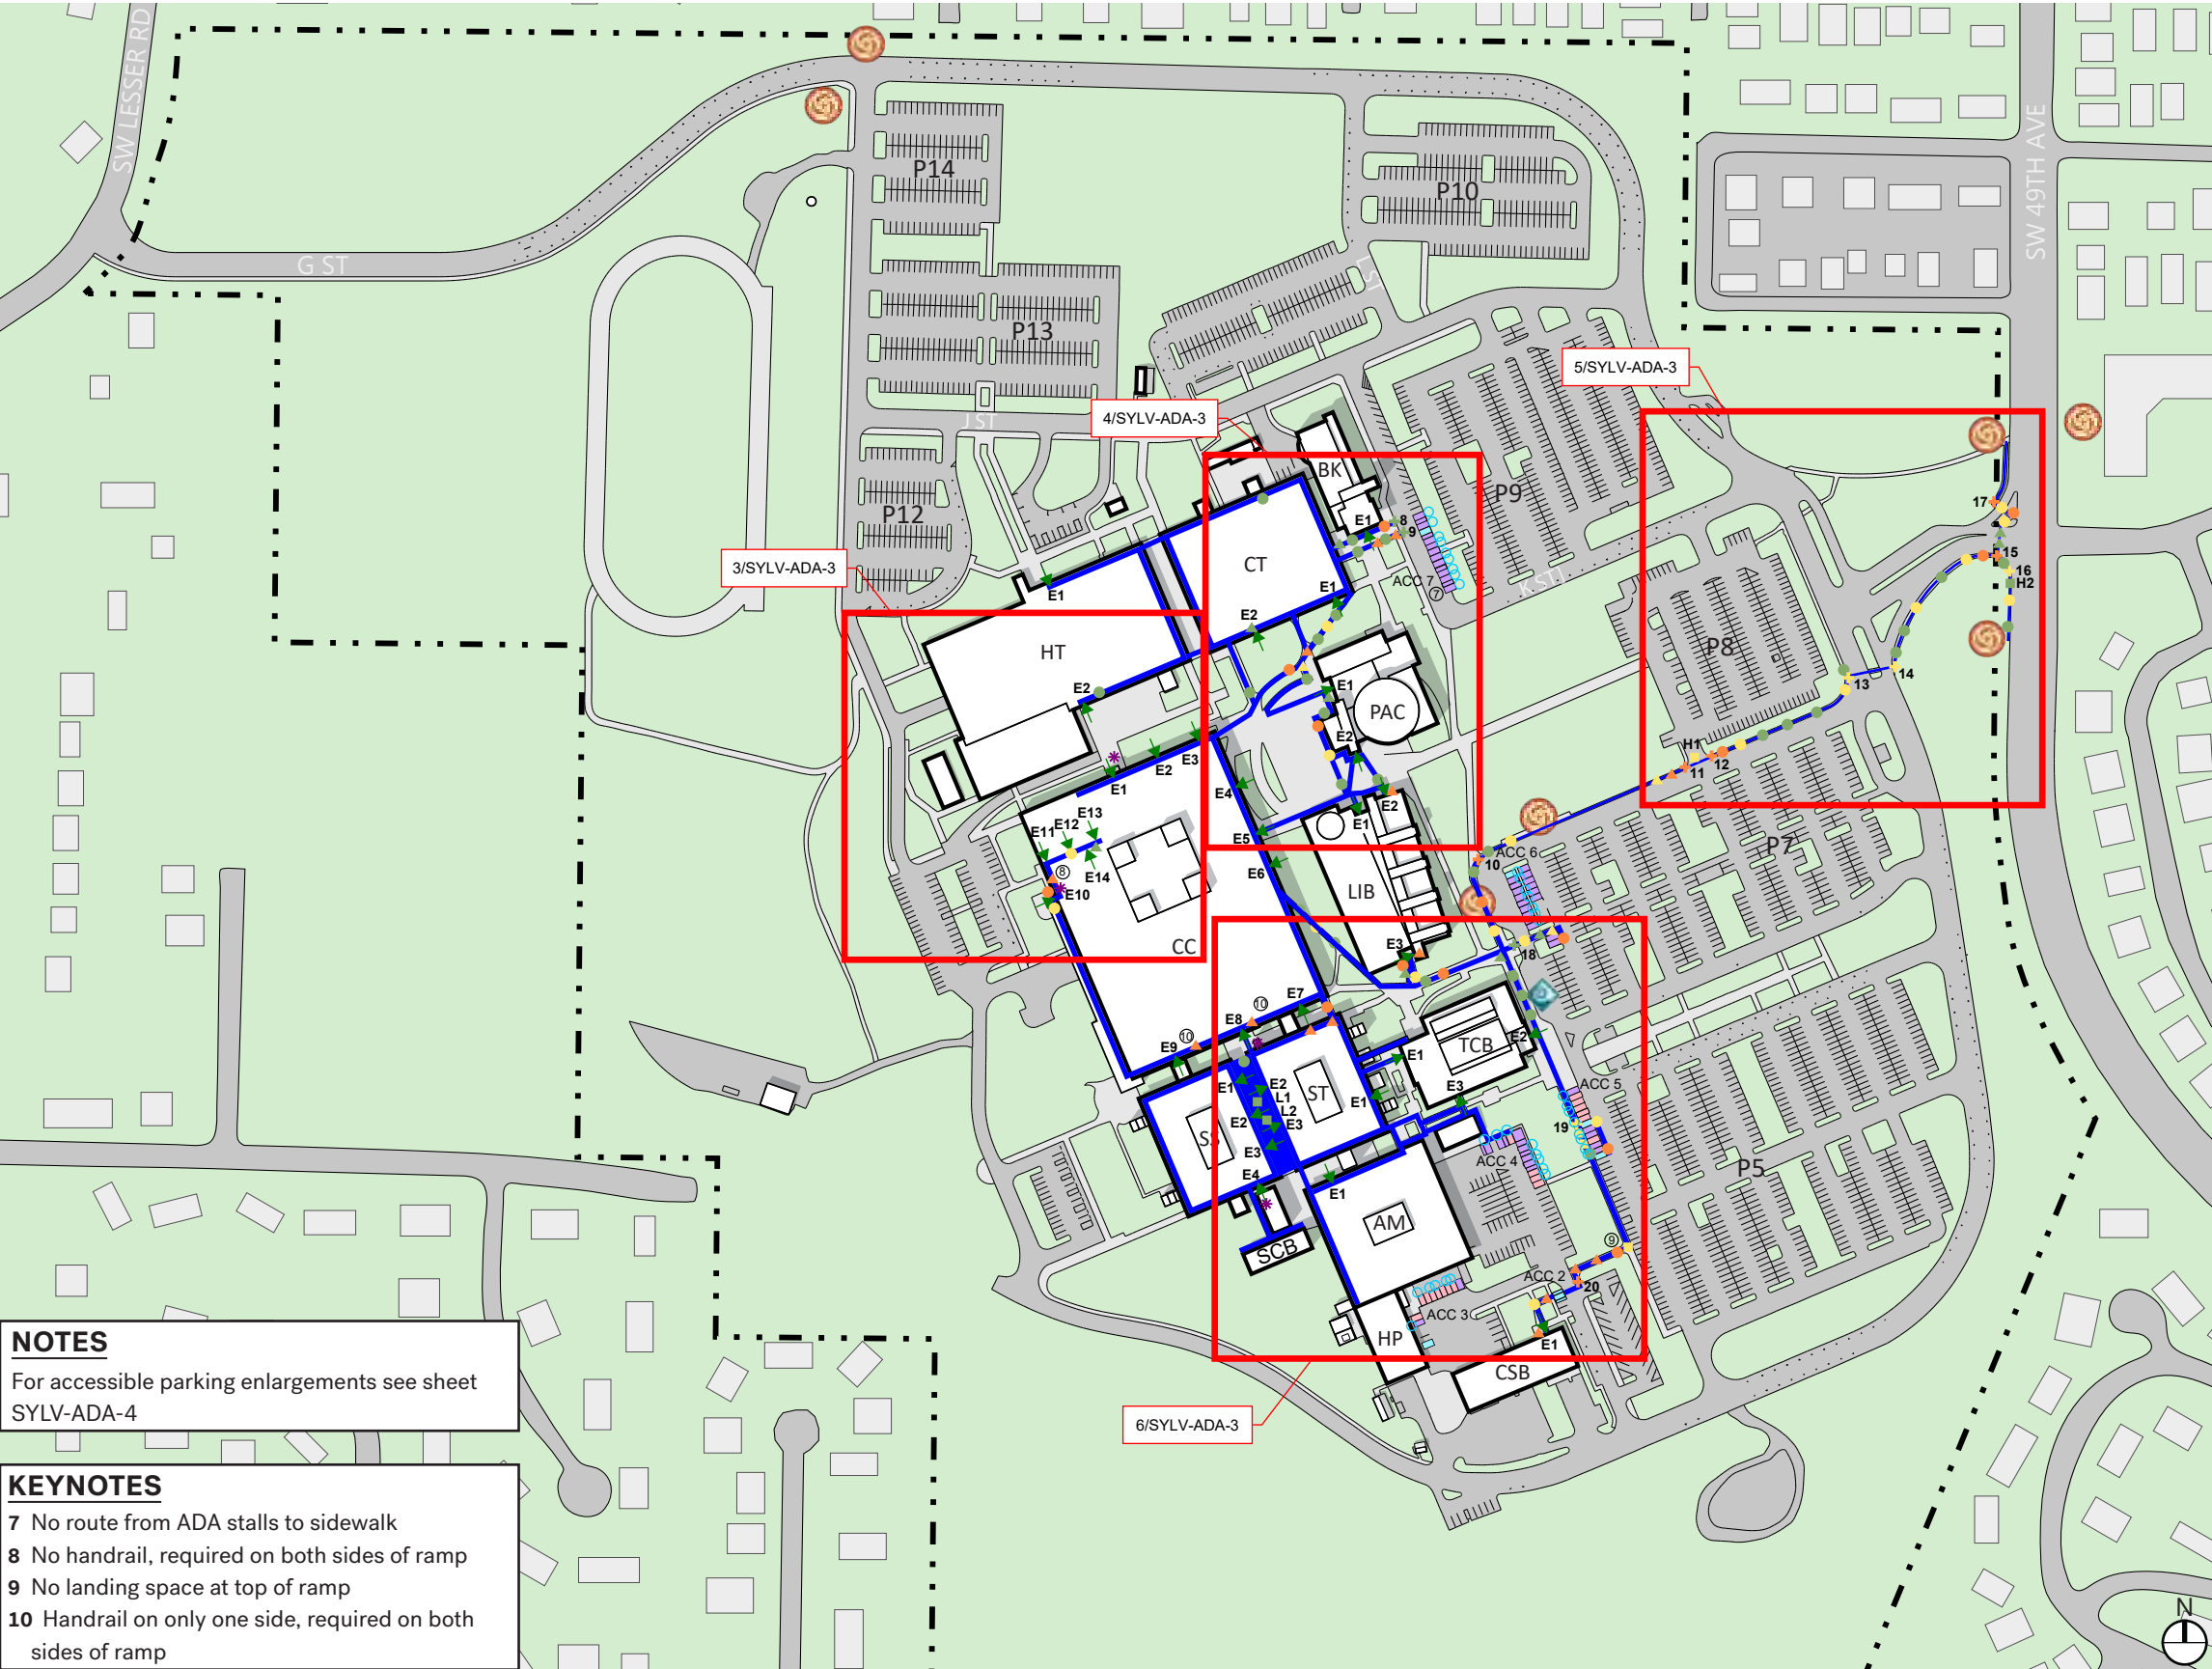
9 No landing space at top of ramp

10 Handrail on only one side, required on both sides of ramp

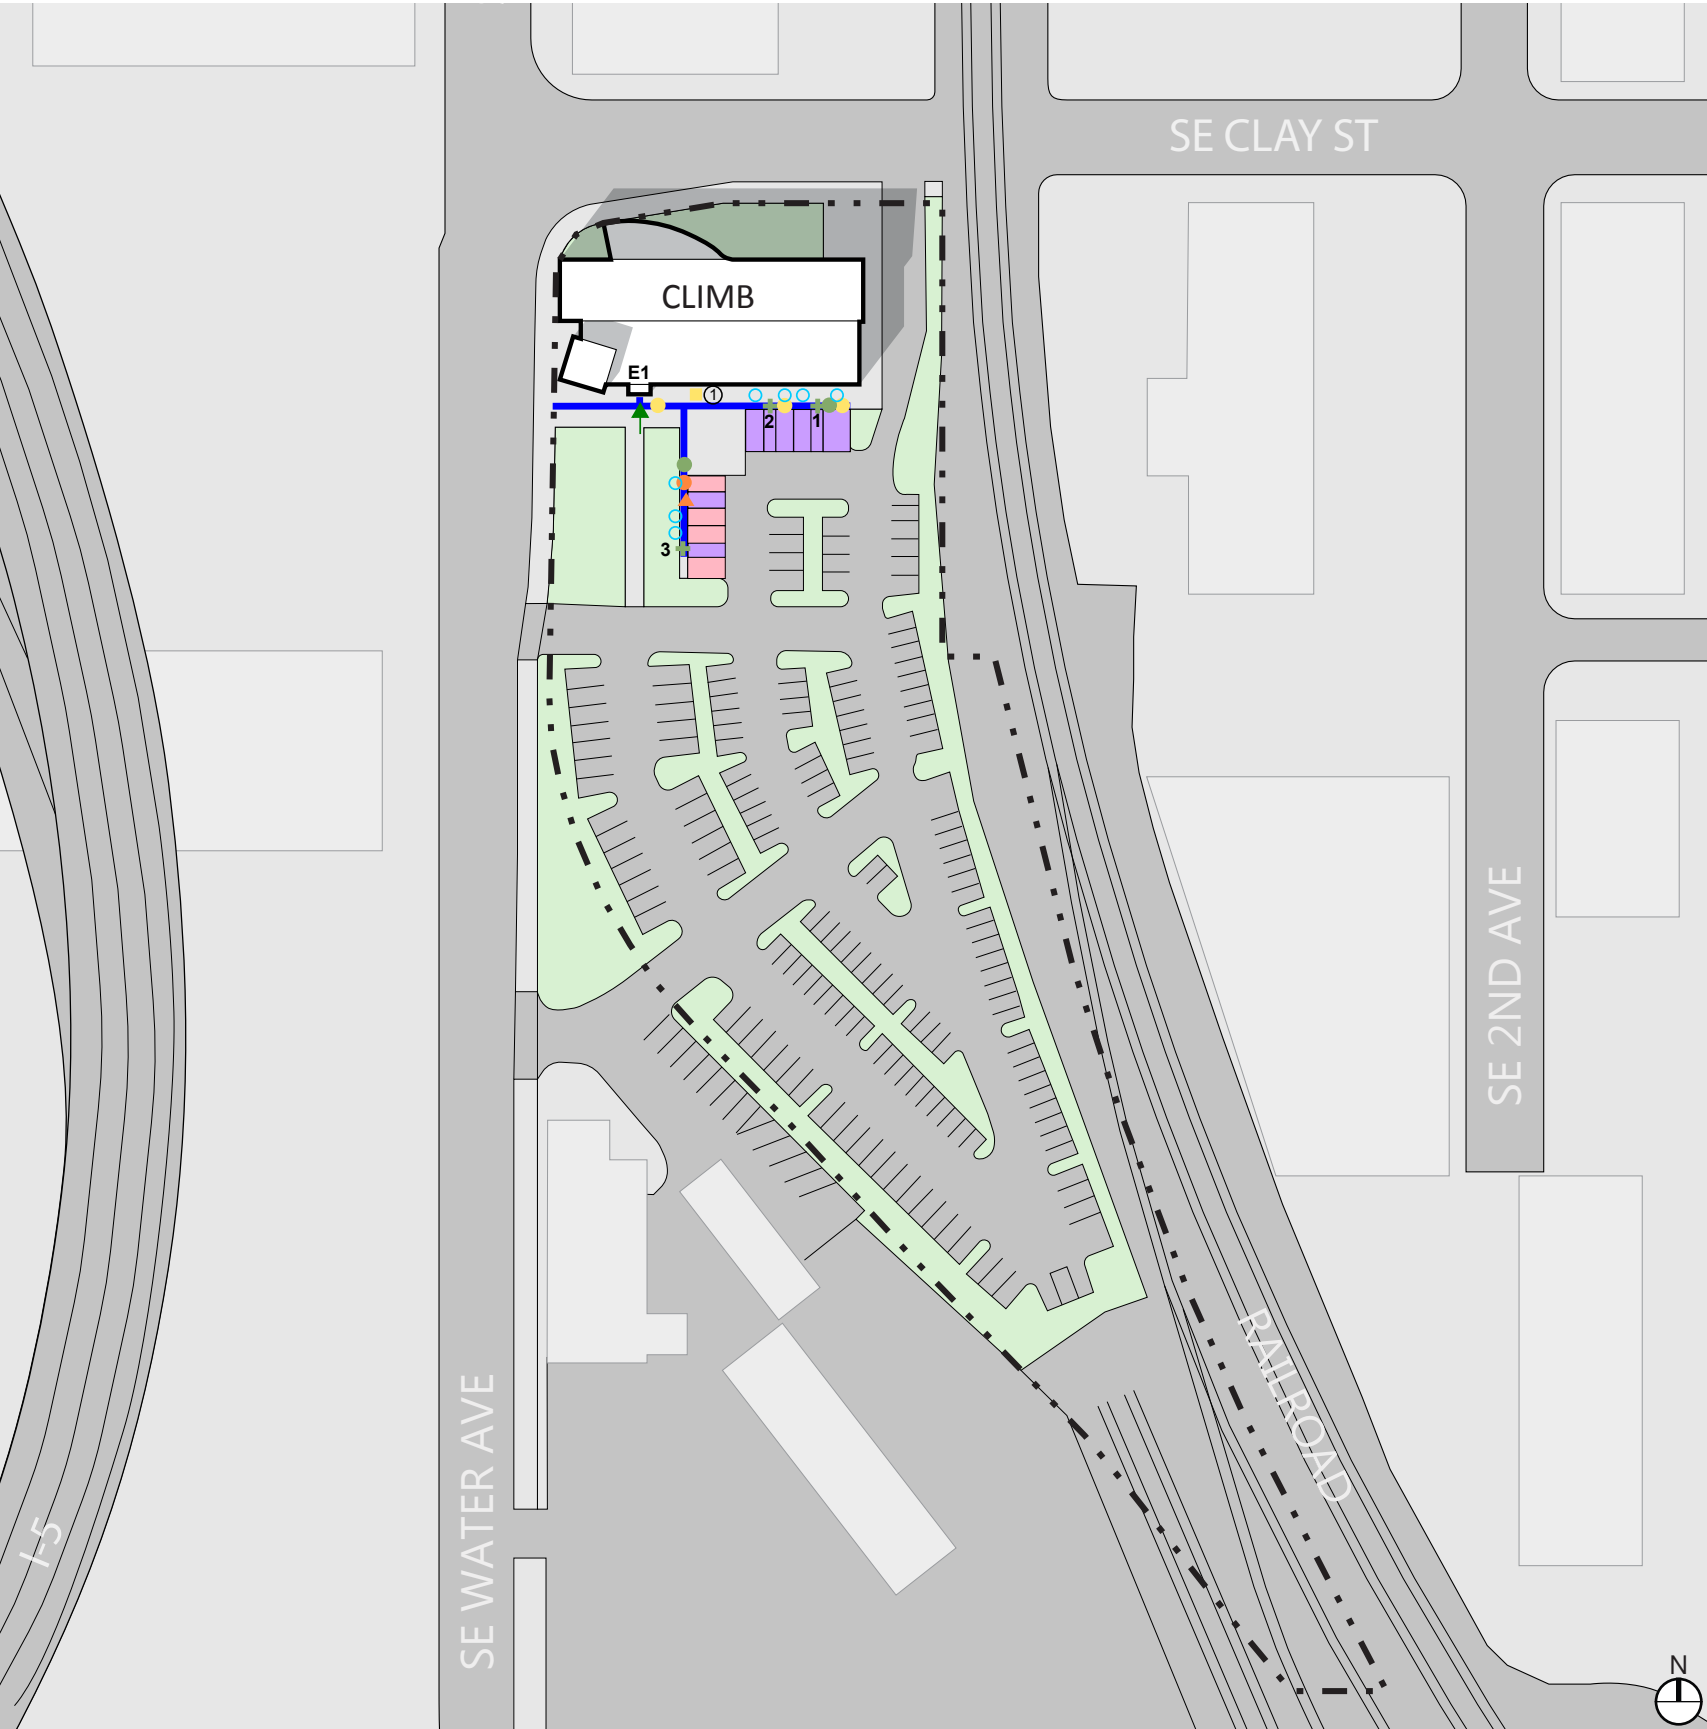
CLIM-ADA-1

1 Minimum clearance requirement to waste receptacle is not met

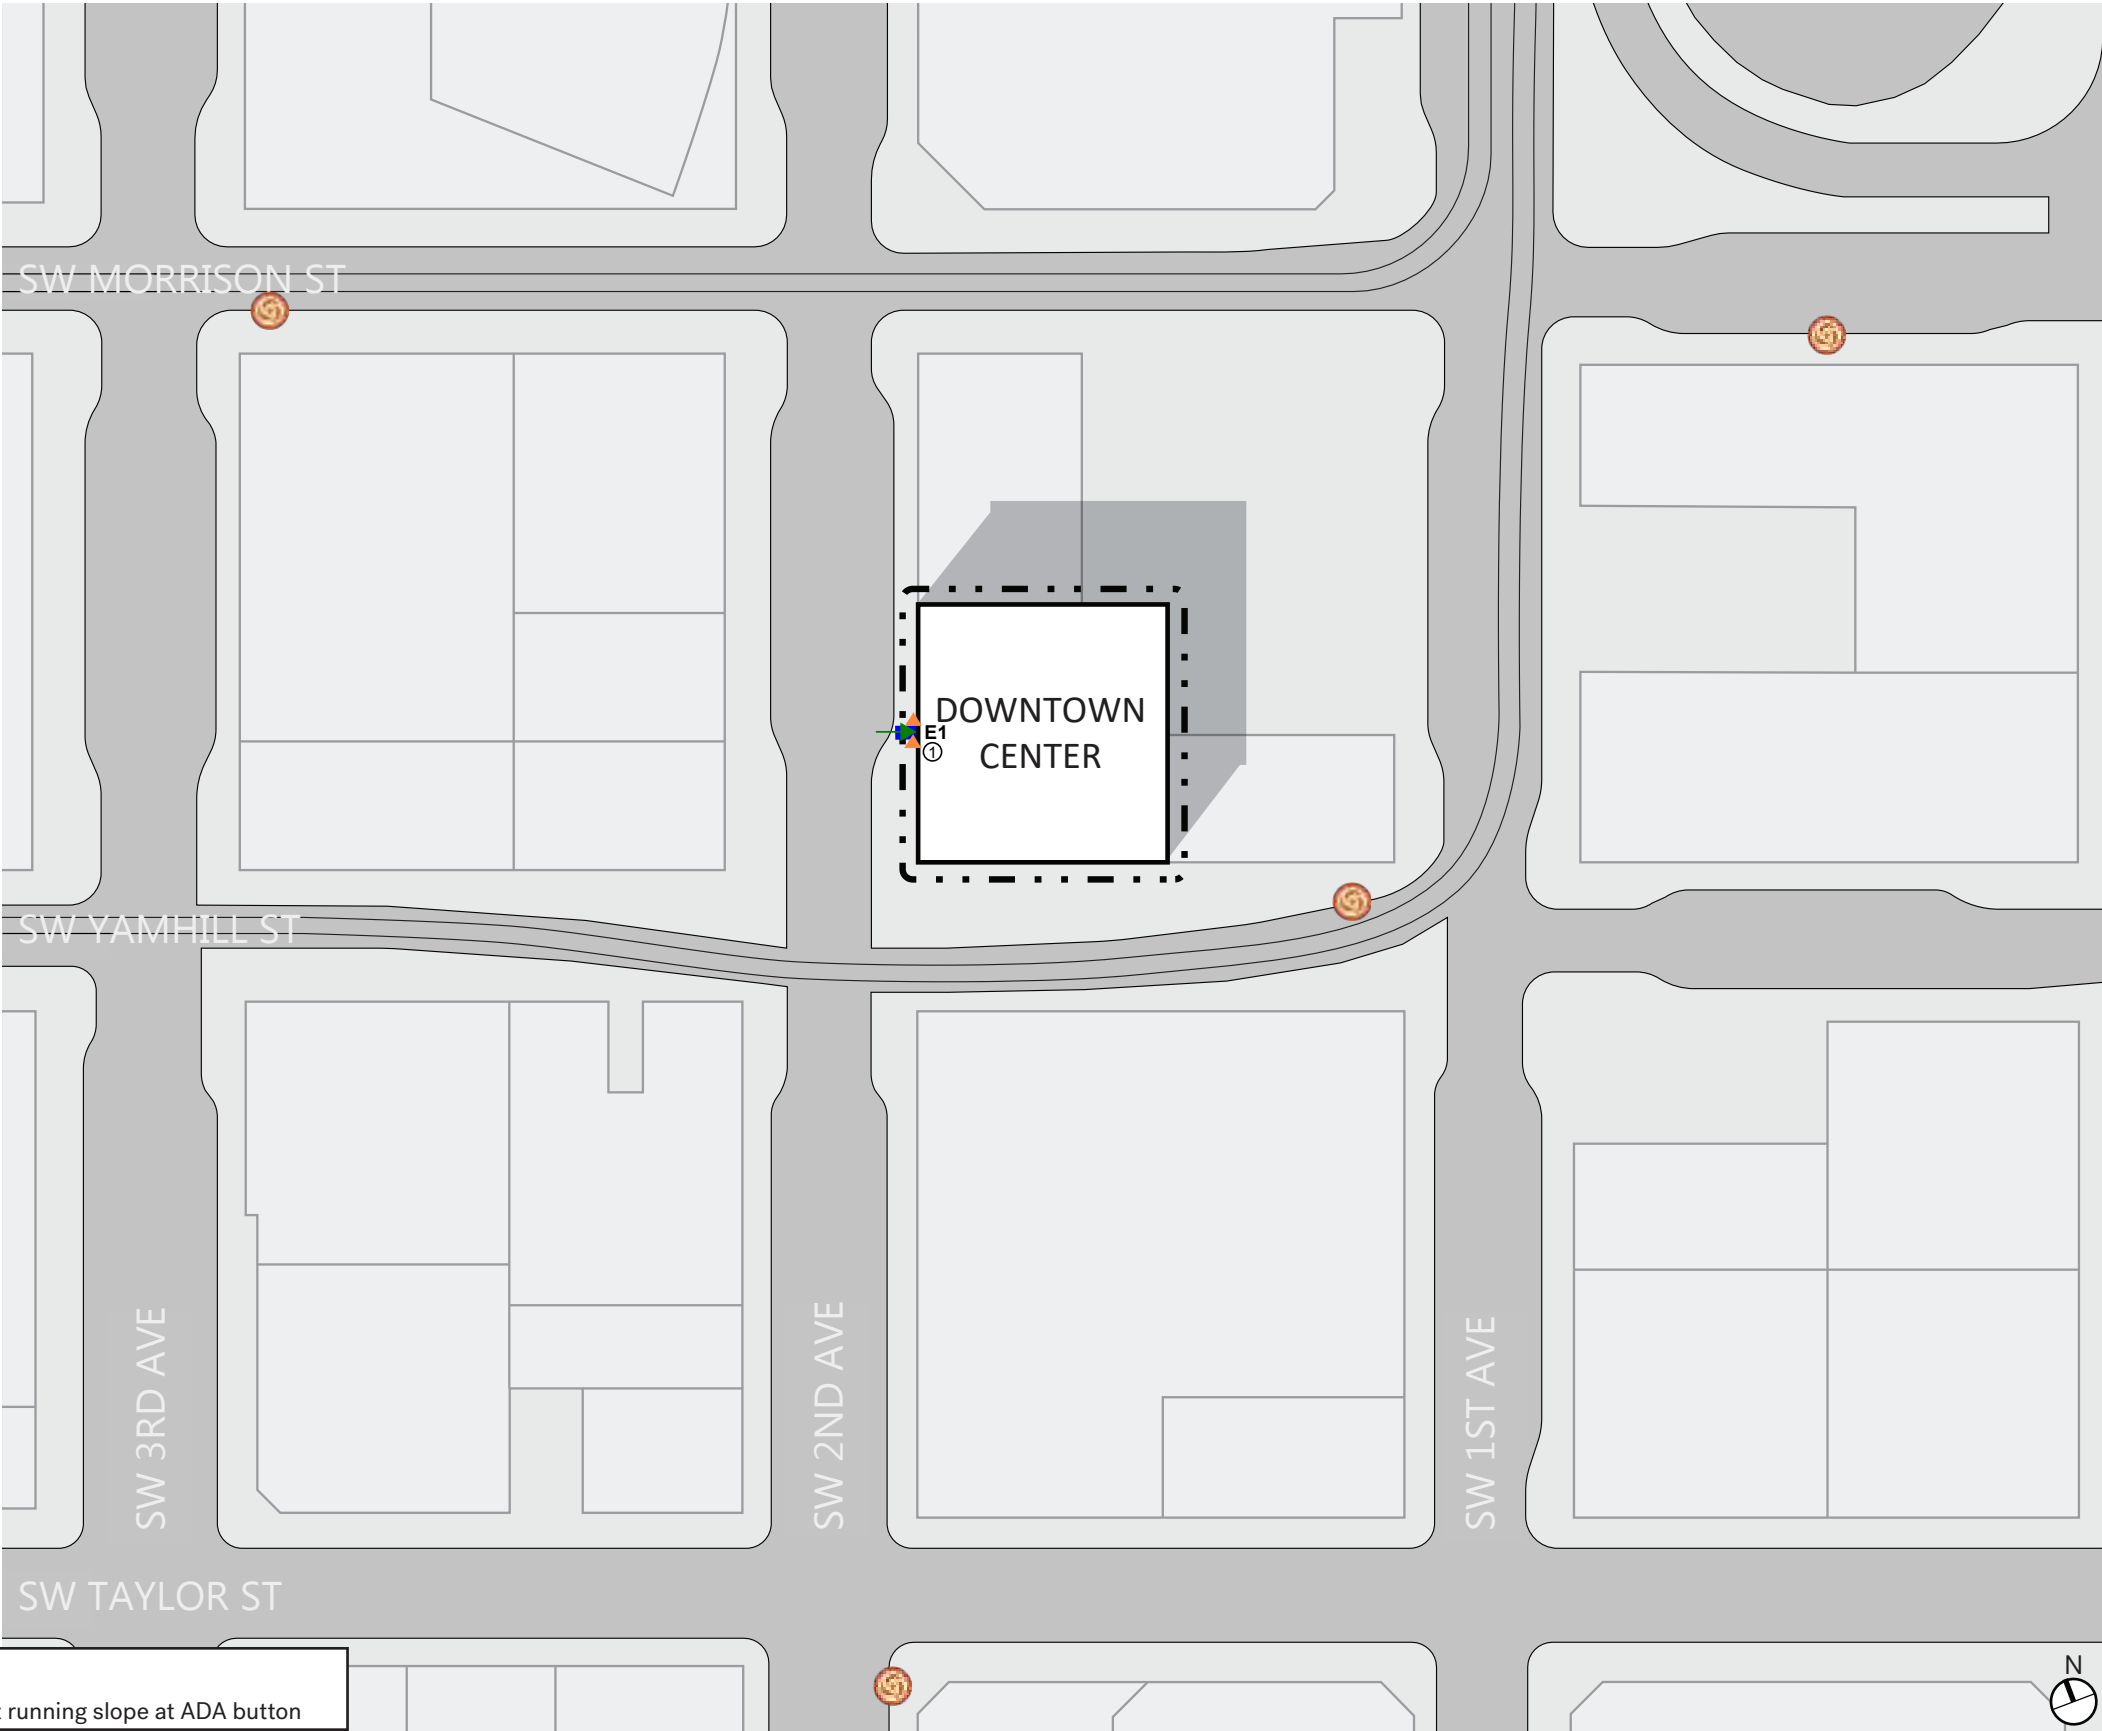
1 Non-compliant running slope at ADA button

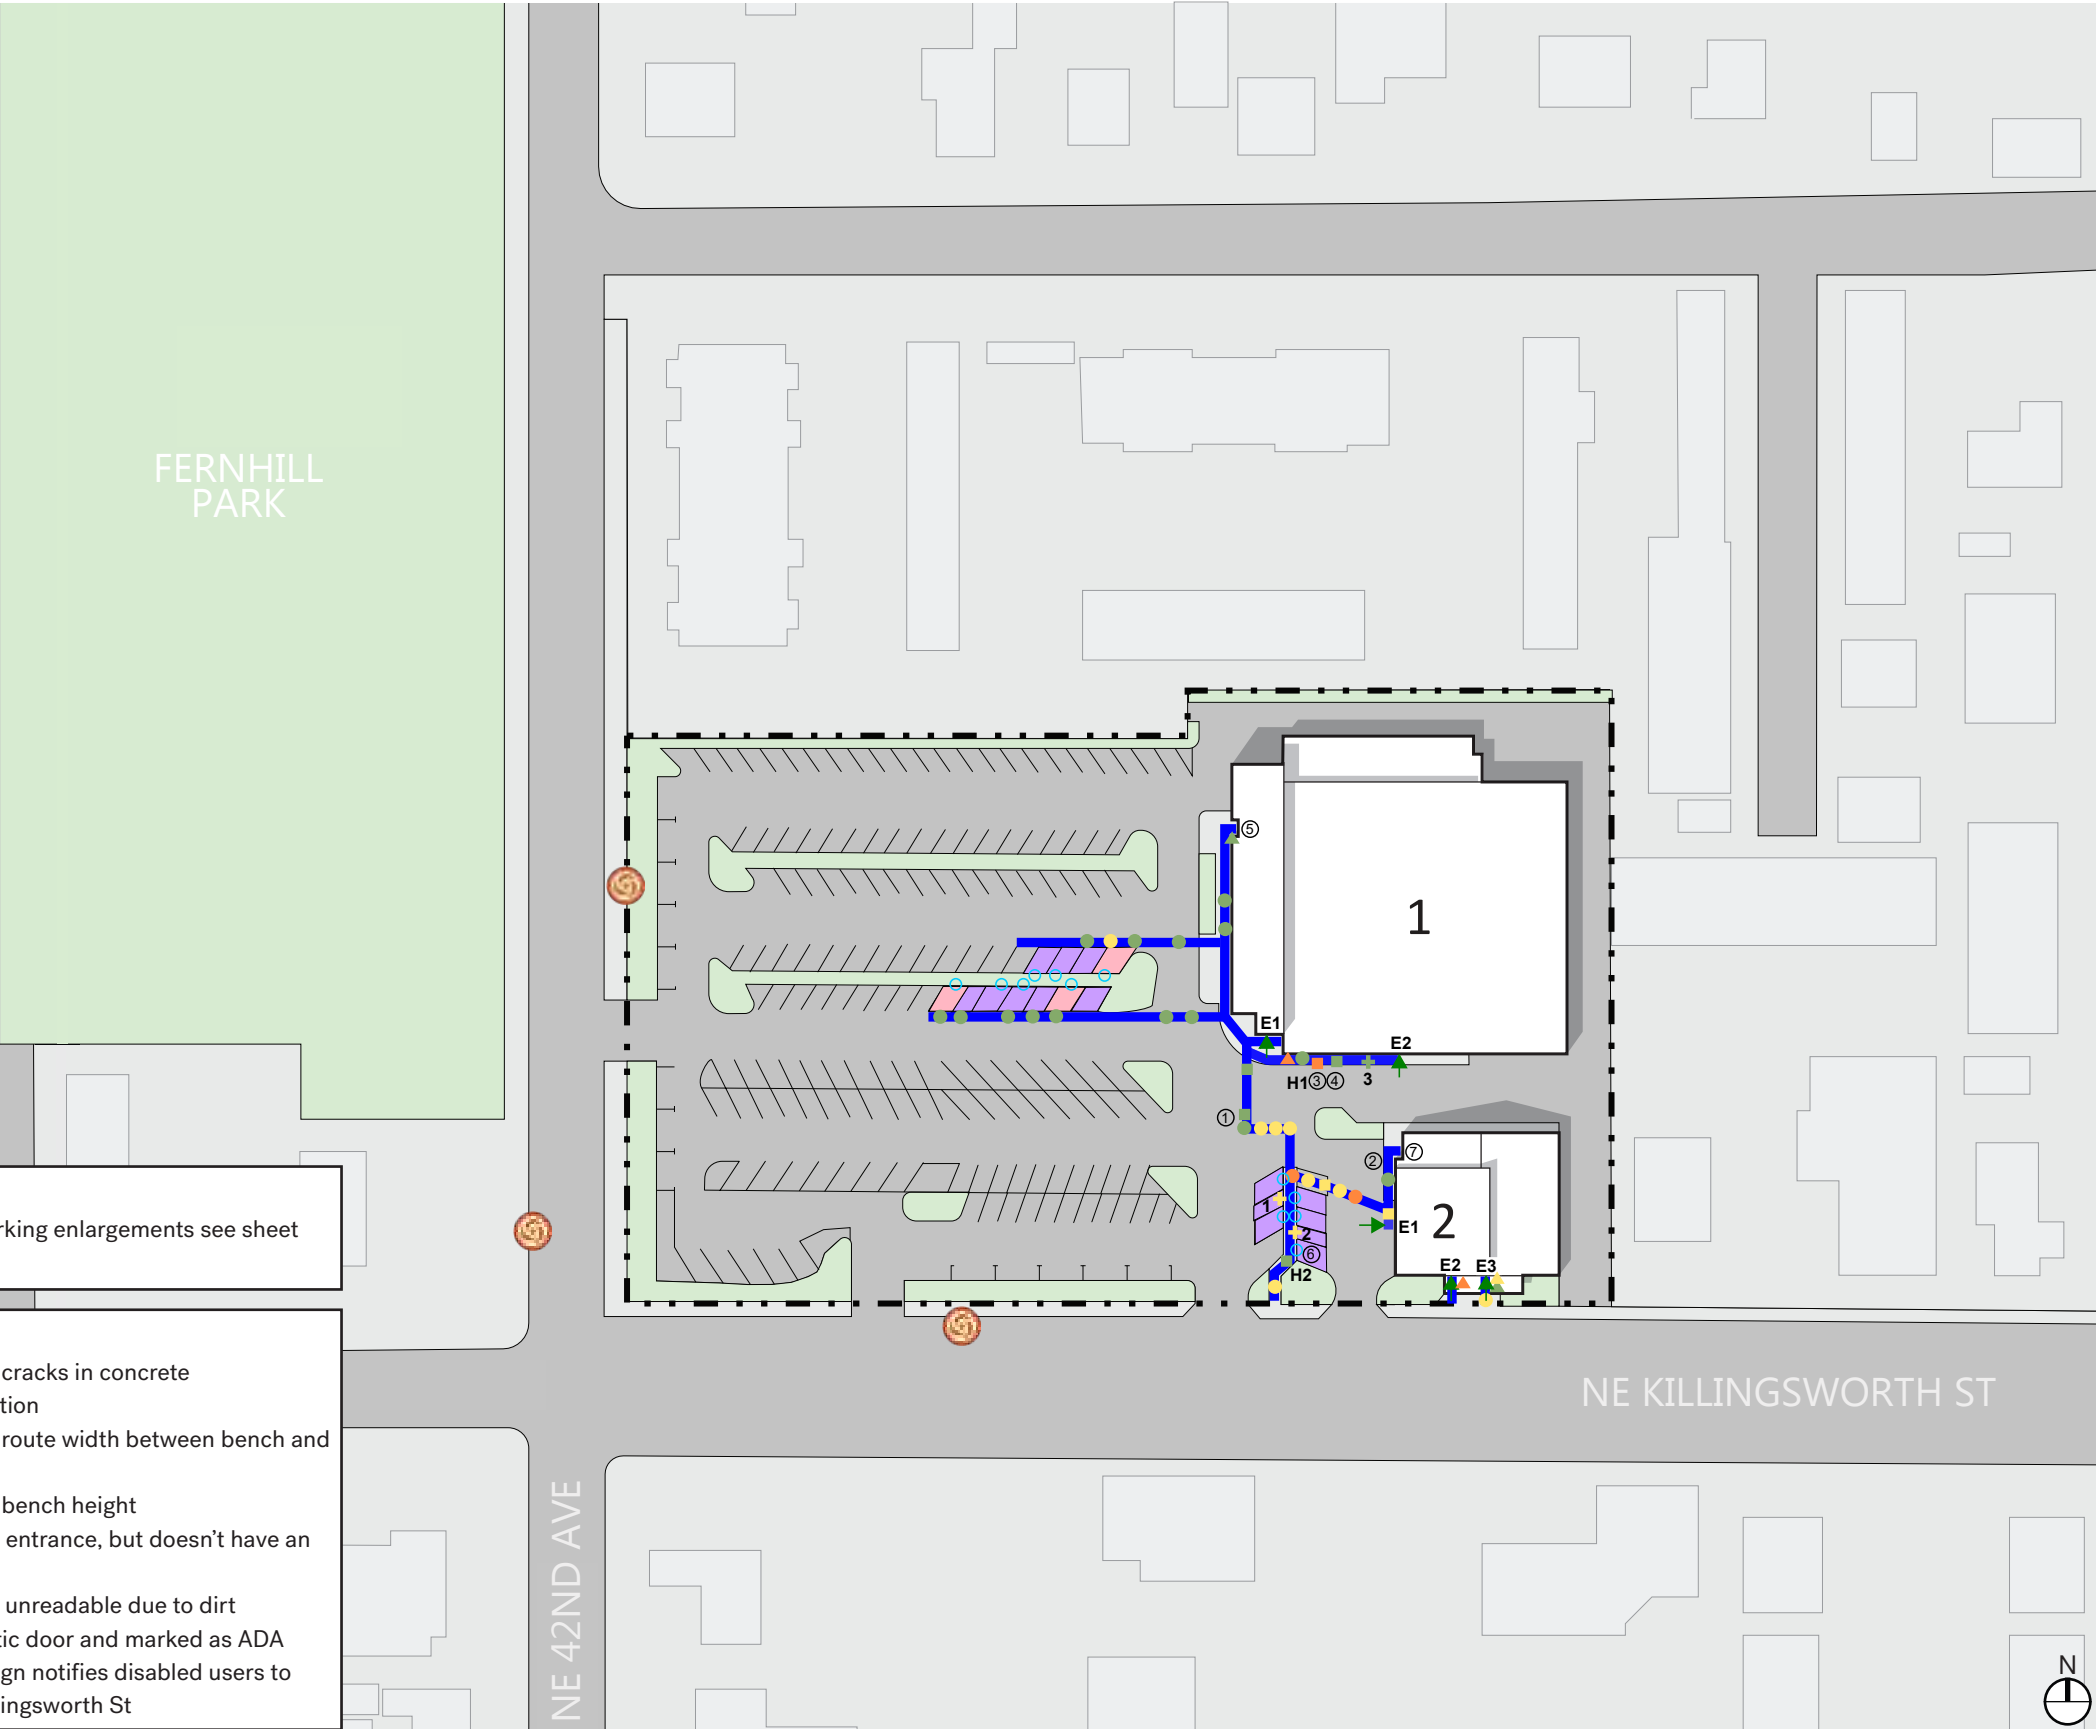
1 Non-compliant cracks in concrete

6 Accessible sign unreadable due to dirt

7 Has an automatic door and marked as ADA entrance, but sign notifies disabled users to enter on NE Killingsworth St
