FACILITIES PLAN TECHNICAL REPORTS

# Civil Site Accessibility and Utilities

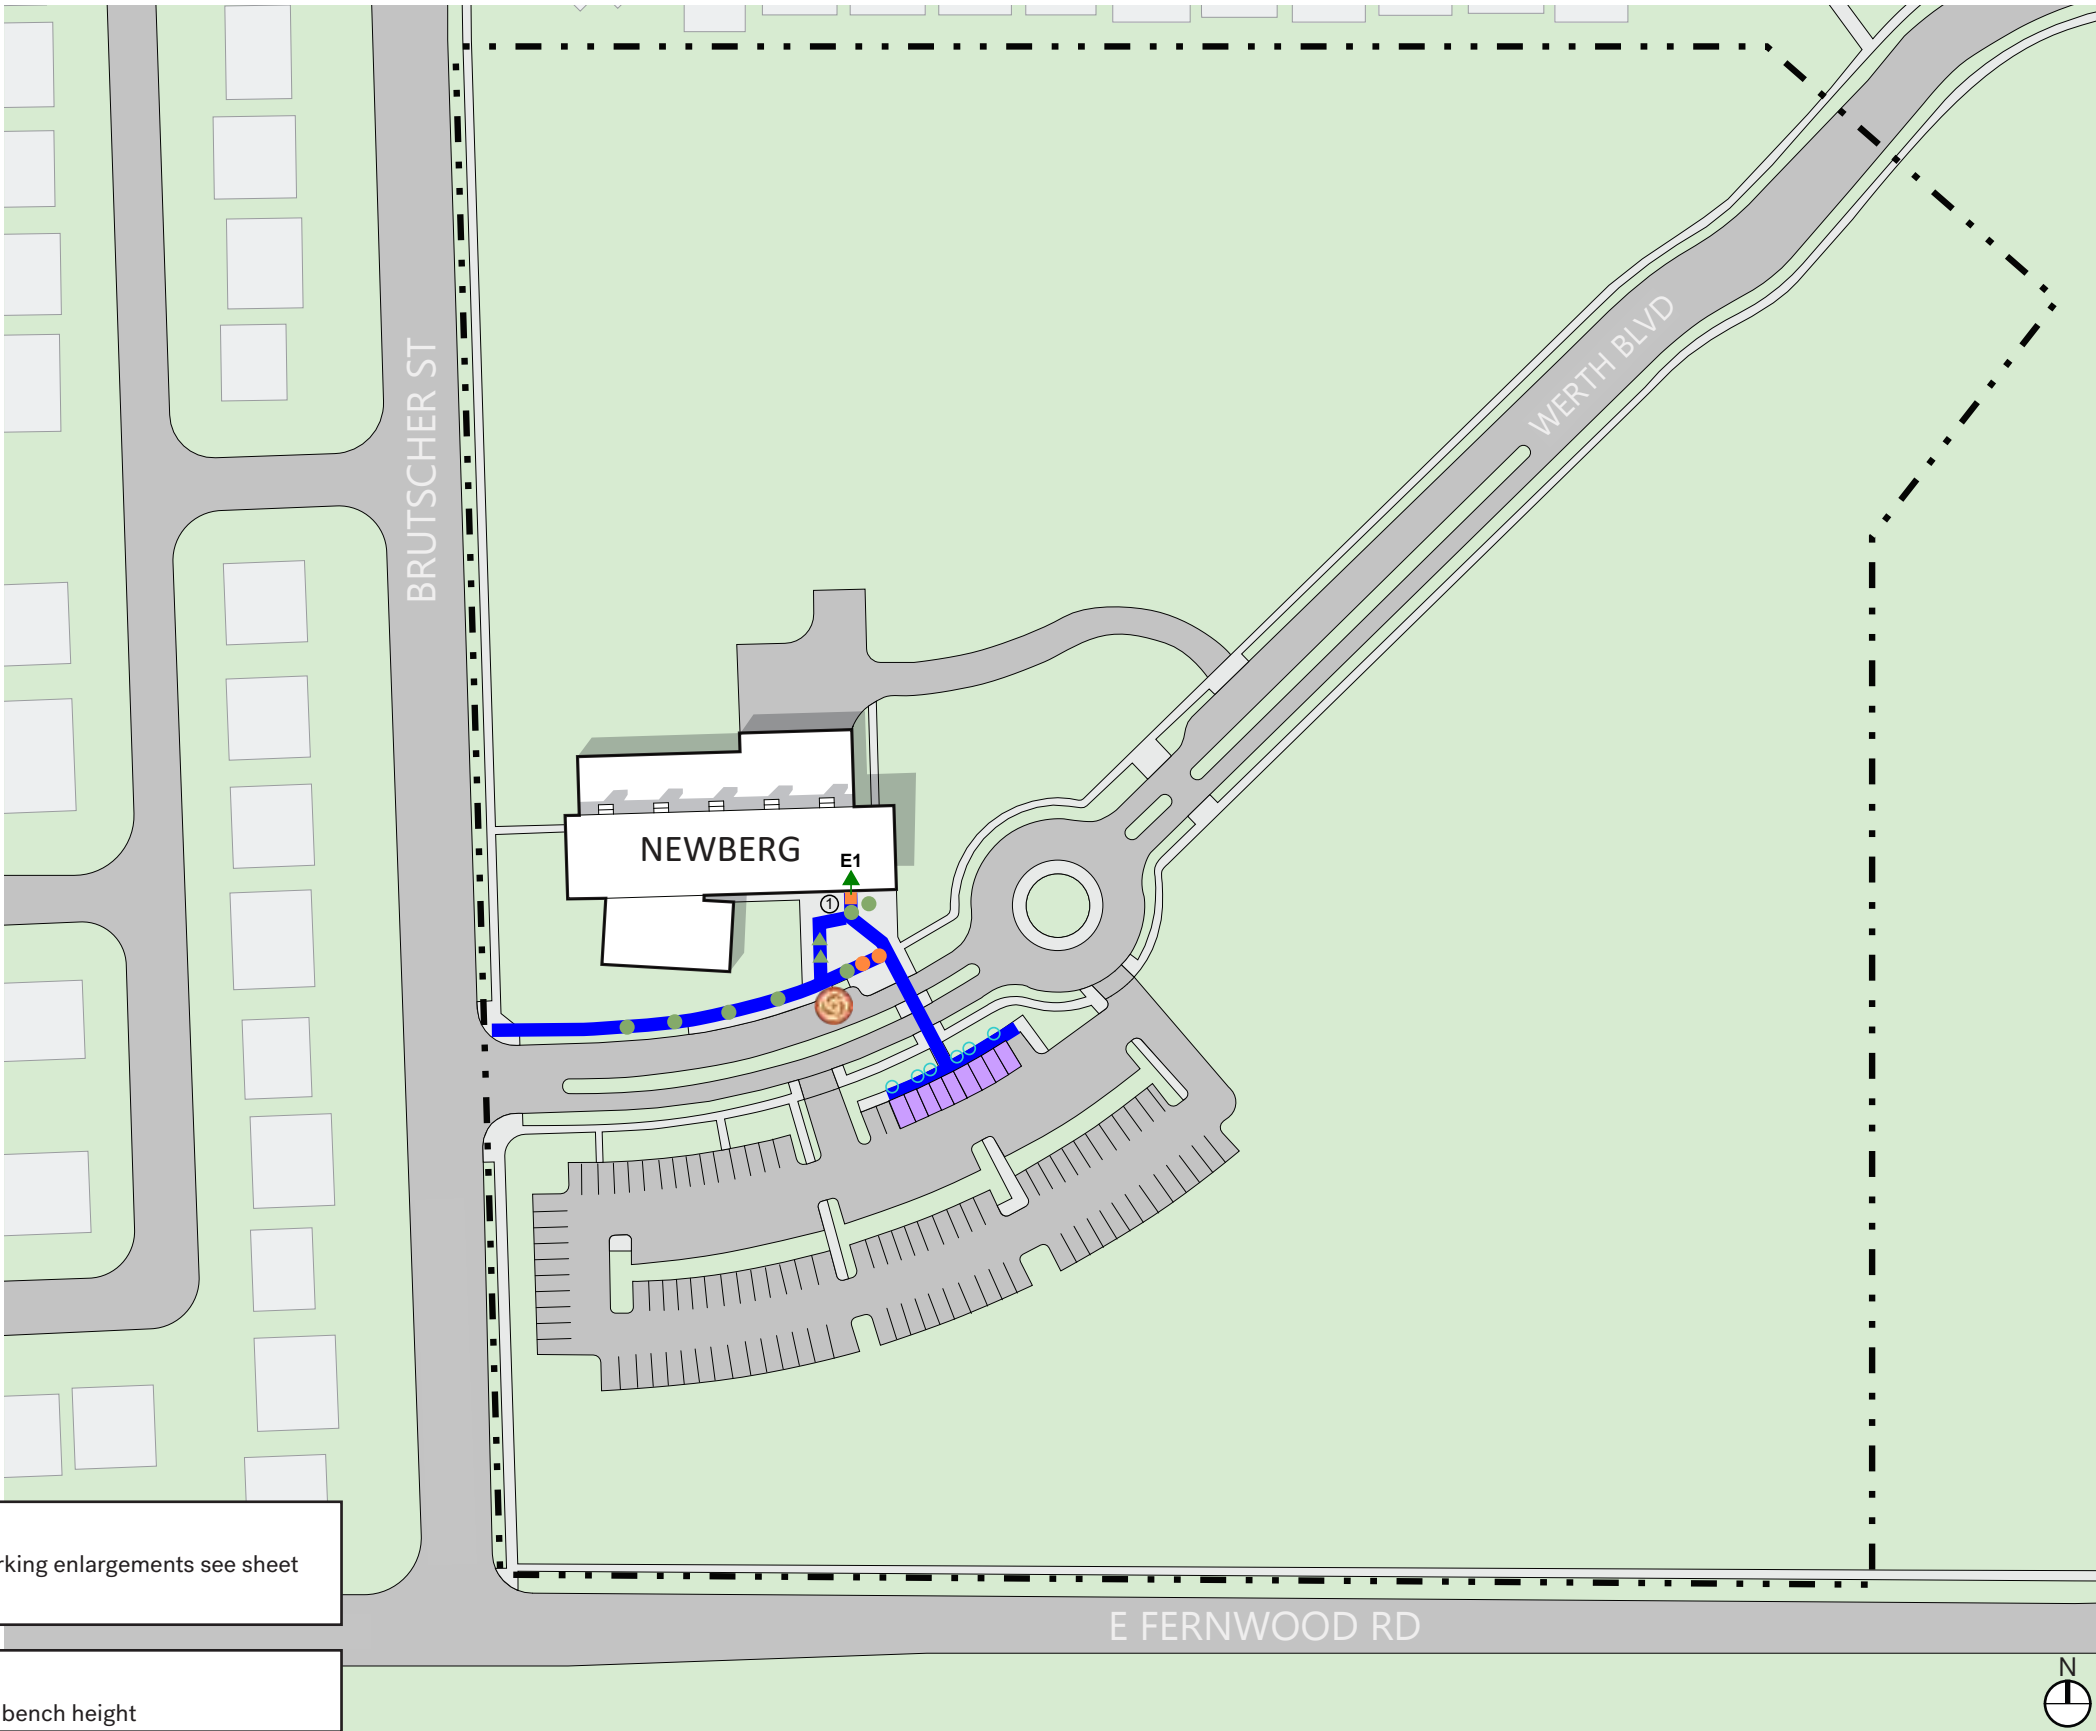
1 Non-compliant bench height

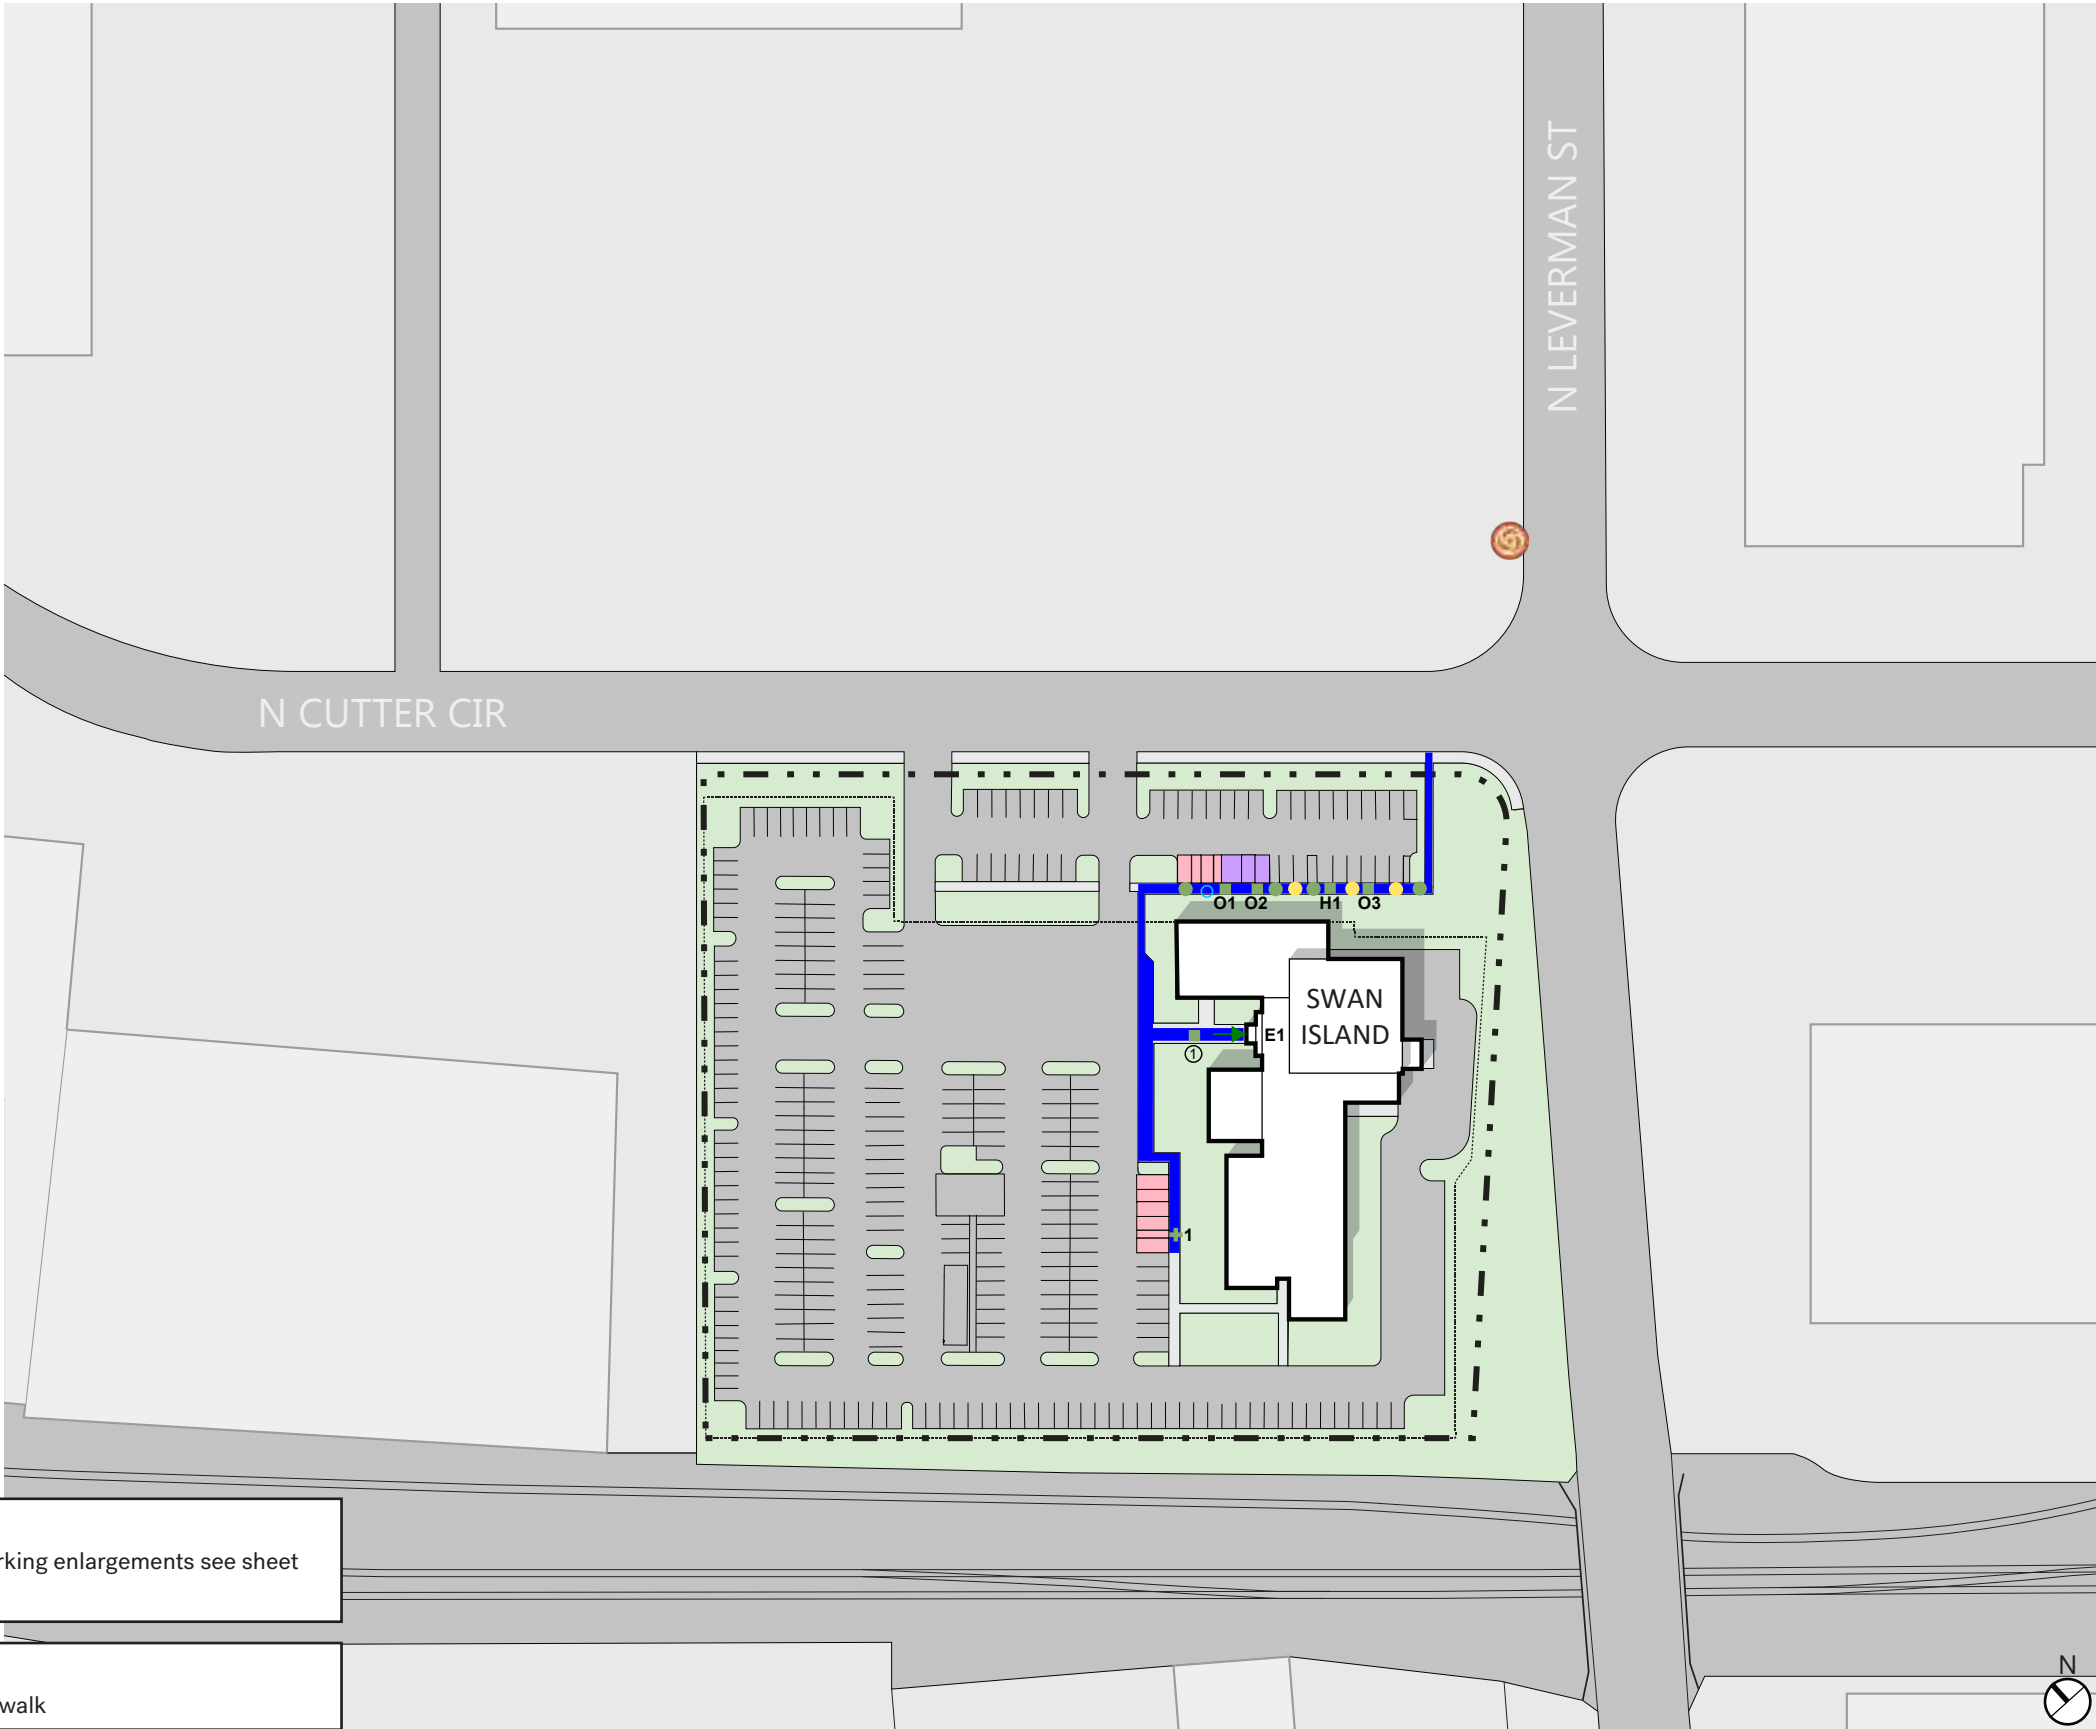
1 Ponding in sidewalk

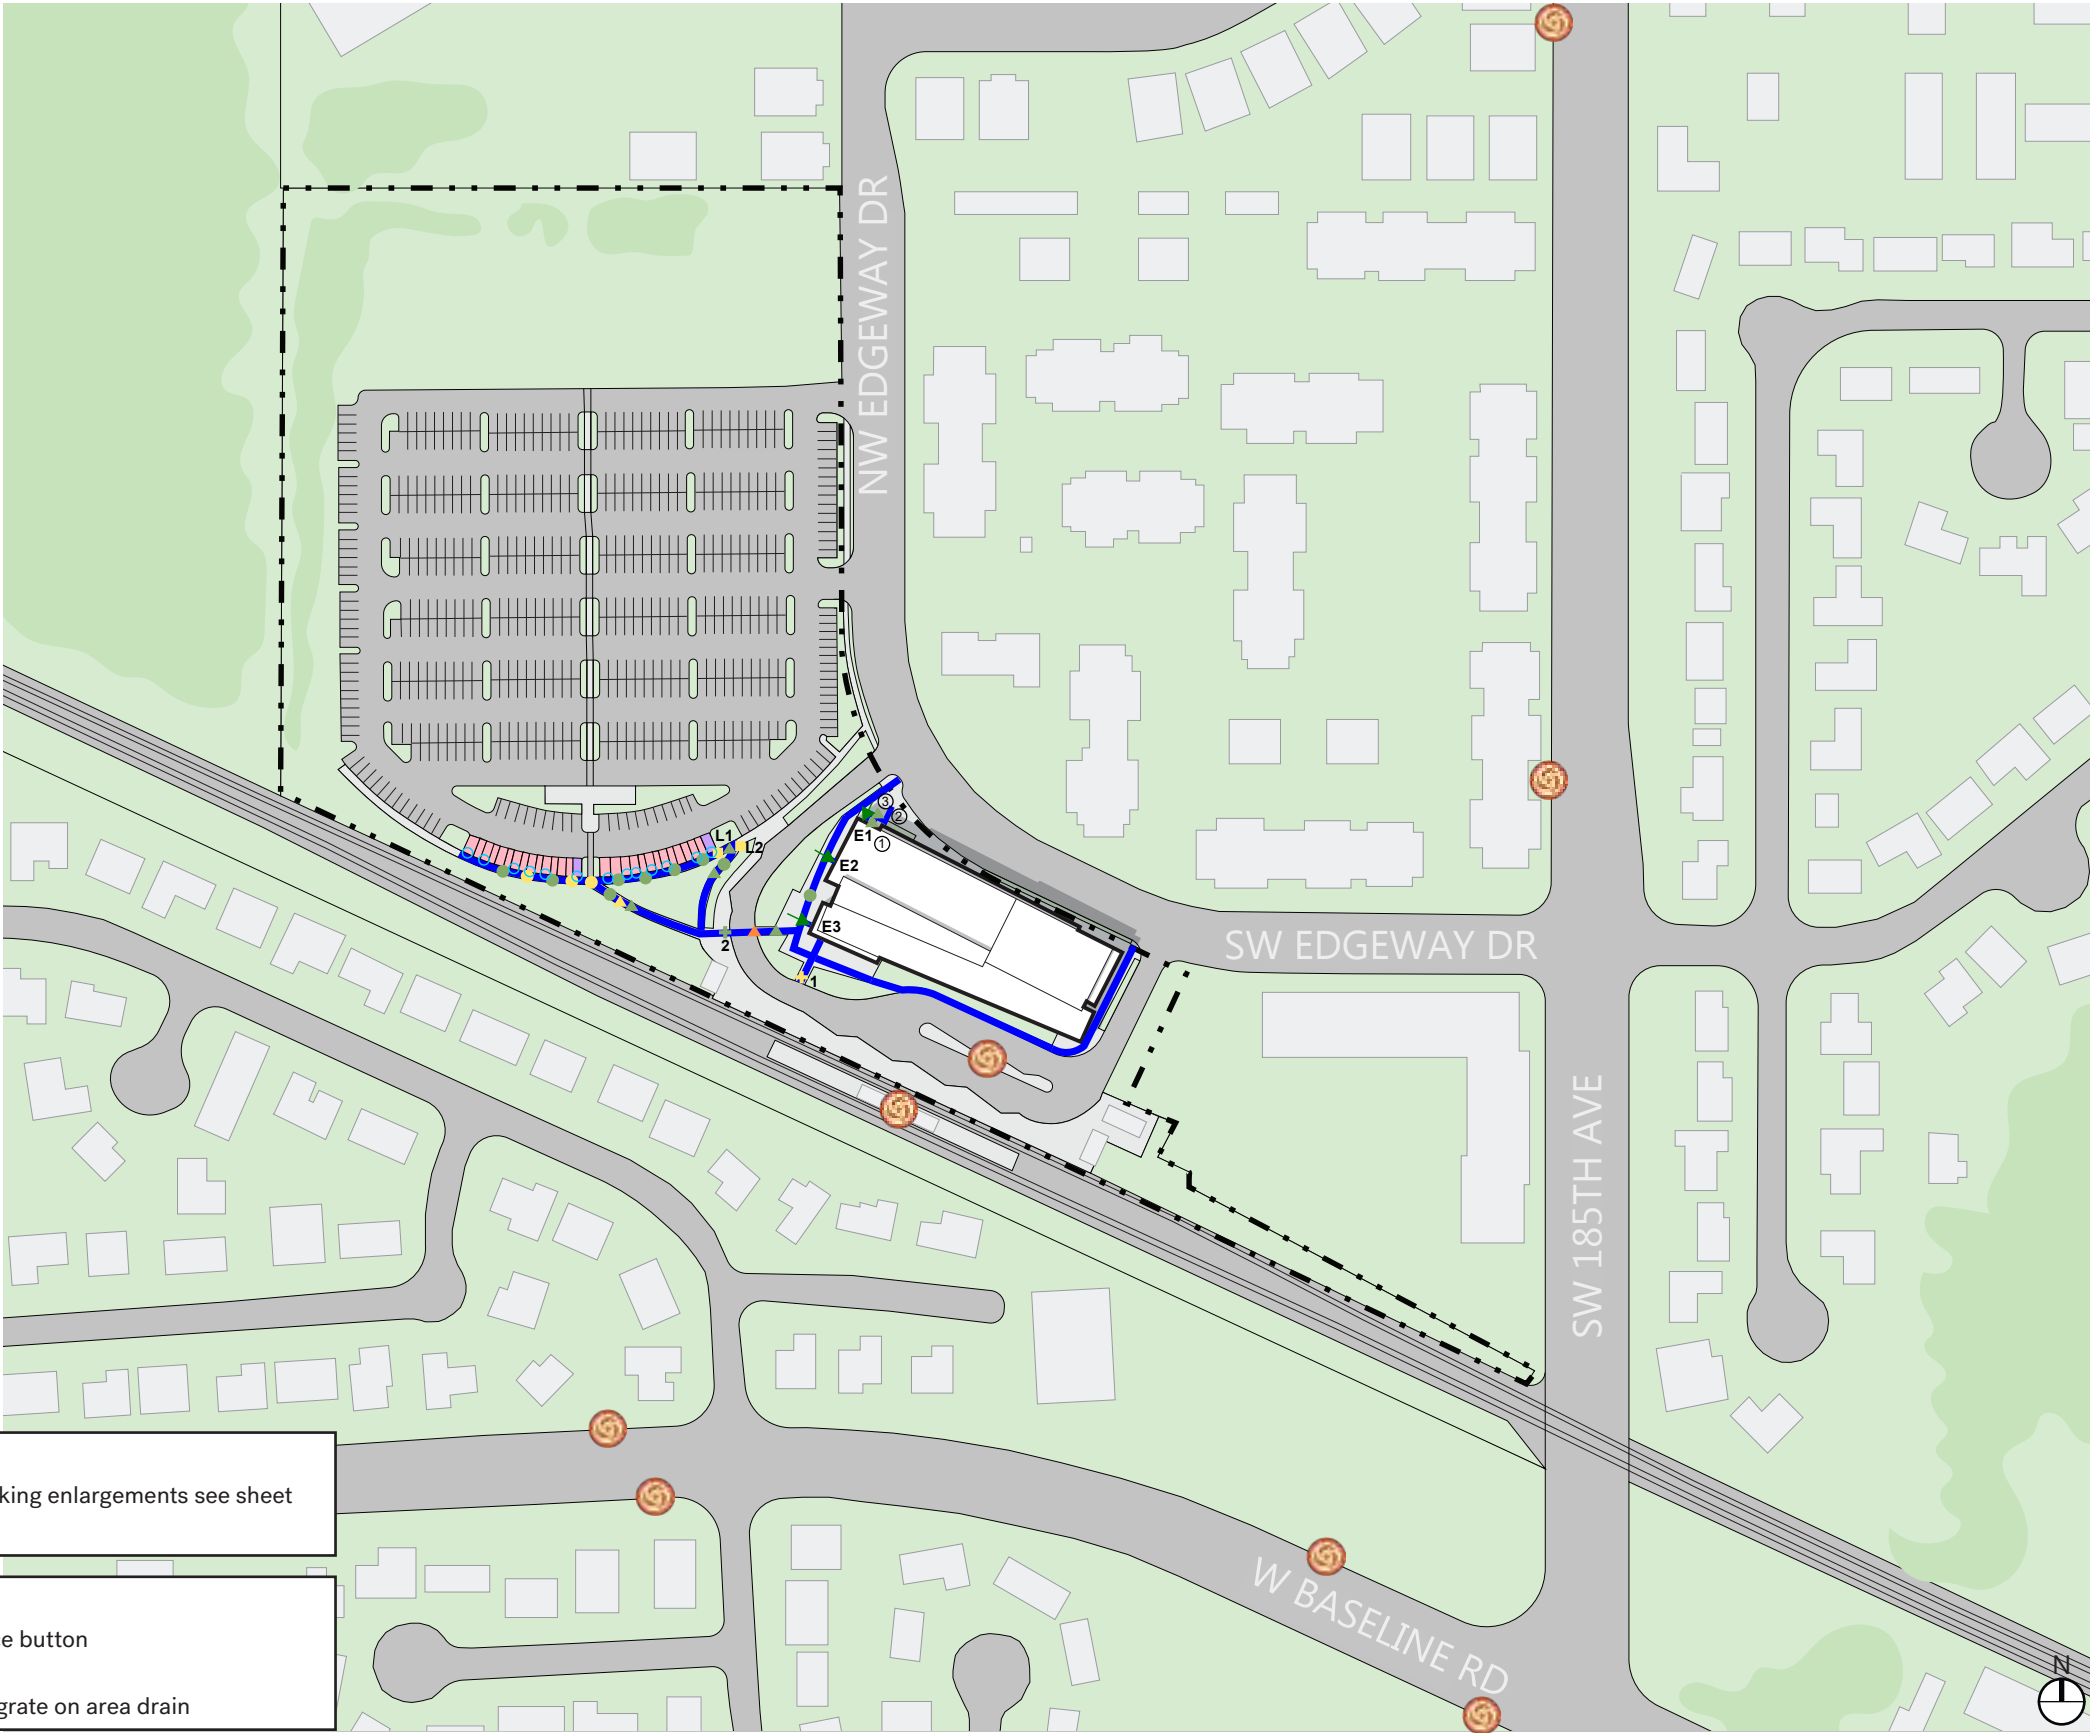
2 No handrails

3 Non-compliant grate on area drain
