FACILITIES PLAN TECHNICAL REPORTS

PORTLAND COMMUNITY COLLEGE
IT Master Plan
Infrastructure Existing Conditions Report

Date: April 17, 2018

Prepared for:
SRG Partnership

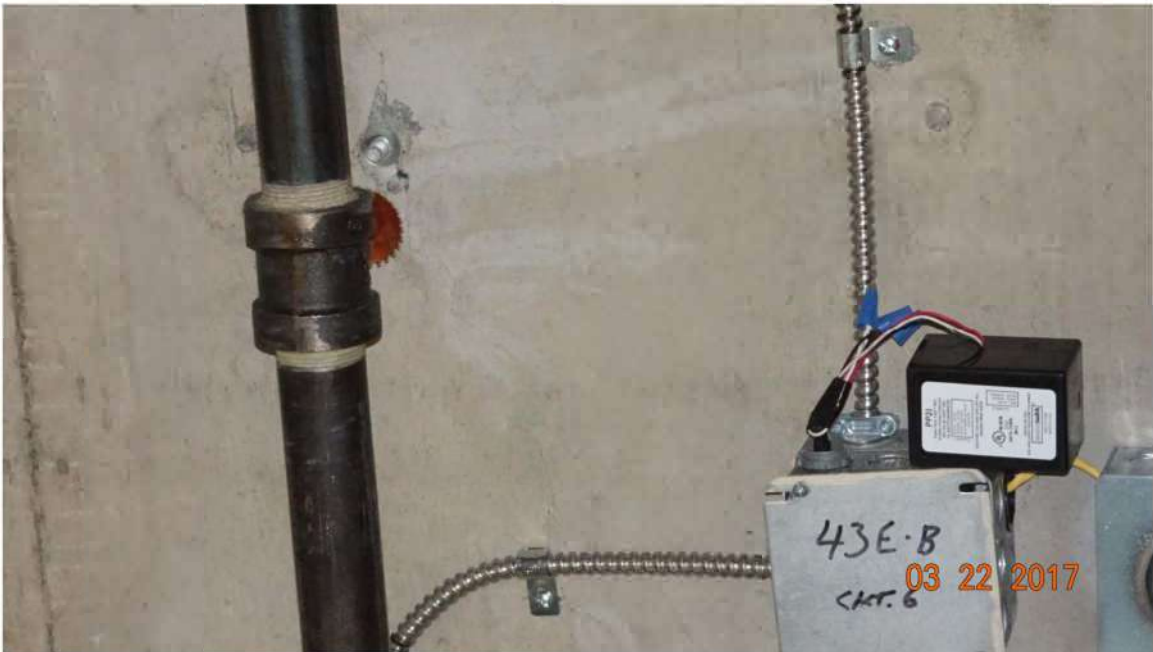
Figure 15 Sprinkler adjacent to open electrical circuits presents a hazard.

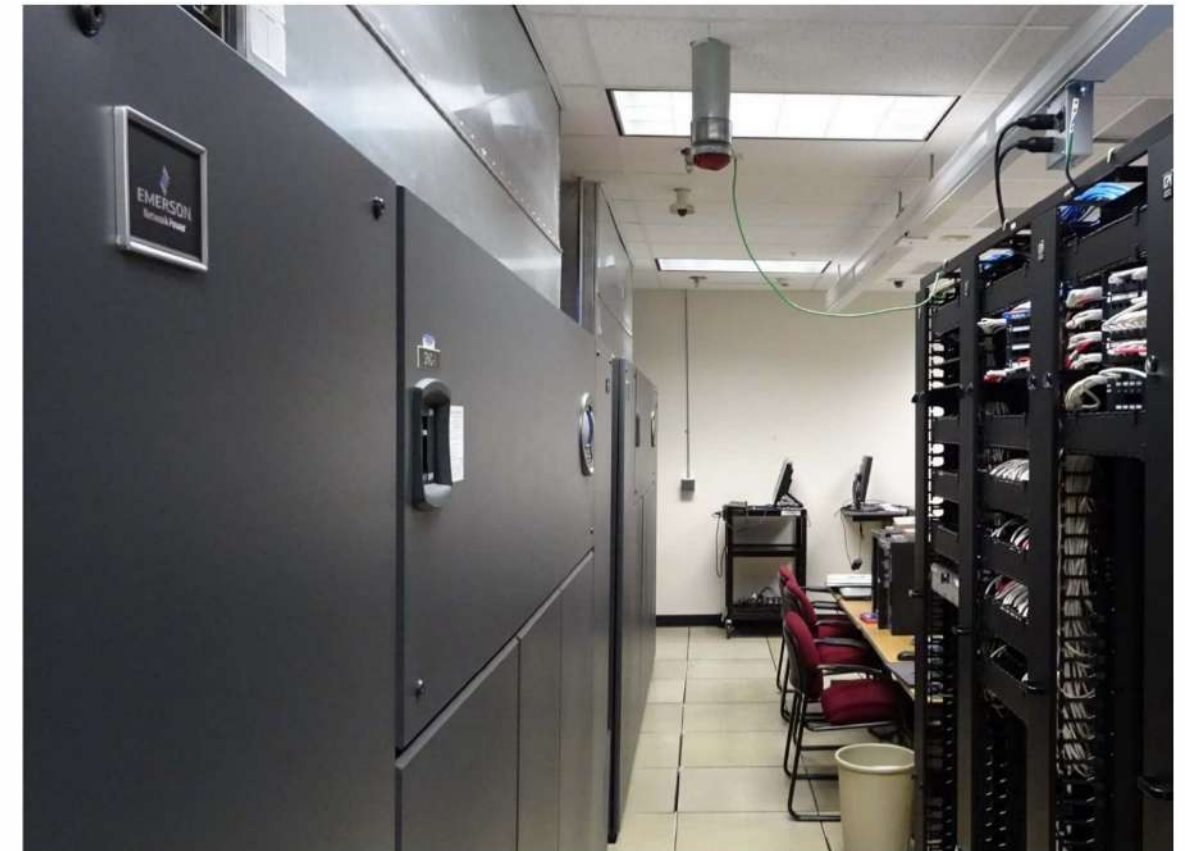
1. The data center at the Sylvania campus was renovated in 2011. The data center has 1120 sqft of useable raised floor space supporting up to 19 cabinets with less than 19 cabinets currently populated. A non-contained “hot aisle / cold aisle” method of cooling is used. This involves lining up server racks in alternating rows with cold air intakes facing one way and hot air exhausts facing the other. The rows composed of rack fronts are called cold aisles. Typically, cold aisles face air conditioner output ducts. The rows the heated exhausts pour into are called hot aisles. Typically, hot aisles face air conditioner return ducts. Two (N+1) 40-ton CRAC units in addition to an older 10ton CRAC. Cold air distribution is via underfloor areas and perforated floor tiles, and the hot air return uses overhead ducting with no hot aisle containment or other mechanism to separate the return air from the conditioned air.

Figure 16 CRAC Units cool the hot air from the plenum above the ceiling tiles.

5. Recommendation: Install a lug for a roll-up generator. Improve data center HVAC efficiency with hot aisle containment, chimneys or some other mechanism to separate conditioned from return air. Replace end-of-life active electronics. See PAE's report for additional detail.

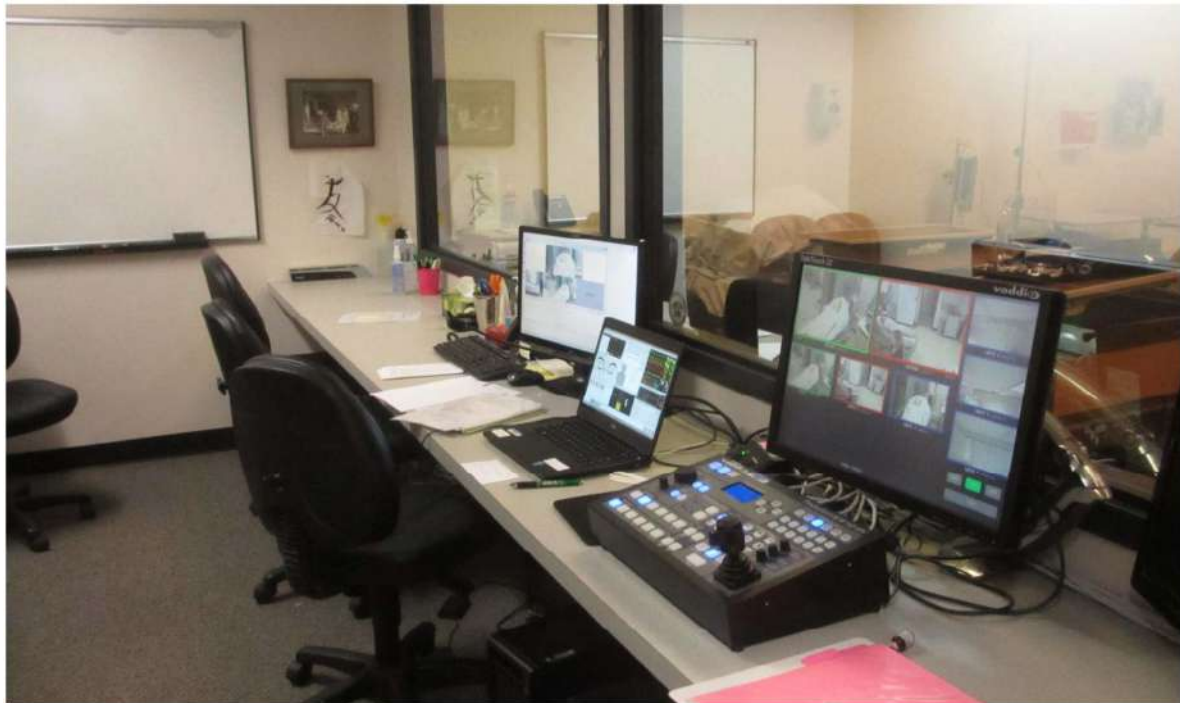
Figure 8 Simulation Lab control room.

8. Recommended changes to this space would include:
 - a. New camera control processor that will work with all existing cameras
 - b. Additional cameras (a total of 6 is preferred by the staff for the room) and microphones for new stations (including "Nursing Station")

- c. New audio management console
 - d. New recording equipment
 - e. Better layout of control space to also simulate "Nursing Station"
 - f. Expand program to include other technologies found in hospital such as nurse call and "Vocera" style paging units (or similar newer technology)

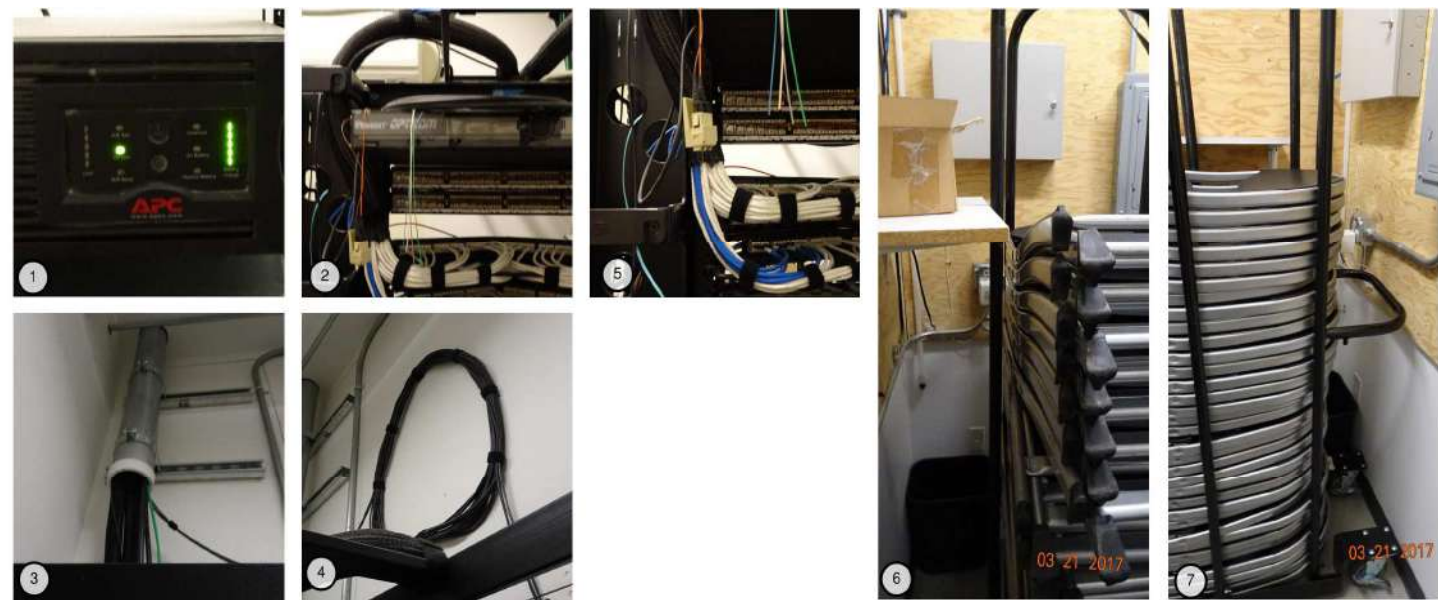
- POSITIVES AND NEGATIVES OF THE IMAGES ABOVE...
- 1. Load and Charge good on UPS.
 - 2. & 5. Bare unterminated fiber optic strands hanging from rack, unsupported fiber connection.
 - 3. Conduits filled beyond recommended capacity – expansion limited – no firestop present.
 - 4. Good example of Fiber optic service loop.
 - 6. & 7 Chair storage behind racks do not allow for clearance to PCC standards.

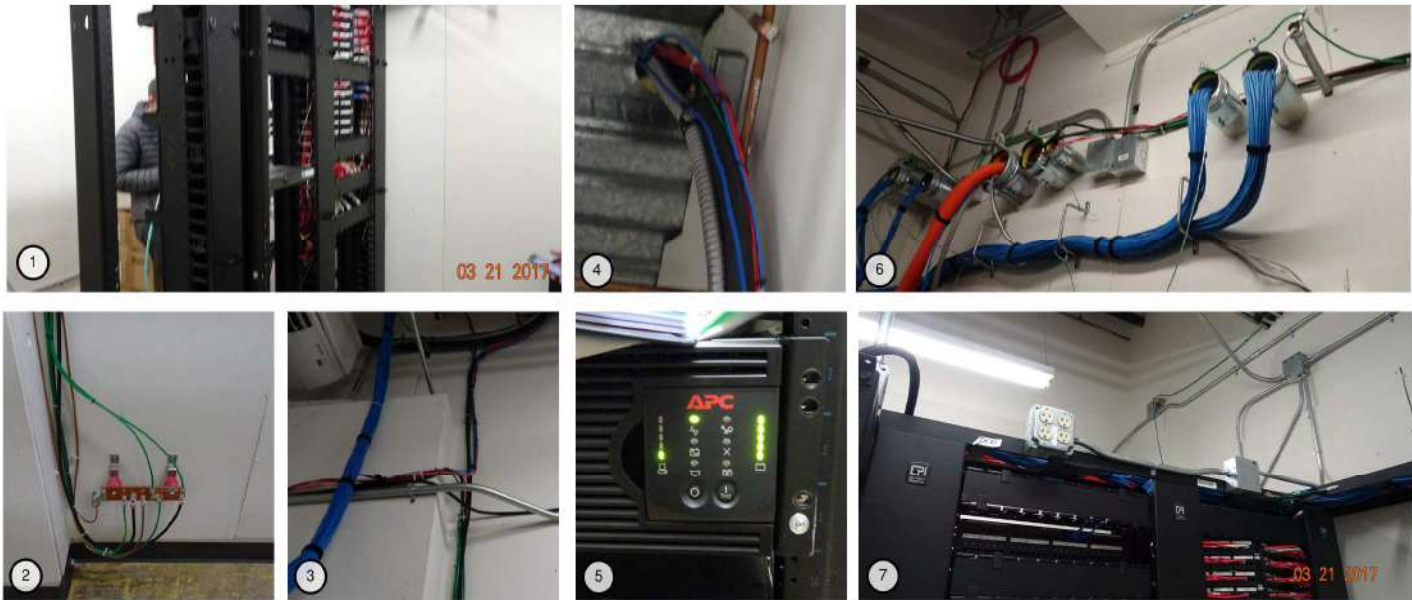
- POSITIVES AND NEGATIVES OF THE IMAGES ABOVE...
- 1. Rack management good, excellent room for expansion.
 - 2. System ground conforms to PCC standard.
 - 3. Poor cable support and routing.
 - 4. Voice Data cables, Electrical, HVAC lines sharing core – no sleeve or Firestop – code violation.
 - 5. Load and Charge good on UPS.
 - 6. Conduit capacity good, but required Firestop / sealant is not present.
 - 7. Cable management good.

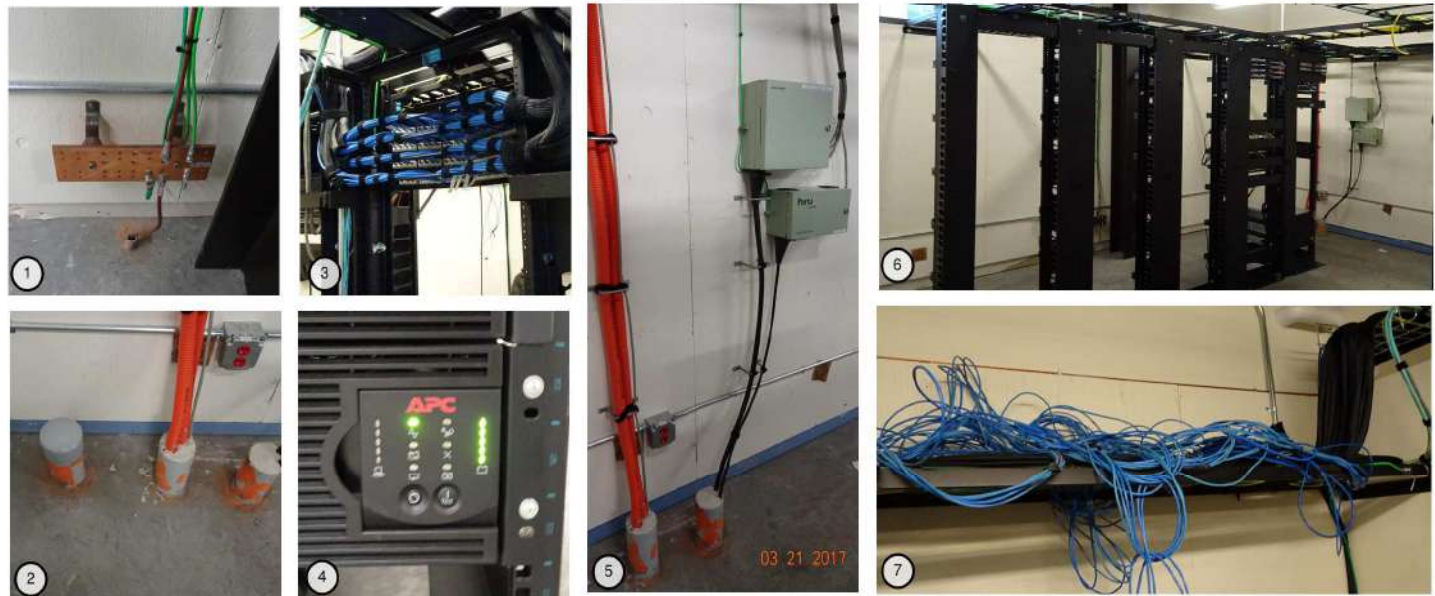
- POSITIVES AND NEGATIVES OF THE IMAGES ABOVE...
- 1. System ground conforms to PCC standard.
 - 2. & 5. Conduit seal good, sealant is not intumescent fire stop.
 - 3. & 6. Rack management good, excellent room for expansion.
 - 4. Load and Charge good on UPS.
 - 7. Unterminated cables on ladder tray (could be work in progress).

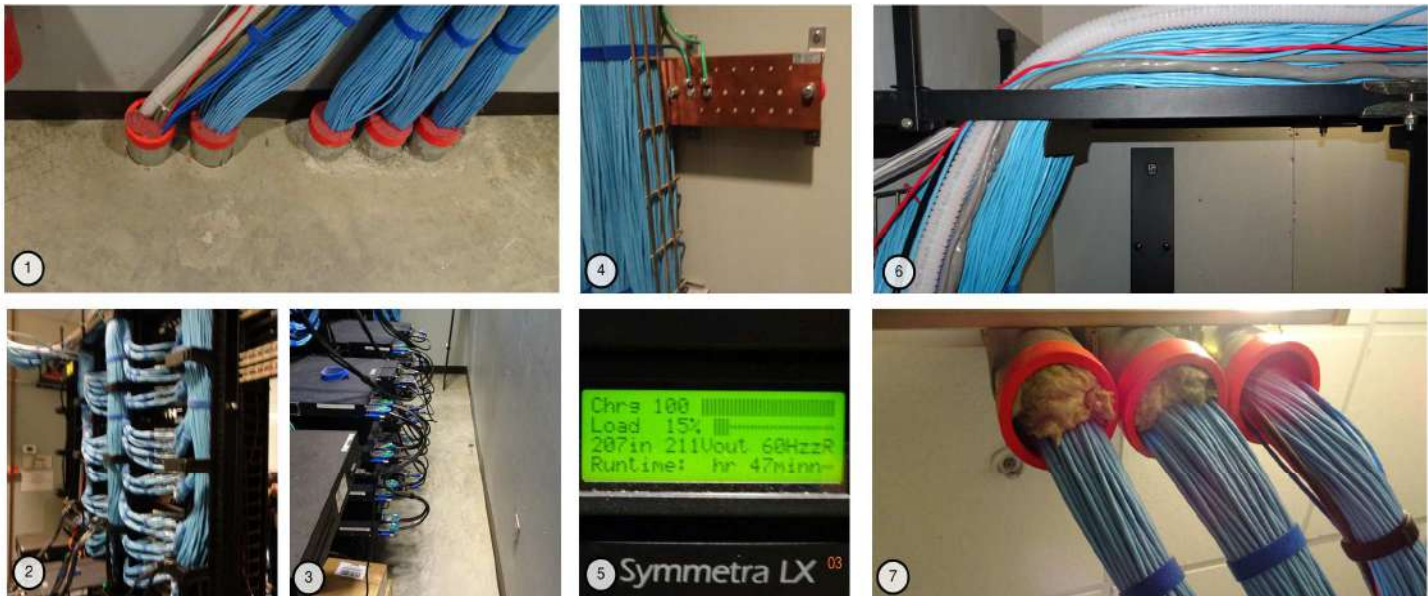
- POSITIVES AND NEGATIVES OF THE IMAGES ABOVE...
- 1. Conduits filled beyond recommended capacity, future expansion limited.
 - 2. Expansion capacity adequate, good cable management.
 - 3. Clearance behind racks not PCC standard.
 - 4. System ground barely conforms to PCC standard.
 - 5. Load and Charge good on UPS.
 - 6. Cable tray loading exceeds recommended capacity.
 - 7. Firestop materials not correct.

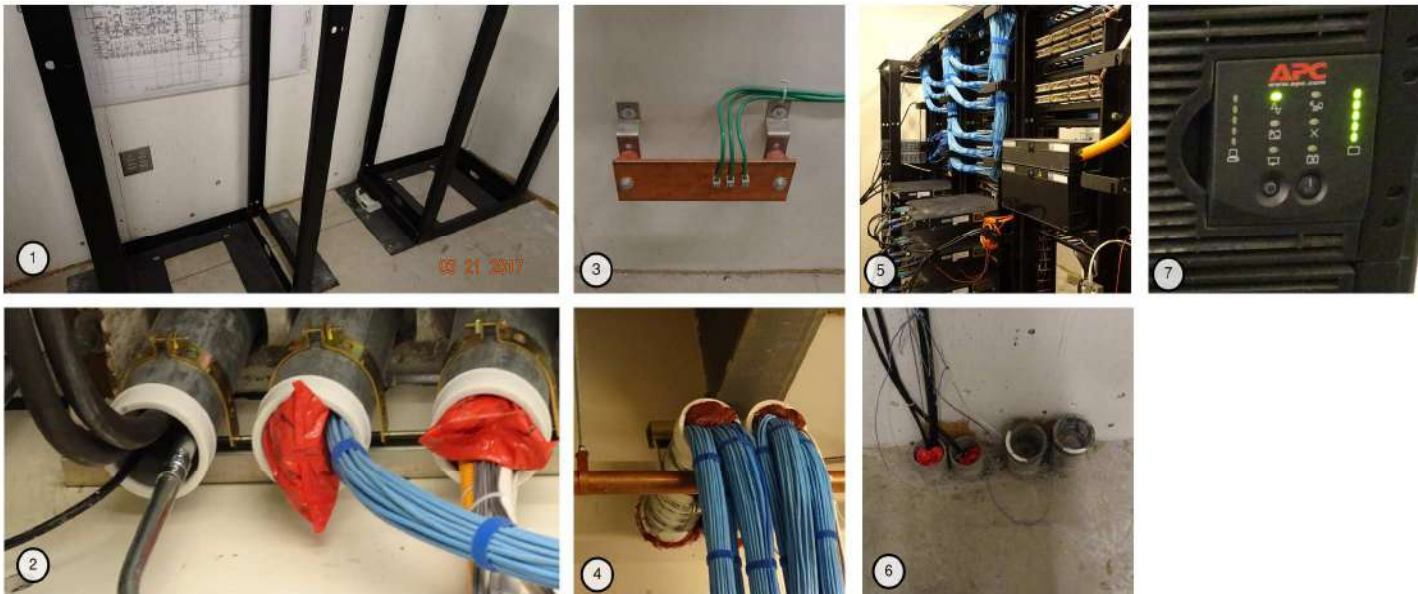
- POSITIVES AND NEGATIVES OF THE IMAGES ABOVE...
- 1. Storage of racks (not bolted) create hazard – personal injury or equipment damage during earthquake.
 - 2. & 4. & 6. Incorrect use of Firestop pillows or Firestop materials not present.
 - 3. System ground barely conforms to PCC standard; lacks individual connections to required components.
 - 5. Expansion capacity adequate, good cable management.
 - 7. Load and Charge good on UPS.

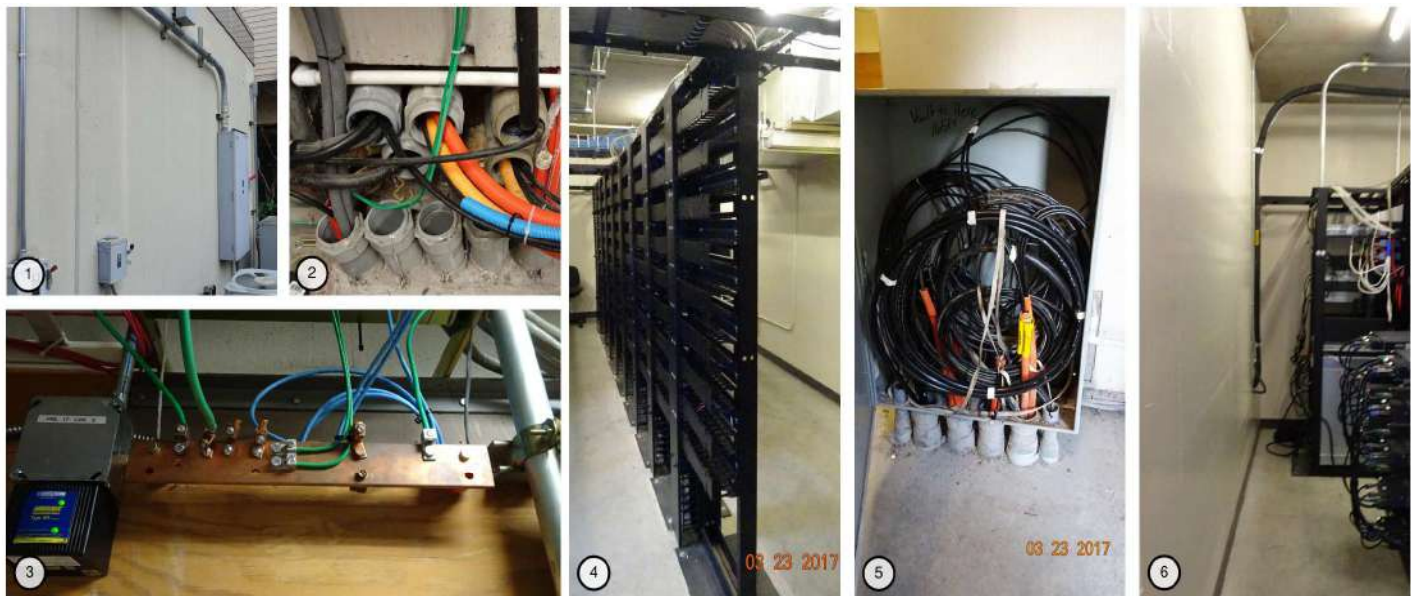
- POSITIVES AND NEGATIVES OF THE IMAGES ABOVE...
- 1. Main power disconnects accessible to public at sidewalk HVAC and / or UPS Main power for campus communications center could be disabled.
 - 2. Conduit capacity good, but required Firestop / sealant is not present.
 - 3. Grounding is fair, but conductor size and lug clamps are incorrect type / size.
 - 4. Rack management good, excellent room for expansion.
 - 5. Conduits filled beyond recommended capacity future expansion limited.
 - 6. Clearance at rear of UPS not to PCC Standards.
- Not shown: lighting poor throughout.

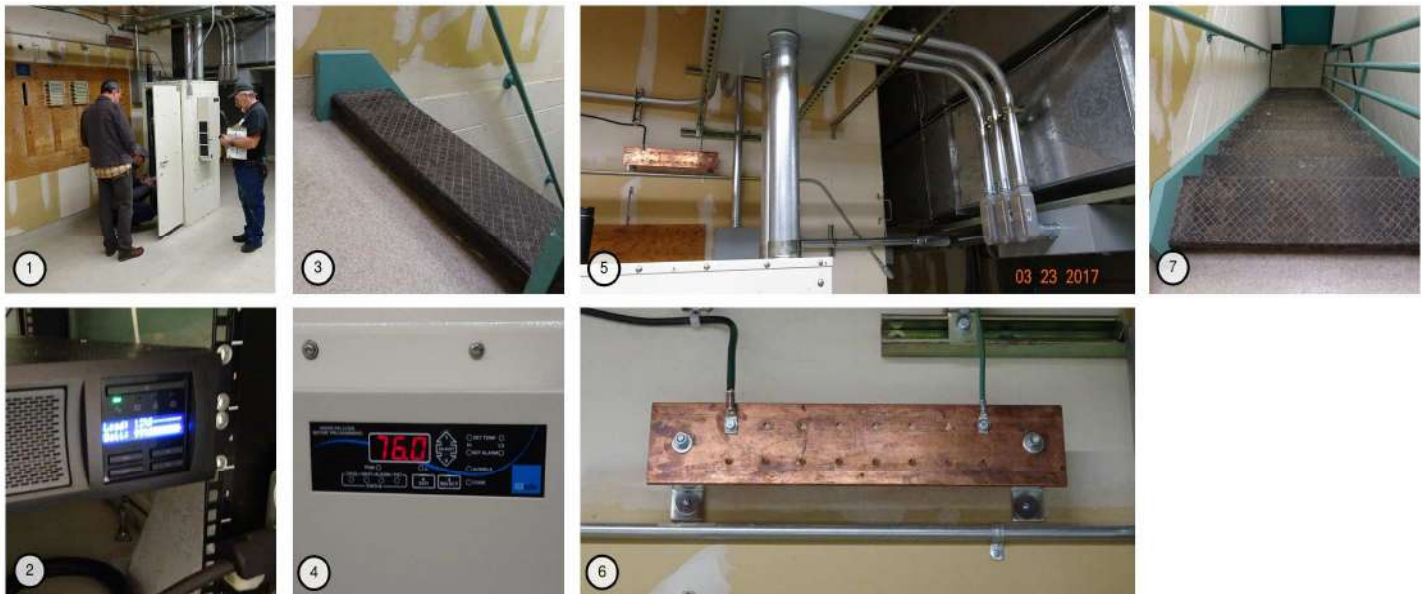
- POSITIVES AND NEGATIVES OF THE IMAGES ABOVE...
1. IDF is a NEMA cabinet with self-cooling systems, inside structure.
 2. Load and Charge good on UPS.
 3. & 7. Raised top step is trip hazard – potential to cause personal injury.
 4. Temperature being maintained, but no fail-over.
 5. Conduits sized per fill ration, but use of 90 degree elbows violate bend radius of cables.
 6. System ground barely conforms to PCC standard; uses only a single undersized conductor for entire NEMA cabinet.

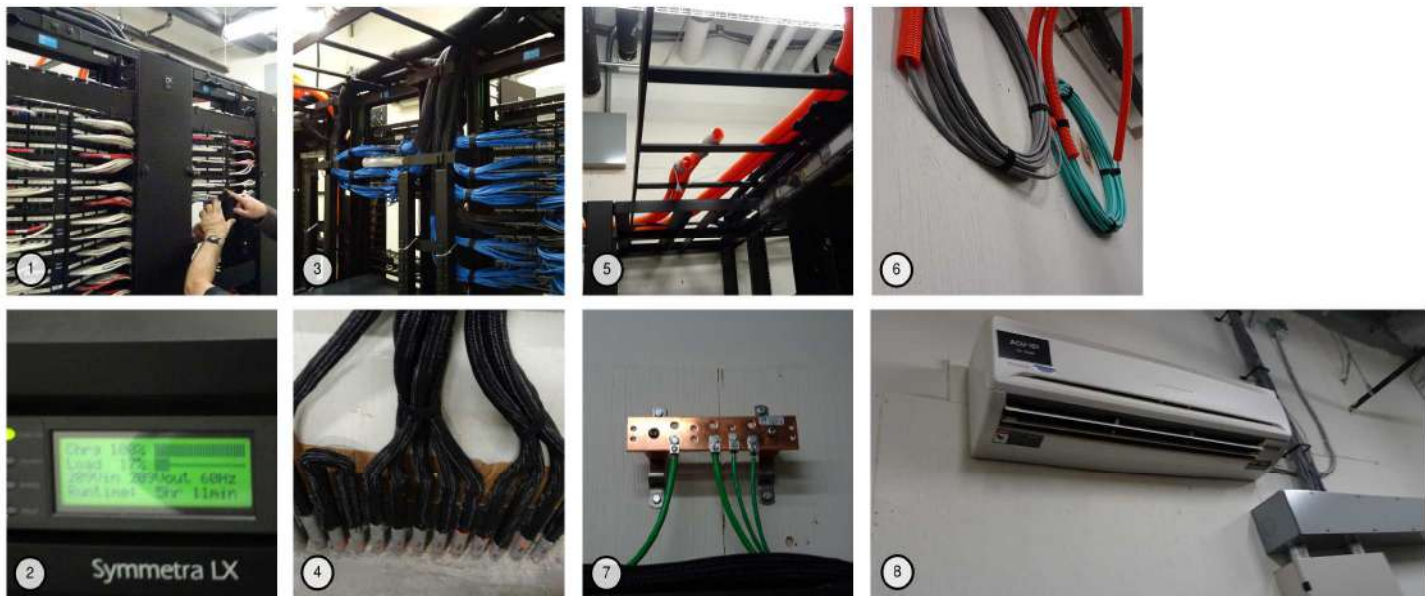
- POSITIVES AND NEGATIVES OF THE IMAGES ABOVE...
- 1. & 3. Rack management good, excellent room for expansion.
 - 2. Load and Charge good on UPS.
 - 4. Conduits filled beyond recommended capacity; Firestop materials not present.
 - 5. Overhead cable tray capacity excellent – suitable for expansion.
 - 6. Service loops for Fiber links per PCC Standards.
 - 7. System ground conforms to PCC standard.
 - 8. Split system could leak condensate into electrical trough.

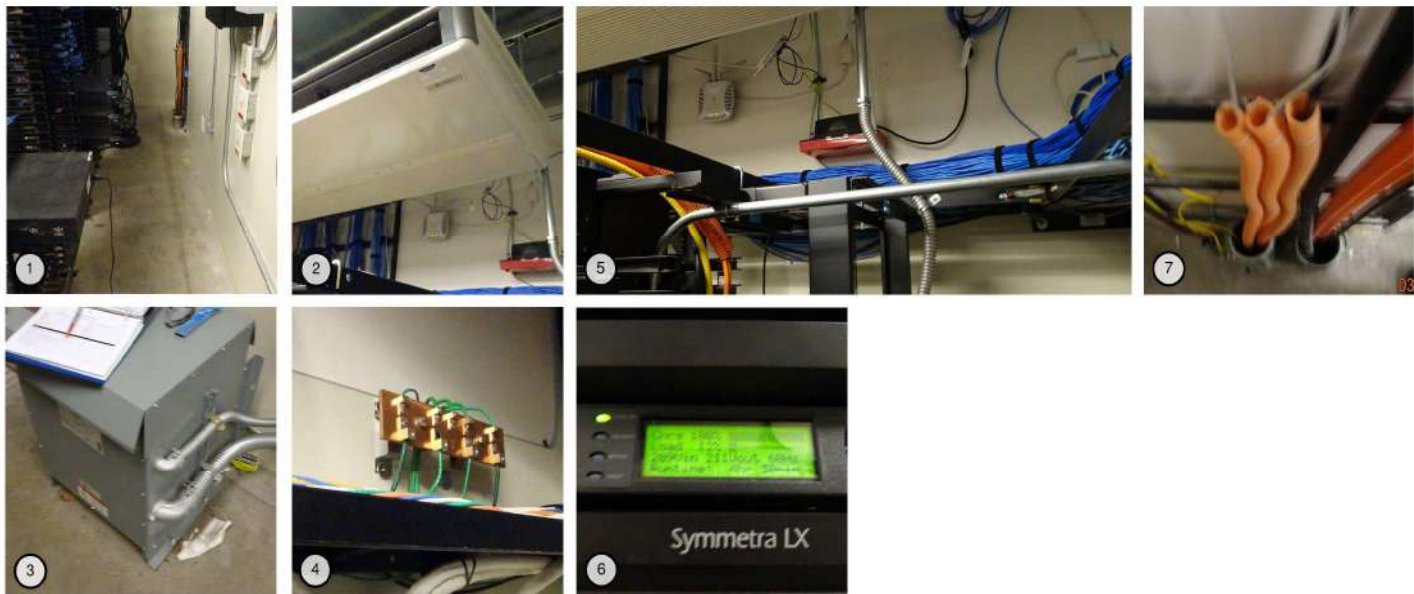
- POSITIVES AND NEGATIVES OF THE IMAGES ABOVE...
- 1. Clearance behind rack limited – not to PCC Standards.
 - 2. HVAC system over racks with no drip pan.
 - 3. Transformer in room adds heat, and is possible source of EMI.
 - 4. System ground conforms to PCC standard.
 - 5. Condensate pump over cabling (Water Hazard) – Cables overfilled on tray.
 - 6. Load and Charge good on UPS.
 - 7. Conduit capacity good, but required Firestop / sealant is not present.

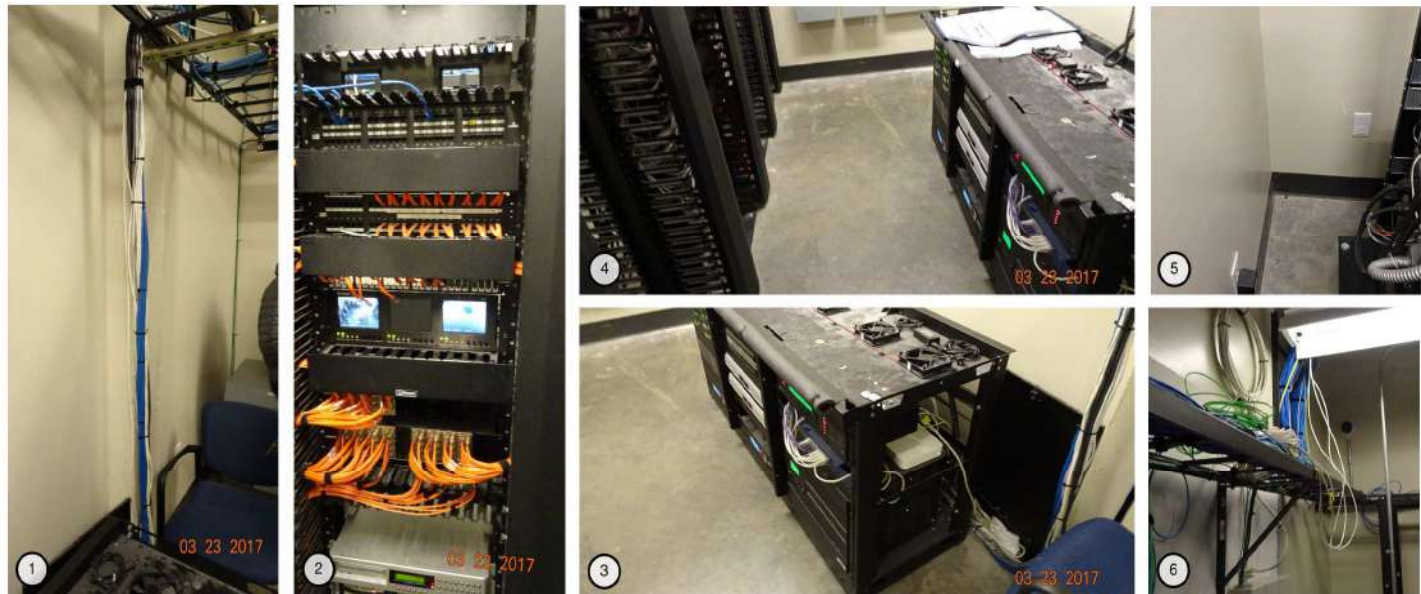
- POSITIVES AND NEGATIVES OF THE IMAGES ABOVE...
- 1. Unsupported AV Cables to adjacent space, for the AV cabinet.
 - 2. CCTV systems in room. Not shown: Camera power power brick easily disconnected.
 - 3. & 4. AV Media cabinet placed in room – restricting PCC Clearances – Dirt on top of cabinet can infiltrate IT as well as AV equipment, leading to failure, AV cabinet ground not connected to IDF TGB.
 - 5. Clearance behind UPS not to PCC Standards.
 - 6. AV cabling added to room for Media Cabinet not managed.

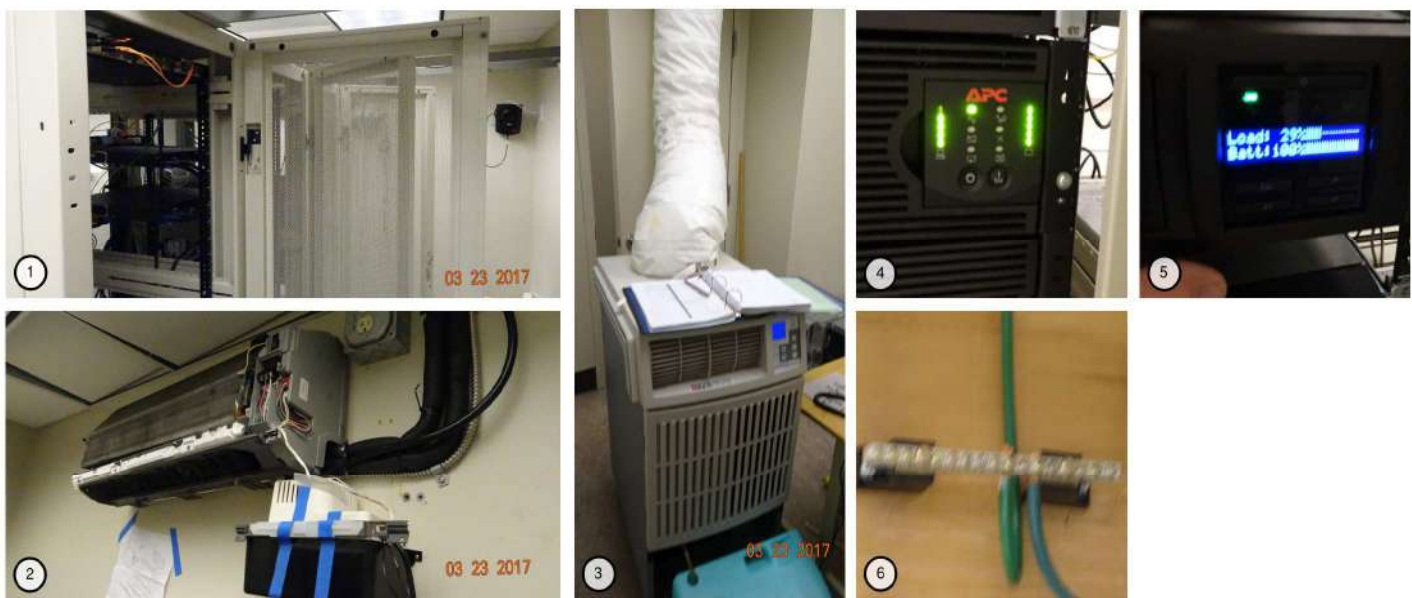
- POSITIVES AND NEGATIVES OF THE IMAGES ABOVE...
- 1, 2, & 3 HVAC unit not operable – Temp cooling systems in place.
 - 4. UPS Load exceeds recommended headroom.
 - 5. UPS for servers load and charge good.
 - 6. Ground conductors are undersized and Grounding Buss Bar not approved type.

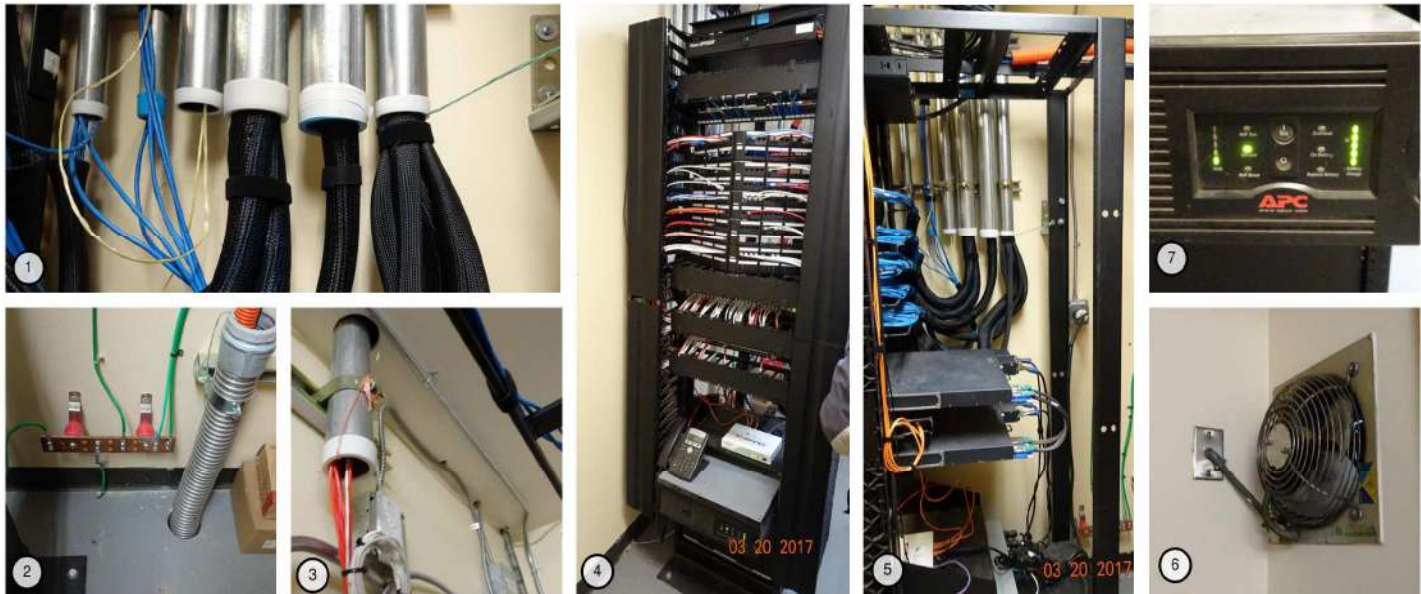
- POSITIVES AND NEGATIVES OF THE IMAGES ABOVE...
- 1. Conduits filled beyond recommended capacity – future expansion limited.
 - 2. System ground conforms to PCC standard.
 - 3. Fire stop materials not present.
 - 4. & 5. Rack management good, but little room for expansion.
 - 6. Secondary exhaust fan inoperable and not thermostatically controlled.
 - 7. UPS load good, but unit is over 10 years old.
- (not shown) Two of three doors have card access, one is direct to outside. 3rd door was missing door knob.

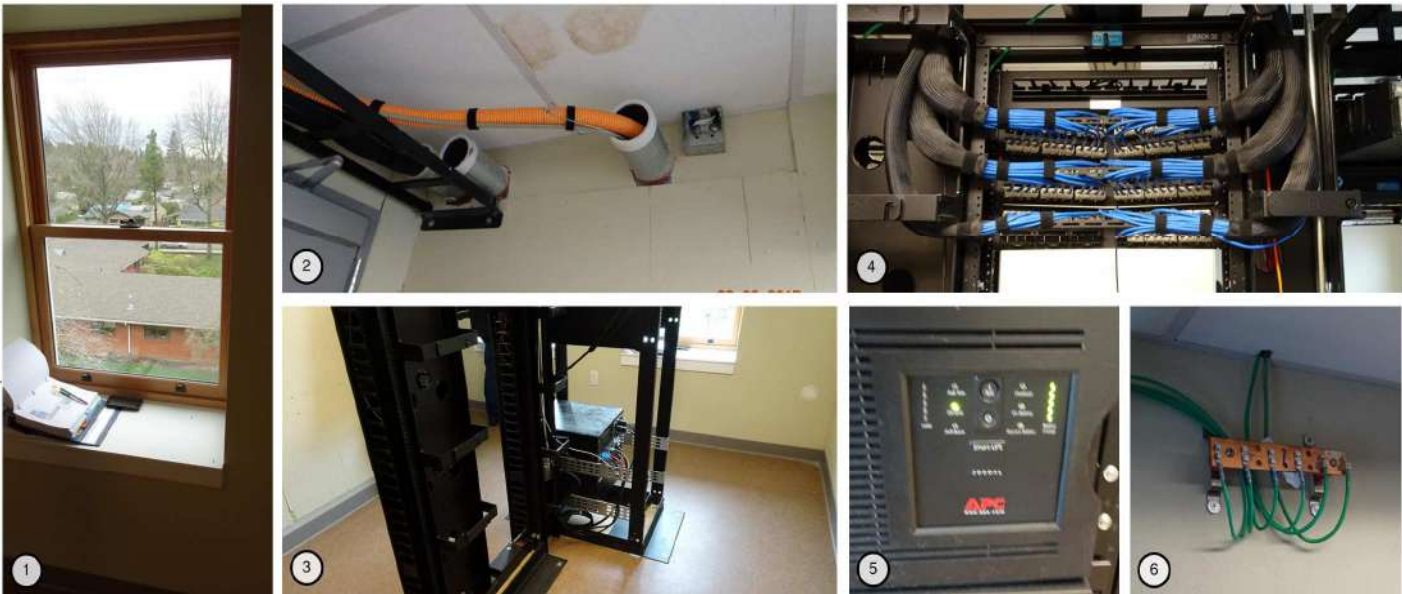
- POSITIVES AND NEGATIVES OF THE IMAGES ABOVE...
- 1. Window contributes to heat in room.
 - 2. Water leak evidence on ceiling. Fire stop materials not present.
 - 3. & 4 Expansion capacity adequate, good cable management.
 - 5. UPS load good, but unit is over 10 years old.
 - 6. System ground conforms to PCC standard.

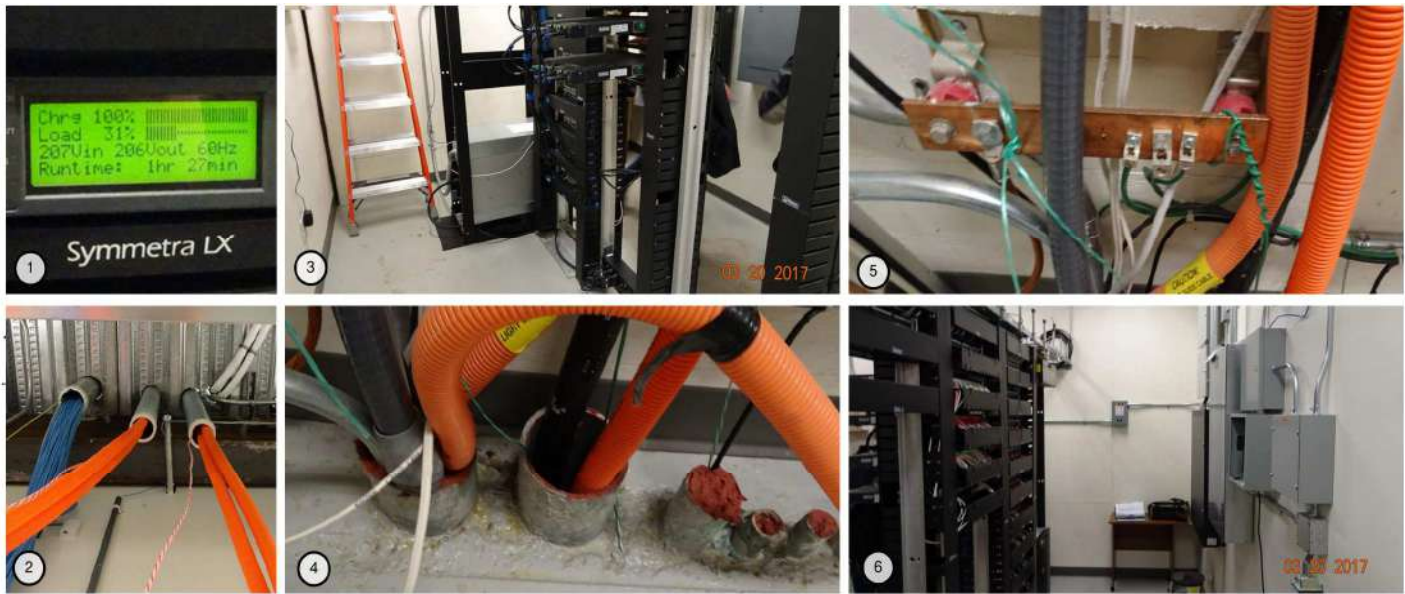
- POSITIVES AND NEGATIVES OF THE IMAGES ABOVE...
- 1. UPS load good, unit is almost new.
 - 2. Conduits to upper floors are full, with no spare. Expansion requires new conduit installation.
 - 3. Ladders and other tall objects may fall on equipment in earthquake.
 - 4. Firestop removed and not replaced.
 - 5. Grounding is fair, but conductor size and lug clamps are incorrect type / size.
 - 6. Rack management good, excellent room for expansion.

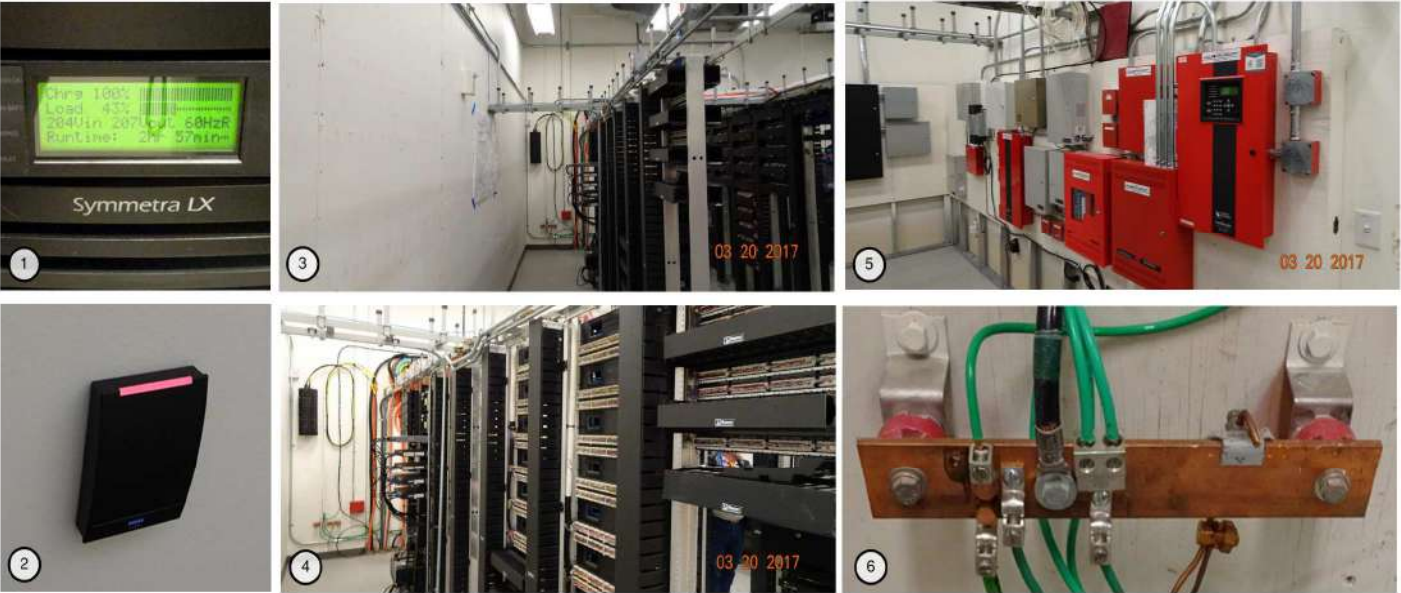
- POSITIVES AND NEGATIVES OF THE IMAGES ABOVE...
- 1. UPS load good, unit is approaching 7 years old.
 - 2. Entry Access operable and conforms to PCC Standards.
 - 3. Overhead cable tray capacity excellent – suitable for expansion.
 - 4. Rack management good, excellent room for expansion.
 - 5. Limited room for expansion beyond existing panels on this wall.
 - 6. System ground conforms to PCC standard but connections are not using industry standard lug types. (not shown) No security camera.

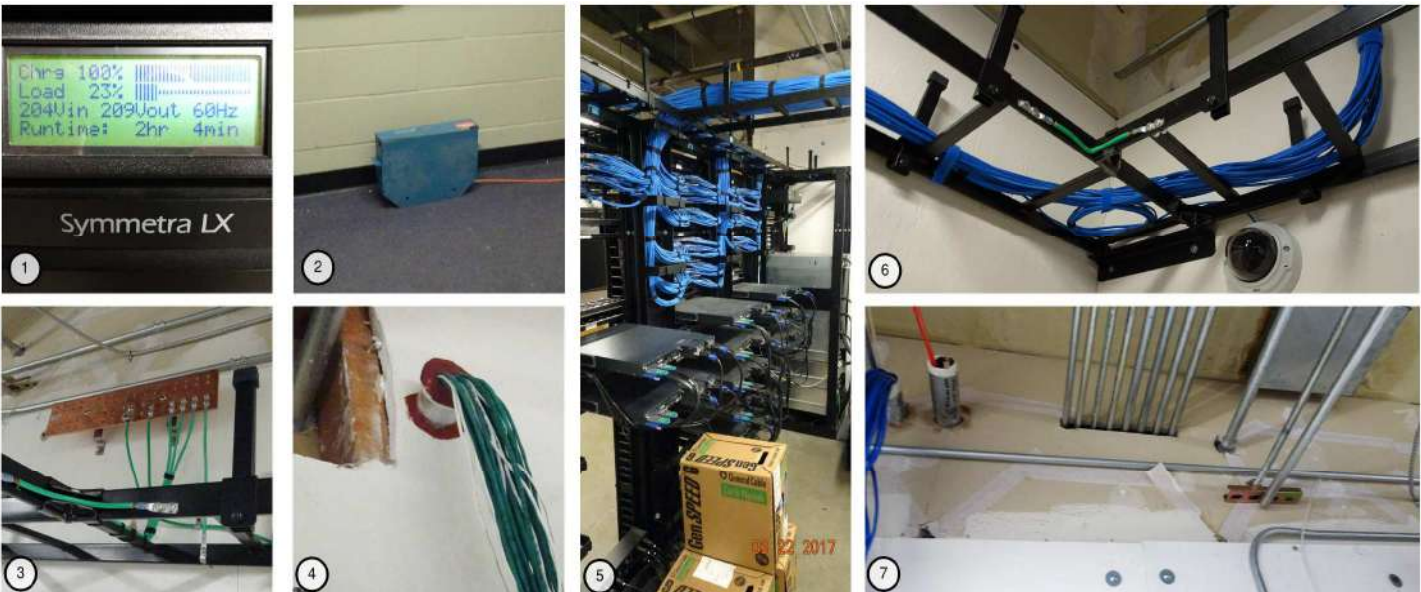
- POSITIVES AND NEGATIVES OF THE IMAGES ABOVE...
- 1. Load less than 25% utilization.
 - 2. Fiber Termination box on floor.
 - 3. System ground conforms to PCC standard.
 - 4. Wall opening adjacent to fire stopped conduit needs to be sealed.
 - 5. Rack management good, excellent room for expansion.
 - 6. Overhead cable tray capacity excellent – suitable for expansion.
 - 7. Fire stop materials not present.

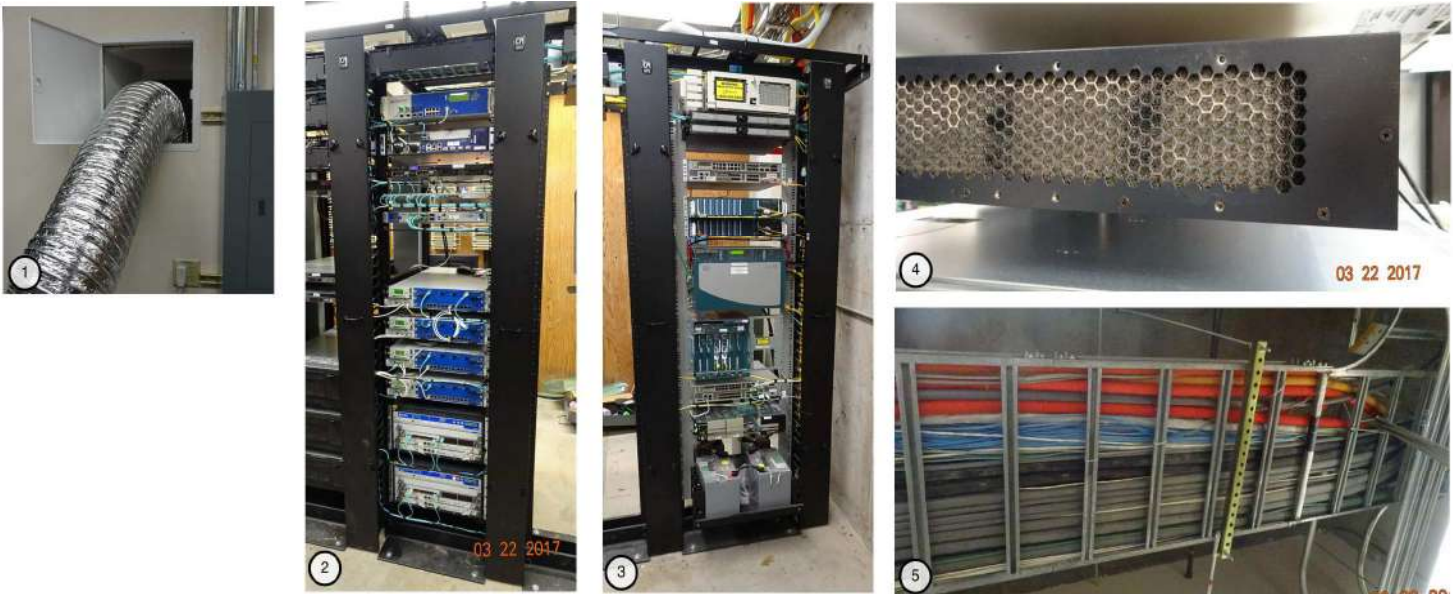
- POSITIVES AND NEGATIVES OF THE IMAGES ABOVE...
- 1. "Permanent" temporary cooling system in place due to frequent failures.
 - 2. & 3. Rack management good, excellent room for expansion.
 - 4. Filter constricted – in need of maintenance.
 - 5. Cable trays filled beyond capacity.

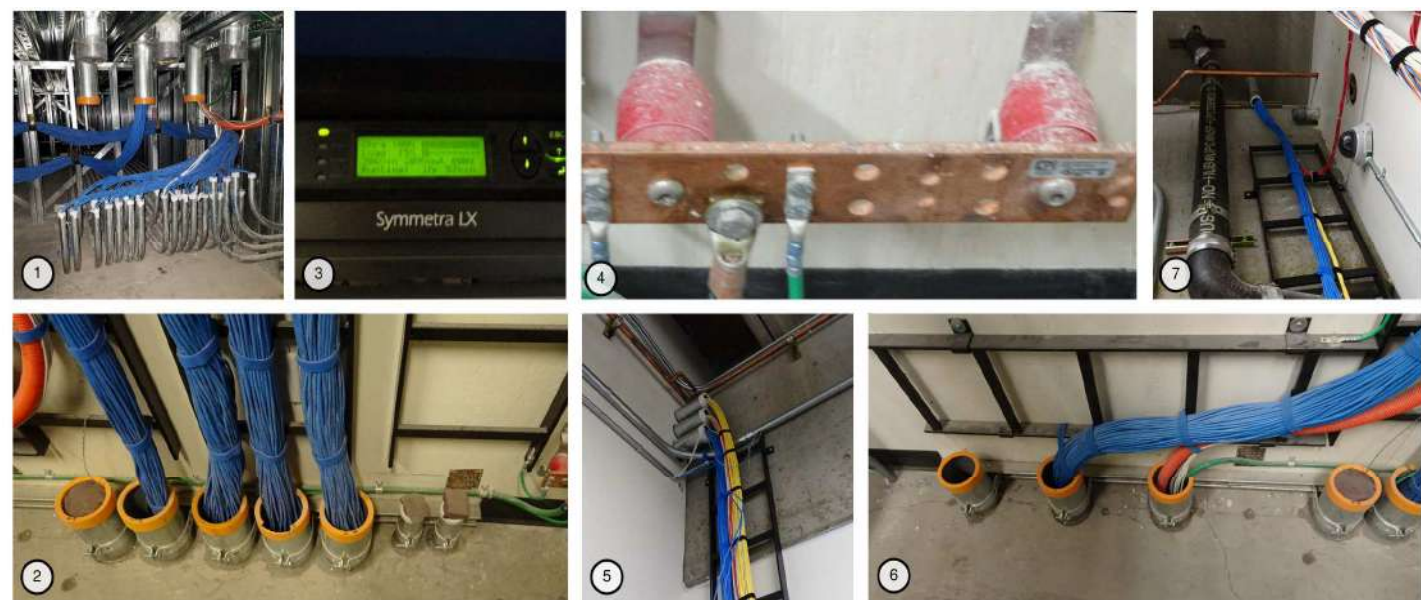
- POSITIVES AND NEGATIVES OF THE IMAGES ABOVE...
- 1. Underfloor cable management good.
 - 2. & 5. & 6. Fire stop materials not present.
 - 3. Load less than 17% utilization.
 - 4. System ground barely conforms to PCC standard; lacks individual connections to required components.
 - 7. Drain pipe in room, water hazard

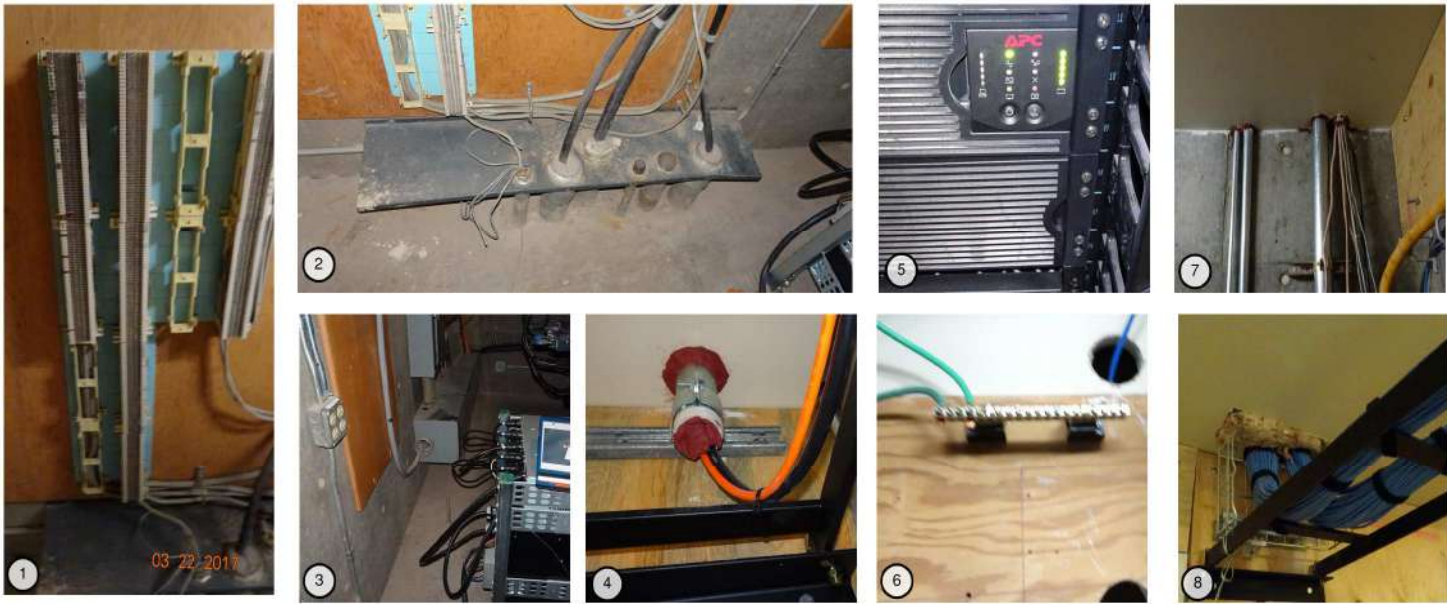
- POSITIVES AND NEGATIVES OF THE IMAGES ABOVE...
- 1. & 2 Copper cables not managed or terminated – remove if abandoned.
 - 3. Clearance behind racks not per PCC standards.
 - 4. Penetration firestop and fill ration is good.
 - 5. Load and Charge good on UPS.
 - 6. Grounding Buss Bar not approved type.
 - 7. & 8. Fire stop materials not present or correctly installed.

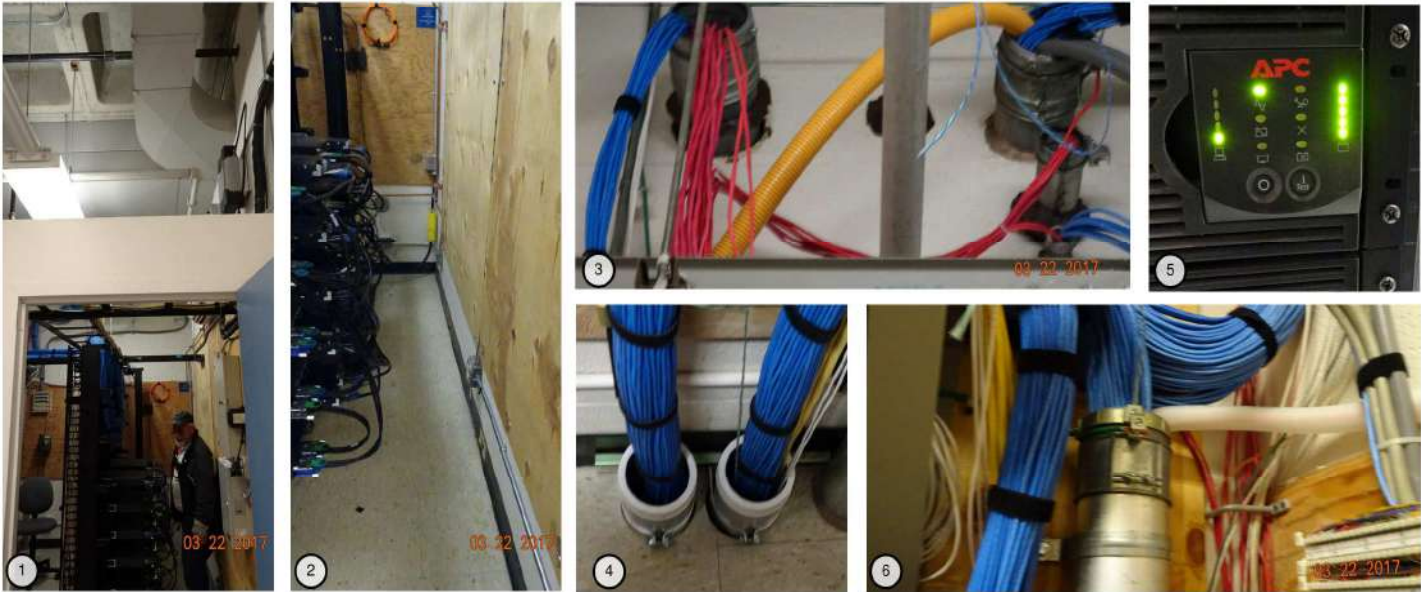
- POSITIVES AND NEGATIVES OF THE IMAGES ABOVE...
- 1. Access control poor (easy to climb over wall).
 - 2. Clearance behind racks not per PCC standards.
 - 3. & 4. & 6. Conduits filled beyond recommended capacity; required firestop is not present.
 - 5. Load and Charge good on UPS.
