FACILITIES PLAN TECHNICAL REPORTS

PORTLAND COMMUNITY COLLEGE
IT Master Plan
Infrastructure Existing Conditions Report

Date: April 17, 2018

Prepared for:
SRG Partnership

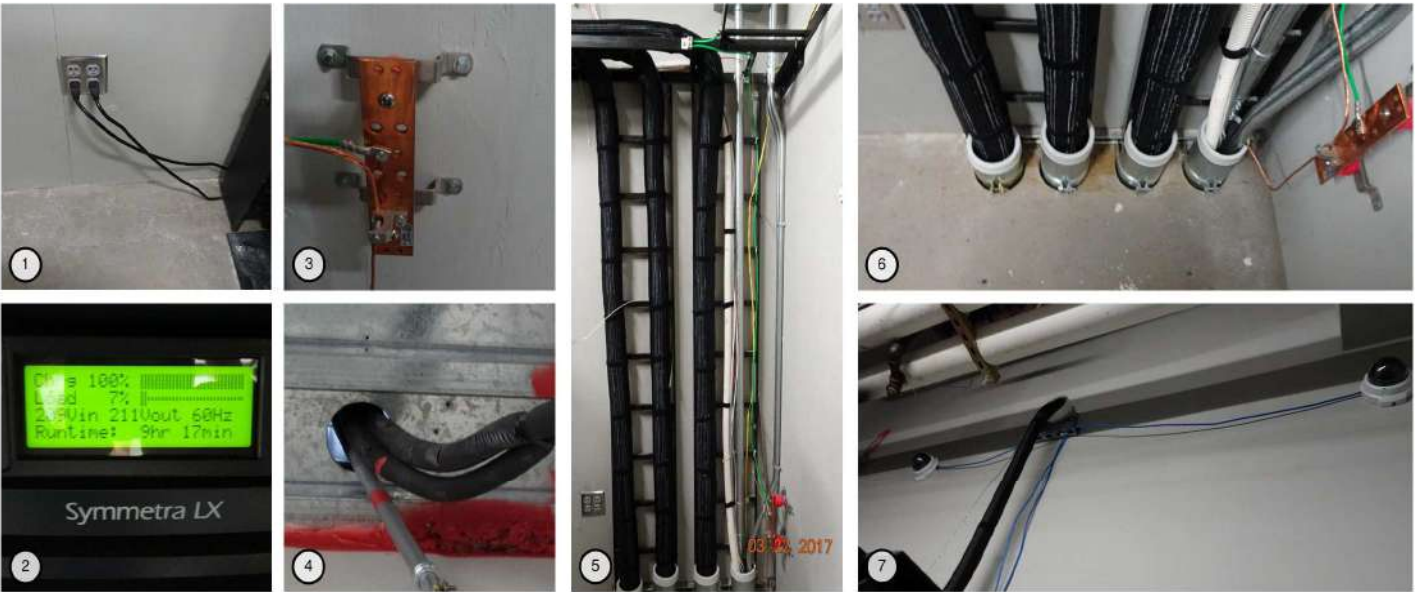
- POSITIVES AND NEGATIVES OF THE IMAGES ABOVE...
- 1. Power strips (PDUs) for network equipment are not plugged into the UPS .
 - 2. Load and Charge good on UPS.
 - 3. System ground barely conforms to PCC standard; lacks individual connections to required components.
 - 4. Roof penetrations over equipment.
 - 5. & 6. Conduits filled beyond recommended capacity – future expansion limited.
 - 7. Camera placements good.

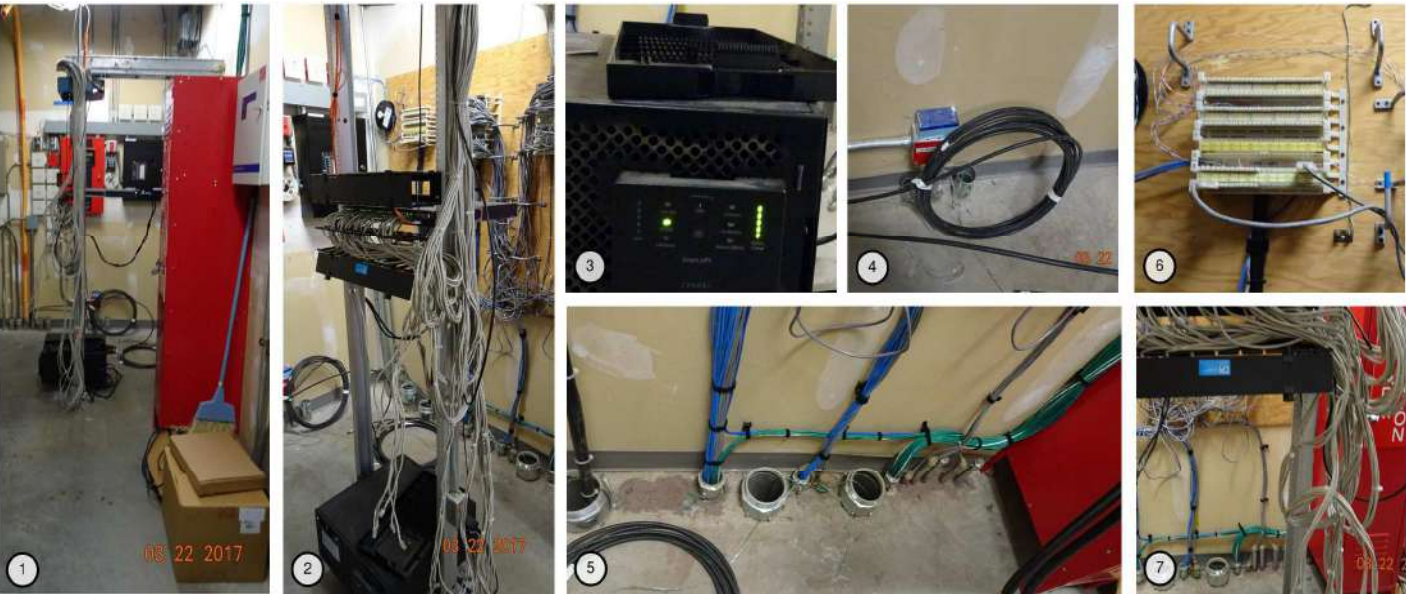
- POSITIVES AND NEGATIVES OF THE IMAGES ABOVE...
- 1. & 2. No side cable management at rack.
 - 3. Load and Charge good on UPS.
 - 4. & 5. Fiber optic coils loose on ground, required firestop / sealant is not present.
 - 6. Telecommunications ground wire connected to nothing.
 - 7. Cable management poor – remove abandoned cables.

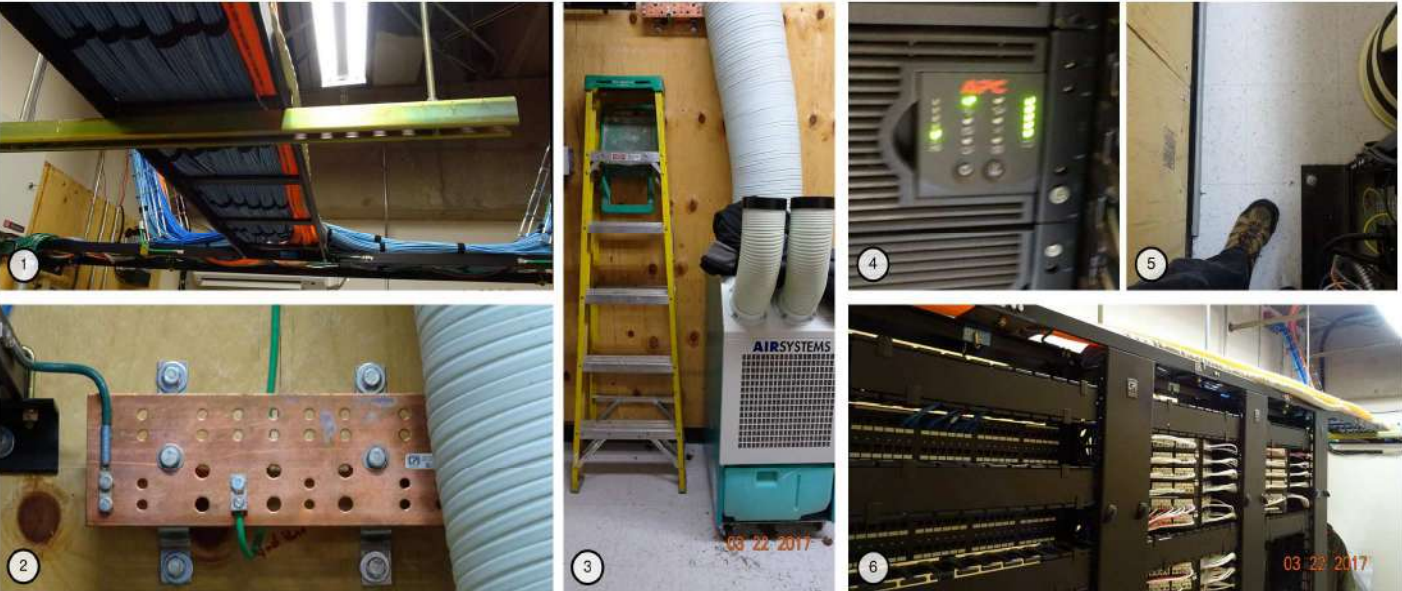
- POSITIVES AND NEGATIVES OF THE IMAGES ABOVE...
- 1. Rack management good, but little room for expansion.
 - 2. System ground barely conforms to PCC standard; lacks individual connections to required components.
 - 3. Portable AC in case of sys failure.
 - 4. Load and Charge good on UPS.
 - 5. Clearance behind rack not to PCC Standard.
 - 6. Rack management good, excellent room for expansion.
