FACILITIES PLAN TECHNICAL REPORTS
Building Summary

# **CASCADE**

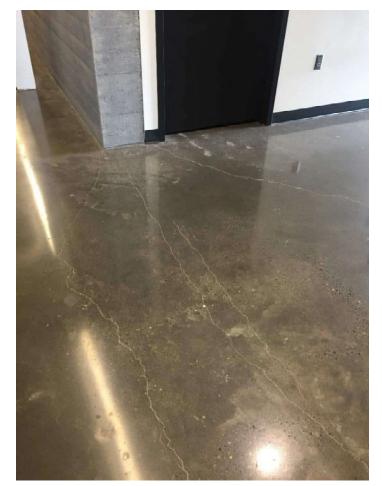
Cracking in the floor slabs is exacerbated by the polishing process. The building exhibits signs of use and required maintenance typical of a structure of this vintage and construction type.

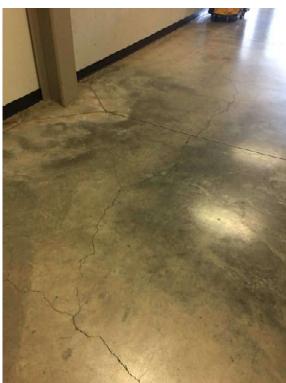
The building exhibits signs of use and required maintenance typical of a structure of this vintage and construction type. The first-floor concrete slab-on-grade exhibits areas of cracking exceeding what we would expect for a building of this use and vintage; see adjacent photos. Cracking likely occurred during construction. We recommend repairing the cracks to avoid long term maintenance and possible tripping hazards.

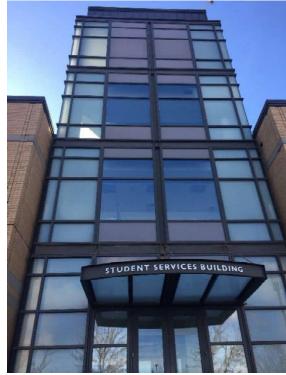
The stair tower exhibited signs of moisture accumulation. We recommend addressing the moisture to avoid long term maintenance issues. The building exhibits signs of use and required maintenance typical of a structure of this vintage and construction type.

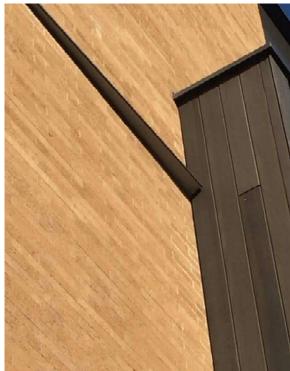
While conducting a walkthrough, we noted lose flashing within the brick veneer shown in the adjacent photo. We alerted maintenance personnel of the issue. In general, the building exhibits signs of use and required maintenance typical of a structure of this vintage and construction type.

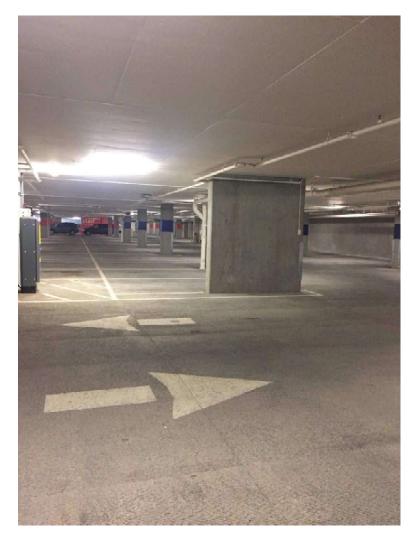
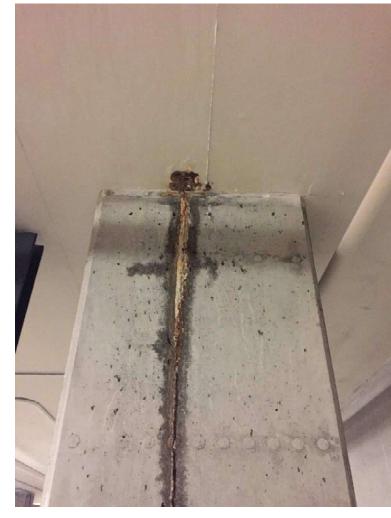
Cracking in the post tensioned concrete slab was observed at the southern end of the garage and water intrusion is apparent in some areas of the garage. We recommend addressing the issues to help avoid long term maintenance issues.

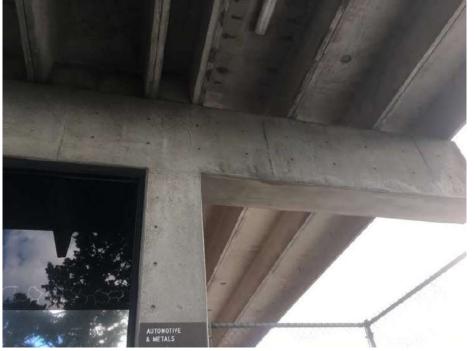
The building exhibits signs of use and required maintenance typical of a structure of this vintage and construction type. Visible cracking was observed at some of the exterior concrete girders. Interior conditions were not visible. We recommend a maintenance and repair program to seal existing cracks to avoid water intrusion and further deterioration.

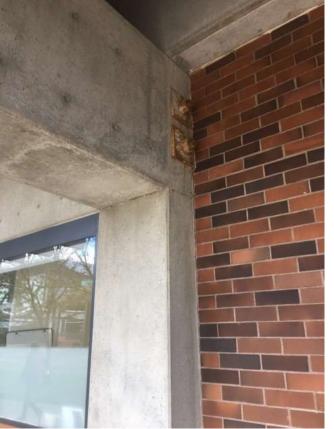
The building exhibits signs of use and required maintenance typical of a structure of this vintage and construction type. Visible cracking was observed at some of the exterior concrete girders. Interior conditions were not visible. We recommend a maintenance and repair program to seal existing cracks to avoid water intrusion and further deterioration.

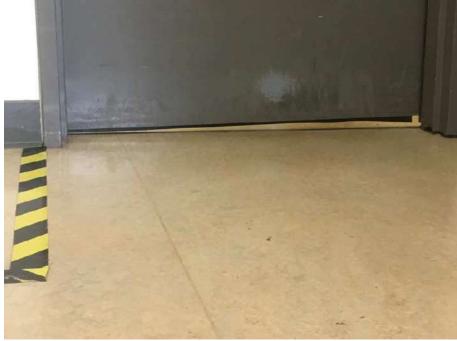
The building exhibits signs of use and required maintenance atypical of a structure of this vintage and construction type. Elevated floor slabs are visibly deflected with visible cracking. Anecdotal evidence suggests that movement continues to occur. Doors are repaired to maintain operability. Sheetrock walls, soffits, and ceilings are continuously repaired. We recommend further investigating the structural condition of the building.

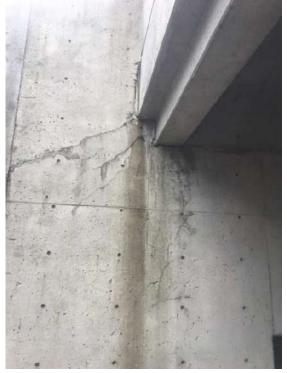
The building exhibits signs of use and required maintenance typical of a structure of this vintage and construction type. Visible cracking was observed at some of the exterior concrete girders. Interior conditions were not visible. We recommend a maintenance and repair program to seal existing cracks to avoid water intrusion and further deterioration.

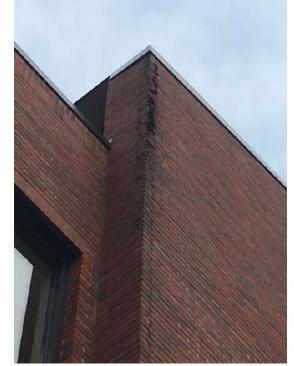
We noted signs of water damage at exterior brick veneer and foggy windows. Staff on-site indicated some deflection concerns above and below roof 201. We could not verify the deflections anecdotally described during our visit. In general, the building exhibits signs of use and required maintenance typical of a structure of this vintage and construction type.

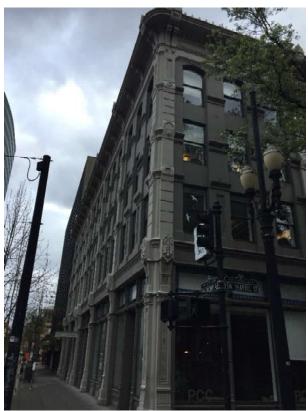
During our walkthrough, we noted the lack of support at the ends of some of the existing floor joists. It is unclear how the joists are currently supported. We recommend further investigation and the addition of a beam or wall to support the joists.

We understand from anecdotal evidence and discussions with staff that the basement regularly floods along the southern end of the basement. We recommend addressing the water intrusion to avoid long term maintenance issues.

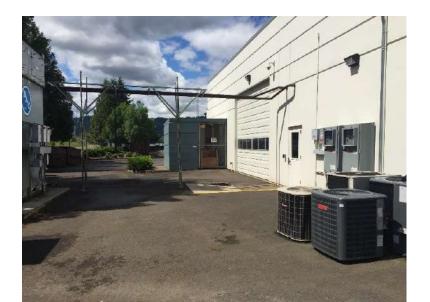
Conduit support racks shown in the photograph below appear to be temporary. We recommend supporting the emergency power conduit feeds using more permanent structure. The building exhibits signs of use and required maintenance typical of a structure of this vintage and construction type.

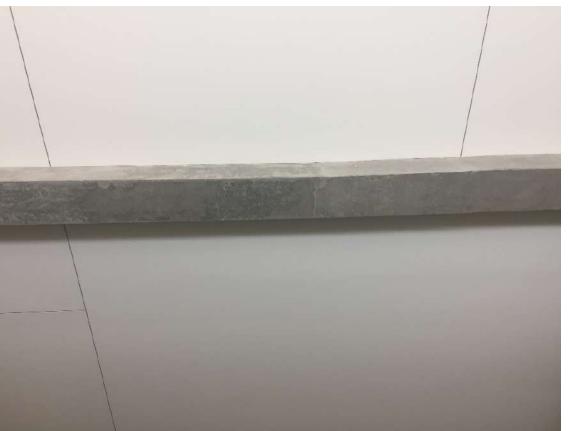
While conducting a walkthrough, we noted lose terra cotta siding shown in the adjacent photo. We alerted maintenance personnel to the issue. We also noted signs of deflection within the floor slabs at approximately the mid-point of the building plan. It is unclear what is causing the deflection shown in the adjacent photo. We recommend further study of the floor deflections.
