# **Food Services**

## 2016 Renovation Document

**Sylvania  
Food  
Services**

## **Sylvania Campus - Kitchen Design Services**

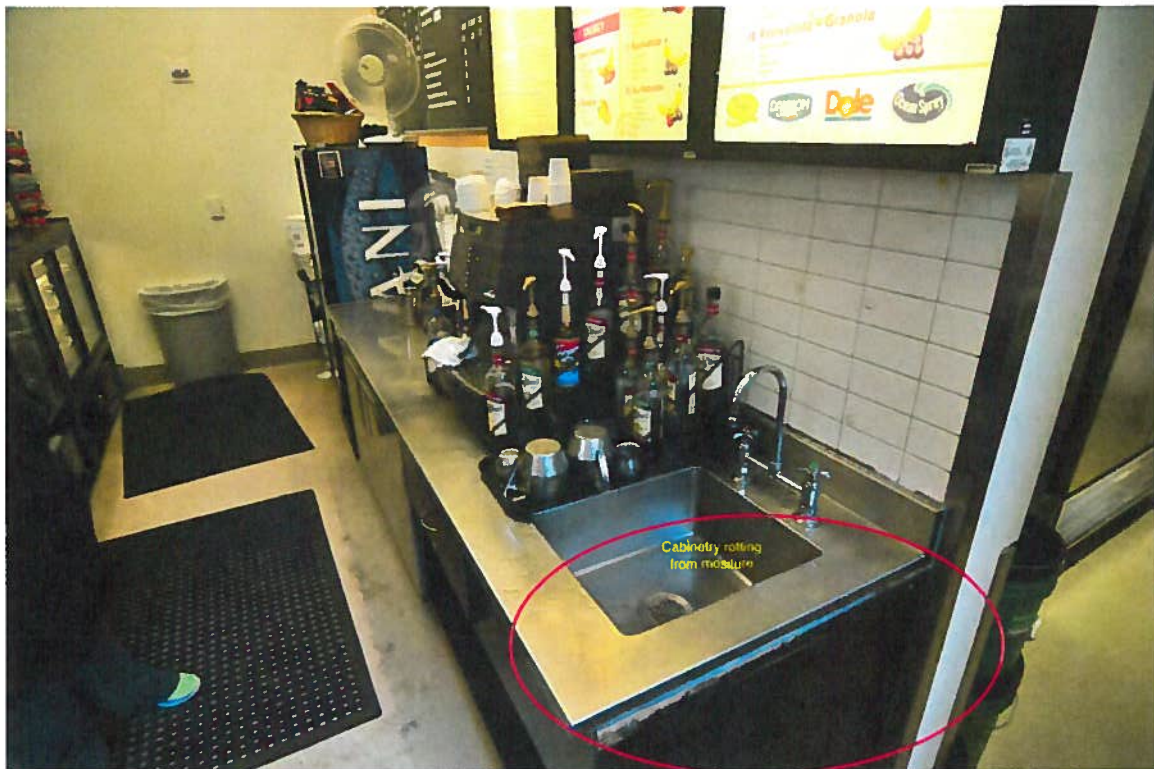
Cabinetry has been water damaged over the past 14 years. Cabinets are made of laminate and plywood, and water has warped the integrity of the structure. Water damage comes from rinsing blender containers for smoothies and miscellaneous coffee equipment. Blender containers are rinsed an average of 200 per day, 6-days a week in this sink.

Drawers have been repaired many times. We have been advised the wear and tear is irreversible.

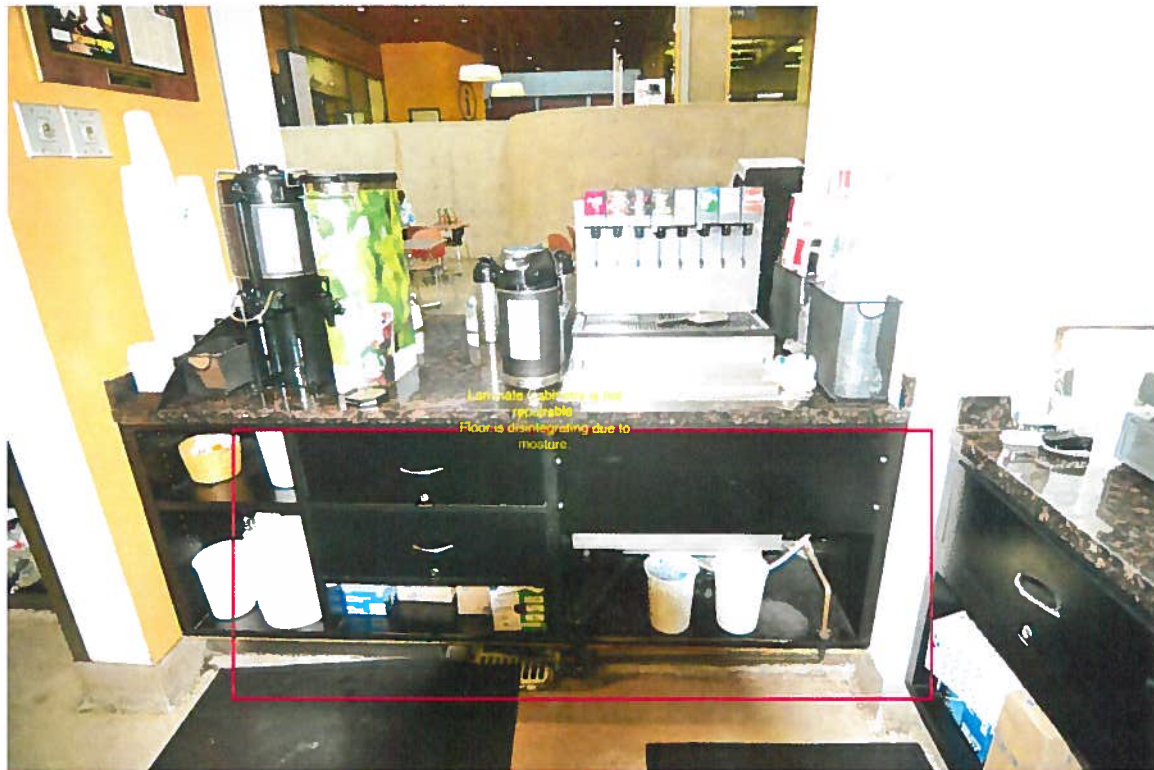
Cabinetry rotting from water damage, (i.e. water line leaked, coffee spills, moisture from ice, and cleaning towels) have put wear on laminate cabinets. Counter drawer locks cannot be repaired, and the latch notches in the wood are worn and locks will not stay secure.

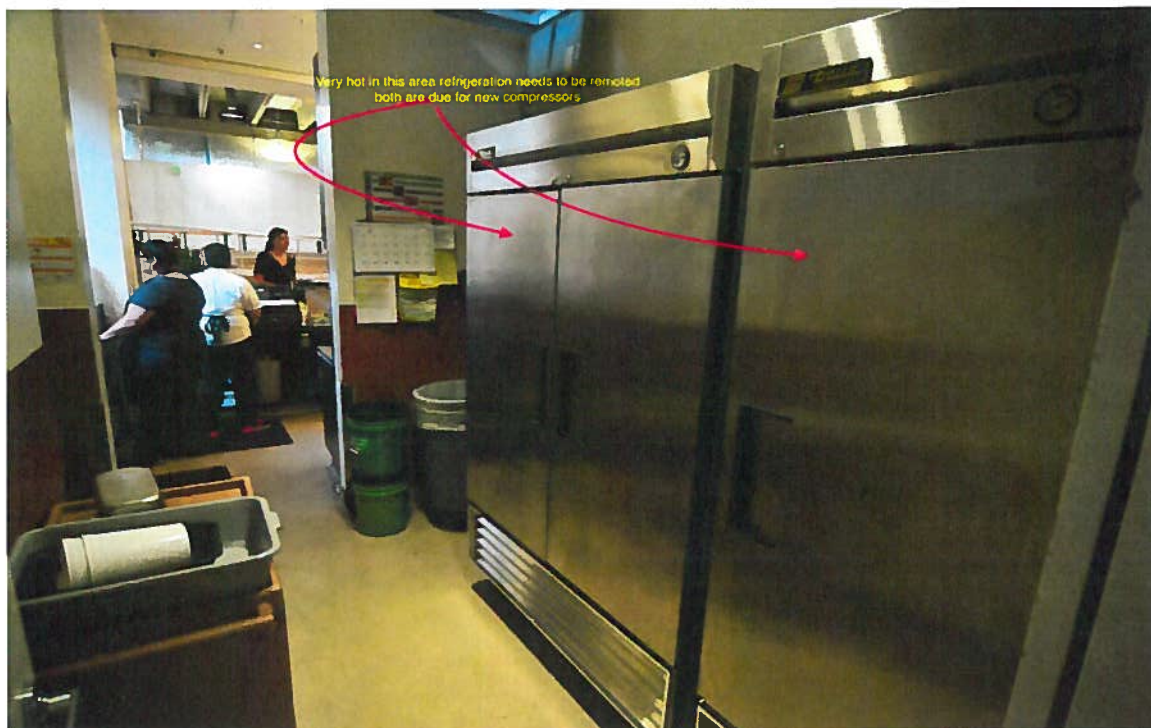
Refrigeration is in need of compressors; they run hot and need to be on a remote system.

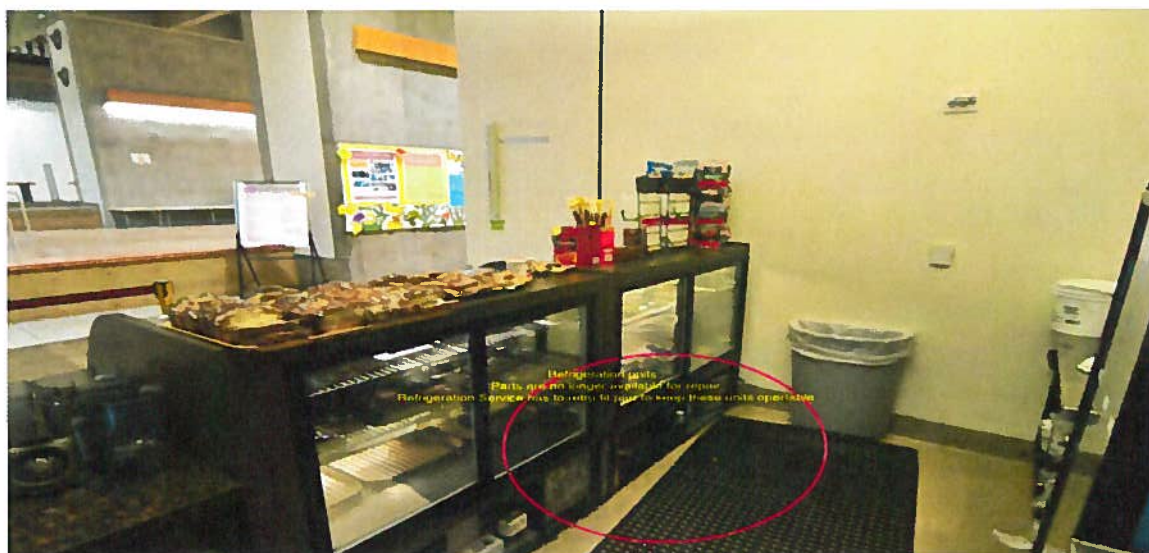
Refrigeration units (bottom left) have to be retro-fitted for repairs as there are no replacement parts available on the market, (i.e. evaporator pans, defrost thermostats, coils, etc.).

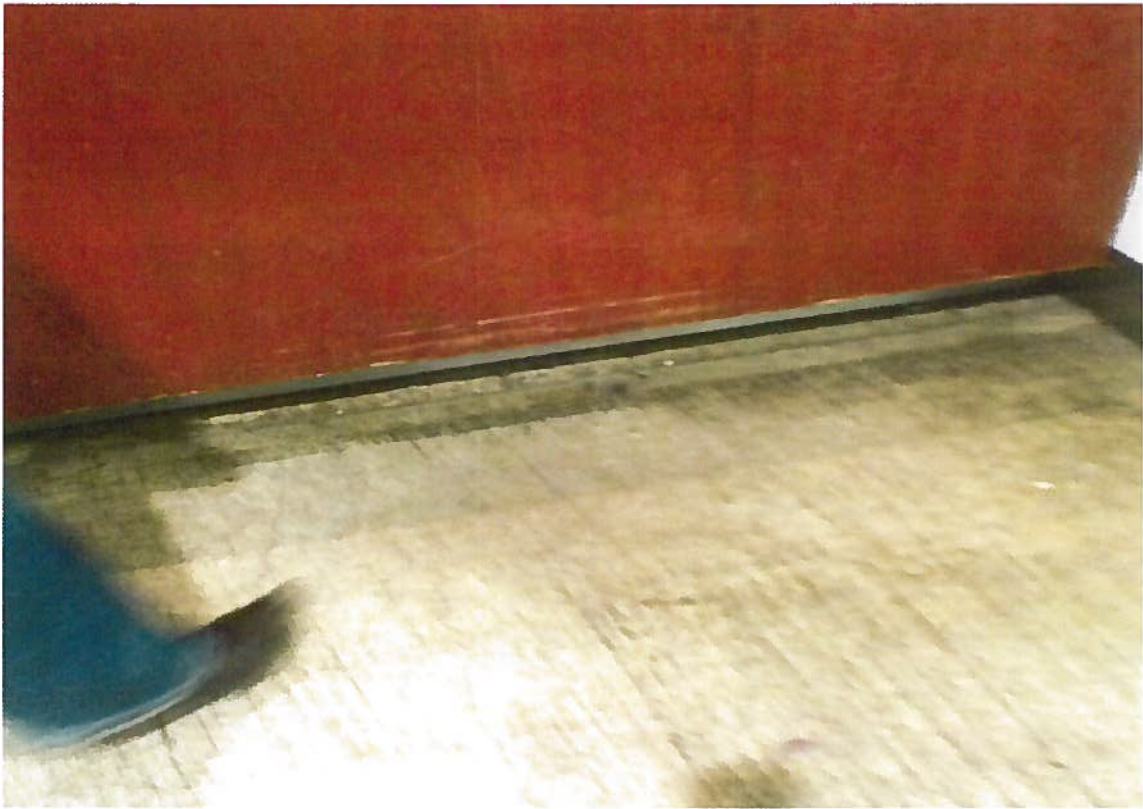
Laminate counter fronts surface damaged.

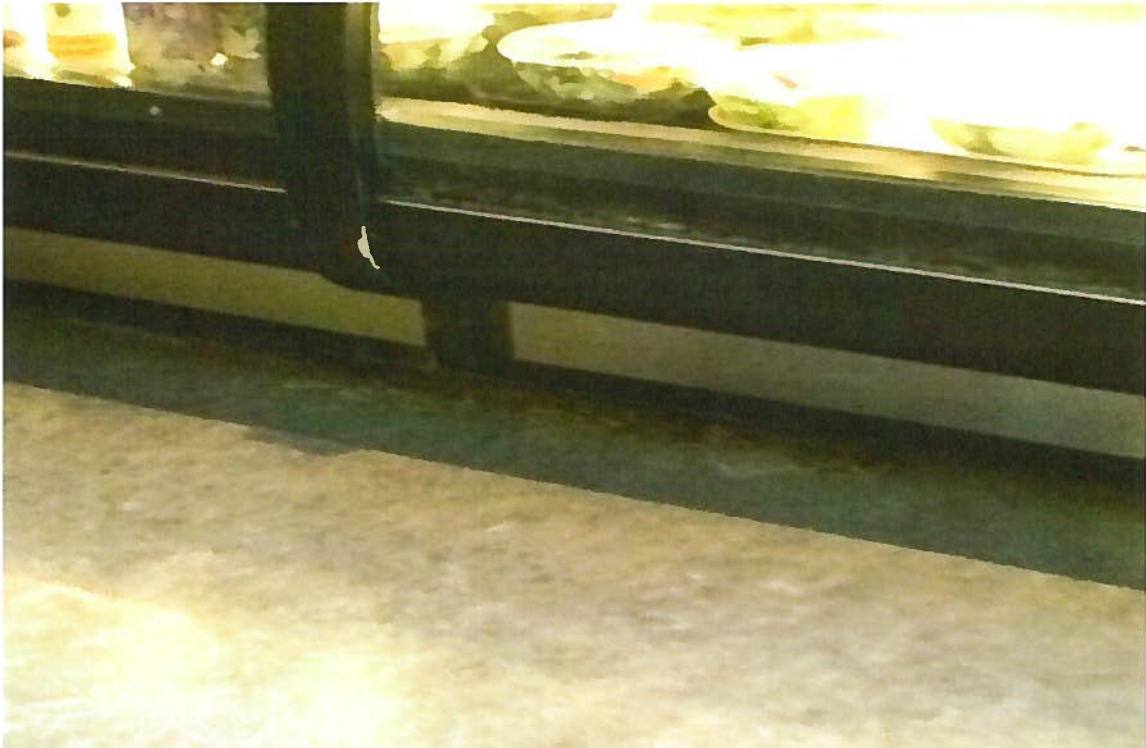
Floor seams are split and flooring is pulling up due to water and debris seeping in between the seam openings. Water damaged flooring in service area is a hazard for mold. Granite counter seams are splitting and will become an environmental health violation should it increase over time. Soup hot wells life-span has expired (10-year life). Refrigeration units have to be retro-fitted for repairs as there are no replacement parts available for the evaporator pans, defrost thermostats, coils, etc.

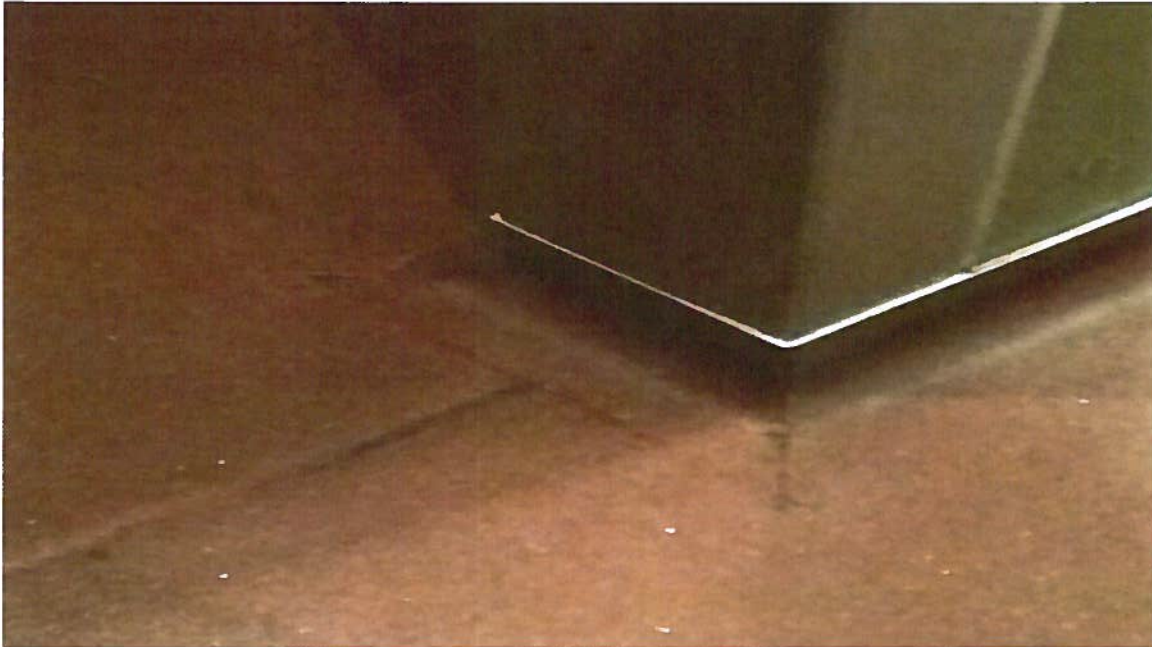
Flooring water damage comes from leaking pipe and/or evaporator pan overflowing from heater in pan not working.

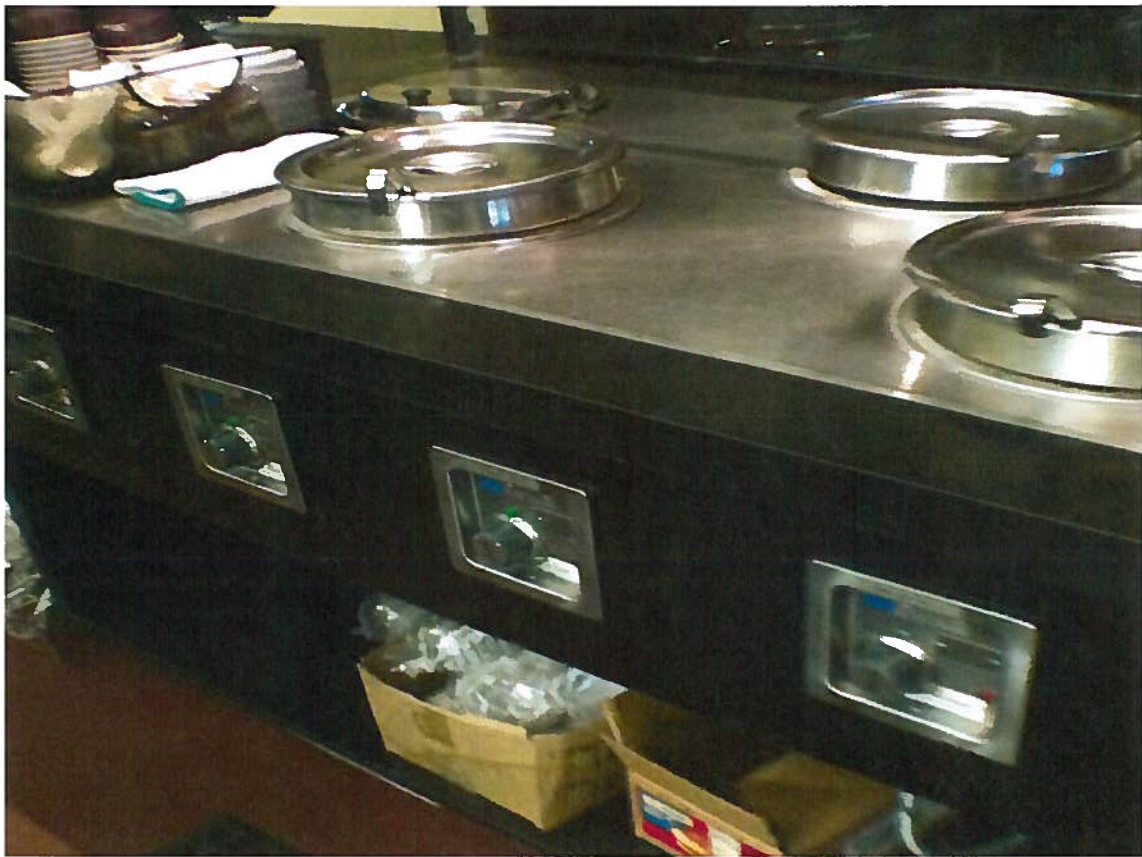
Soup wells need to be upgraded. They leak and thermostat parts are becoming obsolete.

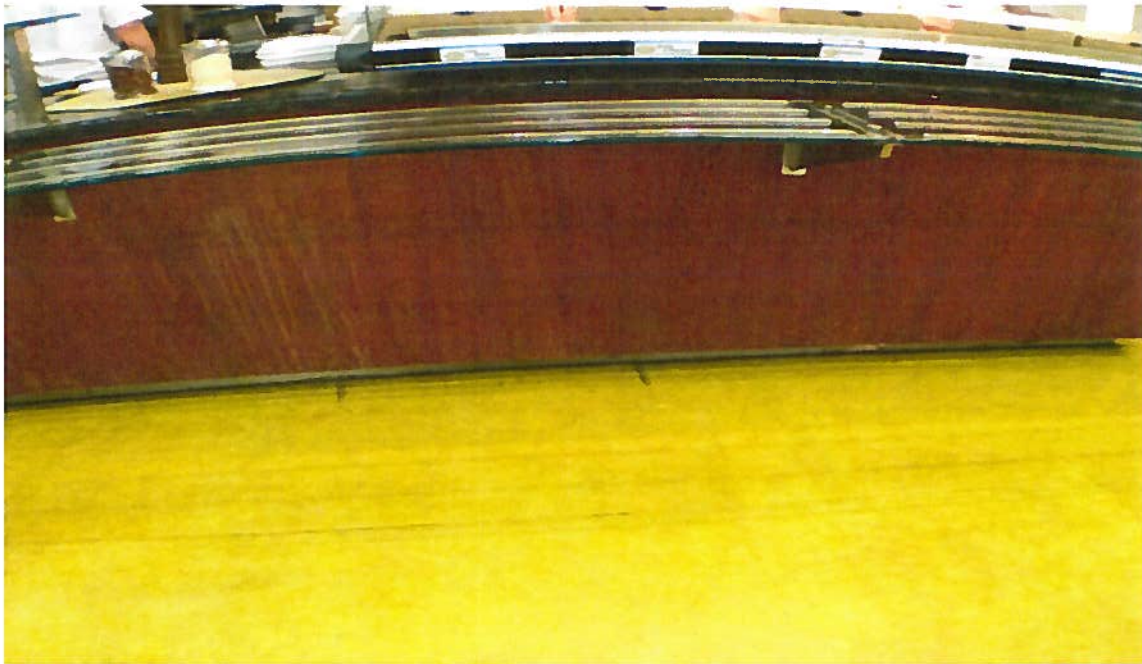
Laminate cabinets are water damaged the same as CHILL. Additionally, custodial cleaning equipment has damaged the cabinetry. Flooring has been patched with gray flooring due to water damage and cleaning equipment. Water damage has come from leaking pipes, cleaning towels, and water from cleaning equipment. The laminate cabinetry was not designed to withstand 15 years of exposure to moisture.

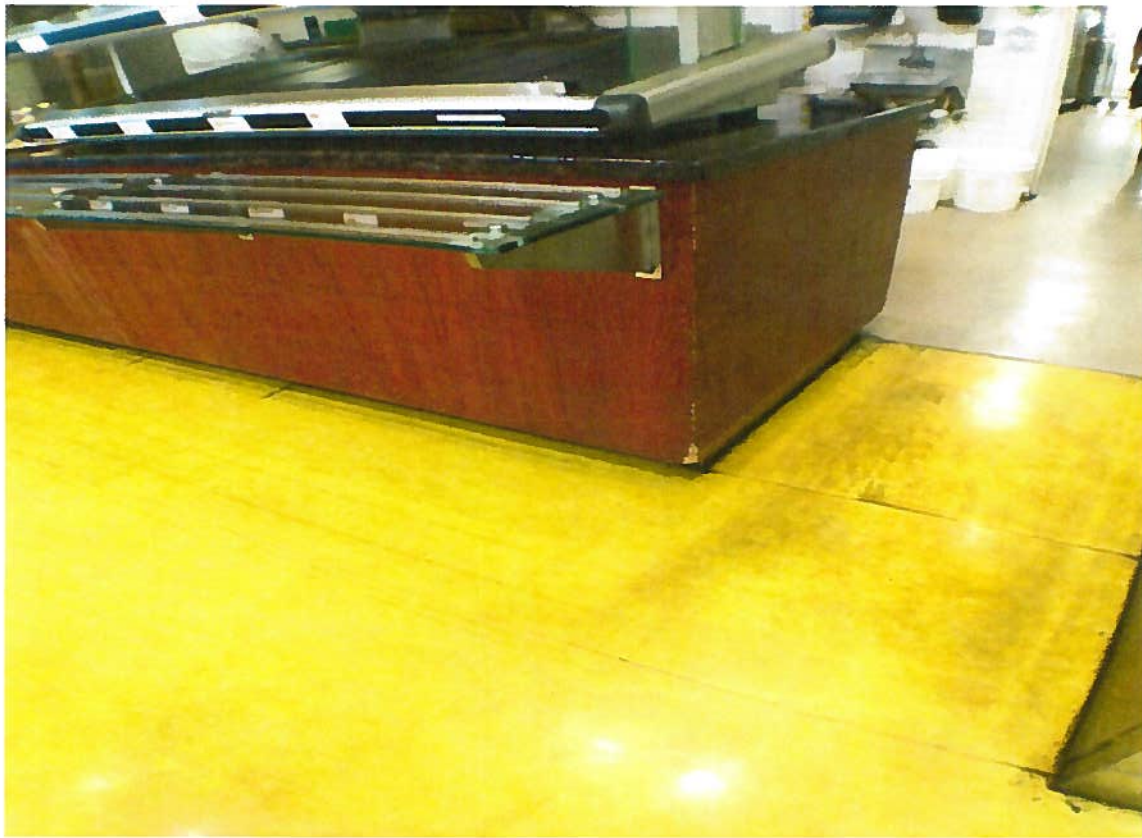
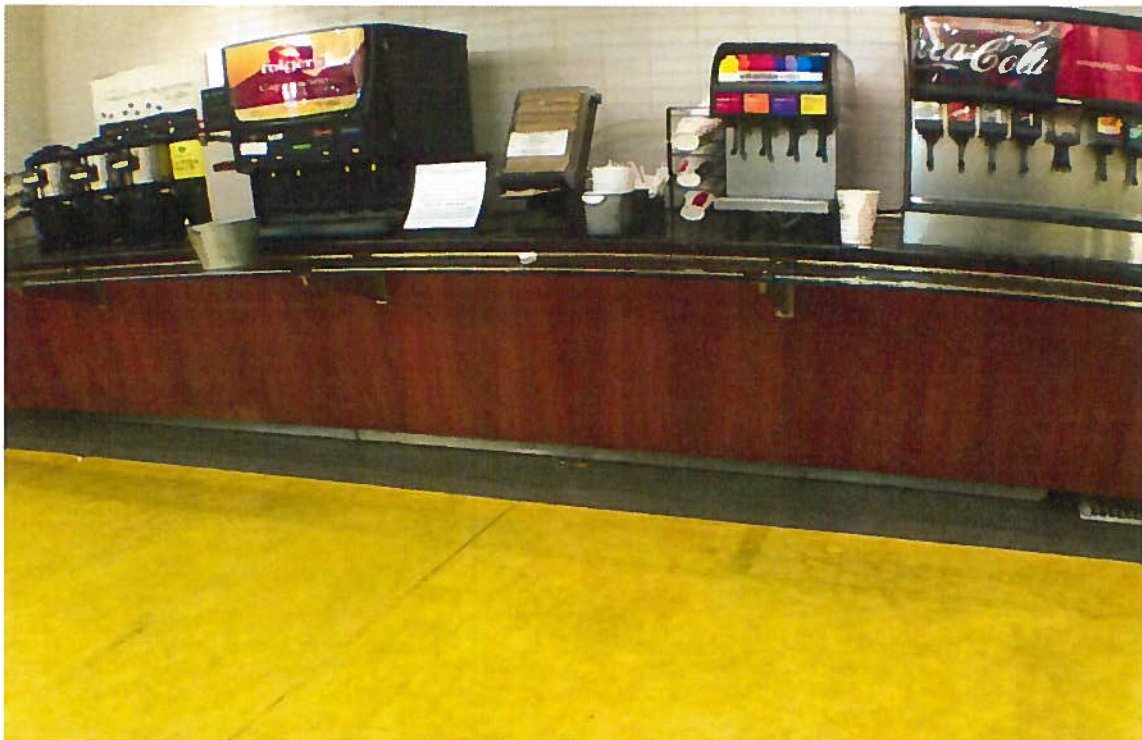
Gray colored flooring represents water damaged repair. Yellow colored flooring stained and scarred.

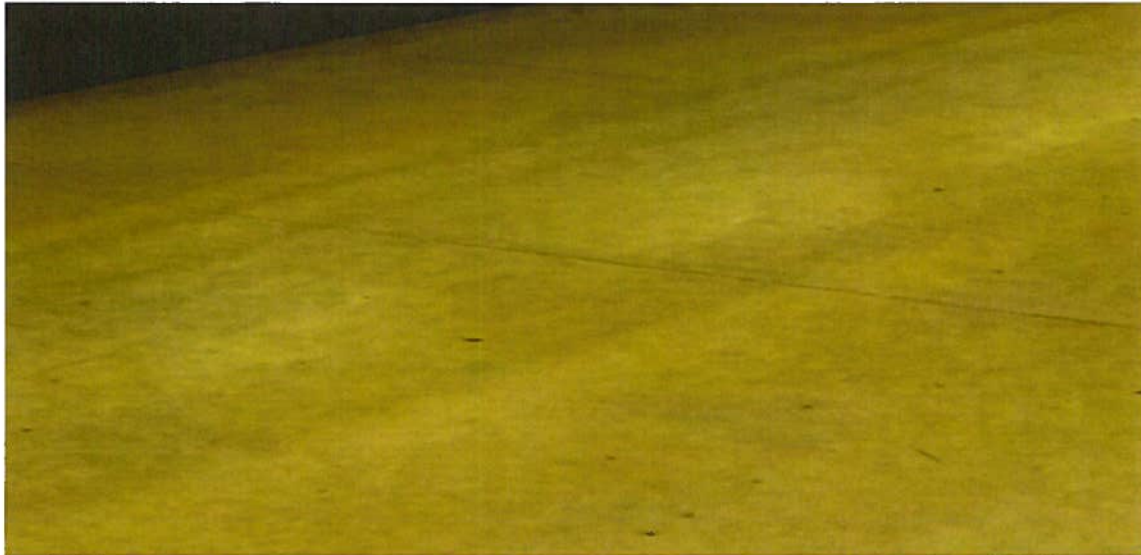
Floors are scarred with marks that cannot be repaired. The flooring been worn to where the backing is starting to expose and will not be cleanable in the near future.

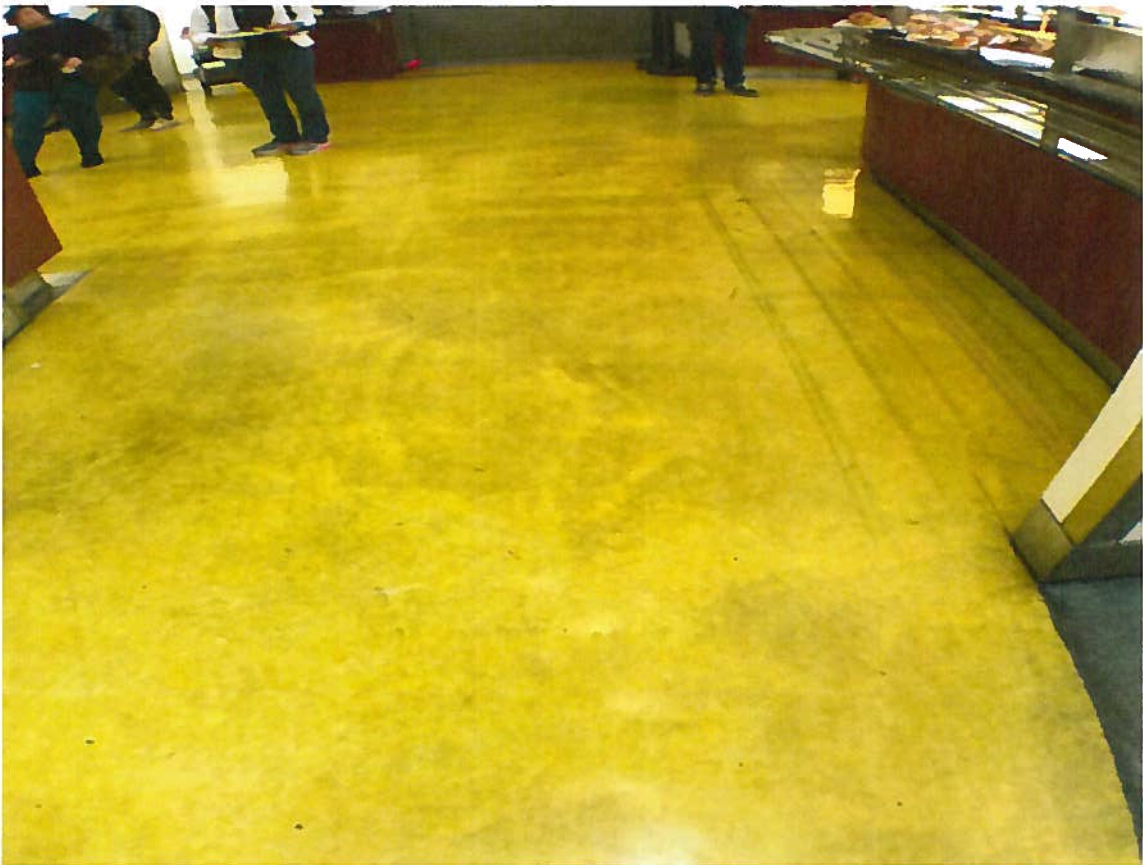
Damaged flooring continued...

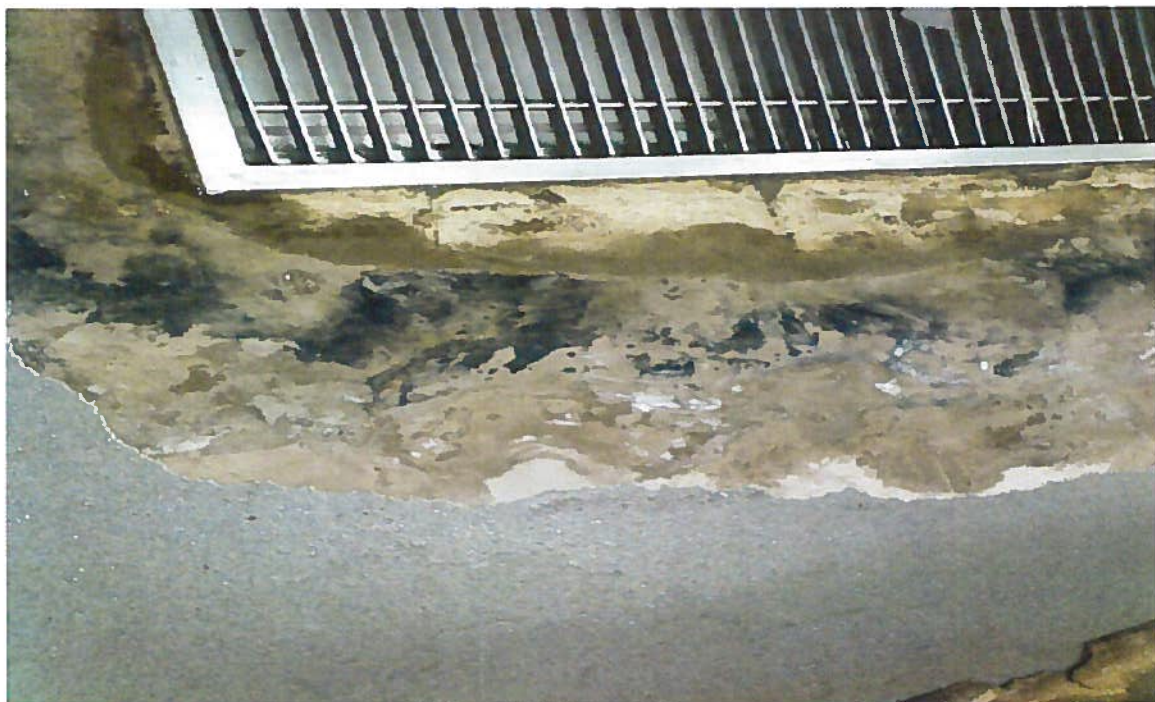
Currently, the Sylvania Food Service operation is facing similar maintenance/repair issues but not as drastic as the problems faced in the late 90's. The flooring in the servery of Forest View is so worn that the backing is becoming exposed and seams are splitting resulting in mold/mildew growth. This exact situation occurred in the Sylvania production kitchen. There was concern about a posed health risk associated with the mold so FMS replaced this flooring in July 2012 (see following photos).

Example of mold under kitchen flooring July 2012.

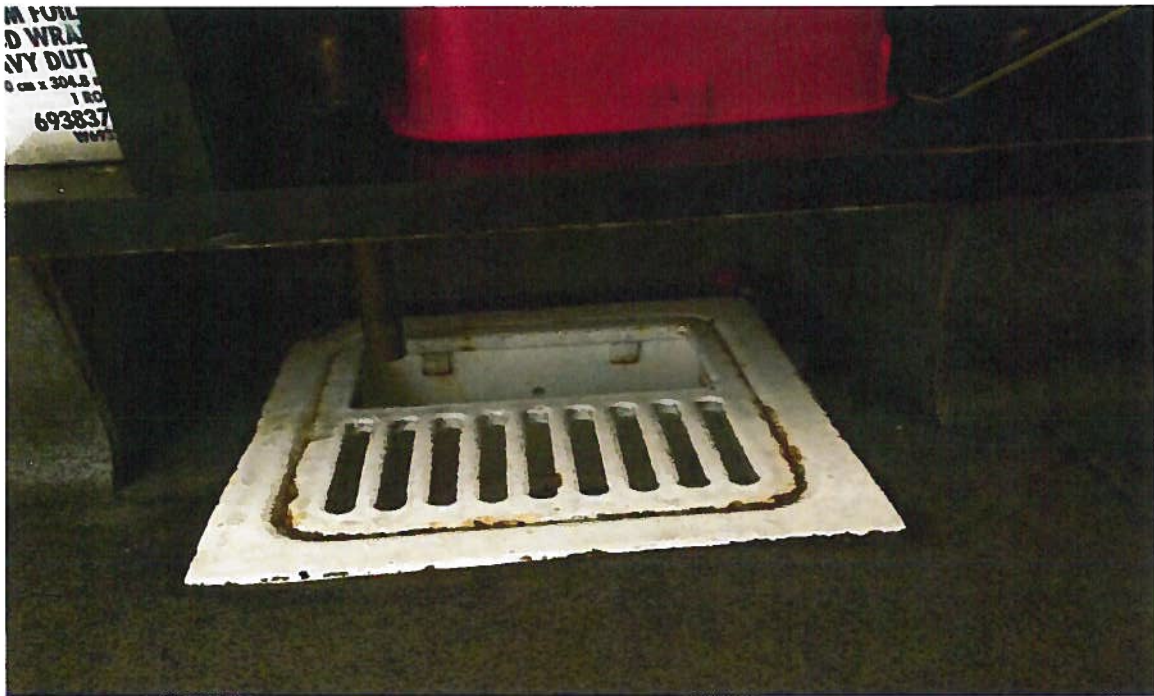
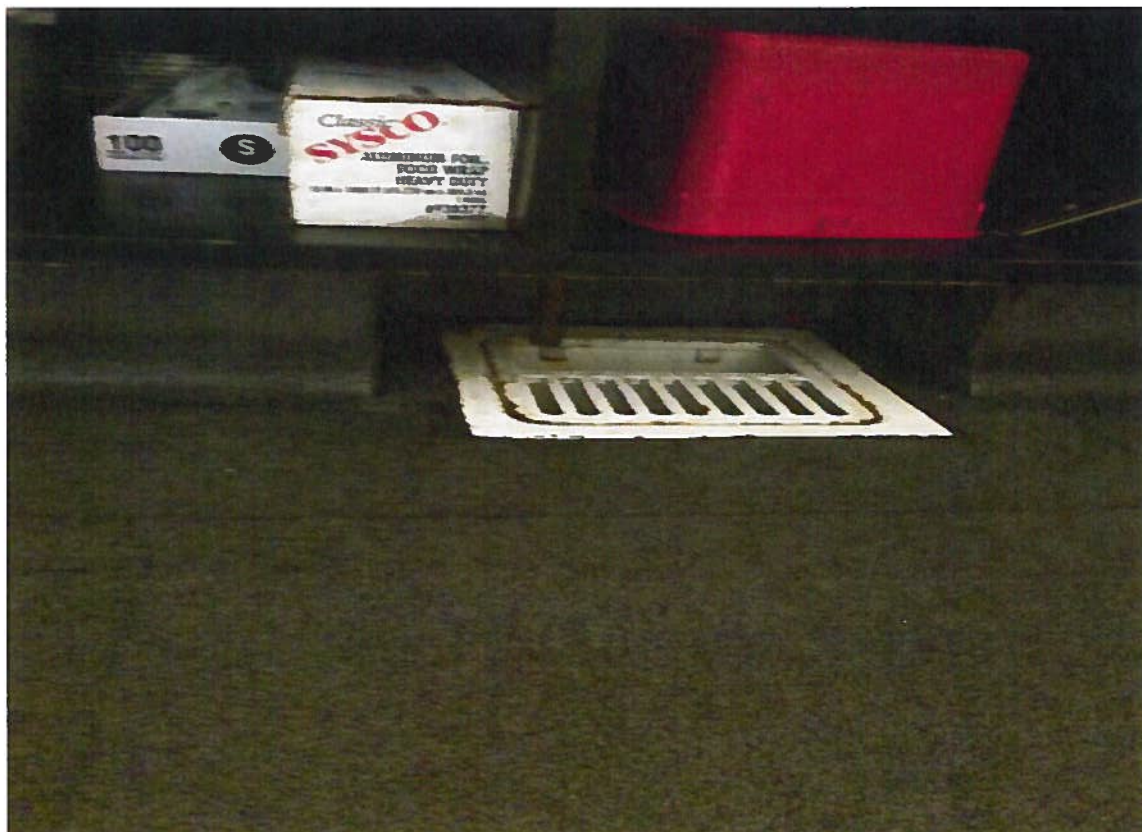
This same flooring that was replaced in the production kitchen in 2012, still exists in the servery (production area of the salad bar).

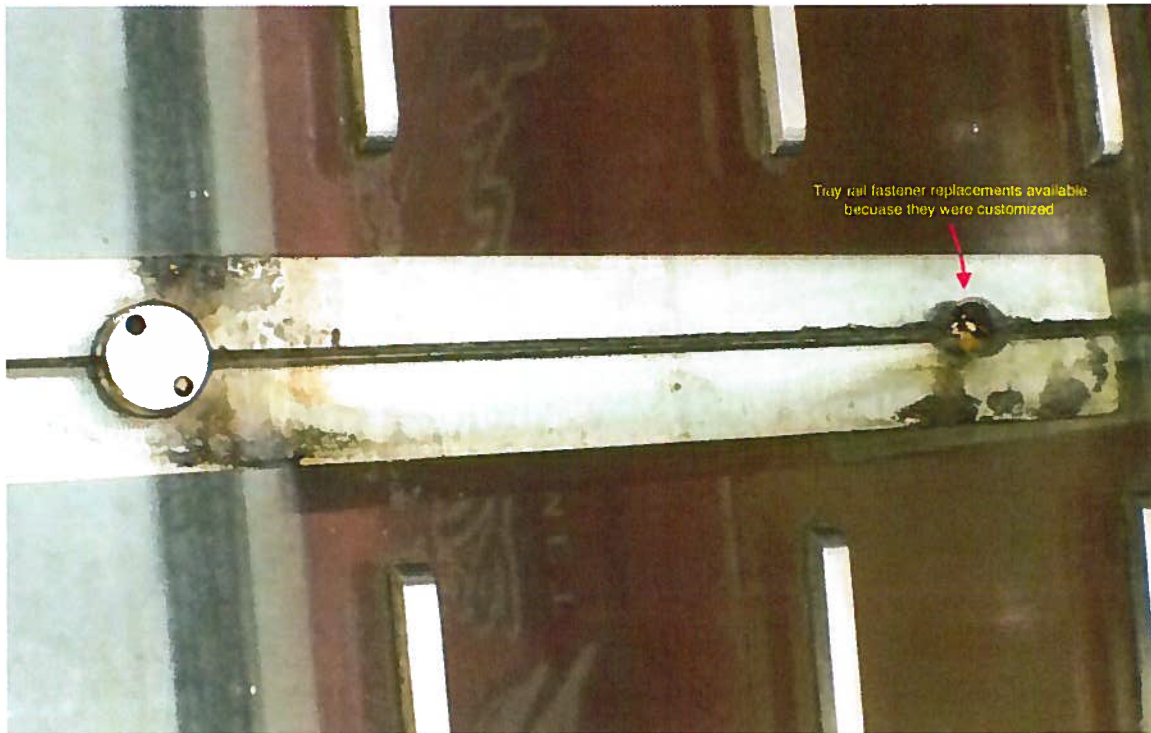
Tray rail seams and fastner damage.

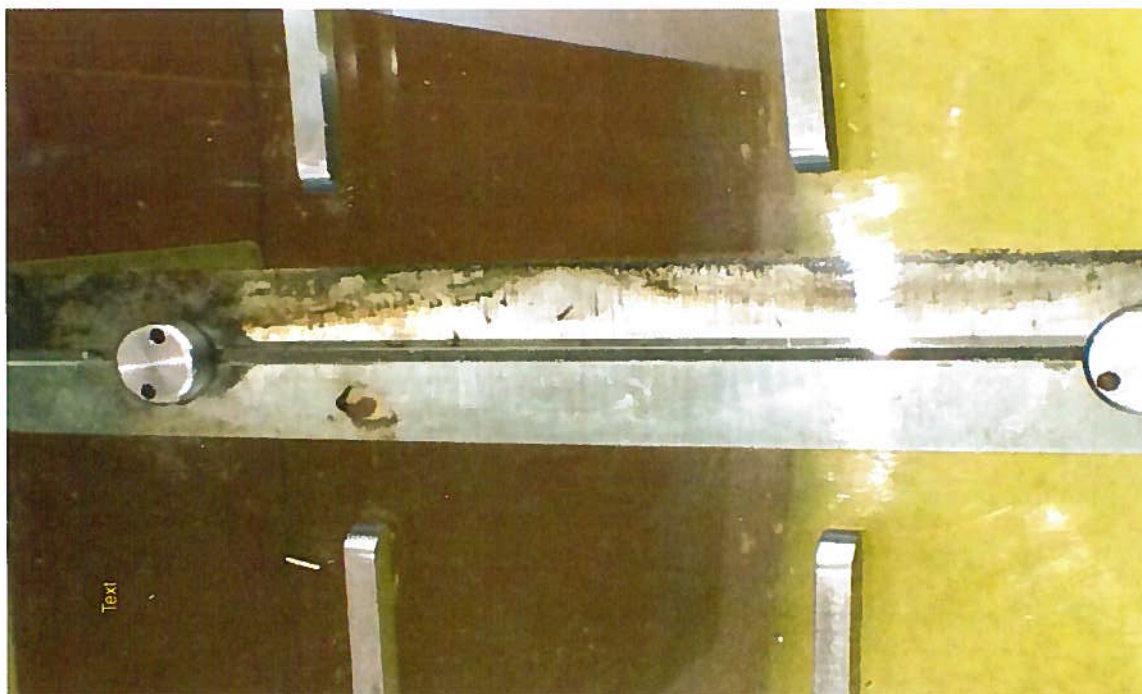
Tray rails were custom built in 2001, fasteners are obsolete and seals between sections have decayed over the years allowing moisture to seep under the glass.

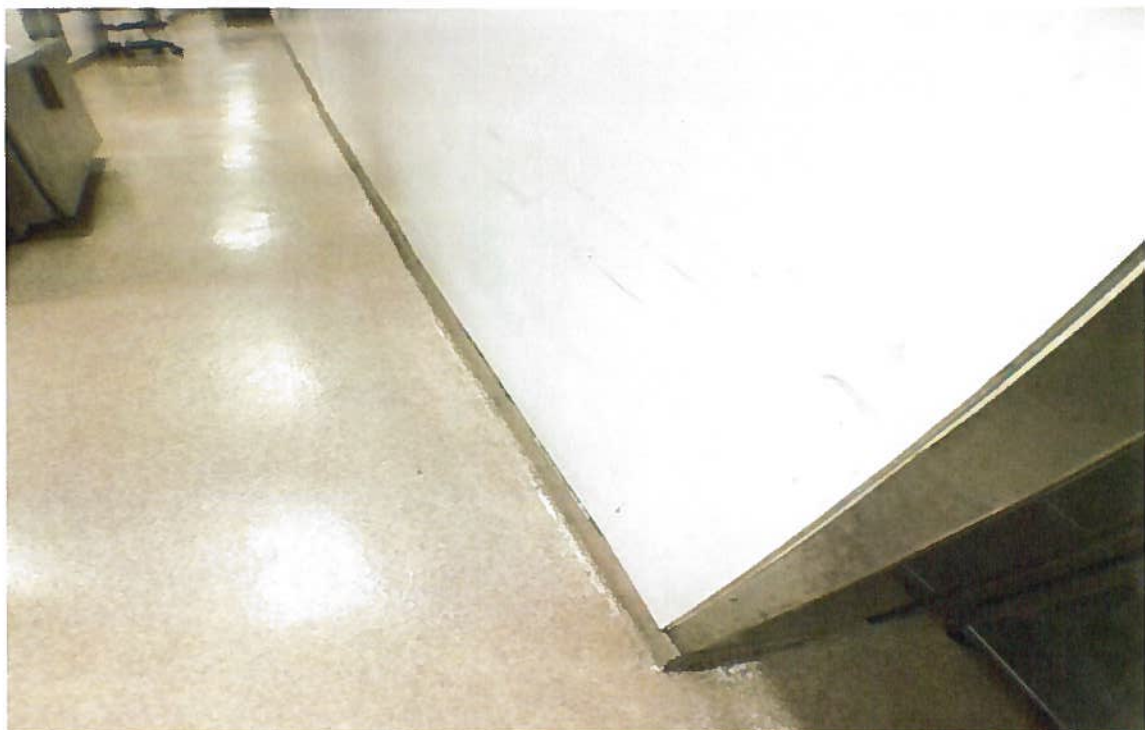
Walls and flooring separating. Kitchen walls have been damaged by wear-n-tear, as well as cleaning equipment.

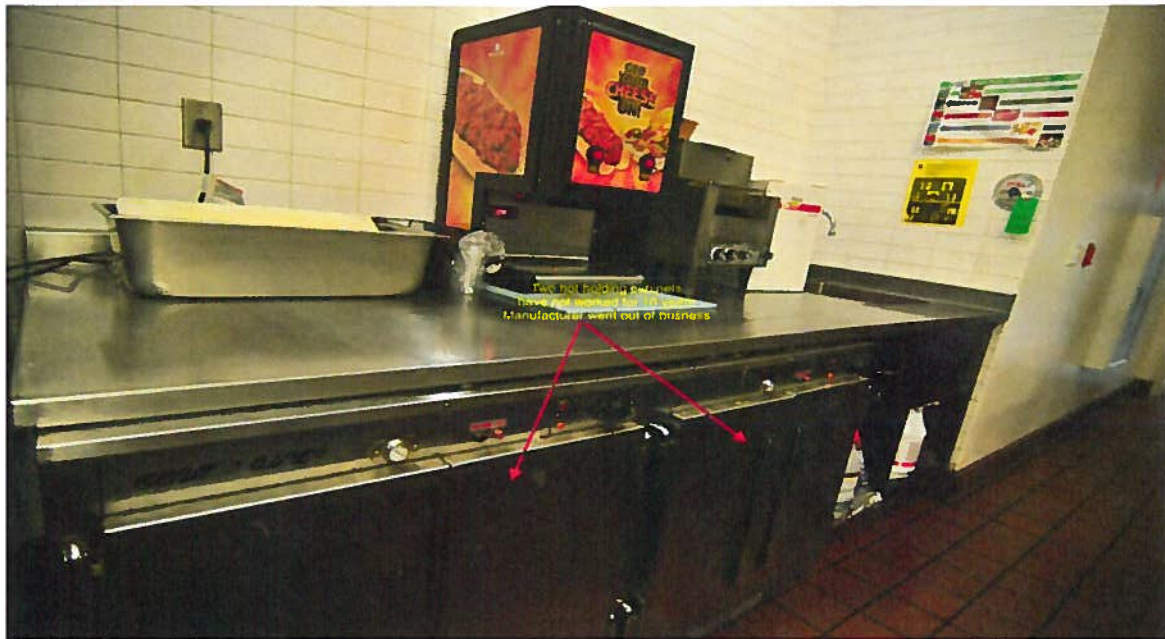
In 2010, the two hot food holding cabinets (top picture) were cited by the health inspector for not holding the correct temperature. The handles were retro-fitted three years after installation, but repairs are costly and we were advised not to repair. The two hot food holding cabinets not been used for 5 years. The hot food holding cabinets depicted in the bottom picture were built into the counters and cannot be replaced because of the custom fit.

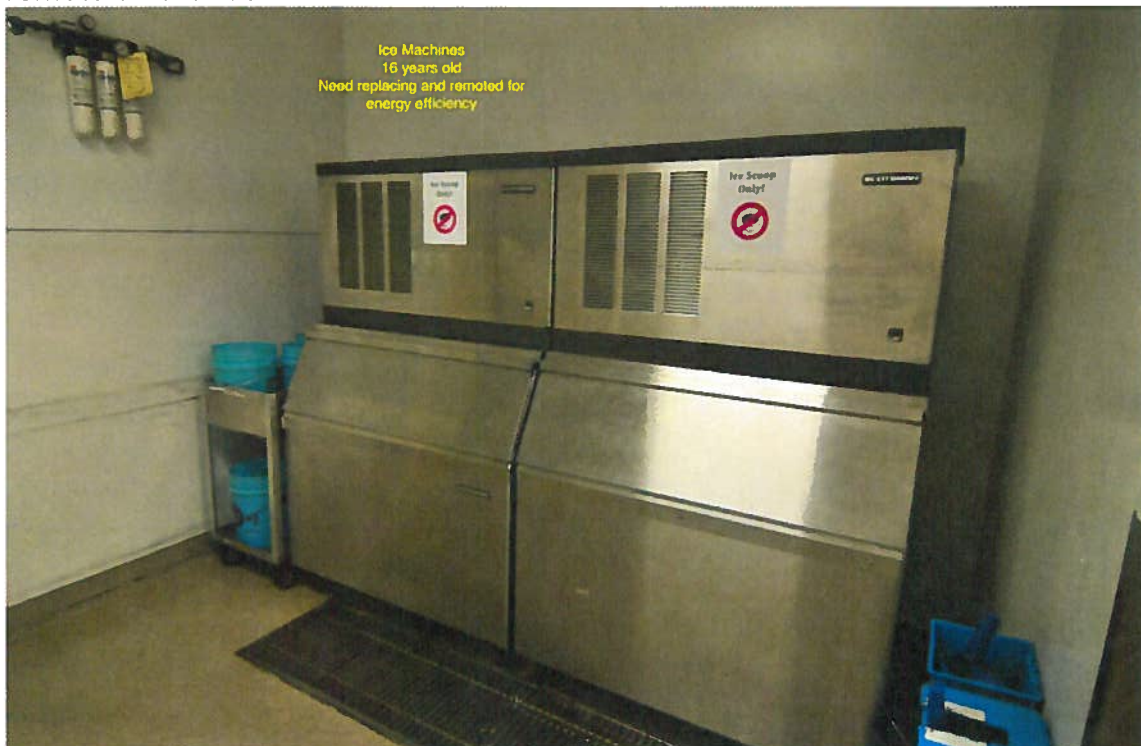
Ice machines need compressors. Their life span has expired making parts harder to obtain. The heat, noise, and energy can be reduced if the compressors were remote on the roof.

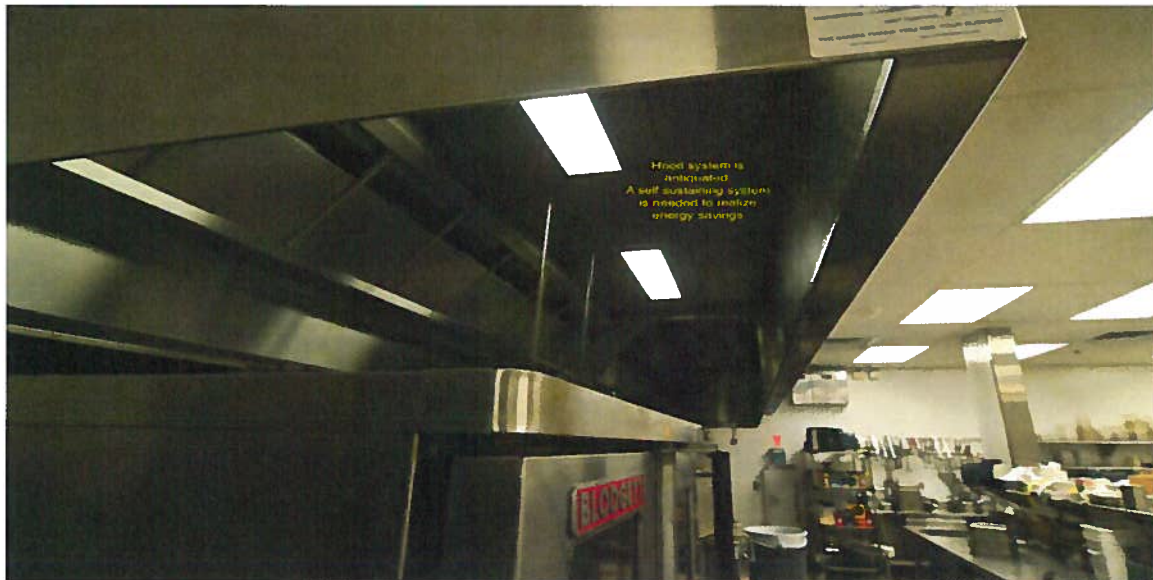
The exhaust hood system does not work to its full capacity, it run 15-hours a day, 7 days a week and can to be retro fitted for energy efficiency.

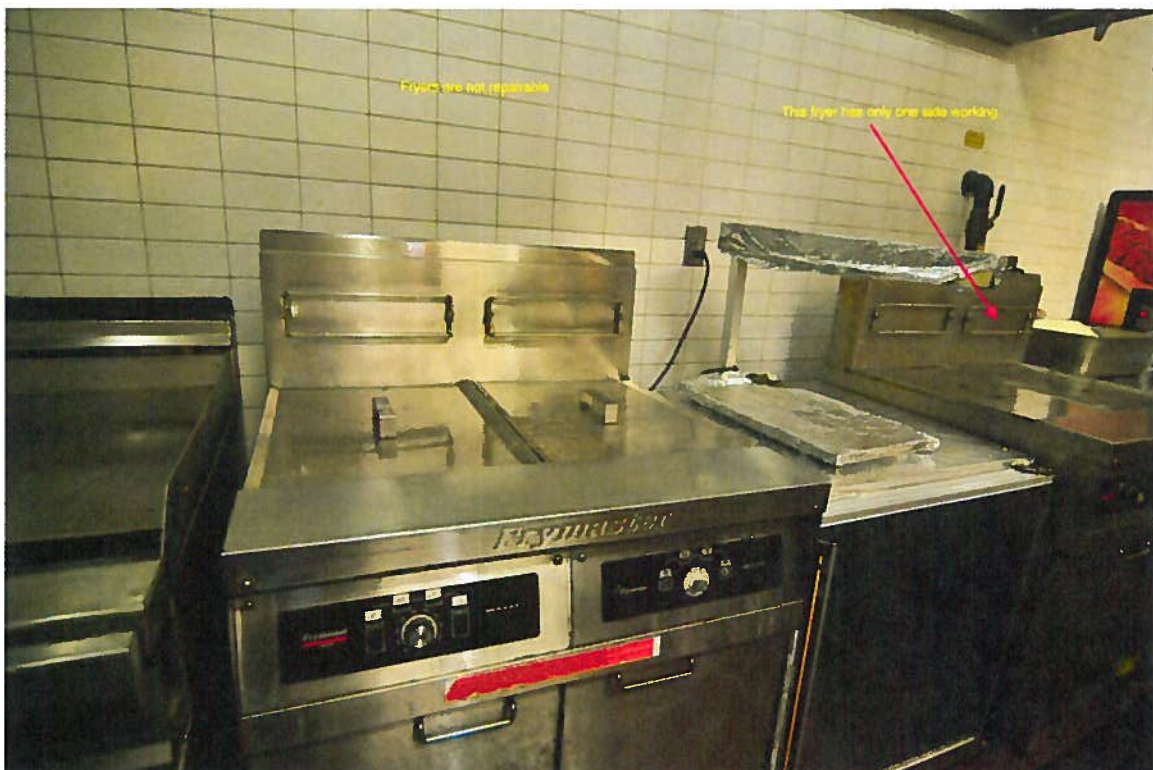
Fryers life span has expired. Three of the four tanks are working. There are not any replacement parts for these units. Fryer on the right has only one side working.

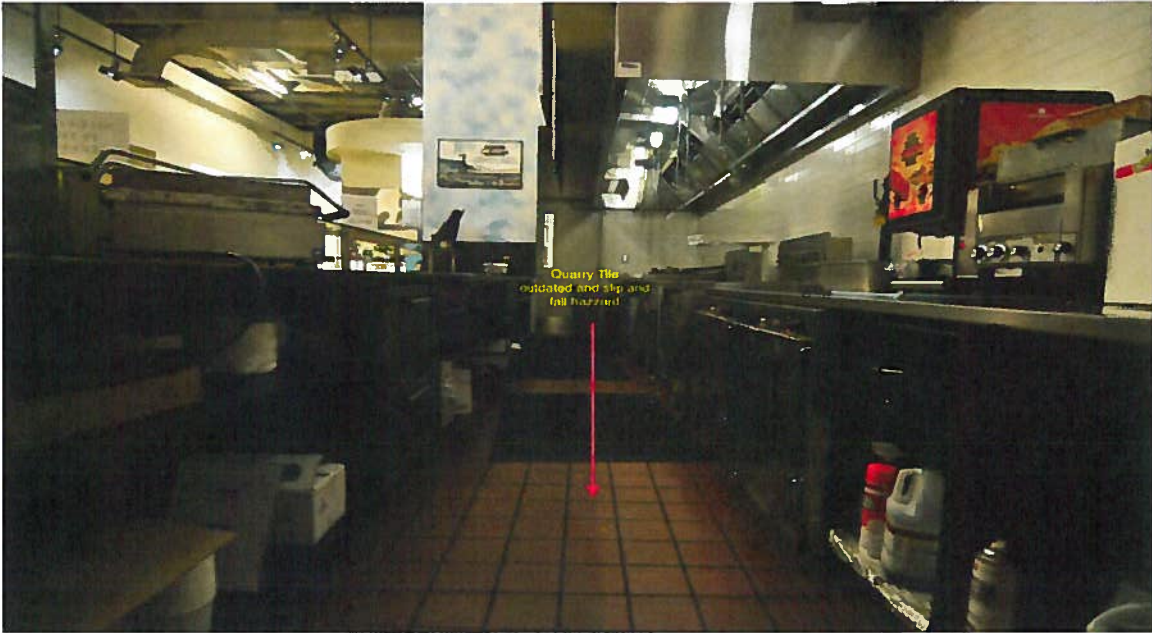
Quarry tile out dated, in need of repairs, plus it's a slip and fall safety hazard.

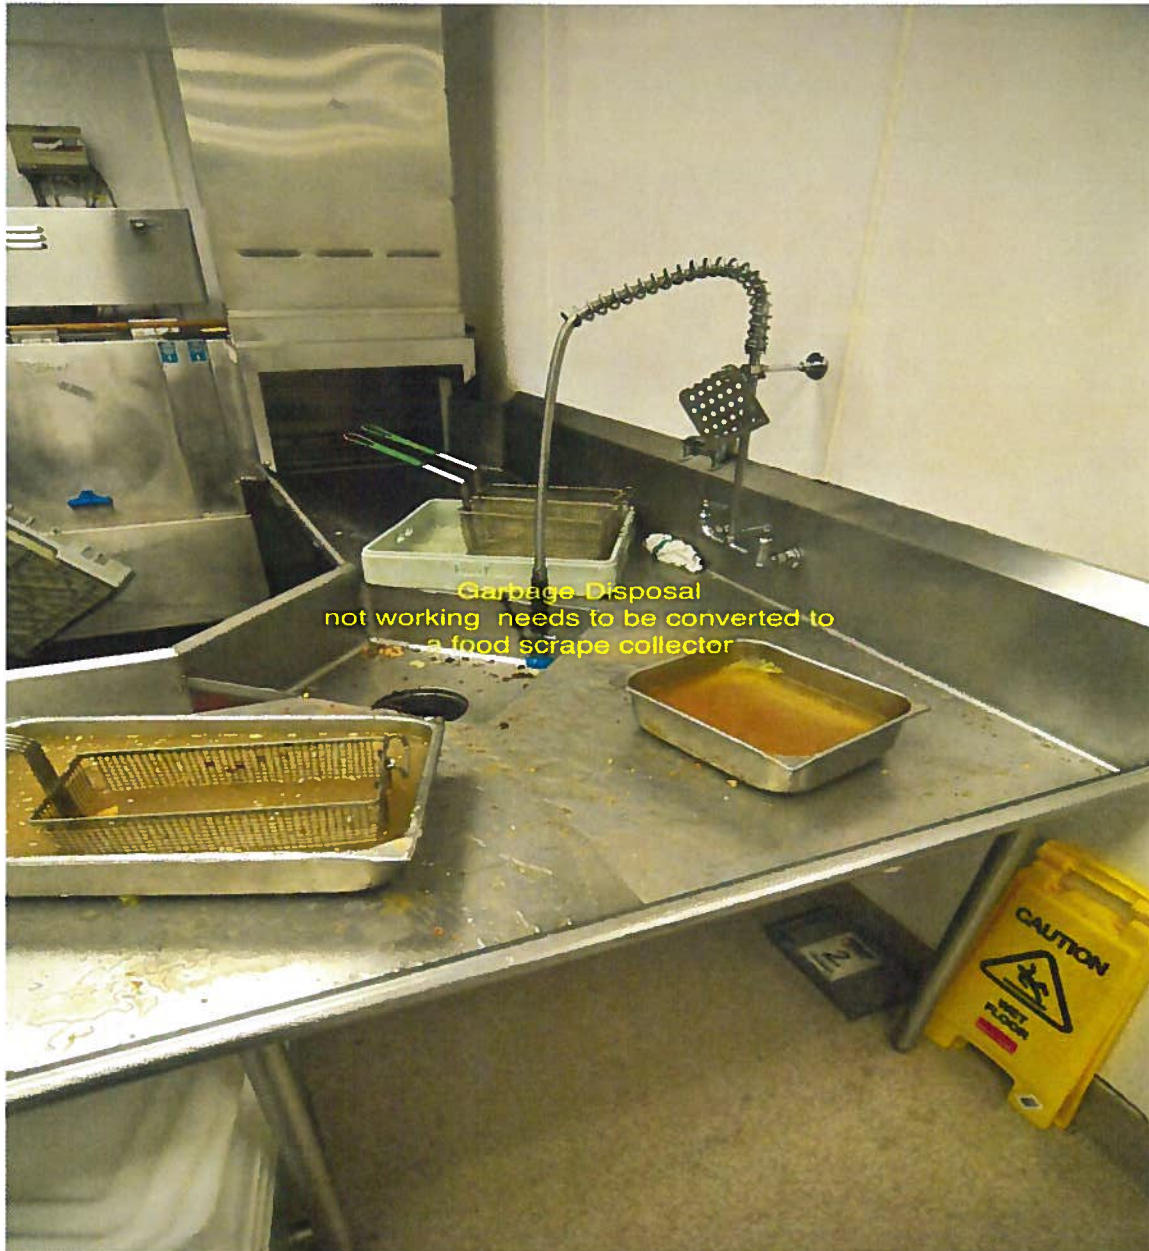
Letter from the City of Portland Environmental Service....

**Food Grinder Devices:** It was also noted during our visit that your facility has a food grinder/garbage disposal. The removal of this device would qualify your facility for an additional surcharge rate reduction. Removal of the grinder in conjunction with the existing waste food composting program would result in a greater surcharge rate reduction.
