# **Food Services**

## 2016 Renovation Document

**Sylvania  
Food  
Services**

## **Sylvania Campus - Kitchen Design Services**

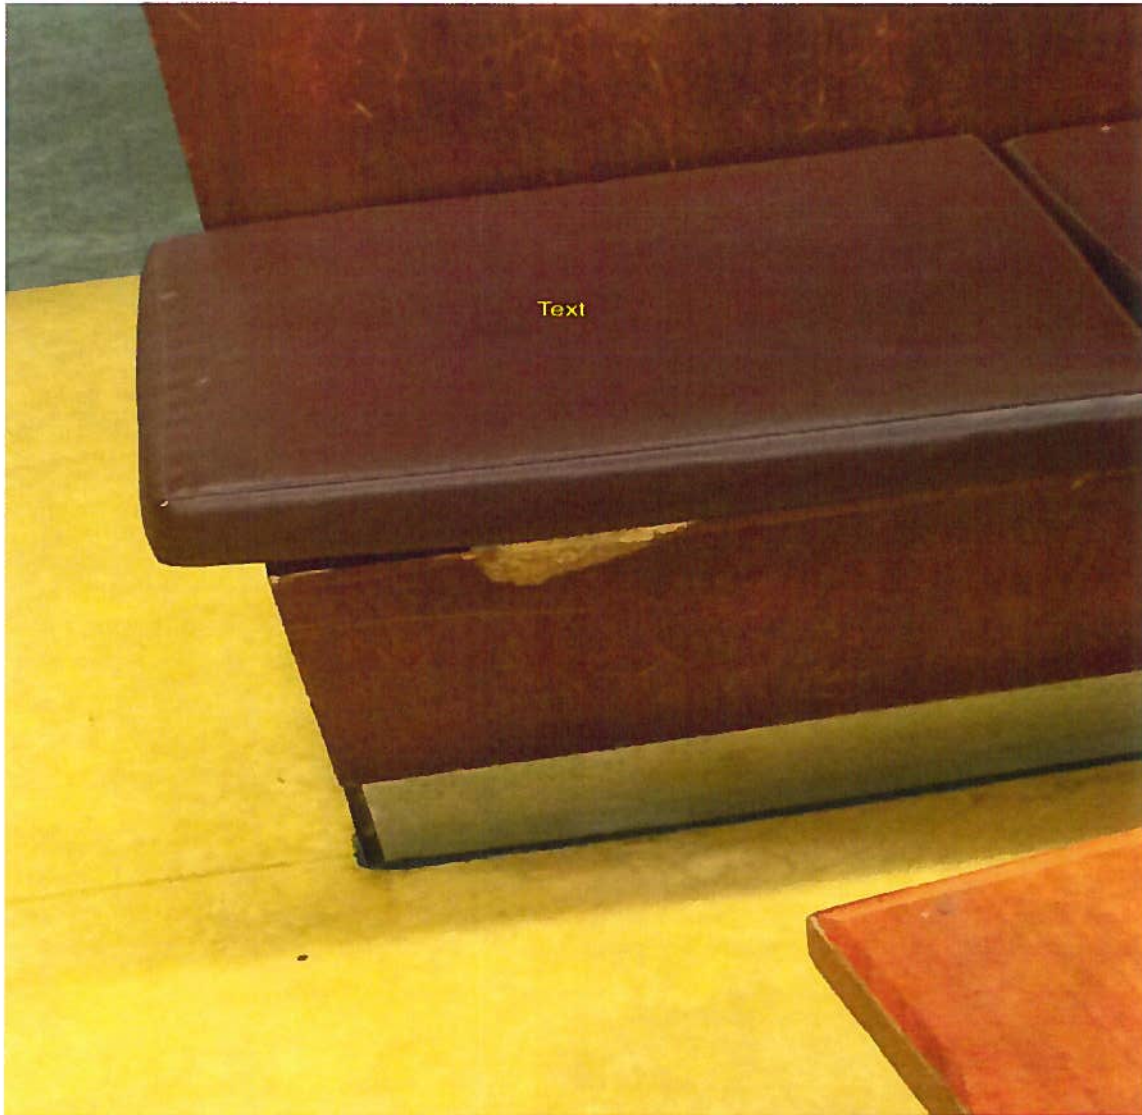
Bench in dining room

The dining room chairs and tables are scarred, display carvings, worn, broken and beaten up by movement over the past 15 years. They have out lived their life span.

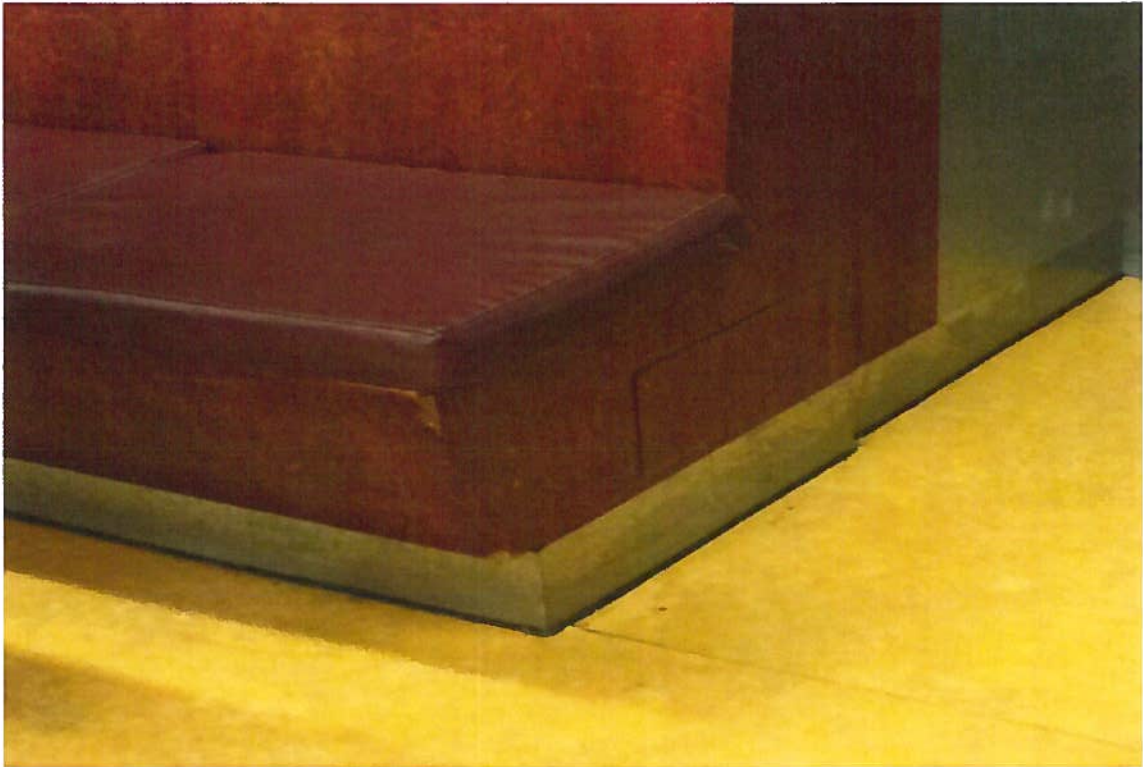
More damaged seating..

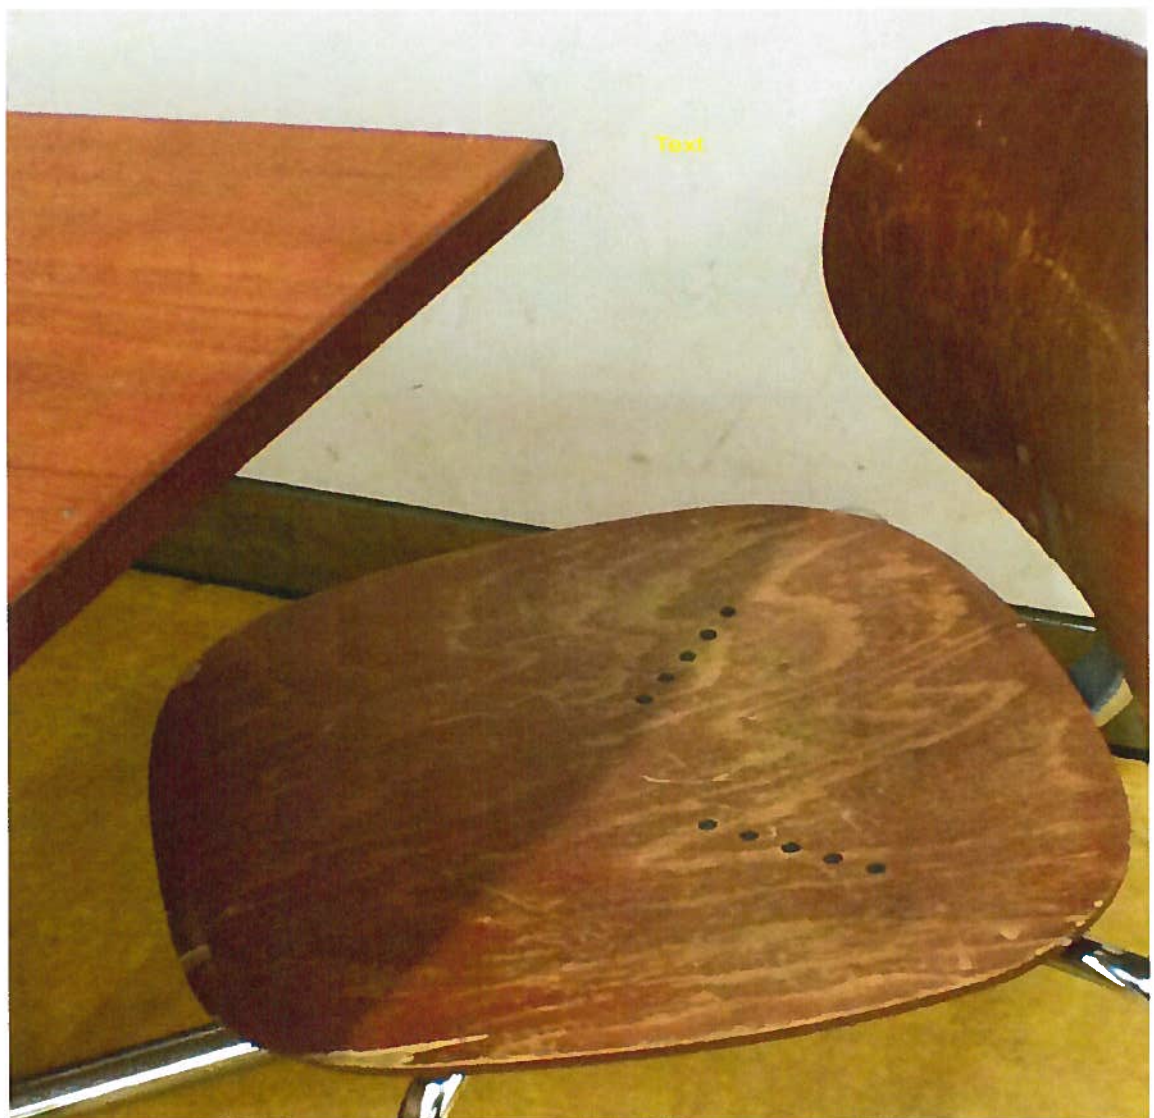
Damaged Dining Room Table & Chairs

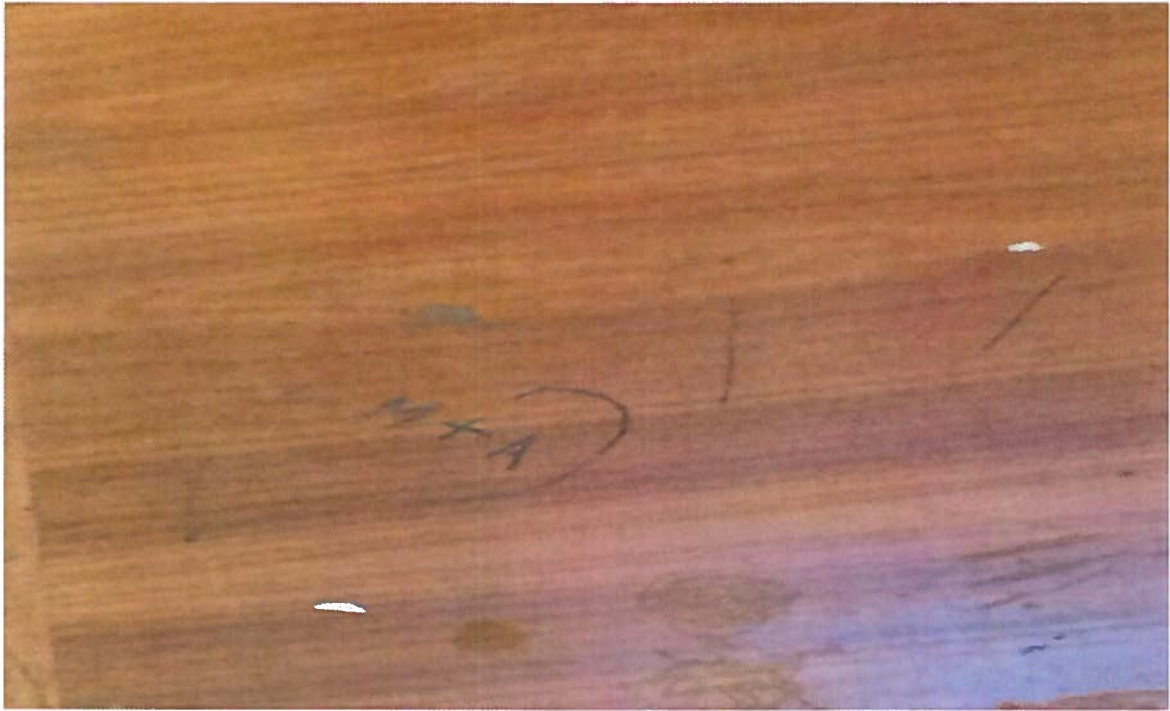
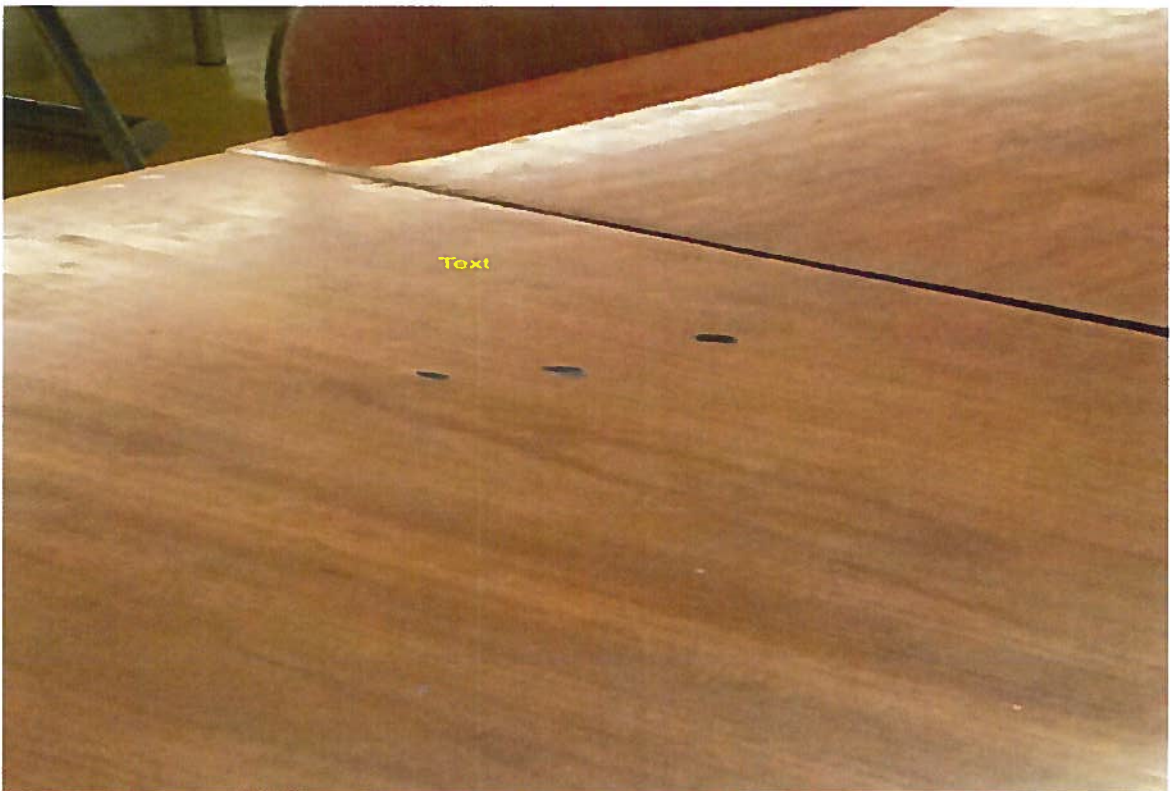
More damaged tables.....

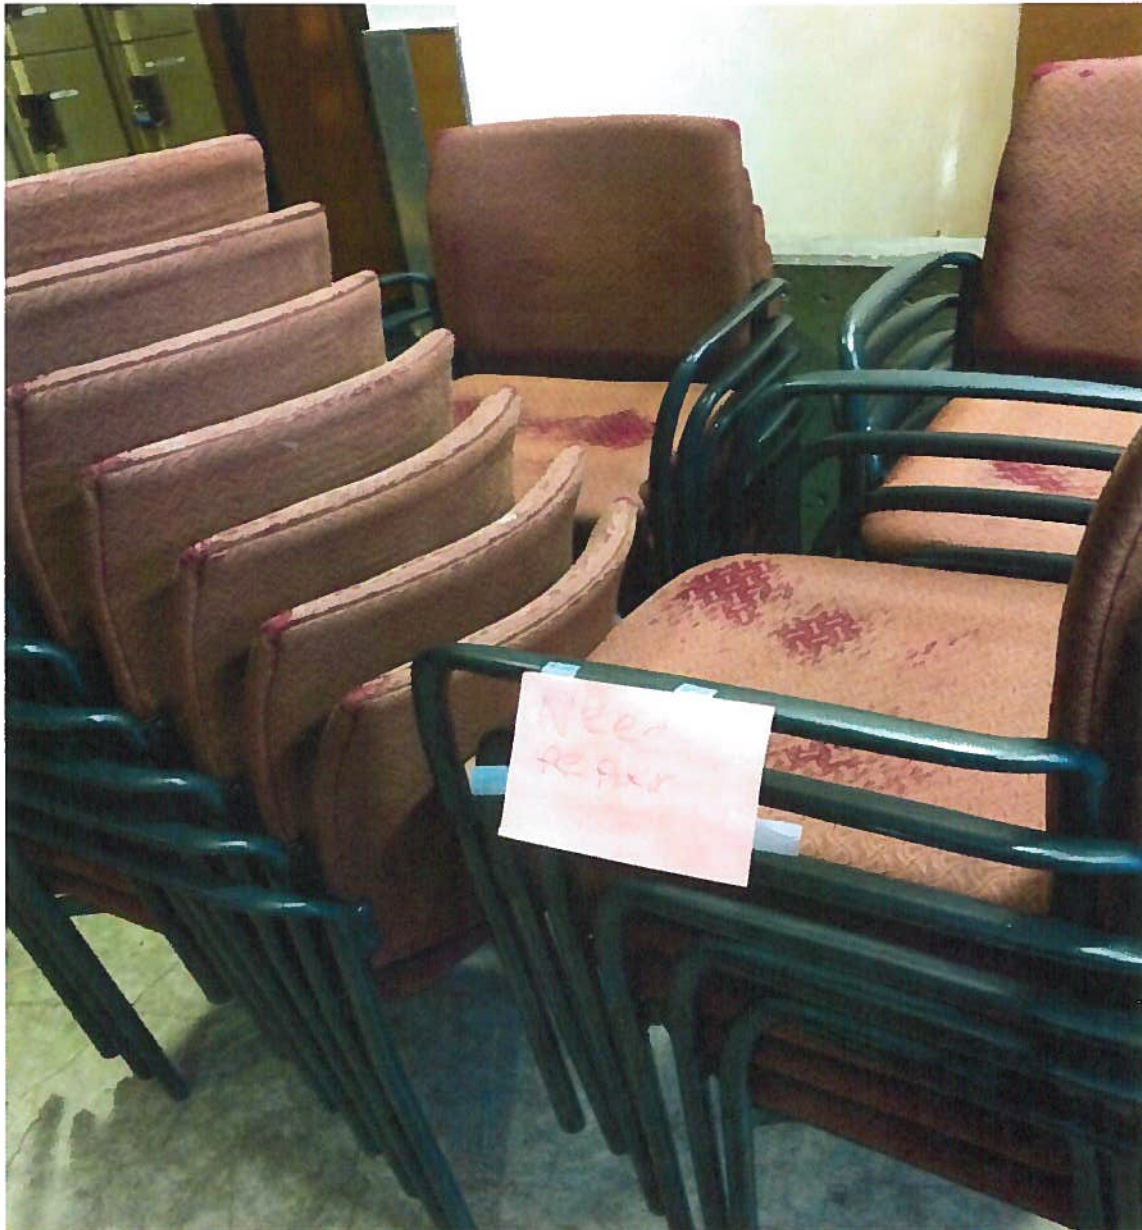
Note left by Safety & Risk Enviornmental Health & Occupancy Specialist

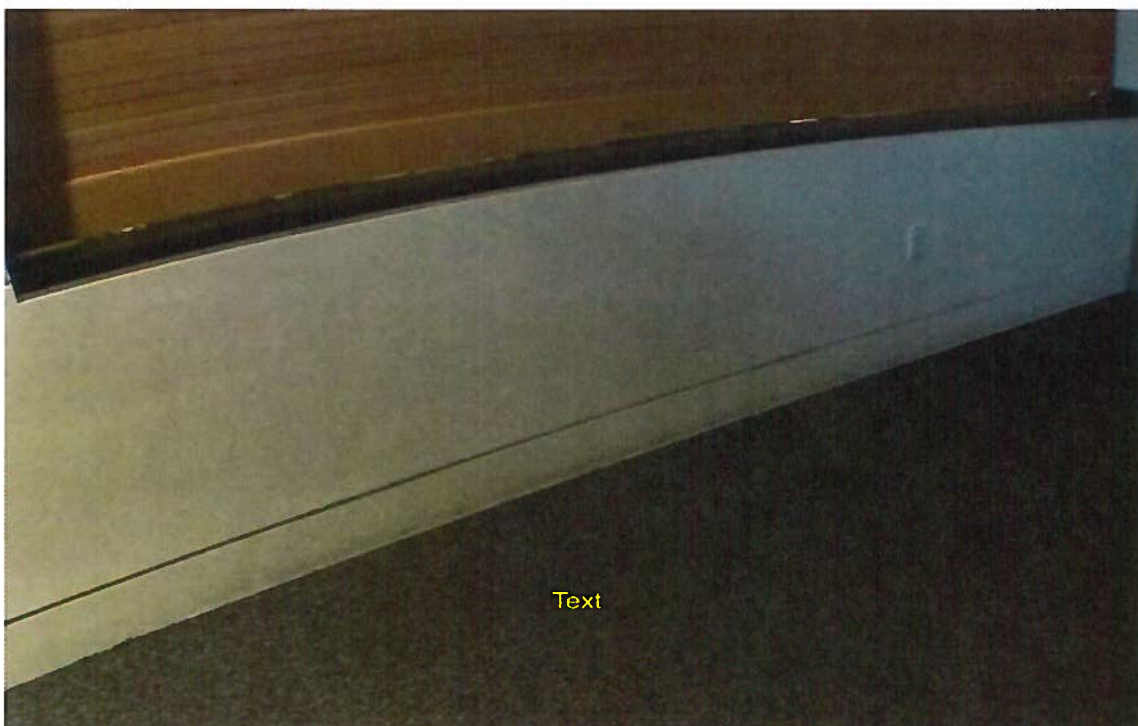
Tree room damaged walls
