Portland Community College

Facilities Plan - Phase 1

Monthly Report

May 30, 2017

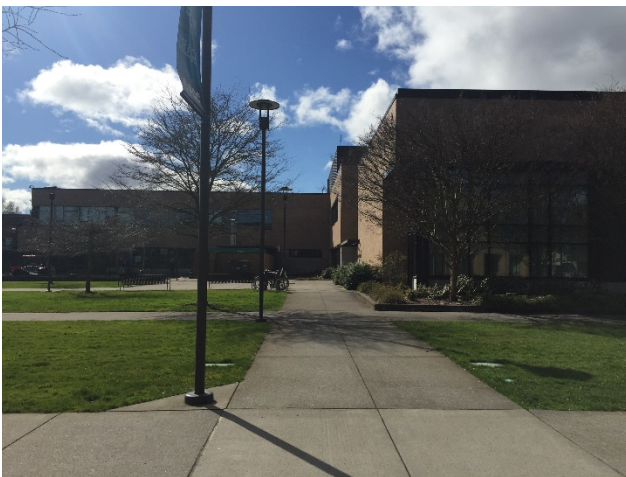
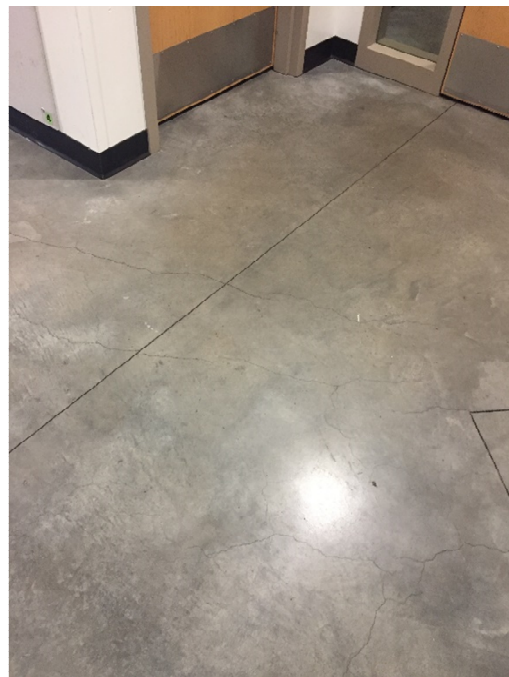
The Moriarty Arts and Humanities building is a 42,173-square foot two-story structure. The building was constructed in 2005. Design relied upon the 1998 Oregon Structural Specialty Code. Construction consists of:

- Metal roof deck supported by steel framing
- 2nd floor: 2 ½" concrete topping slab over 3" metal deck supported by steel framing
- Roof and floor are supported by steel columns
- The foundation system consists of reinforced concrete spread and strip footings
- Lateral forces are resisted by special concentric braced frames in each direction

The structural design utilized a recent building code with standards similar to current building code. Building structural performance under gravity loading, wind loading, and seismic loading is expected to match that of buildings designed under current code.

The building exhibits signs of use and required maintenance typical of a structure of this vintage and construction type. The first-floor concrete slab-on-grade exhibits areas of cracking exceeding what we would expect for a building of this use and vintage. Cracking likely occurred during construction. We recommend repairing the cracks to avoid long term maintenance and possible tripping hazards.

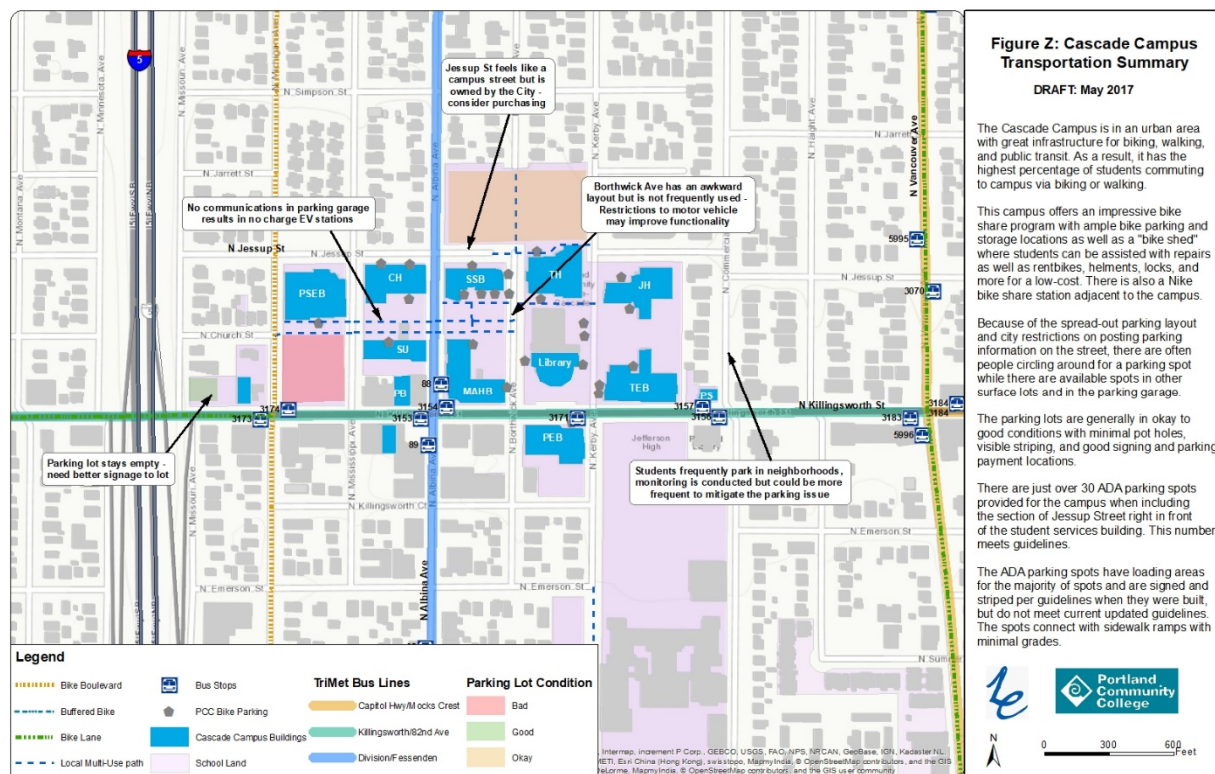
Summary of Activities: A transportation group meeting occurred on April 28th. The work over the last month was reviewed. Field visits at each campus to review ADA compliance with parking spots, inventory bicycle, pedestrian, and transit infrastructure, as well as review general parking demand and any other transportation related components was conducted. Additional field review is planned to measure ADA spaces and get parking lot quality inventory. From the field visits and meetings we are working on summary maps for our report that can be transferred into the final report. Example below:
