APPENDIX B

BUILDING FUNCTIONAL ASSESSMENTS

DATE: NOVEMBER 2021

A. FACILITIES ASSESSMENT - FUNCTIONAL CONDITIONS

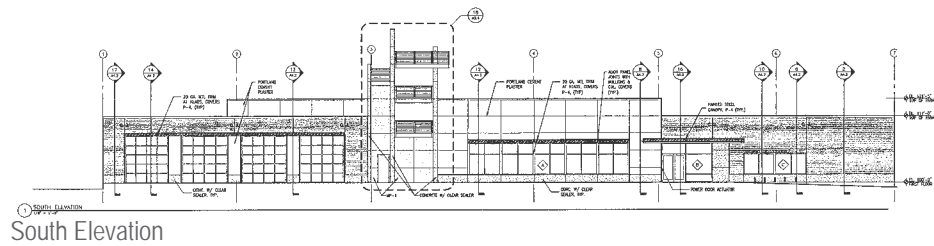
Fire Protection Truck Bays on west provide good access to daylight for future use however there could be significant glare throughout the day with Southern orientation

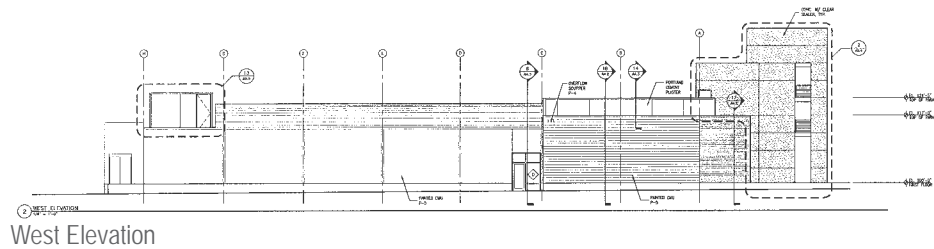
West and North façades facing the community do not have windows.

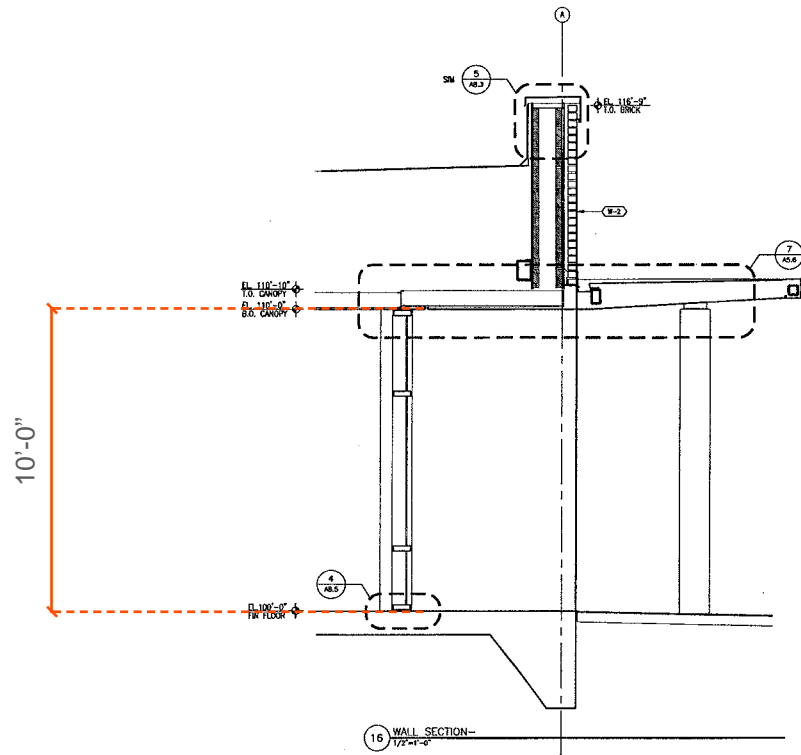
- Floor to ceiling height is adequate for small to medium classrooms but would not be well-suited to large classrooms.

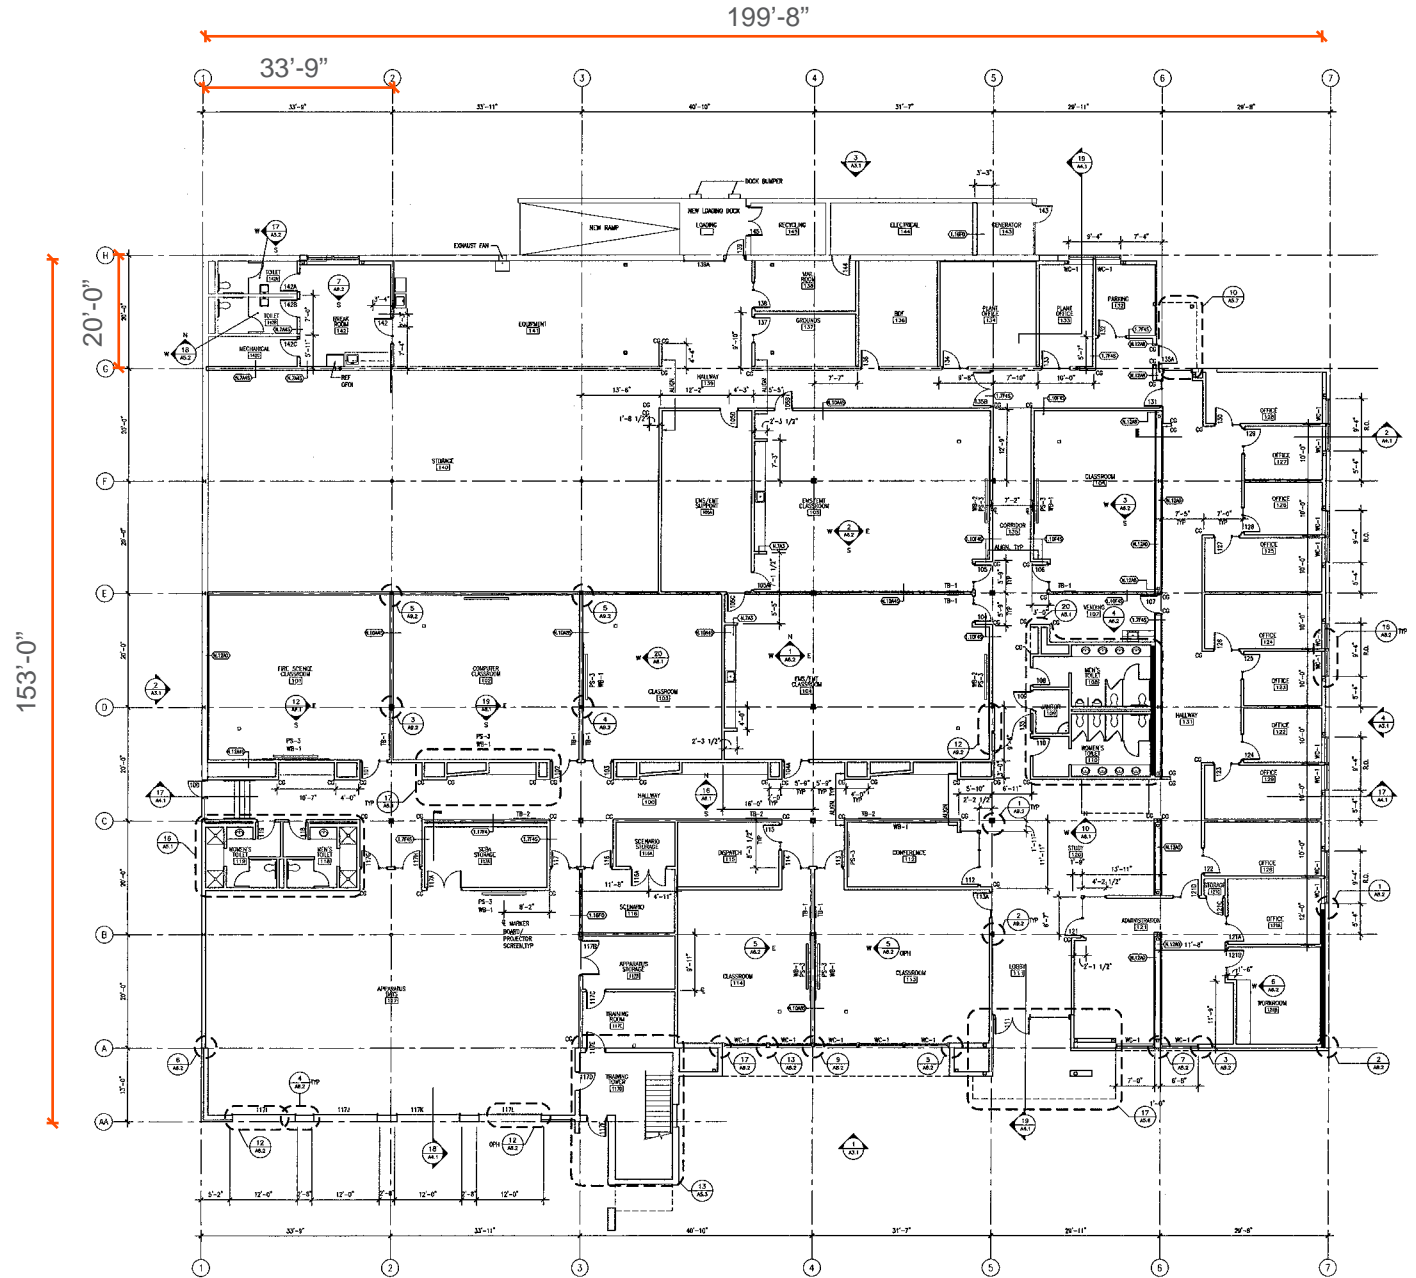
- With multiple structural bay dimensions and columns, large classrooms or other functions that require sight lines would not be functional.
- Open office, classrooms and/or student gathering and collaboration spaces would work well.
- With wide building dimensions access to daylight into the interior is limited and therefore not ideal for classroom.

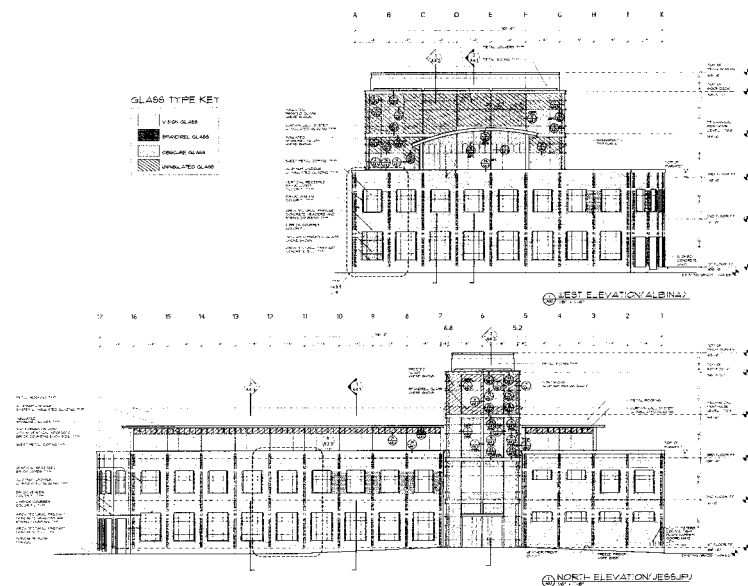
- Building projects a positive image, consistent with a PCC identity and is coherent with adjacent buildings on campus.
- Appears in good condition.

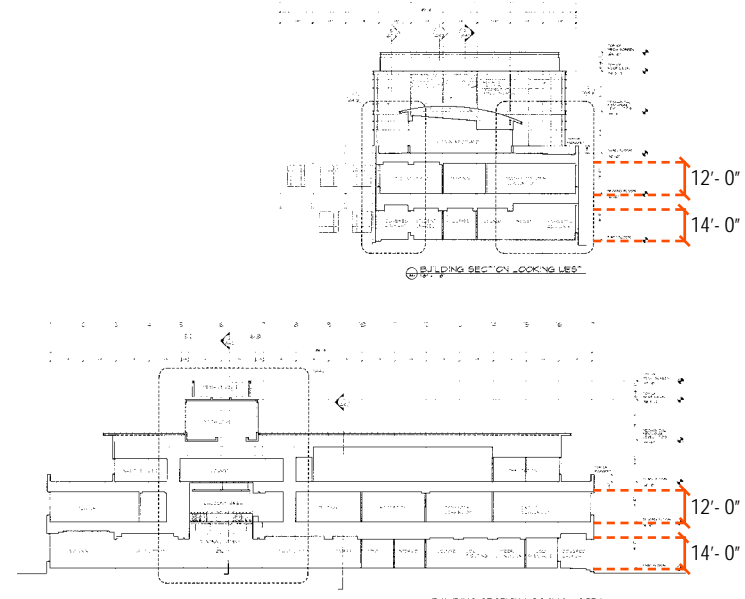
- Floor-to-ceiling height is adequate for classrooms on the first and second floors.
- The first floor is best suited for large classrooms.

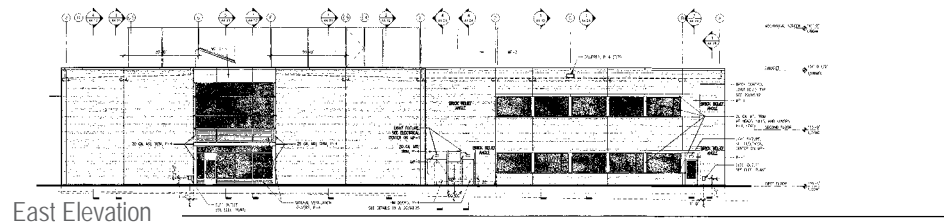
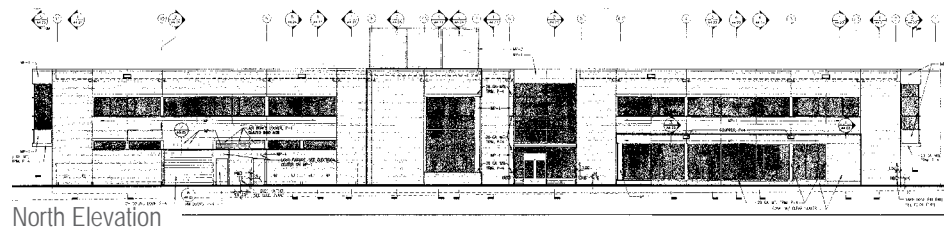
- The building projects a positive image for the college along Killingsworth & internal to campus. However it does not read as a major destination on campus.
- If the Computer Resource Center (CRC) on the north were more transparent (window coverings removed), the building would have a stronger presence.

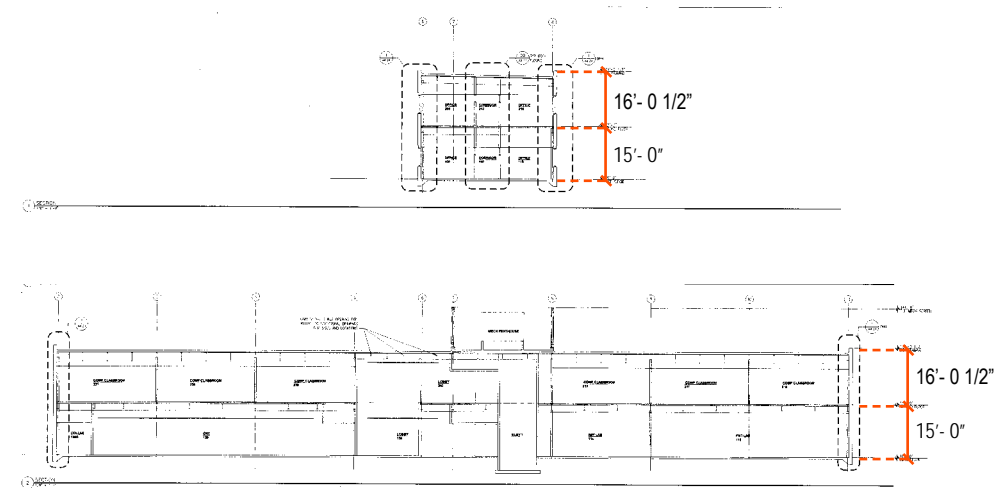
- Floor-to-ceiling heights are very good to support a range of classrooms/ classlab sizes and types.

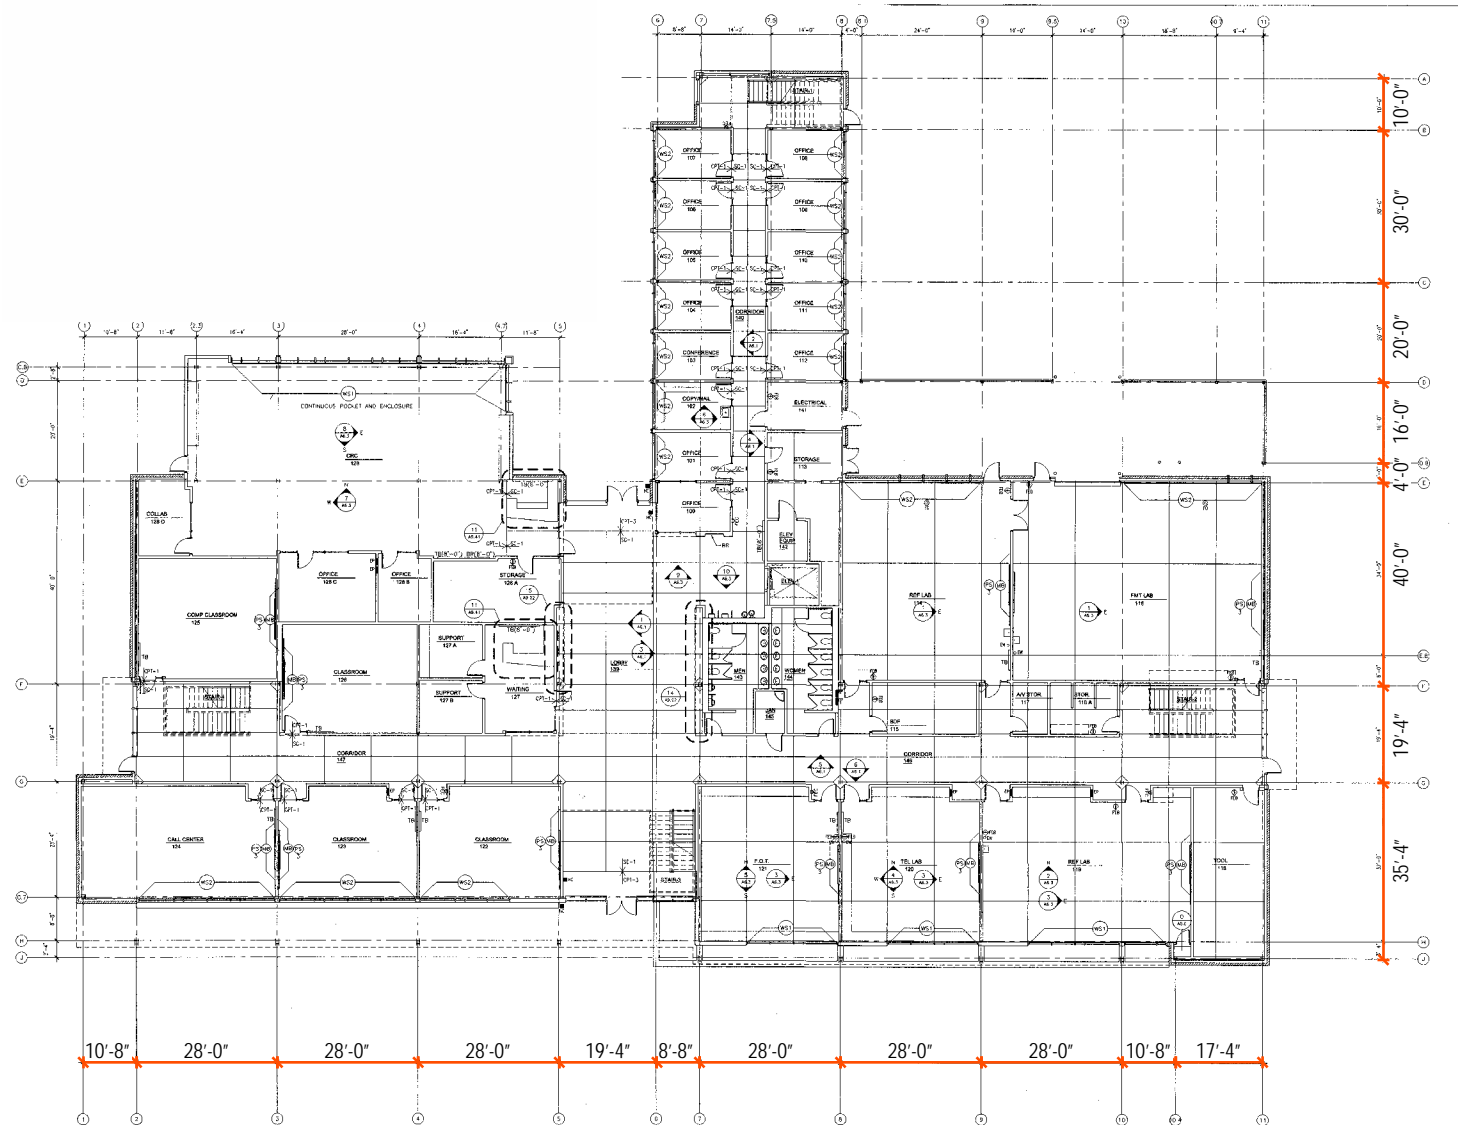
- Structural bay dimensions in the larger wing support a range of uses well, including larger classrooms, classlabs and gathering spaces.
- North wing dimensions limit its use to offices and possibly small (seminar) classrooms.

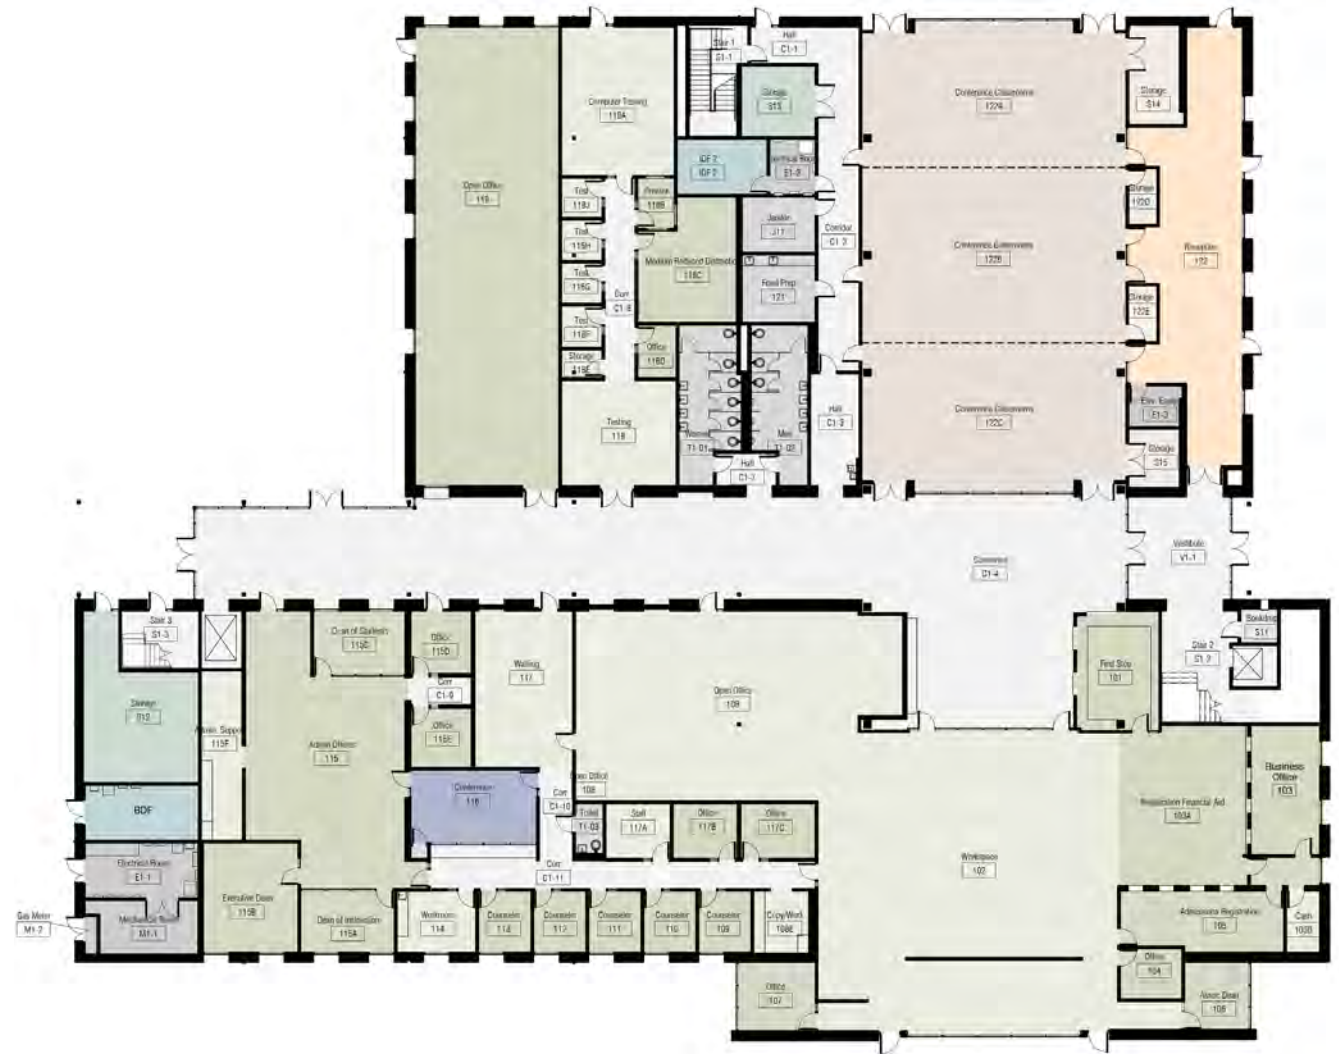
Level 1

- Some Student Services spaces lack access to daylight.
- Transactional Student Services functions may not be complementary with the library on the second floor because high Student Services activity only occurs during peak times at the beginning of the term.
- Absence of gender inclusive restrooms.
- Interacts well with central courtyard space and other PCC buildings on campus.
- Building is efficiently configured and makes good use of its footprint.
- Large conference space is a benefit to campus.
- Difficult wayfinding to the library on the second floor.
- First floor could be converted to medium to small sized classroom space if needed.

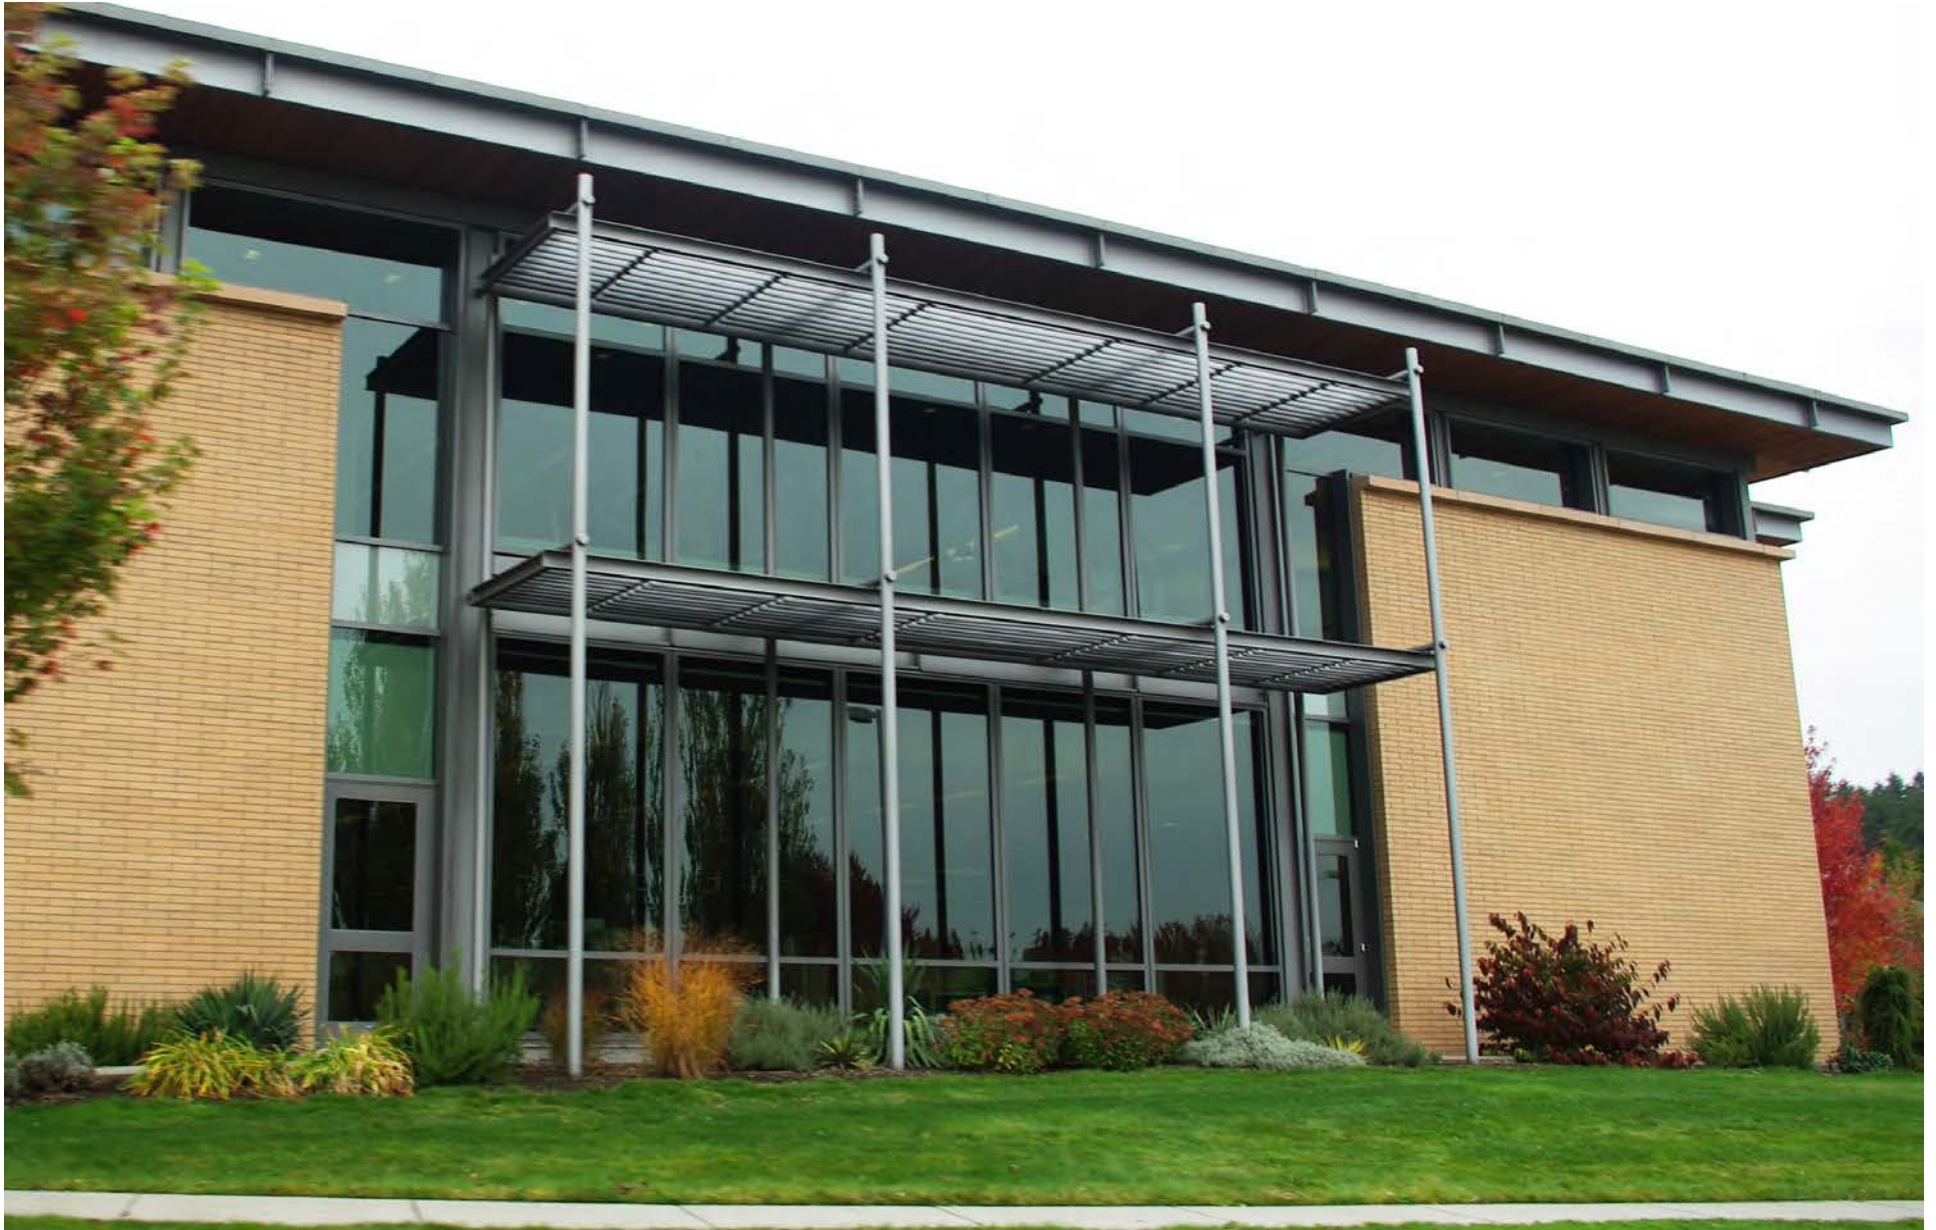
- The building presents a very positive image at the campus front door and internal to the campus.
- Has a positive presence along the adjacent road.

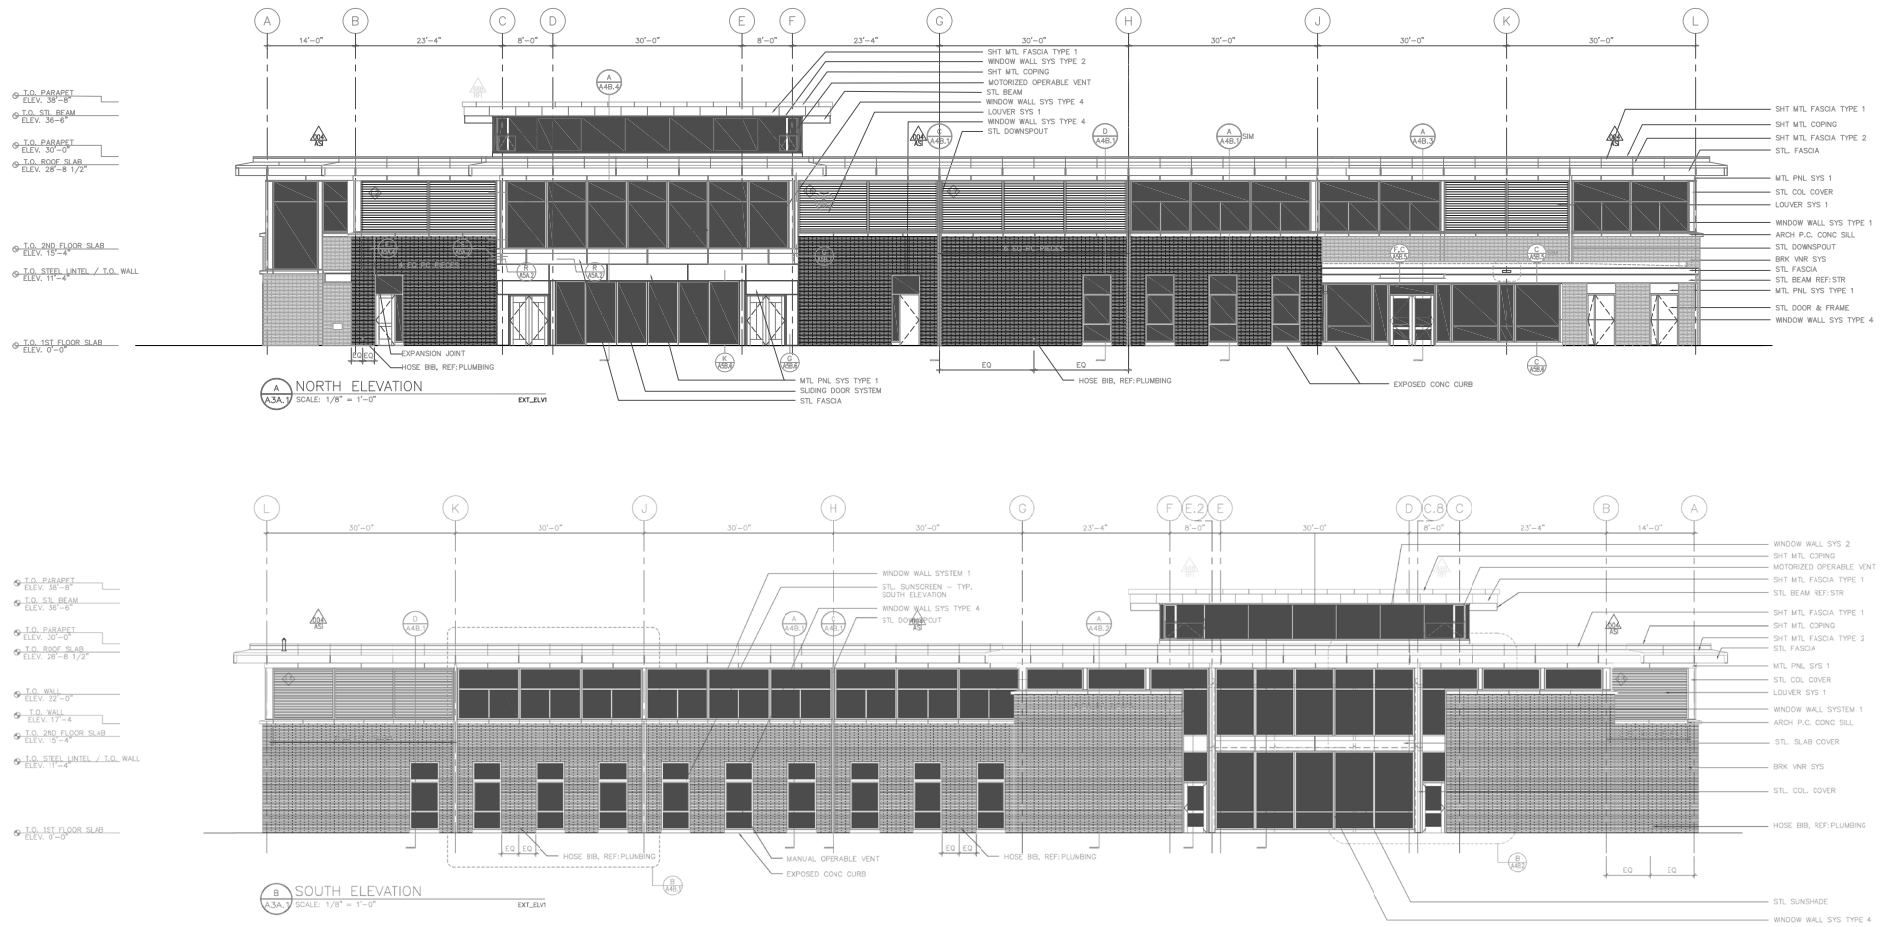
- Floor-to-ceiling heights are best suited for small and medium classrooms, except in the event center.

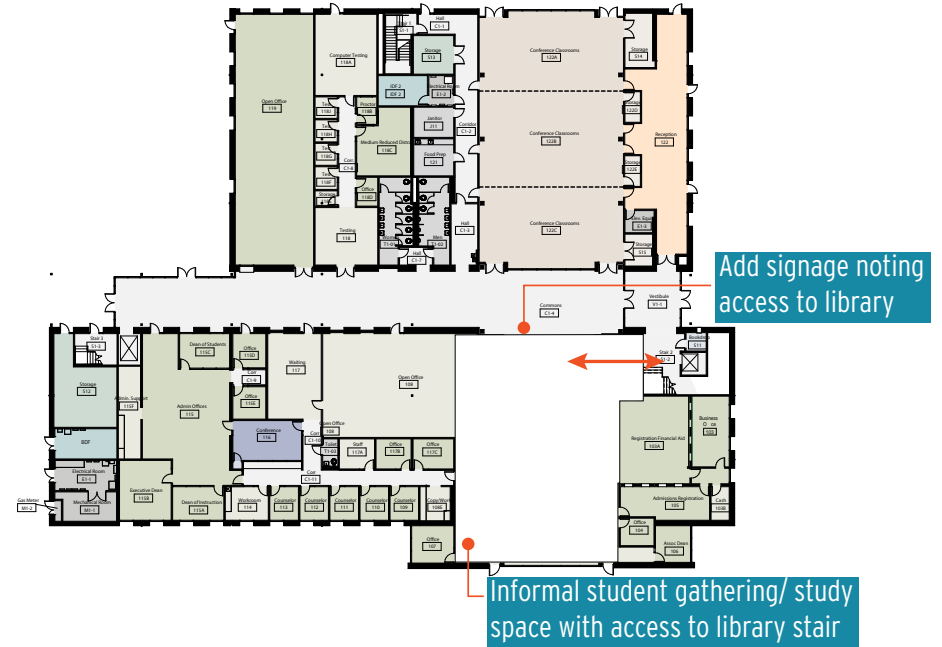
Strategy 1 - Level 1

Transform front Student Services / Answer Center to student gathering/study space with more direct access to the library and prominent signage.

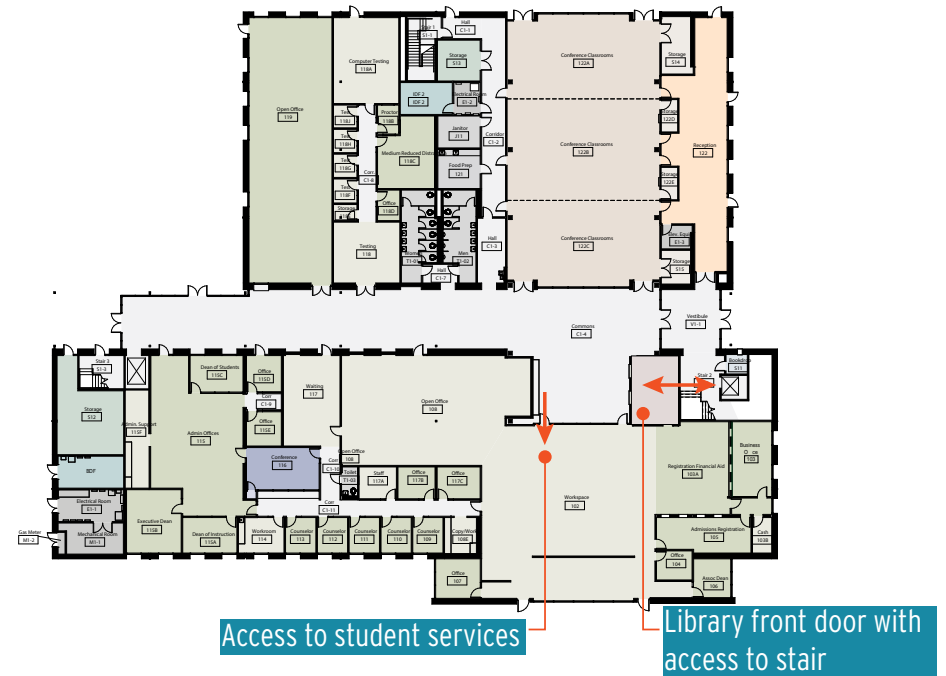
Strategy 2 - Level 1

Add direct access and identity signage to library from first floor main corridor

- Circulation could be a bit awkward.
- No first floor presence of library aside from the access point.

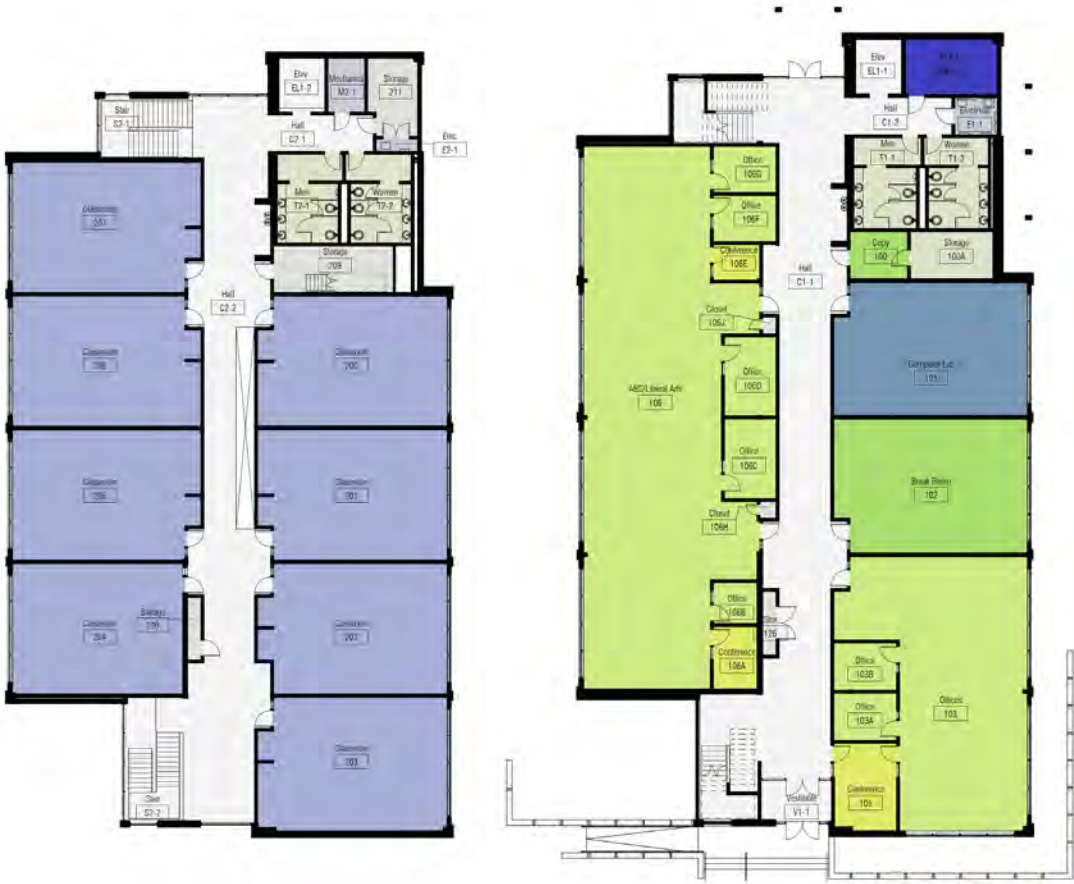
Level 1 & 2

- Spaces overall are well designed contemporary learning spaces.
- Building configuration lends itself well to classroom and office space.
- Wayfinding is clear with central corridor and stairs at each end.
- Multiple doors into the offices are confusing to students.
- Absence of gender inclusive restrooms.
- Hallway is wide and could accommodate some furniture for study or informal gathering.

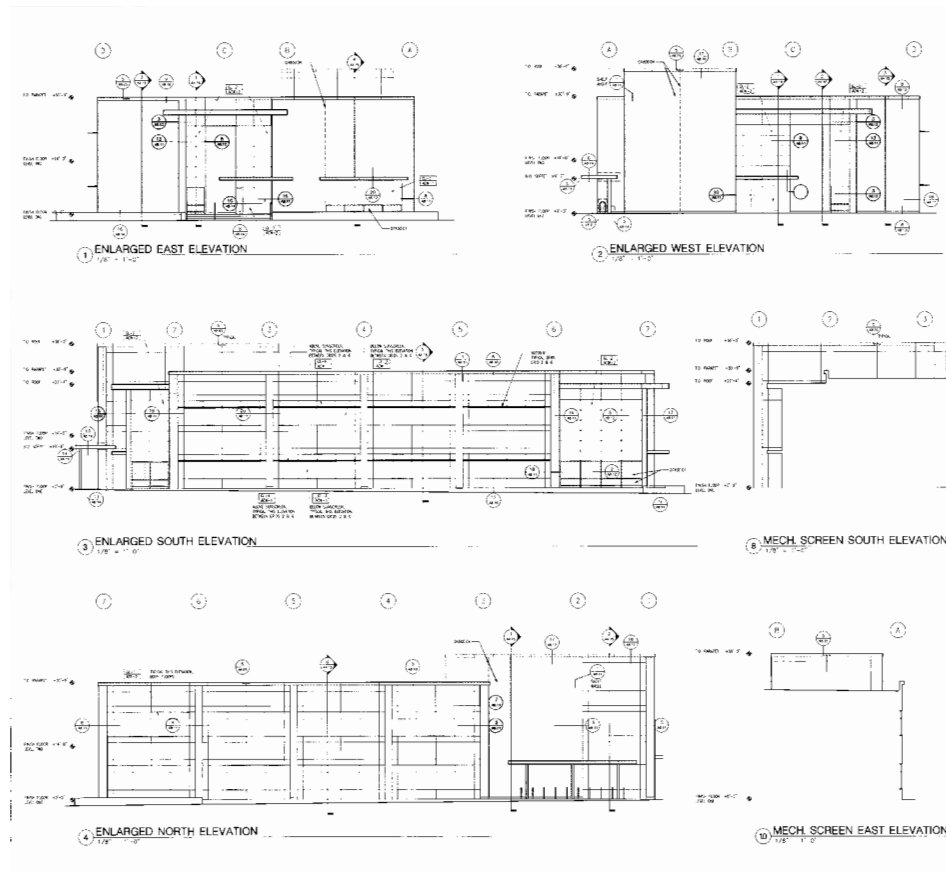
- Good access to daylight. Comfortable floor-to-ceiling heights for multiple uses.

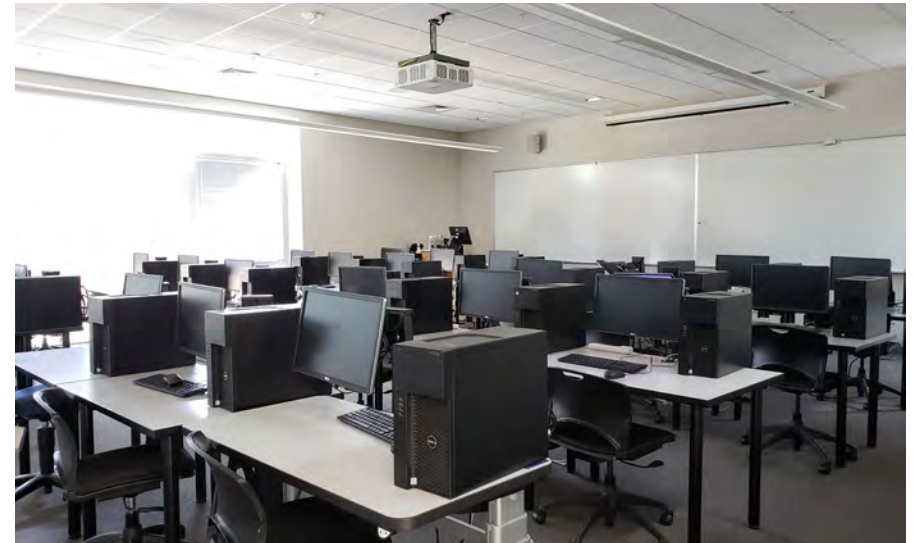
Computer Lab

- Lower floor studio spaces do not lend themselves well to general classroom space without daylight.
- Building configuration lends itself well to classroom and office space however lower floor is best suited for online distance learning centers.
- Needs better signage for classrooms and offices.
- Poor thermal comfort with extreme weather conditions leading to discomfort especially in the atrium space.
- Absence of gender inclusive restroom on first floor.
- Building is efficiently configured and makes good use of its footprint.

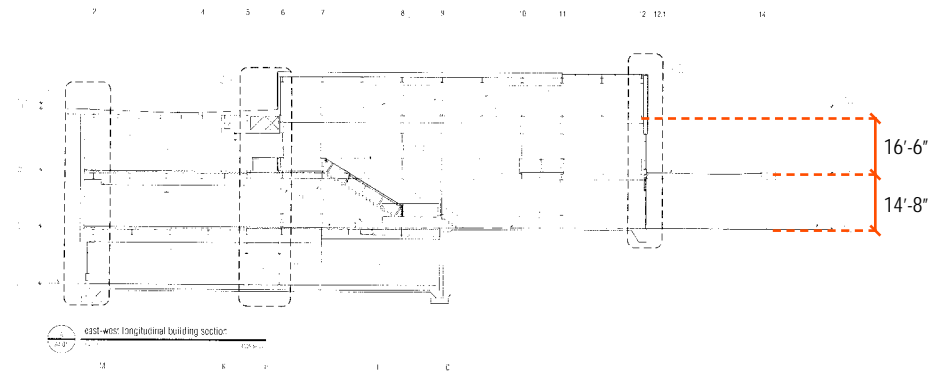
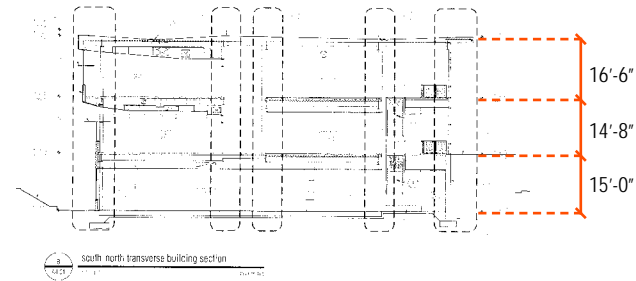
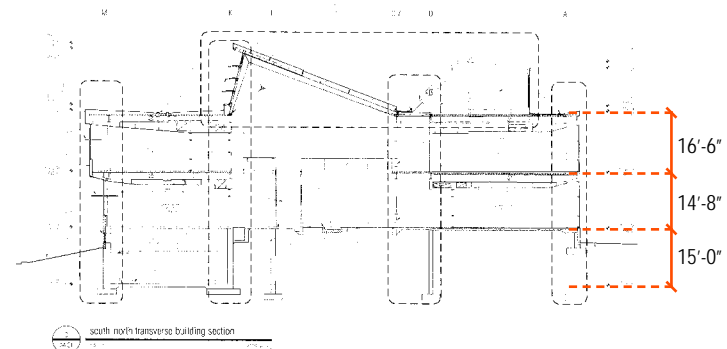
Building Sections - Technology Classroom Building

- Despite the large floor plate, there is good access to daylight and ample ceiling heights

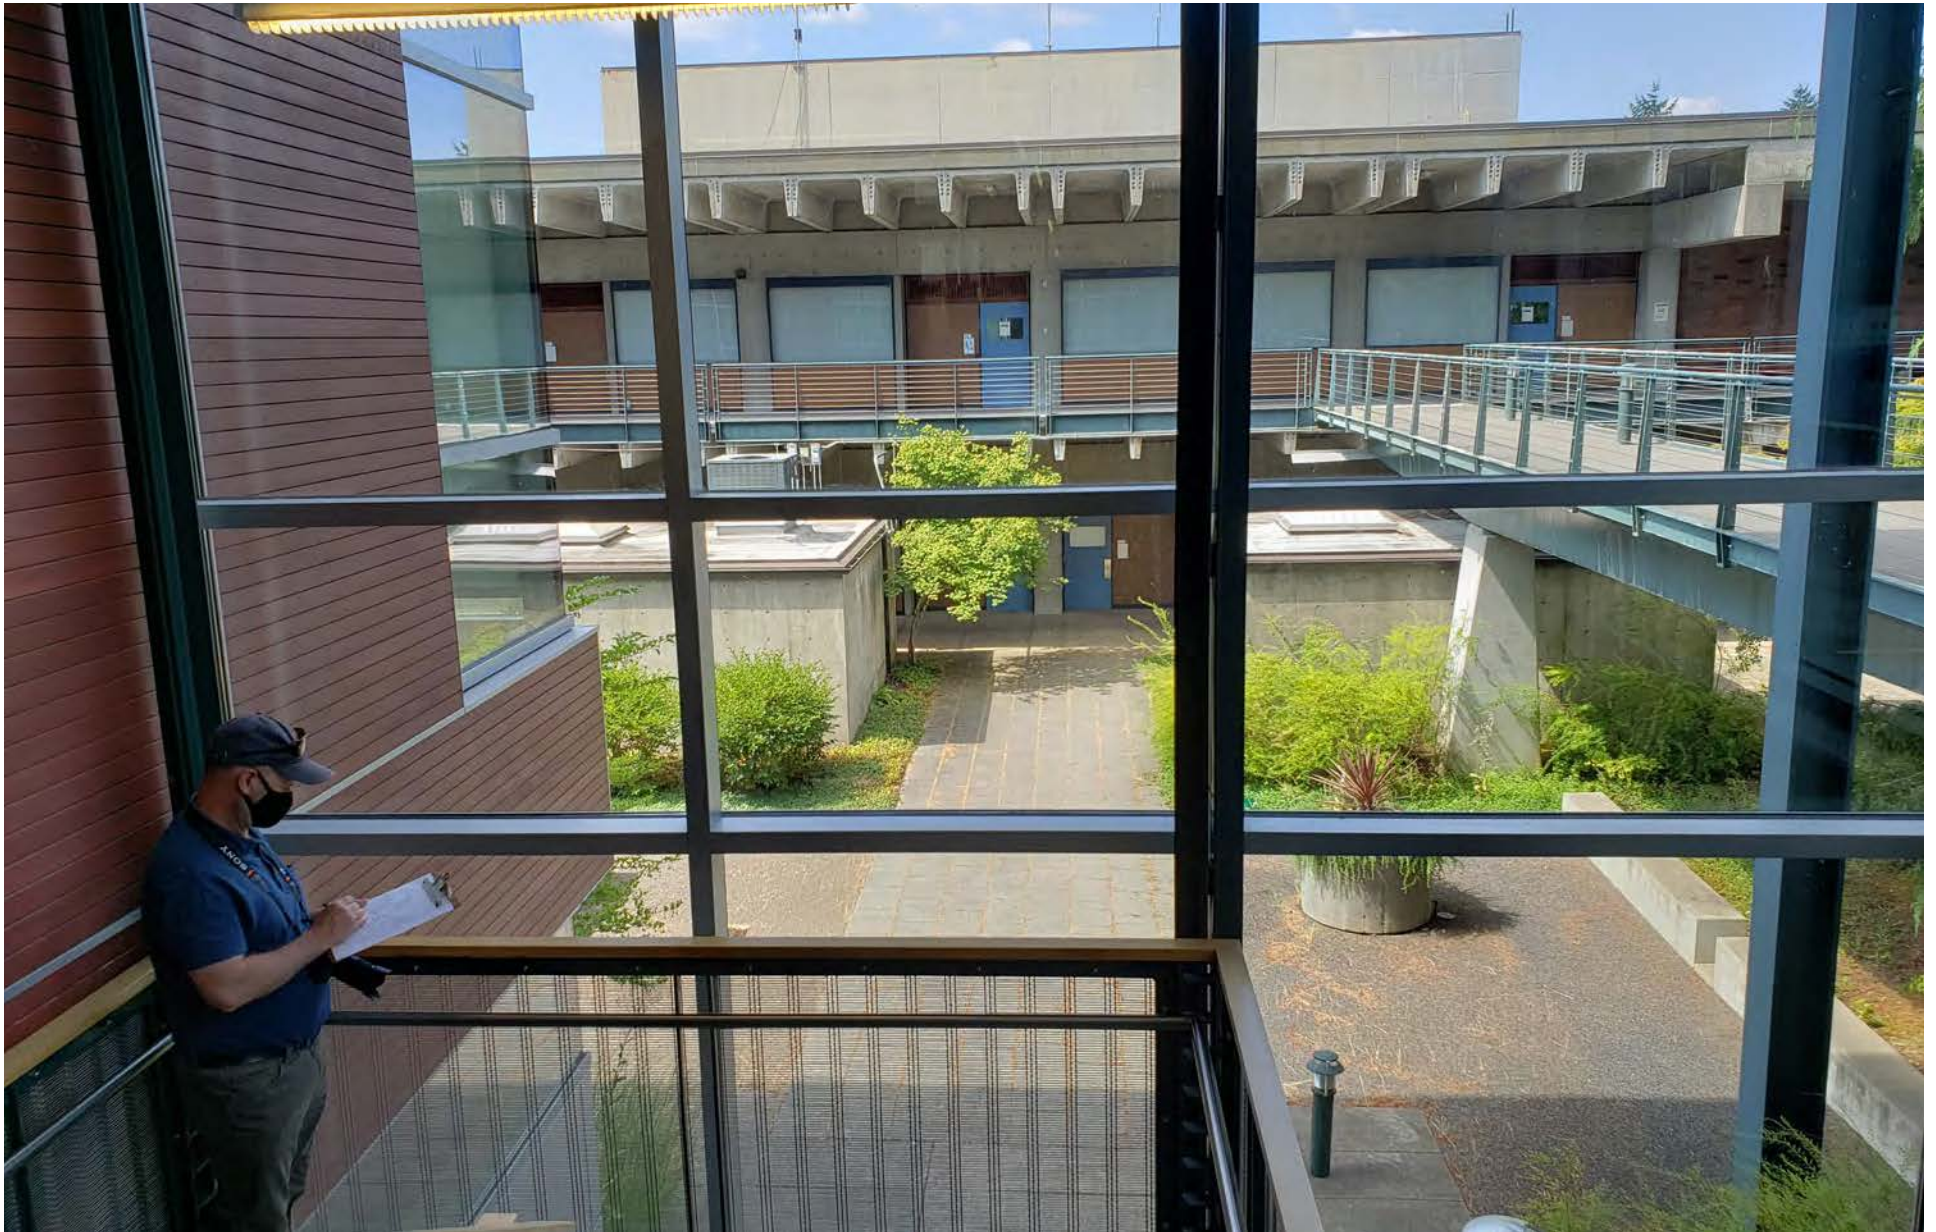
View of open space between Science Technology Building and Technology Classroom Building

- Building has a lot of natural light.
- Welcoming aspect and comfort level of atrium space needs to be improved in order to be more highly used.
- Spaces overall are well designed contemporary learning spaces.
- Building could have a friendly and welcoming vibe with some tweaks to the atrium space. It could instill a sense of community.

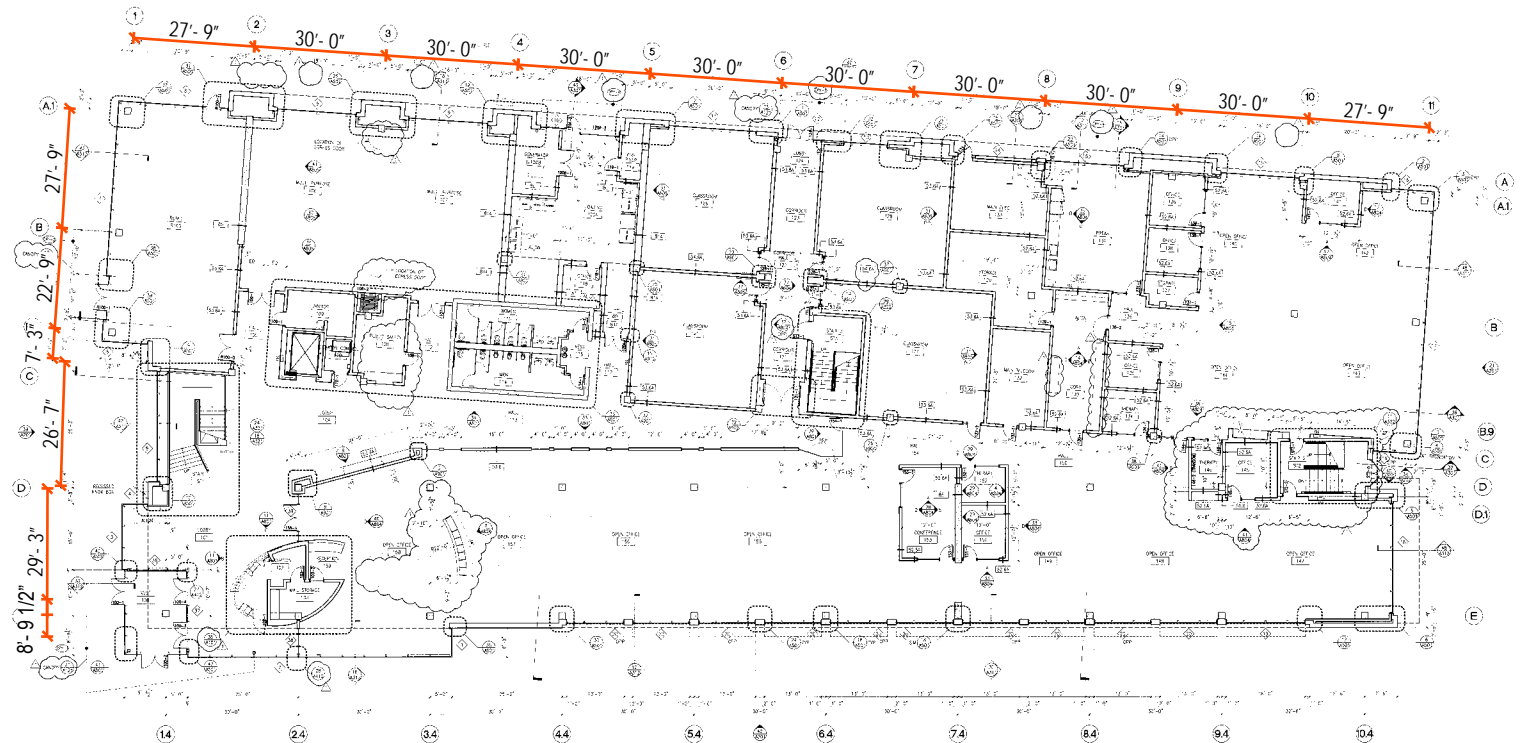
Building Plan - Willow Creek Center

- Spaces overall are well designed contemporary learning spaces.
- Building configuration lends itself well to classroom and office space.
- Some possibilities for gender inclusive restrooms with minor reconfiguration including existing showers.
- Wayfinding is clear with central corridor and stairs at each end. (However the cafe space failed for lack of visibility in its specific location.)
- Structural grid lends itself to small and medium sized classrooms or larger informal labs.
- Building is efficiently configured and makes good use of its footprint.

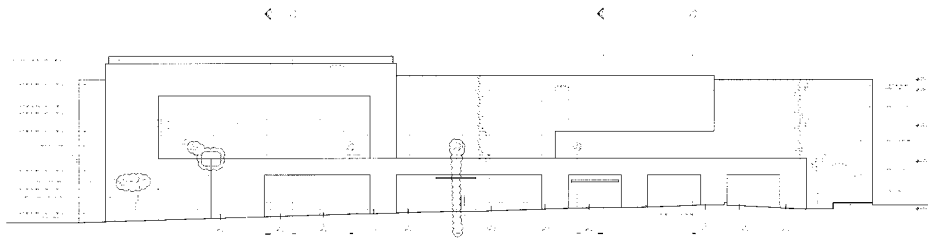
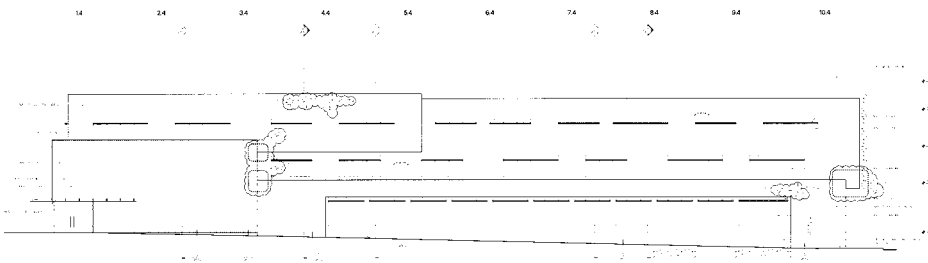
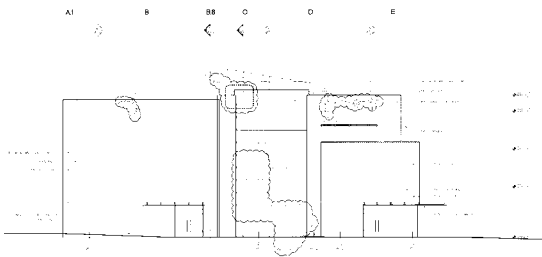
Building Elevations - Willow Creek Center

- Projects a positive image, consistent with a PCC identity across the system.

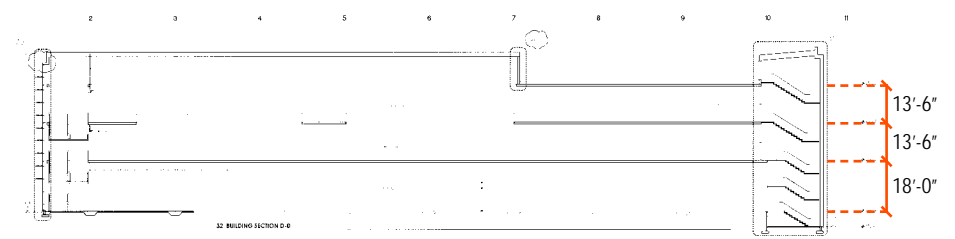
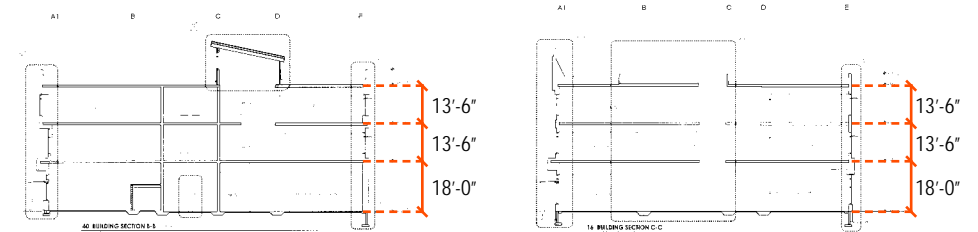
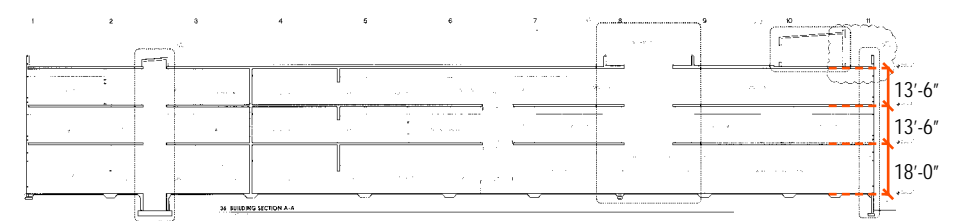
Building Sections - Willow Creek Center

- Good access to daylight.
- Comfortable floor to floor height.
