FACILITIES PLAN TECHNICAL REPORTS

Utilities Assessment

Portland Community College

April 2018

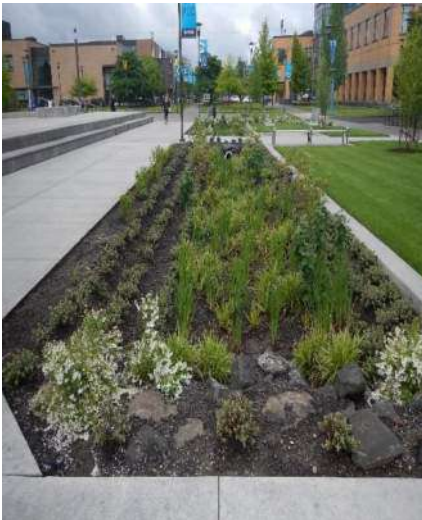
WQ #12	LIDA Swale	Good	Constructed in 2015	Photo: Cascade WQ #12
WQ #13	WQ Planter	Good	Unknown	Observed during 2017 site visit; no as-builts. Photo: Cascade WQ #13

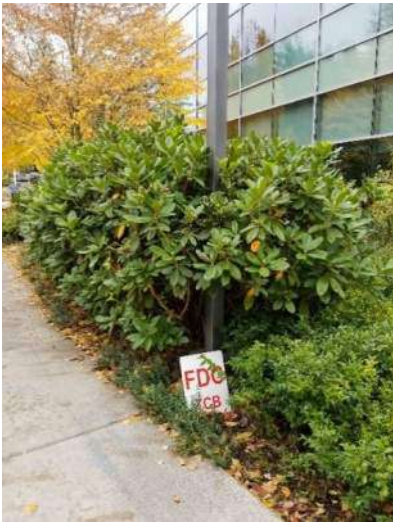
Sylvania 1: Sign to located the FDC for TCB building

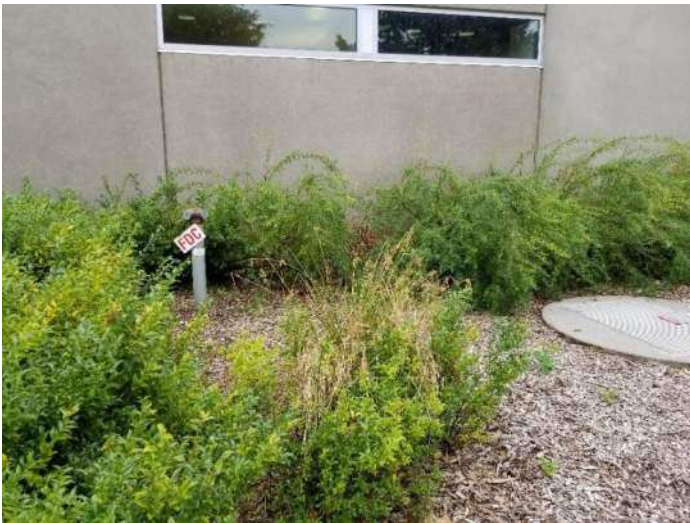
Sylvania 2: FDC for TCB building

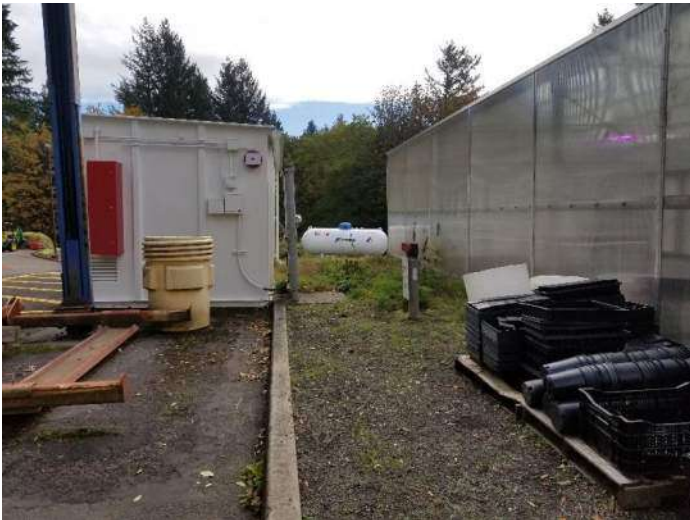
Sylvania 3: FDC for HP building

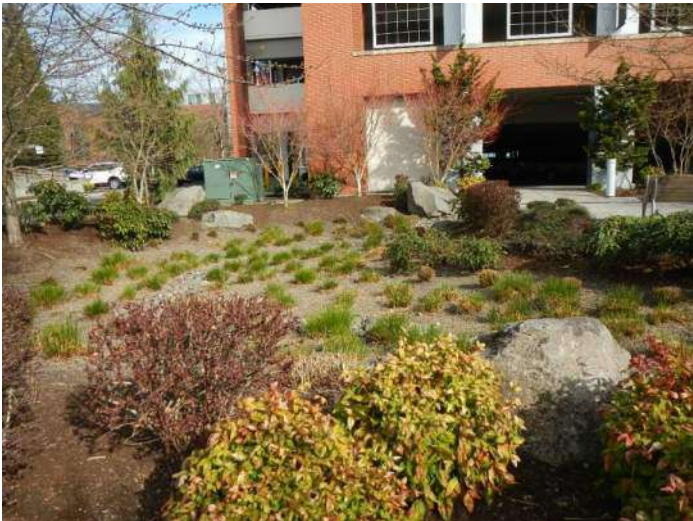
Hillsboro WQ #1
[Table 6](#)

ID	TYPE	CONDITION	AGE	NOTES
WQ #1	Stormwater Infiltration Planter	Good	Constructed in 2009	Photo: Hillsboro WQ #1
WQ #2	Stormwater Infiltration Planter	Good	Constructed in 2009	Photo: Hillsboro WQ #2
WQ #3	Stormwater Infiltration Planter	Good	Constructed in 2009	Photo: Hillsboro WQ #3

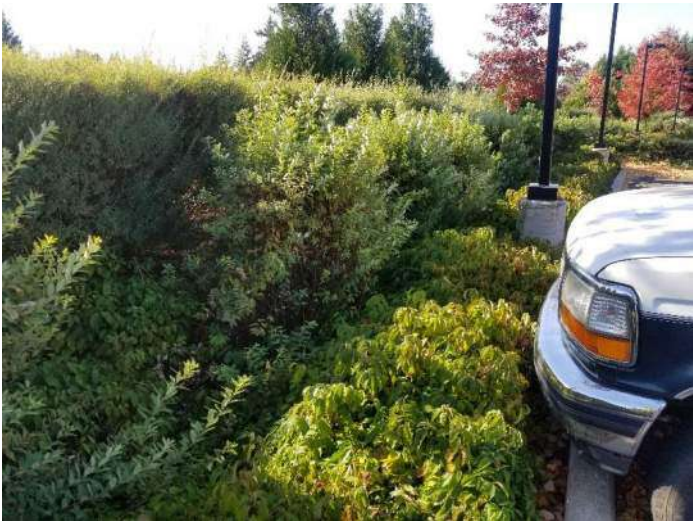
Newberg WQ #1
[Table 7](#)

ID	TYPE	CONDITION	AGE	NOTES
WQ #1	Swale	Good	Constructed in 2009	Treats runoff from parking lot. Photo: Newberg WQ #1
WQ #2	Swale	Good	Constructed in 2009	Treats runoff from parking lot. Photo: Newberg WQ #2
WQ #2	Swale	Good	Constructed in 2009	Photo: Newberg WQ #3

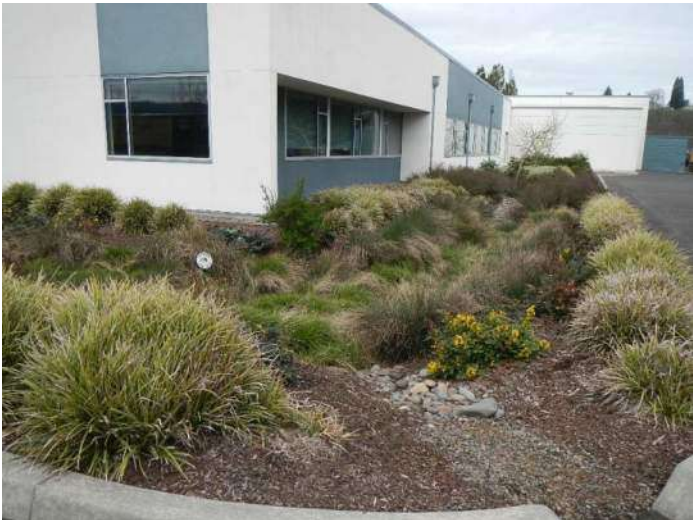
Swan Island WQ #1
[Table 8](#)

stormwater facilities and storm piping. In addition to the swale, a Stormceptor manhole was found at the edge of the property near the public road. That is not typically an approved method of treatment per City of Portland standards, so a more in-depth analysis of this facility is necessary in order to permit any major renovations to the center in the future. Table 8, below, describes the vegetated stormwater facility.

ID	TYPE	CONDITION	AGE	NOTES
SW #1	Swale	Good	Constructed in 2013	Photo: Swan Island WQ #1

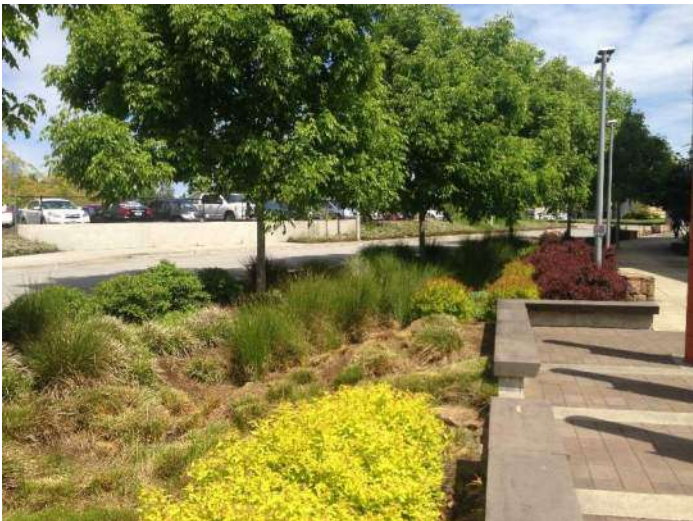
Willow Creek WQ #2
[Table 9](#)

ID	TYPE	CONDITION	AGE	NOTES
WQ #1	WQ Planter	Good	Unknown	Observed during 2017 site visit; no as-builts. Photo: Willow Creek WQ #1
WQ #2	WQ Planter	Good	Unknown	Observed during 2017 site visit; no as-builts. Photo: Willow Creek WQ #2
WQ #3	WQ Planter	Good	Unknown	Observed during 2017 site visit; no as-builts. Photo: Willow Creek WQ #3
WQ #4	WQ Planter	Good	Unknown	Observed during 2017 site visit; no as-builts. Photo: Willow Creek WQ #4

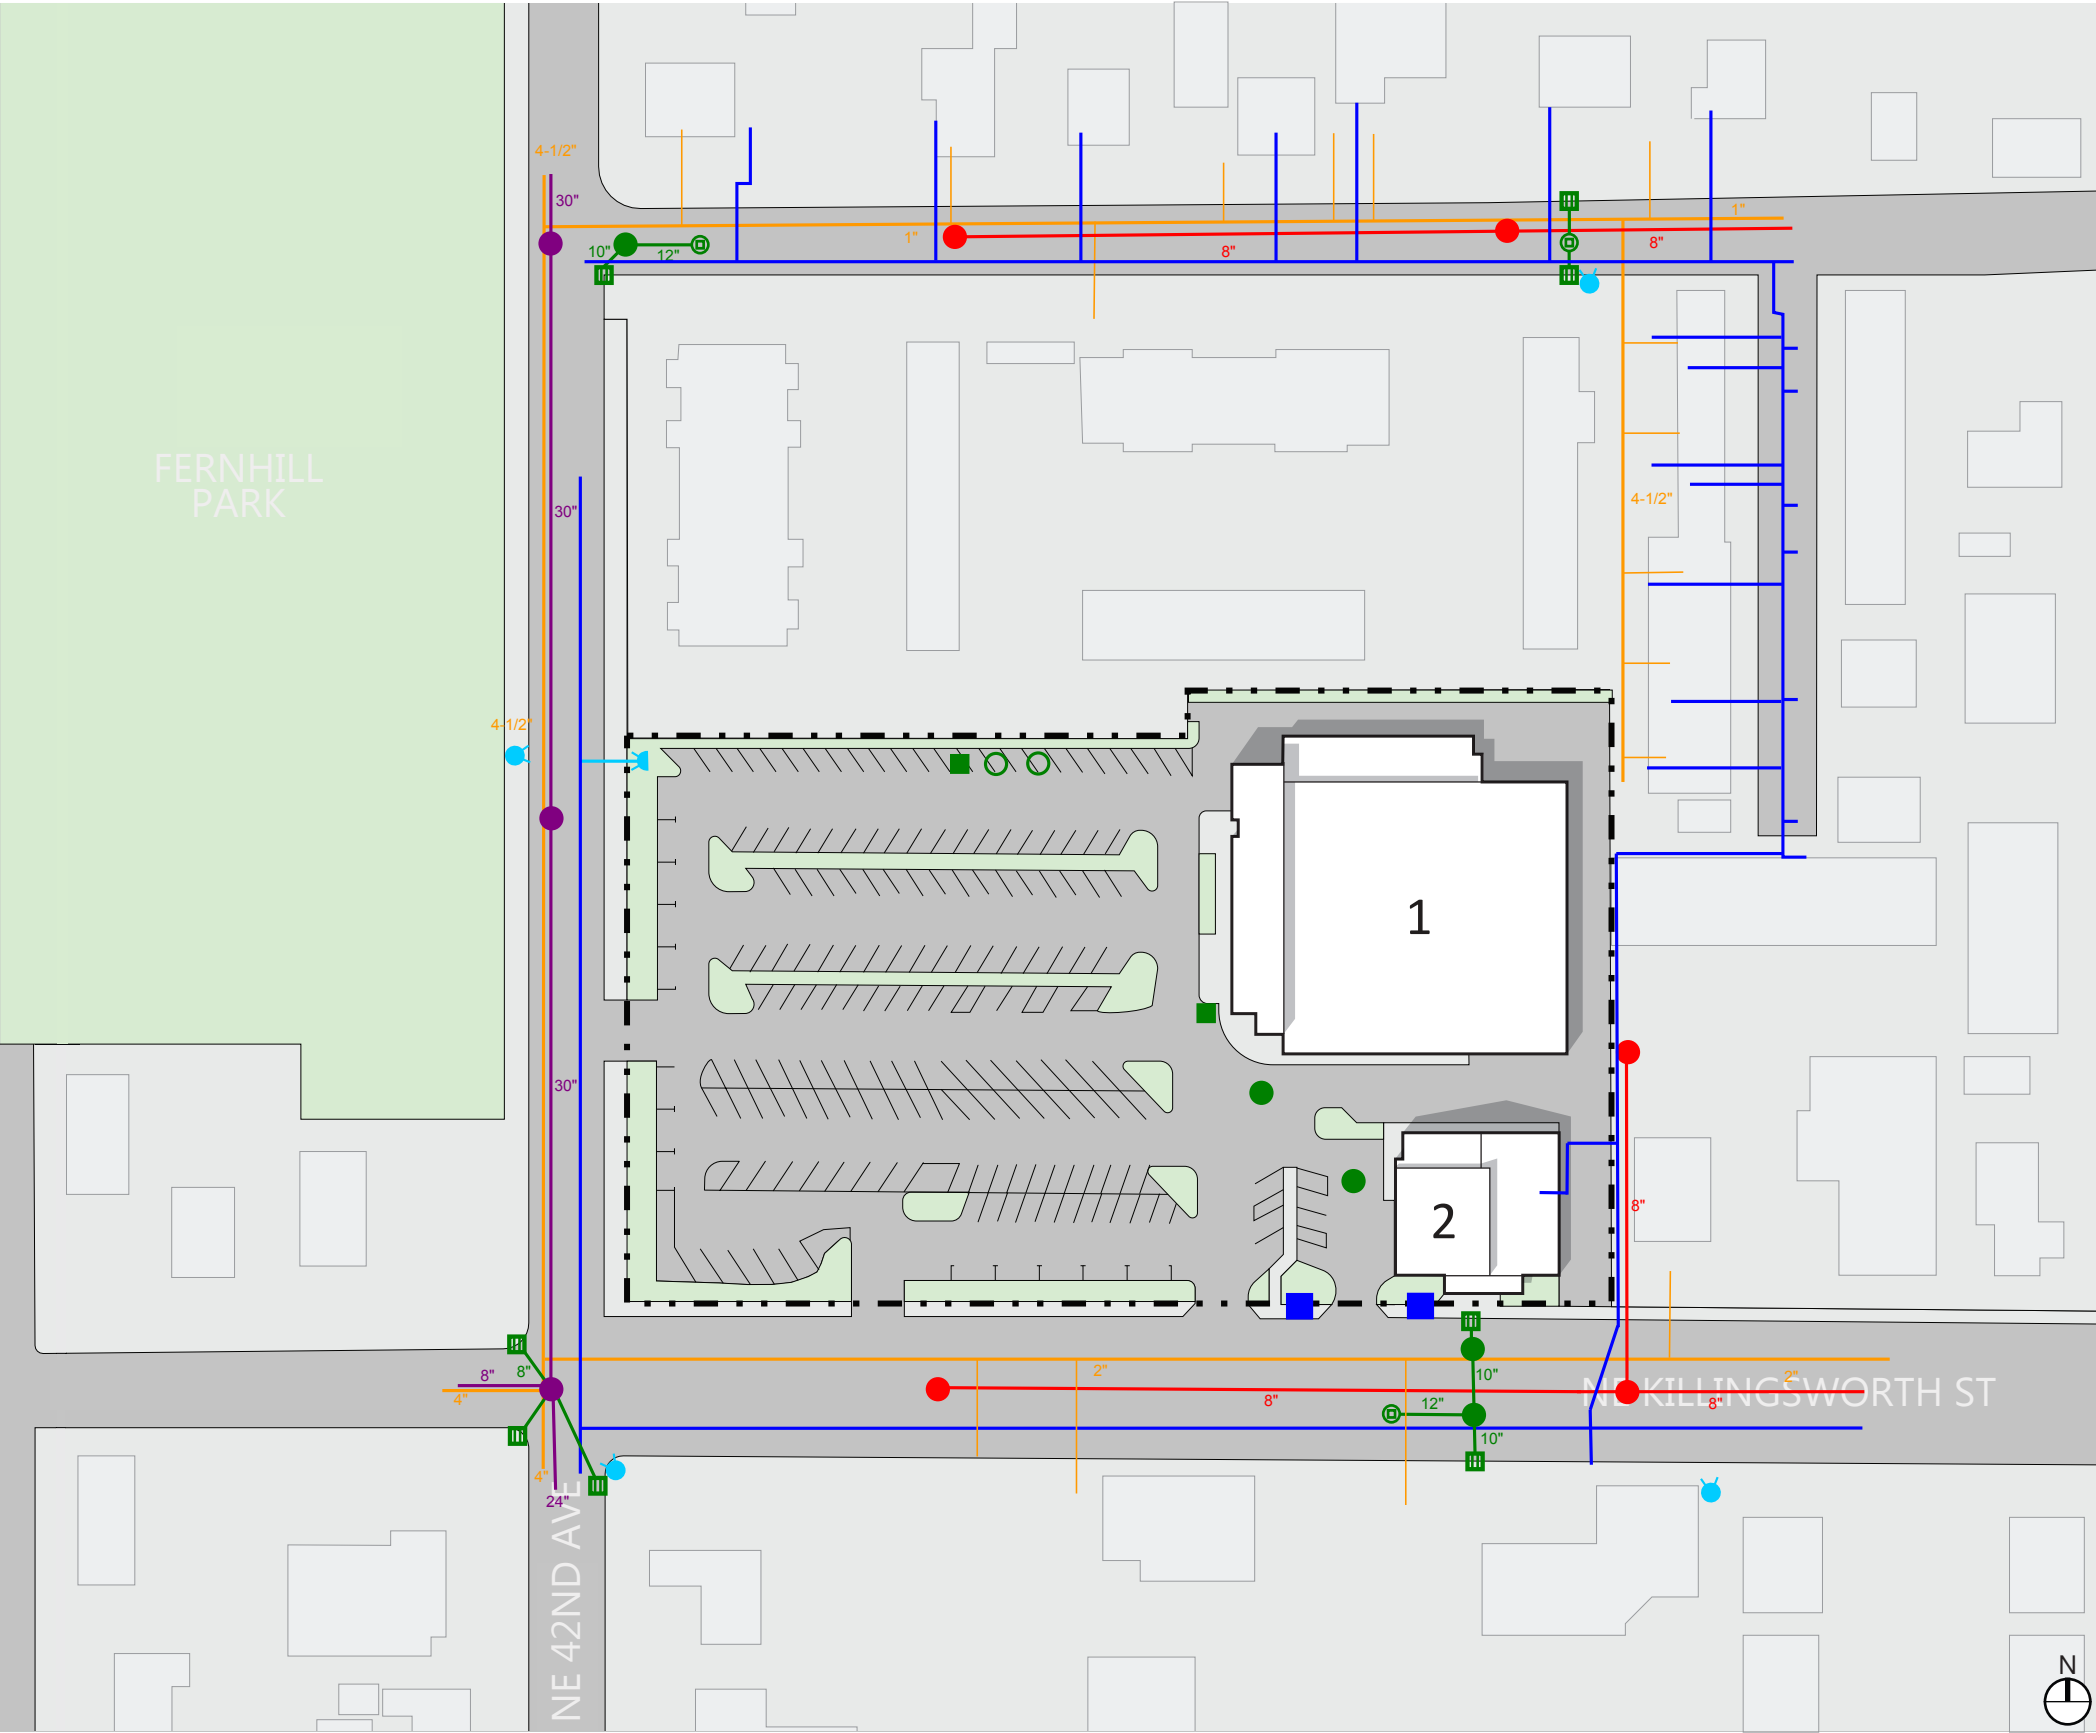
METROPOLITAN WORKFORCE
TRAINING CENTER

For location and size of the existing storm sewer system, refer to exhibit [MWTC-UT-1](#). All storm sewer utilities depicted in the public right-of-way are based on information gathered from Portland Maps. All information regarding water quality facilities are a result of site observation. There were no records found for any on-site storm sewer utilities.

For location and size of the existing sanitary sewer system, refer to exhibit [MWTC-UT-1](#). All sanitary sewer utilities depicted in the public right-of-way are based on information gathered from Portland Maps. There were no records found for any on-site sanitary sewer utilities.

For location and size of the existing water system, refer to exhibit [MWTC-UT-1](#). All water service utilities depicted in the public right-of-way are based on information gathered from Portland Maps. All information regarding visible water structures, including FDCs and water meters, were verified during field visits. There were no records found for any on-site water utilities.

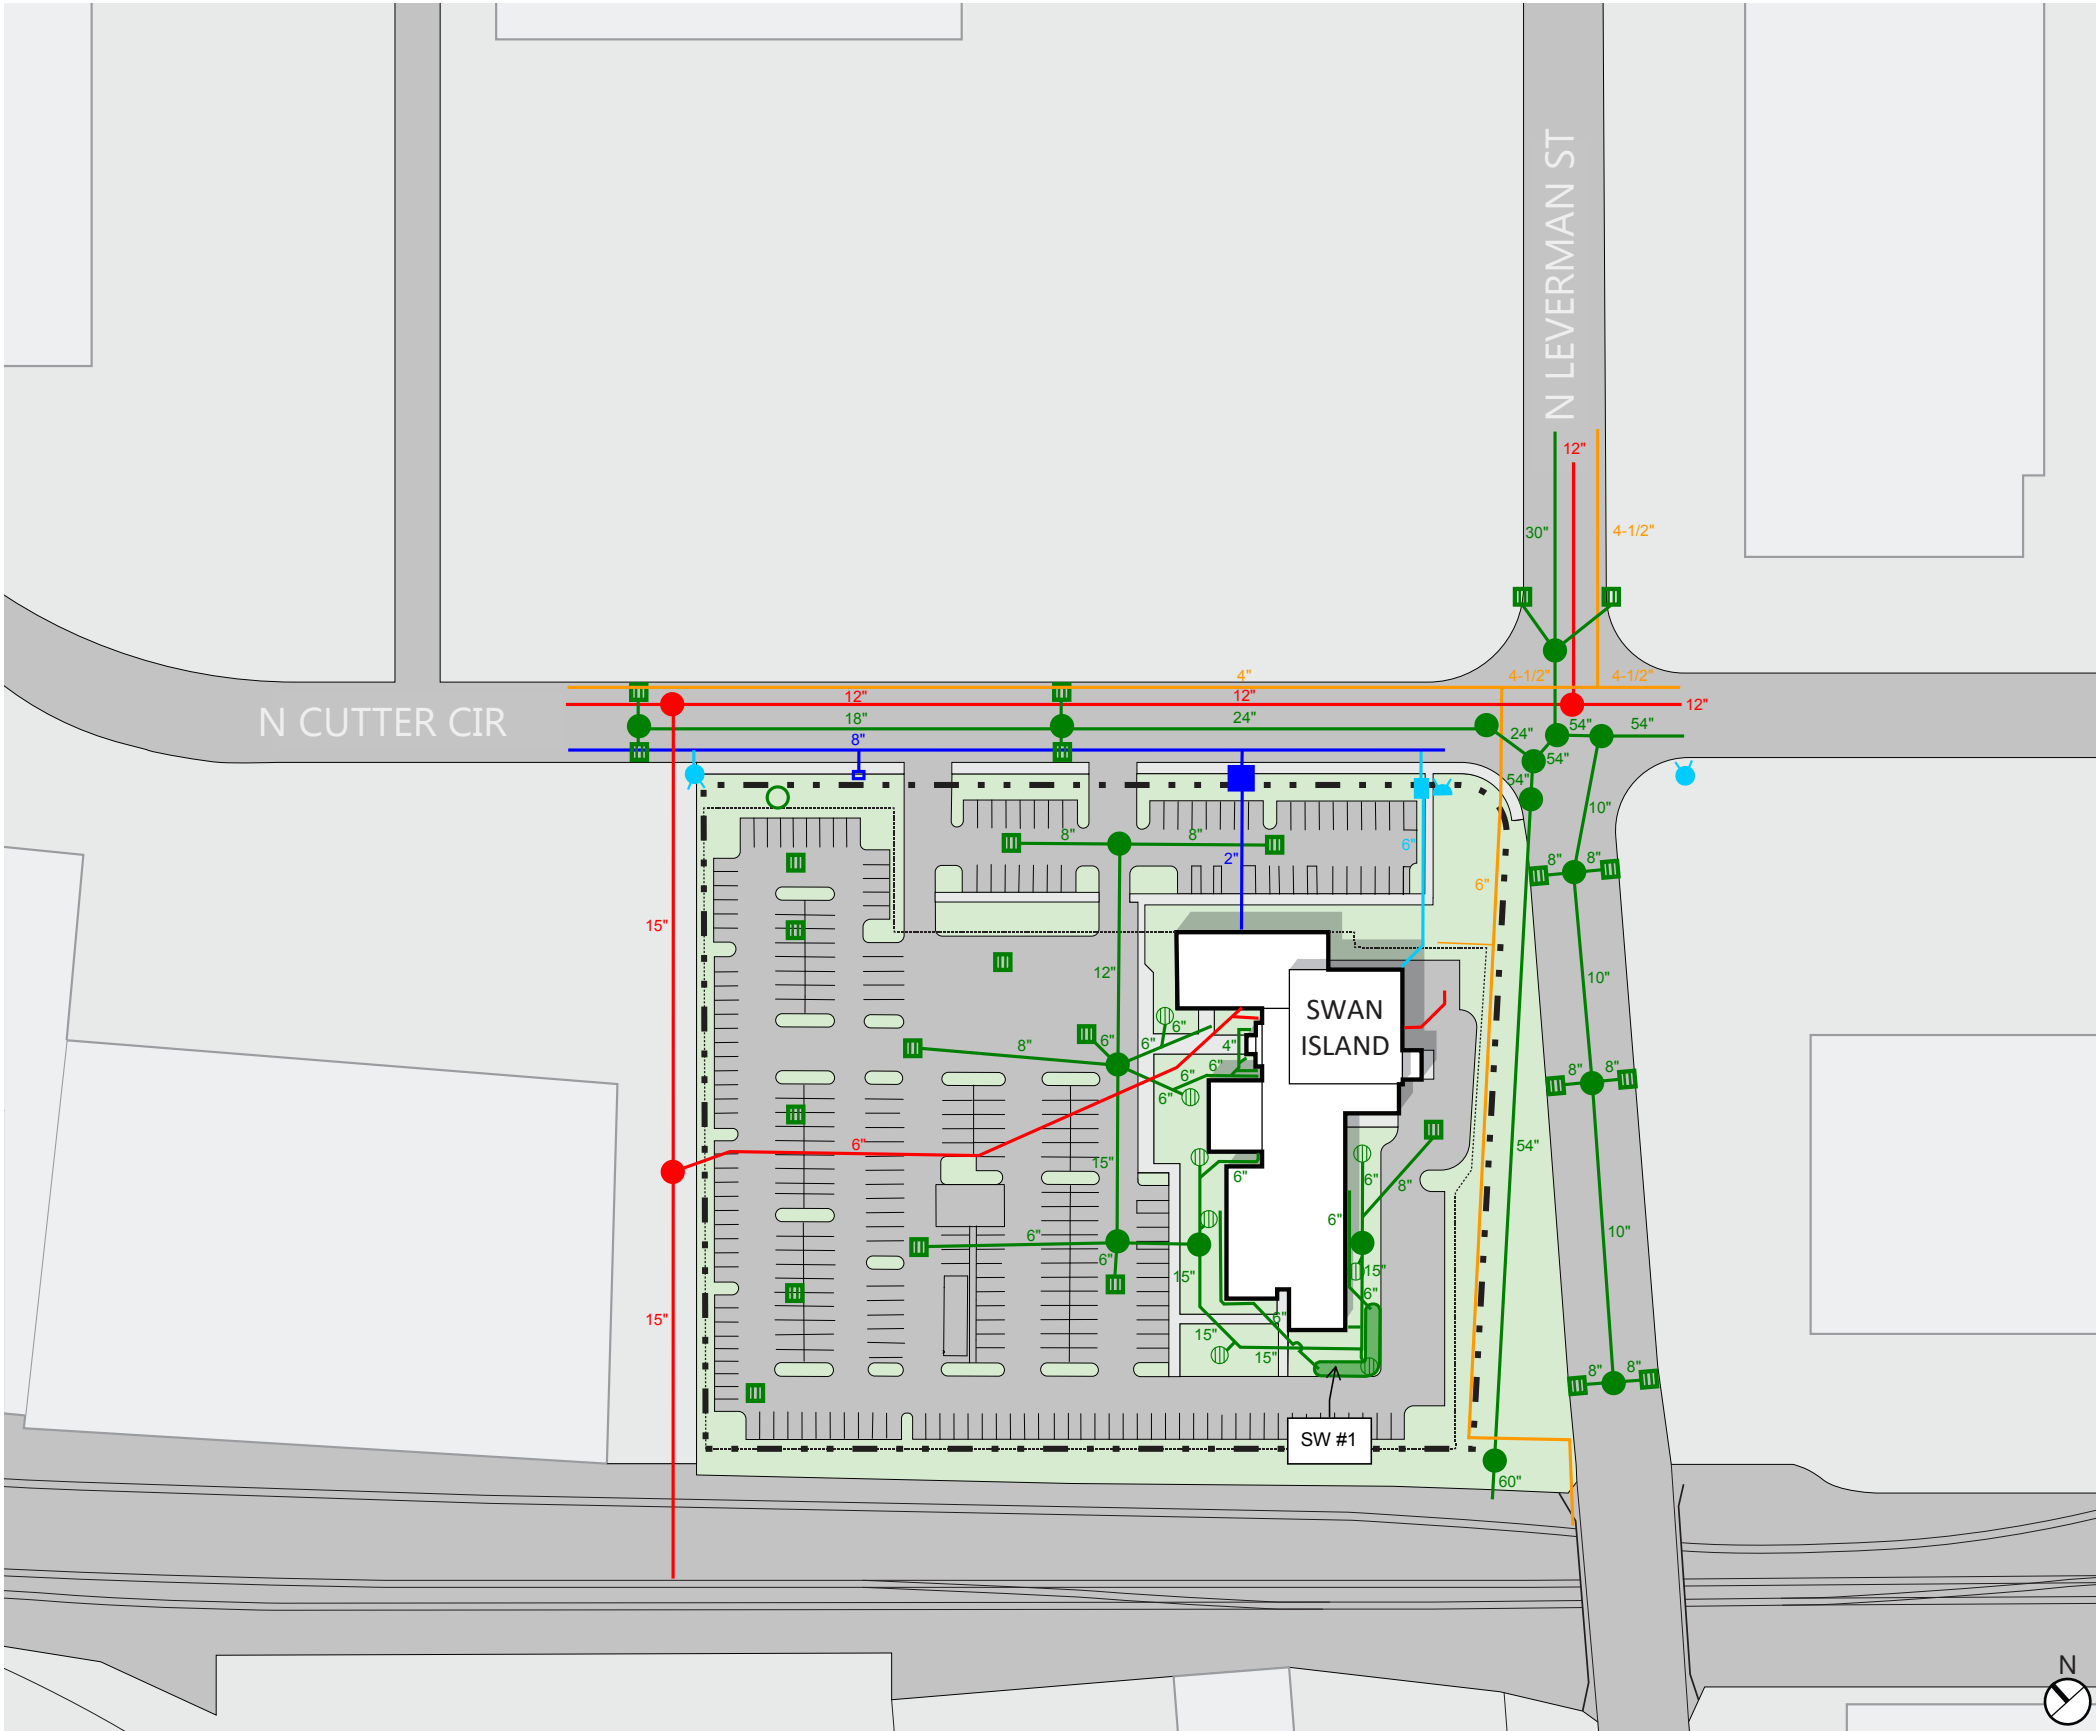
SWAN ISLAND
TRADES CENTER

For location and size of the existing gas service, refer to exhibit [SITC-UT-1](#). There were no records found for the original campus construction. Records from the 2013 building addition and NW Natural’s online mapping indicate an existing gas line on the eastern property line.
