FACILITIES PLAN TECHNICAL REPORTS

# Civil Site Accessibility and Utilities

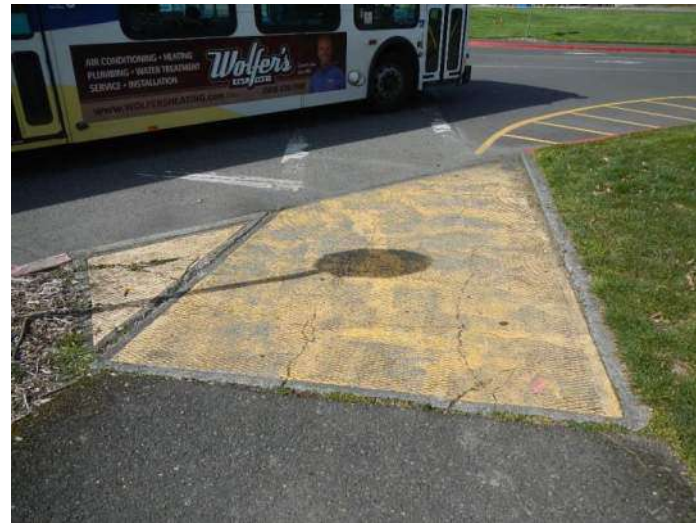
**Rock Creek 9**  
Curb Ramp 5 - [Table 7](#)

Ramp Number	Type of Non-Compliance	Description	Severity
1	No Landing Cross Slope (Ramp) Lip Concrete Condition	Concrete in poor condition <a href="#">Photo: Rock Creek 5</a>	C A A A
2	No Domes Cross Slope (Ramp)	<a href="#">Photo: Rock Creek 6</a>	C C
3	Cross Slope (Ramp) Flare Slope	<a href="#">Photo: Rock Creek 7</a>	B
4	No Domes Cross Slope (Landing) Cross Slope (Ramp) Flare Slope Running Slope (Ramp)	<a href="#">Photo: Rock Creek 8</a>	C
5	No Domes Cross Slope (Ramp) Running Slope (Landing)	Concrete in poor condition <a href="#">Photo: Rock Creek 9</a>	C
