FACILITIES PLAN TECHNICAL REPORTS

PORTLAND COMMUNITY COLLEGE
IT Master Plan
Infrastructure Existing Conditions Report

Date: April 17, 2018

Prepared for:
SRG Partnership

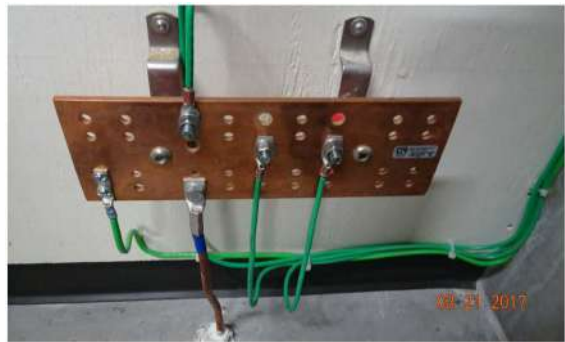
Several buildings were constructed prior to the updated standards requiring two-hole compression lugs on ground conductors, but individual conductors from the TMGB or TGB to each rack, ladder, and conduits used for pathways were required at the time of most construction or remodel projects. Some of the current PCC spaces conform to the new or previous standards, while others are in non-compliance. Refer to appendix for specific room ratings. Examples follow.

Figure 5 Example using one-hole lugs, which are no longer compliant.

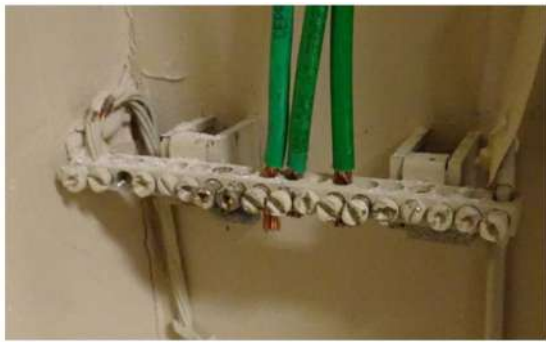
Figure 6 Ground bar is not an approved type.

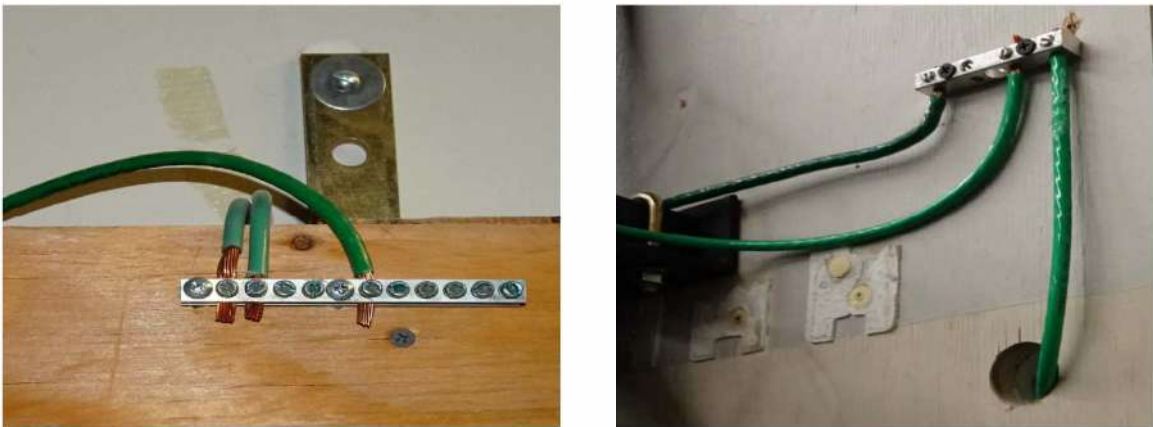
Figure 7 Additional examples of unapproved ground bar. Conductors can easily loosen, compromising ground integrity.

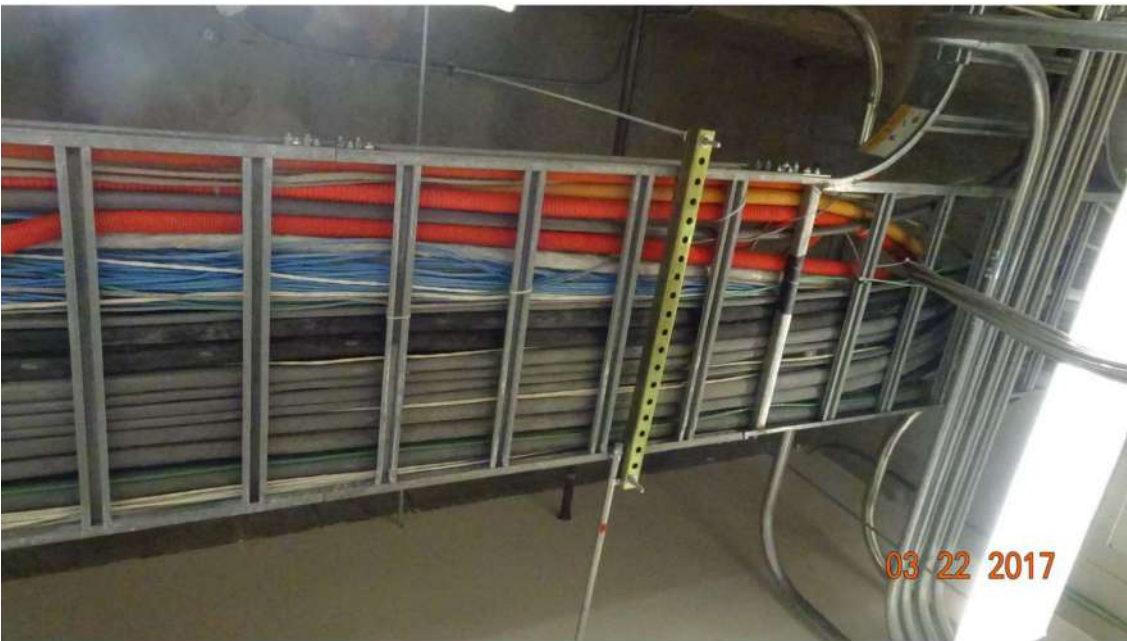
The Sylvania campus has an active Utility Tunnel system, where most low voltage copper and fiber cables connect from the campus MDF to most, but not all, individual buildings' BDF. The trays may have been designed and intended for campus communications, and were initially sized for that purpose. Over time, the cable trays in the tunnel system have been used by multiple trades and campus departments, and now contain alarm, HVAC, Building Automation and Control, landscaping, lighting control, security, as well as abandoned copper analog voice cables. In many places they are overloaded and filled beyond intended capacity. Recommend removing all abandoned cables, and installing additional cable trays where possible, adjacent to, or above existing trays.

Figure 10 Overloaded tray in Sylvania tunnel system.

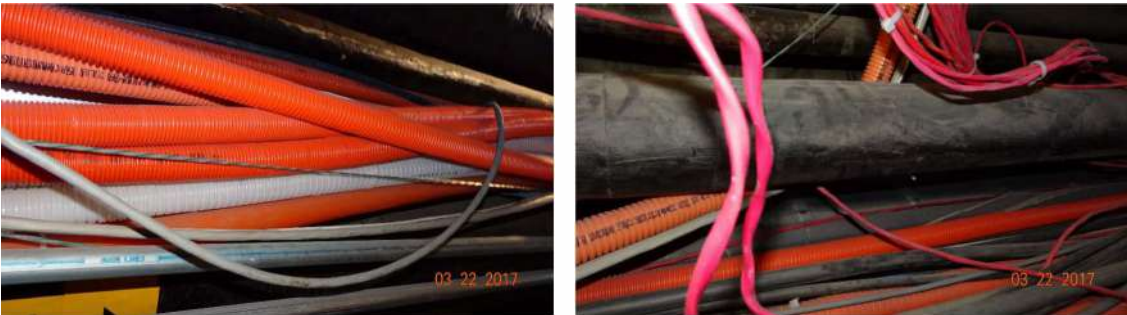
Figure 11 Multiple departments using tray intended for data only.

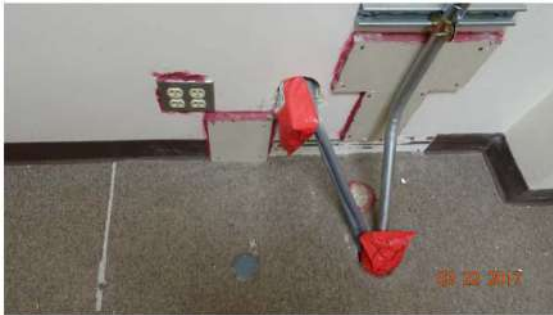
4. Firestopping is required at all penetrations through fire-rated walls and floors. Conduits, cable tray systems, and other cable pathways shall be sealed with an appropriate firestop system. Both single sided and “through-wall” penetrations require firestop assemblies, if required by the local Authority having jurisdiction. Over 50% of all the buildings in the district are lacking proper firestop systems, or have been installed improperly. These penetrations and conduits should be checked and corrected by a specialist in firestopping methods, and any new cable trays, sleeves, or conduits should be firestopped as required.

Figure 13 Poor firestopping methods.

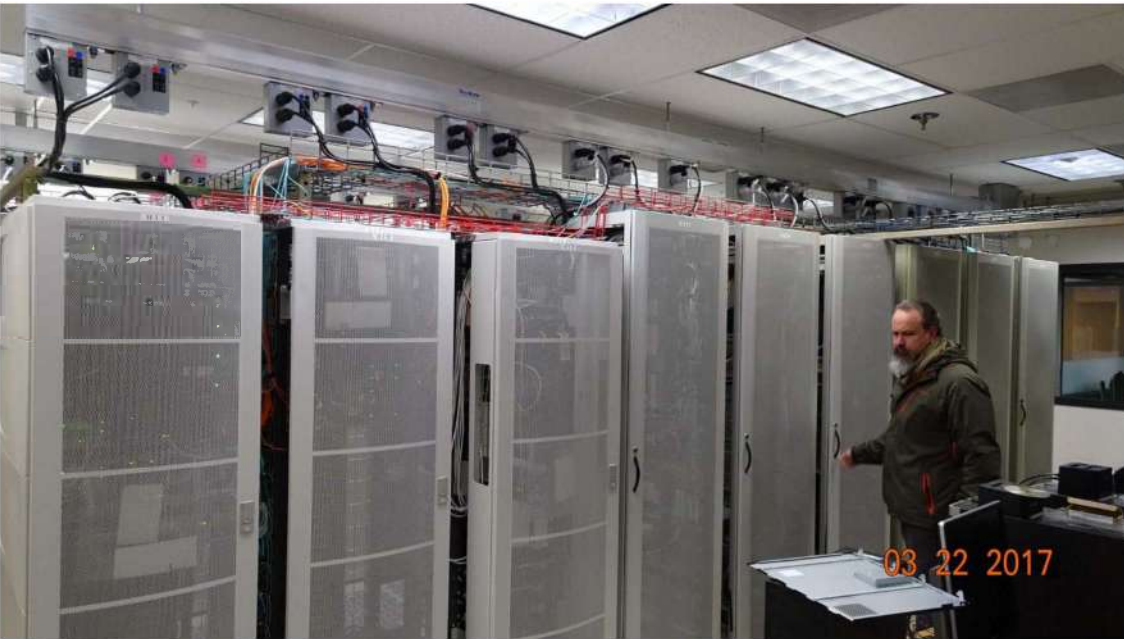
1. The data center at the Sylvania campus was renovated in 2011. The data center has 1120 sqft of useable raised floor space supporting up to 19 cabinets with less than 19 cabinets currently populated. A non-contained “hot aisle / cold aisle” method of cooling is used. This involves lining up server racks in alternating rows with cold air intakes facing one way and hot air exhausts facing the other. The rows composed of rack fronts are called cold aisles. Typically, cold aisles face air conditioner output ducts. The rows the heated exhausts pour into are called hot aisles. Typically, hot aisles face air conditioner return ducts. Two (N+1) 40-ton CRAC units in addition to an older 10ton CRAC. Cold air distribution is via underfloor areas and perforated floor tiles, and the hot air return uses overhead ducting with no hot aisle containment or other mechanism to separate the return air from the conditioned air.

Figure 17 Rear of the cabinets face out to the room. Hot air is exhausted, rising to the ceiling return vents

5. Recommendation: Install a lug for a roll-up generator. Improve data center HVAC efficiency with hot aisle containment, chimneys or some other mechanism to separate conditioned from return air. Replace end-of-life active electronics. See PAE's report for additional detail.

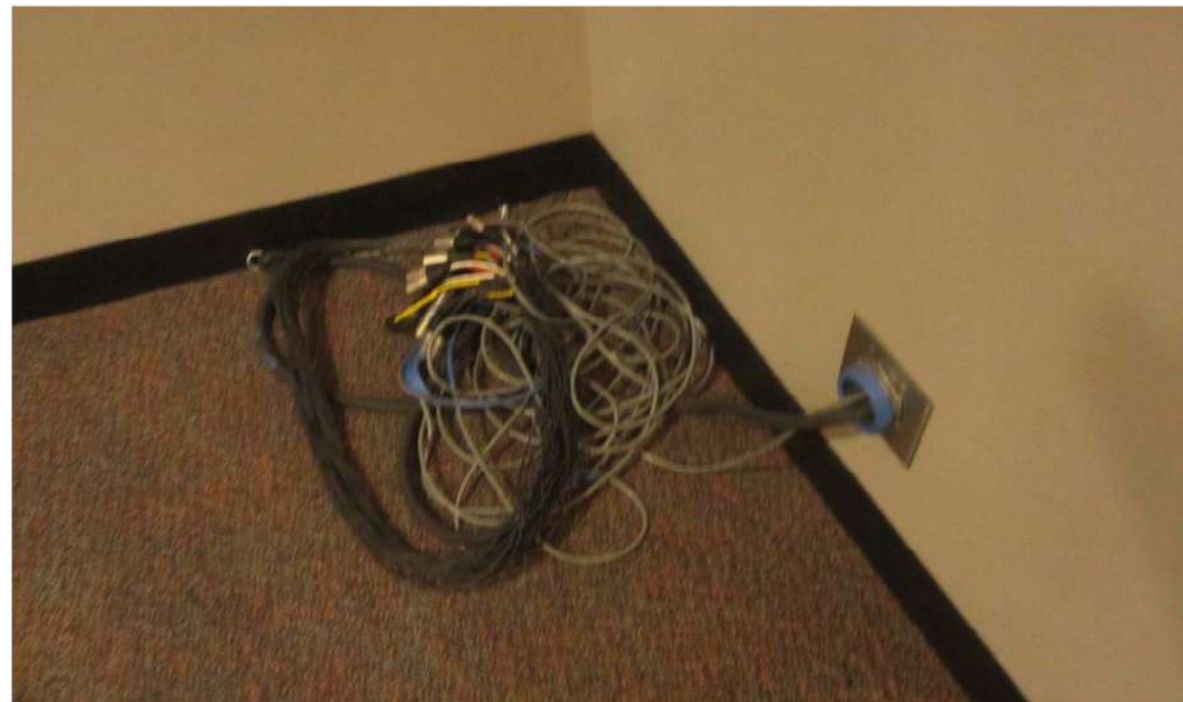
Figure 15 Rear tech station cables.

- c. Clean up bad cabling in rear
 - d. Need more storage area (architectural scope)
 - e. New stage audio connections and cable snake system
 - f. Upgrade control booth to accommodate ventilation and supply and add HVAC system to help control room environment for the booth operators

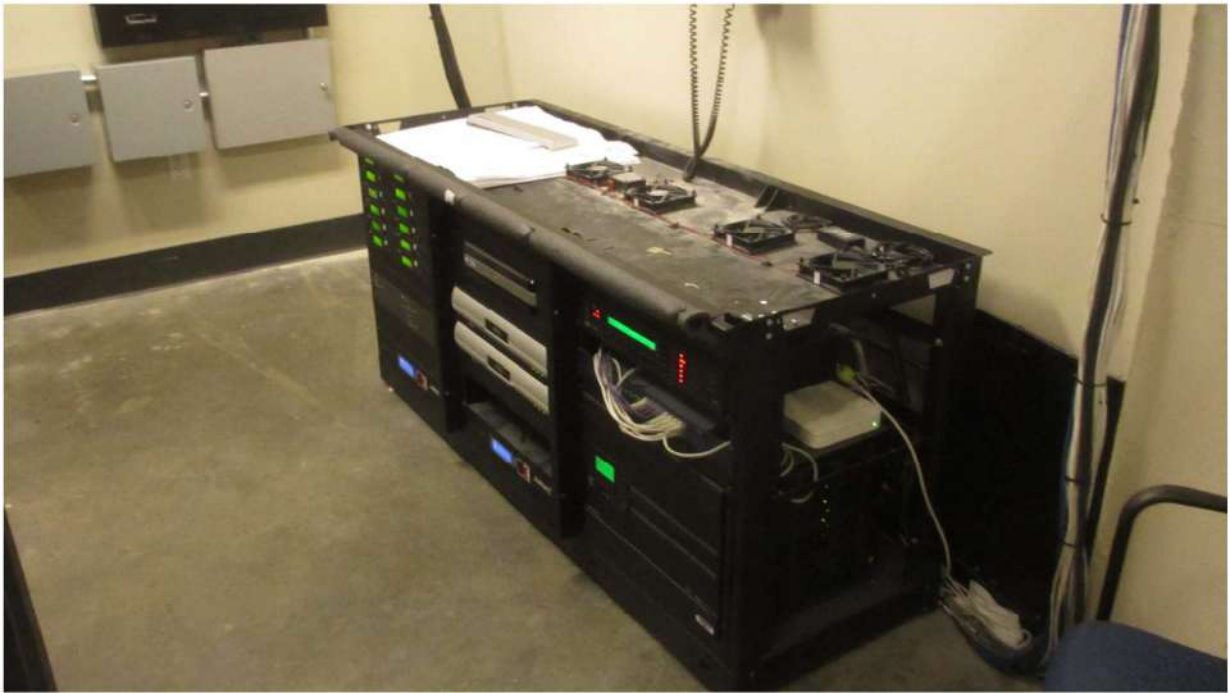
Figure 17 Equipment Credenza.

- j. Replace the existing 3-bay equipment credenza with a single (or two as needed) vertical equipment rack to save space within the room.
 - k. Conduit infrastructure not compliant with N.E.C. requirements. Replace PVC conduit penetration(s) through ceiling with EMT sleeves with vertical cable ladder to rack or direct EMT conduits for cabling. The existing conduits run through a mechanical space before reaching the telcom room and should be re-run as required for a more direct path.

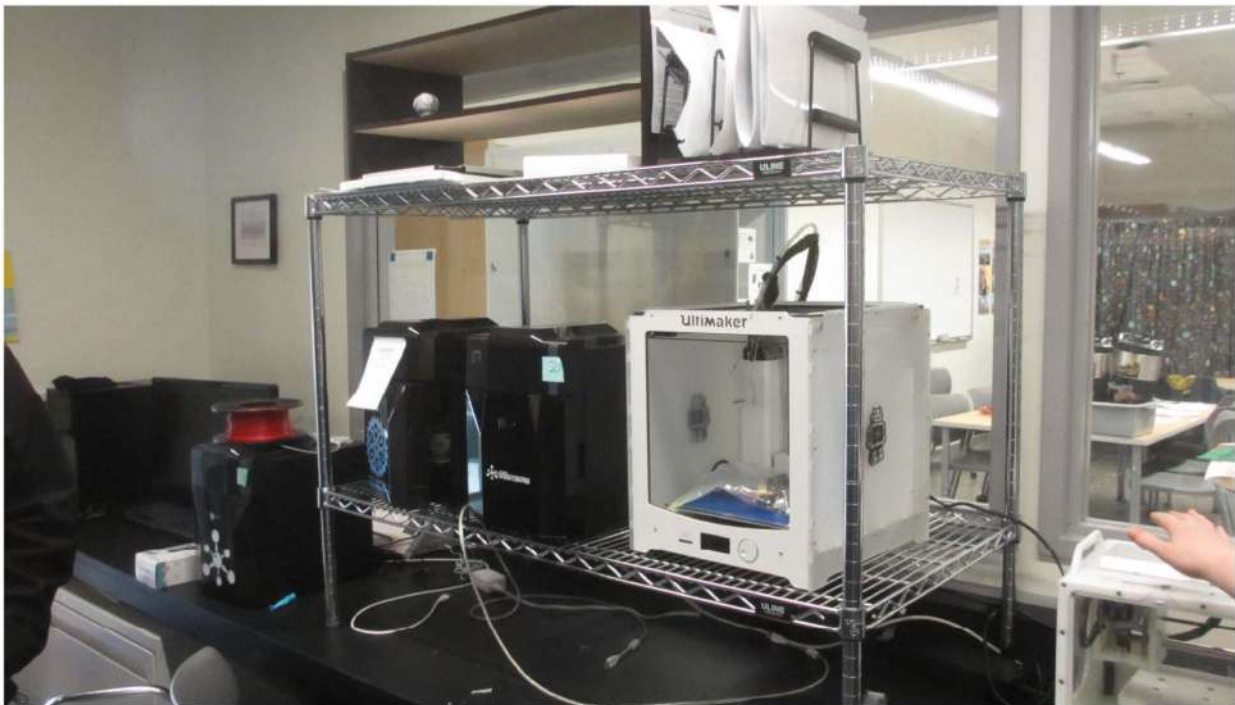
1. The STEM Lab on the SouthEast campus is a very impressive space with the amount of functionality and tools that it holds for the District. Students can explore 3D printing, an interactive augmented reality table for demonstrating effects with changing topography, viewing 3-dimensional content, exploring virtual reality and other interactive tools.
2. This lab takes up two smaller rooms – one being the exploratory space and the other being set up in more of a classroom style which includes a larger interactive TV on a rolling stand used for presentations. The greatest concern in this space is that they are physically out of room for expansion of the program leaving no more room for storage and new equipment stations. This space should be looked at, as part of a growing program, to double its size (at minimum) to accommodate more students and more technology and experimental stations.

Figure 23 3D print station.

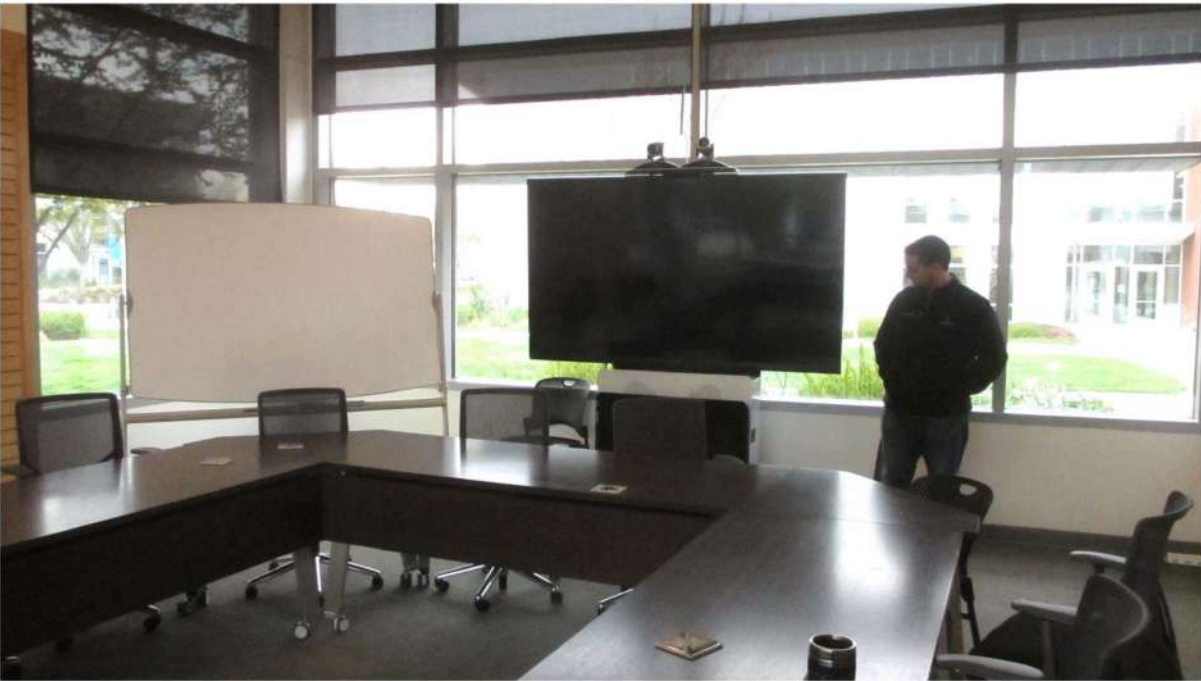
Figure 26 Southeast Conference Room #100 & Rolling VTC Monitor Cart.

Vantage recommends establishing a consistent “kit of parts” that can be deployed in the various conferencing spaces that would best support this including a flat panel display that is appropriately sized for the room for best viewing (can be wall or rolling cart mounted), a dedicated room computer (can be a small-form factor PC behind the display) and wireless mouse and keyboard, a semi-pro grade HD USB camera mounted either under or above the TV (depending on size and location) and an audio conferencing solution such as a USB audio bridge (with dialer) and table microphones or even a simple USB microphone/speaker pod. This combination of components will work with the variety of web-based solutions including Zoom, Goto Meeting, Skype, WebEx, Adobe, Google, etc. and will provide good flexibility for the future to bridge in remote participants communicating via video/audio conference bridge services as well as via phones, computers and other mediums. Light control within the rooms should also be reviewed as this will help the cameras work better.

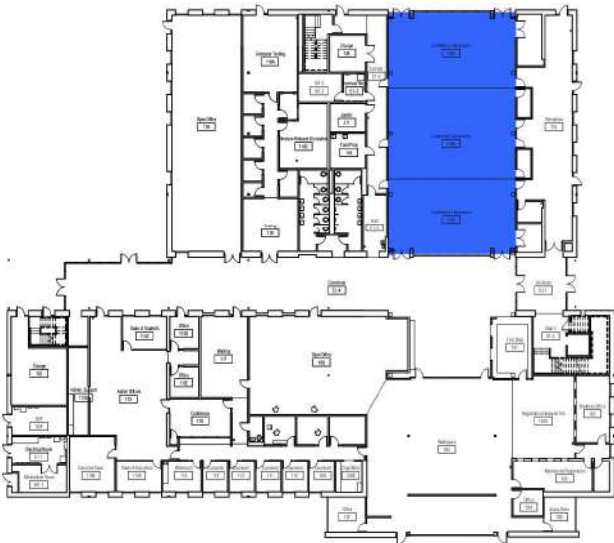
AUDIO VISUAL "ONE-OFF" ROOMS ASSESSMENT
ROCK CREEK CAMPUS: BUILDING 9, ??, EVENT CENTER

1. The Event Center is a large capacity space that can be divided into three separate independent sections. The room(s) are heavily used and need special support as the existing control system is difficult to operate with consistent reliability and will occasionally lock up after 2 hours into usage. The Crestron control hardware is functioning, but the programming needs to be replaced – may look at upgrading Crestron hardware from older 2-series processor to 3-series model that works better in combining applications. Recommend replacing older 8-series control panels with newer versions. The 8-series control panels were a short-lived solution that were soon replaced with a more solid hardware option for both wireless connectivity and battery. These units have been proven to be problematic with control connectivity and reliability.

2. The main equipment rack is a Middle Atlantic 3-bay credenza that is missing the covering panels which help direct proper convection cooling (with the top fans) and keep the equipment cleaner. The rack is very dusty although no issues with equipment overheating have been communicated. This equipment should be relocated to a more appropriate cabinet taking less floor space and improving clearance and access to all equipment in the TR.

Campus	Building	Room	Location											Comments
				Audio	Video	Control	Programming/Usability	Infrastructure	Room Size	Lighting	WiFi	Computer	Acoustics	
RC	Building 9	Event Center	RC9/122ABC	4	4	3	4	3	3	3	3	3	3	Refer to Narrative

3. Recommended changes to this space would include:
 - a. Re-program space and test to function reliably and to add new features like locking out in secondary mode, etc.

- b. Replace control processor and control panels
 - c. Replace projector lenses with ones more suitable for the projector throw.
 - d. Replace fluorescent lighting with newer LED fixtures and connected to AV control system

- h. Look at laptop connection issues and compatibility (EDID) with system and display equipment
 - i. Clean out and service older equipment that will not be replaced and;

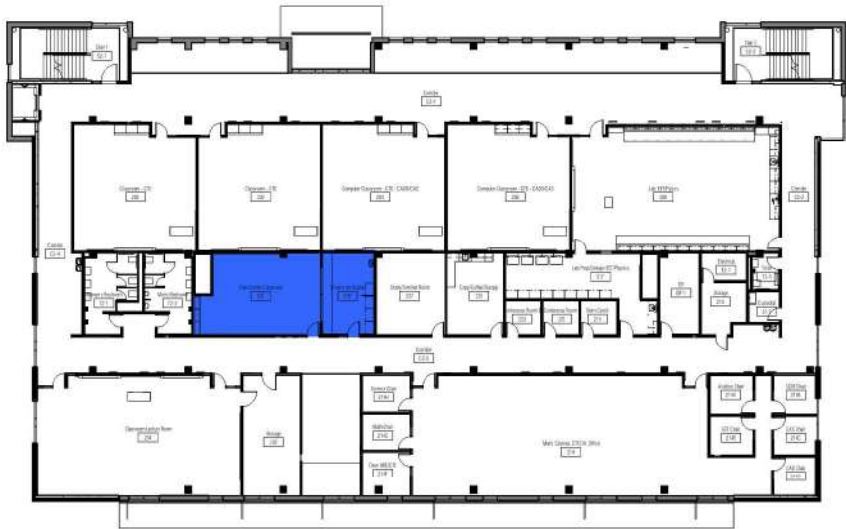
AUDIO VISUAL "ONE-OFF" ROOMS ASSESSMENT
SOUTHEAST CAMPUS: TABOR HALL, 2ND FLOOR, LAB / STEM LAB

Campus	Building	Room	Location	Audio	Video	Control	Programming/Usability	Media Structure	Room Size	Lighting	WiFi	Computer	Acoustics	Other	Comments
SE	Student Commons	STEM LAB	SESCOM229/231	5	1	3	3	4	1	3	3	4	3	1	Refer to Narrative

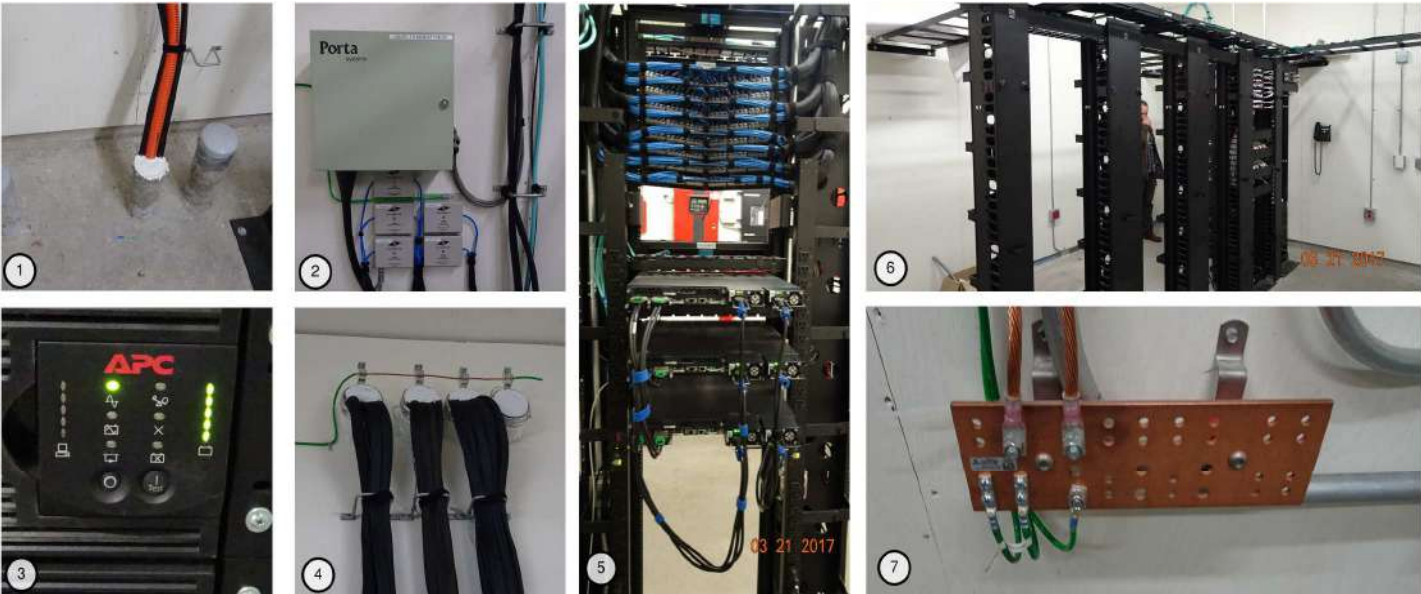
TELECOMMUNICATION ASSESSMENT
CASCADE CAMPUS: CASCADE HALL, 1ST FLOOR, BDF

- POSITIVES AND NEGATIVES OF THE IMAGES ABOVE...
- 1. Conduit seal & cap good practice – sealant is not intumescent fire stop.
 - 2. Proper circuit protection used for outdoor terminations (Blue Light phones, etc).
 - 3. Load and Charge good on UPS.
 - 4. Properly grounded conduits - sealant is not intumescent fire stop.
 - 5. Cable management good.
 - 6. Available expansion space above PCC standards.
 - 7. Grounding methods & materials good.

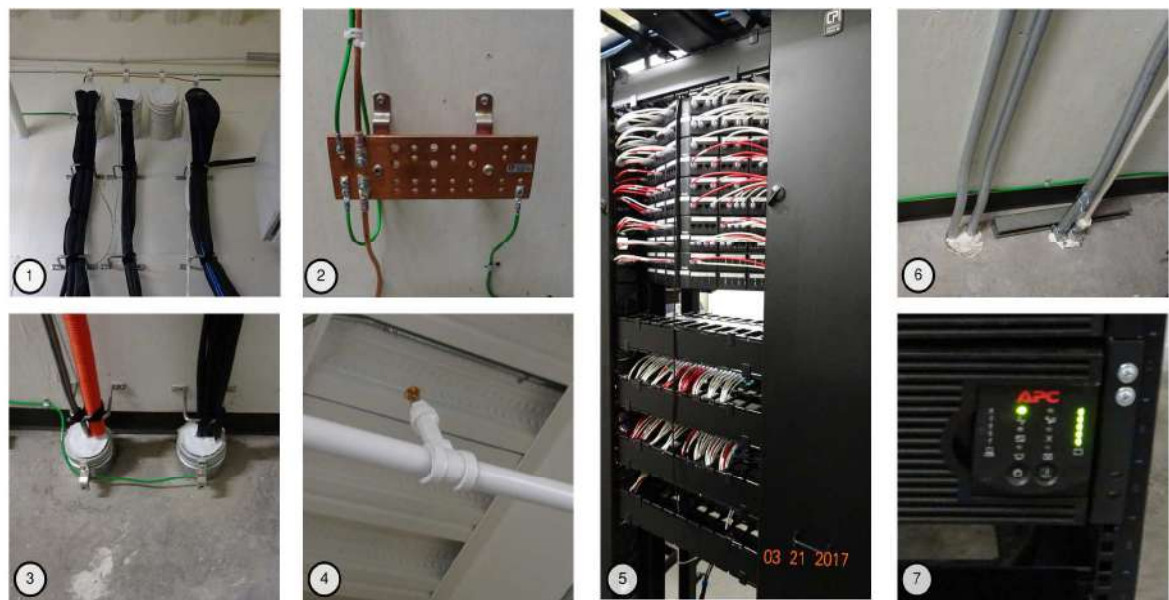
TELECOMMUNICATION ASSESSMENT
CASCADE CAMPUS: CASCADE HALL, 2ND FLOOR, IDF

- POSITIVES AND NEGATIVES OF THE IMAGES ABOVE...
- 1. & 3. Properly grounded conduits - sealant is not intumescent fire stop.
 - 2. Grounding methods & materials good.
 - 4. Overhead fire suppression present.
 - 5. Cable management good.
 - 6. Sealant is not intumescent fire stop.
 - 7. Load and Charge good on UPS.

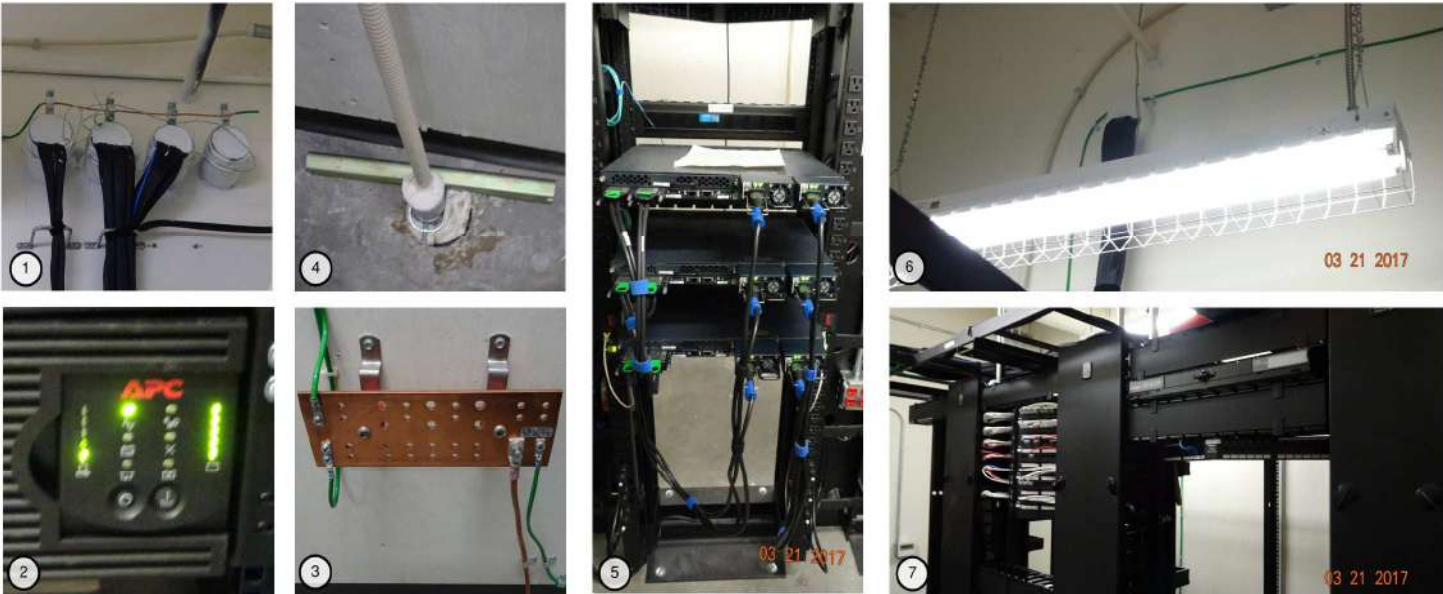
TELECOMMUNICATION ASSESSMENT
CASCADE CAMPUS: CASCADE HALL, 3RD FLOOR, IDF 2

- POSITIVES AND NEGATIVES OF THE IMAGES ABOVE....
1. Properly grounded conduits - sealant is not intumescent fire stop.
 2. Load and Charge good on UPS.
 3. Grounding methods & materials good.
 4. Sealant is not intumescent fire stop.
 5. & 7. Available expansion space conforms to PCC standards.
 6. Light fixture too close to cable path.

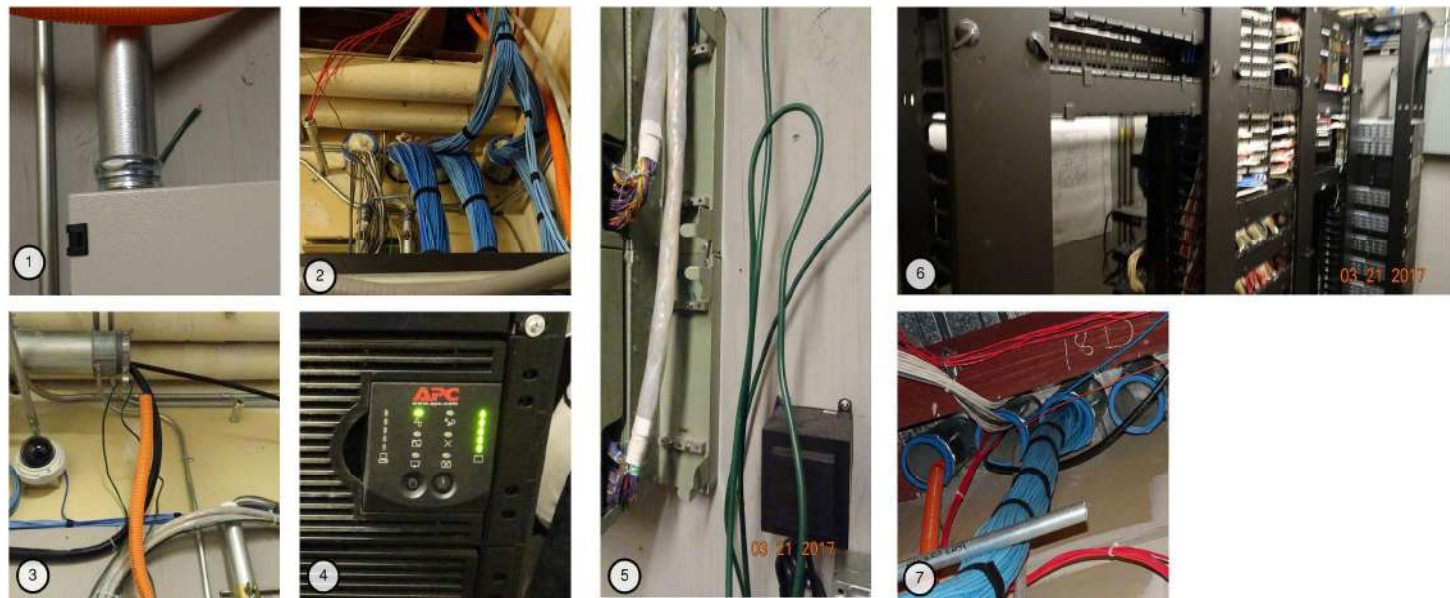
TELECOMMUNICATION ASSESSMENT
CASCADE CAMPUS: JACKSON HALL , 1ST FLOOR, BDF

- POSITIVES AND NEGATIVES OF THE IMAGES ABOVE...
- 1. & 5. Ground wire run but not connected to anything.
 - 2. Conduits overfilled.
 - 3. Cables not supported at conduit entrance - Fire stop materials not present.
 - 4. UPS load good, unit is more than 6 years old.
 - 6. Expansion capacity adequate, good cable management.
 - 7. Fire stop materials not present.

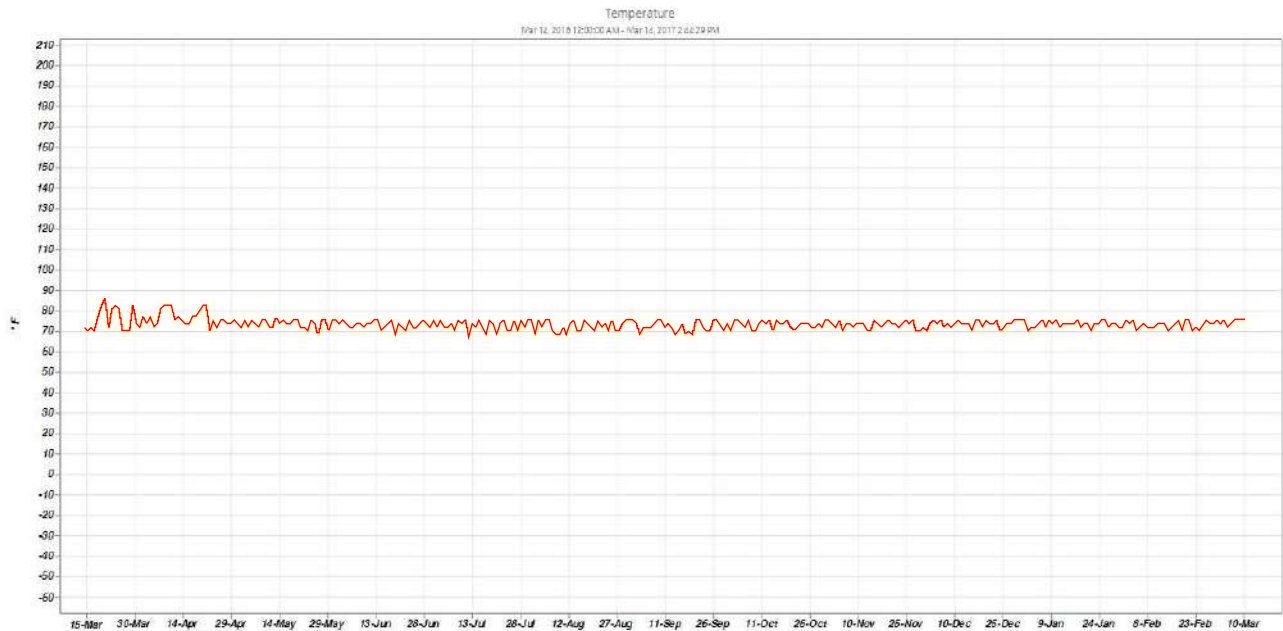
TELECOMMUNICATION TEMPERATURE ASSESSMENT
CASCADE CAMPUS: JACKSON HALL, 1ST FLOOR, BDF

Campus	Building	Room	Location	Time	Unit	Min Value	Max Value	Average Value	Least Known Value	Notes
HC	cajhdbdf-ups (172.17.255.204)	Temp	CA JH BDF	2:52:18 PM	° F	68	86	73.2	73.4	Mid Mar 2016 - (1) High temp event over 86 °

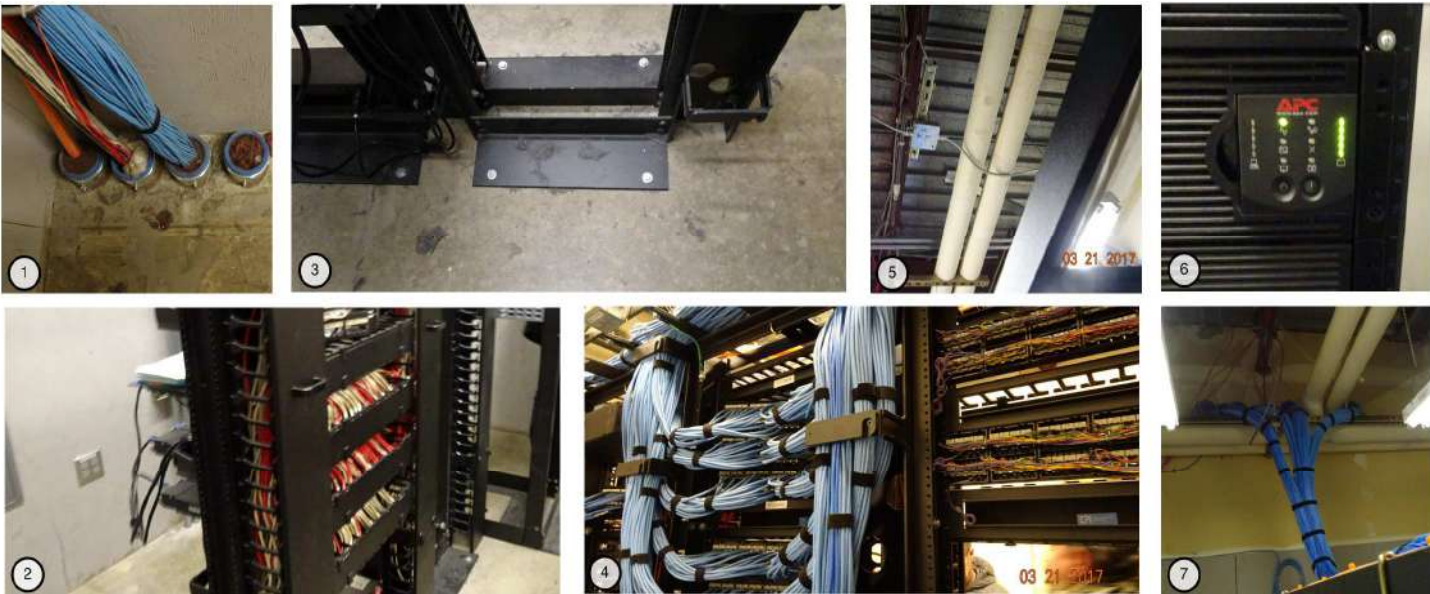
TELECOMMUNICATION ASSESSMENT
CASCADE CAMPUS: JACKSON HALL, 1ST FLOOR, IDF 1

- 1. Firestop materials not correct.
- 2. Expansion capacity adequate, good cable management.
- 3. Dirt / Dust accumulating on floor.
- 4. Rear cable management adequate.
- 5. Water pipes present over rack.
- 6. UPS load good, unit is more than 6 years old.
- 7. Conduits overfilled & cable bundles not supported.

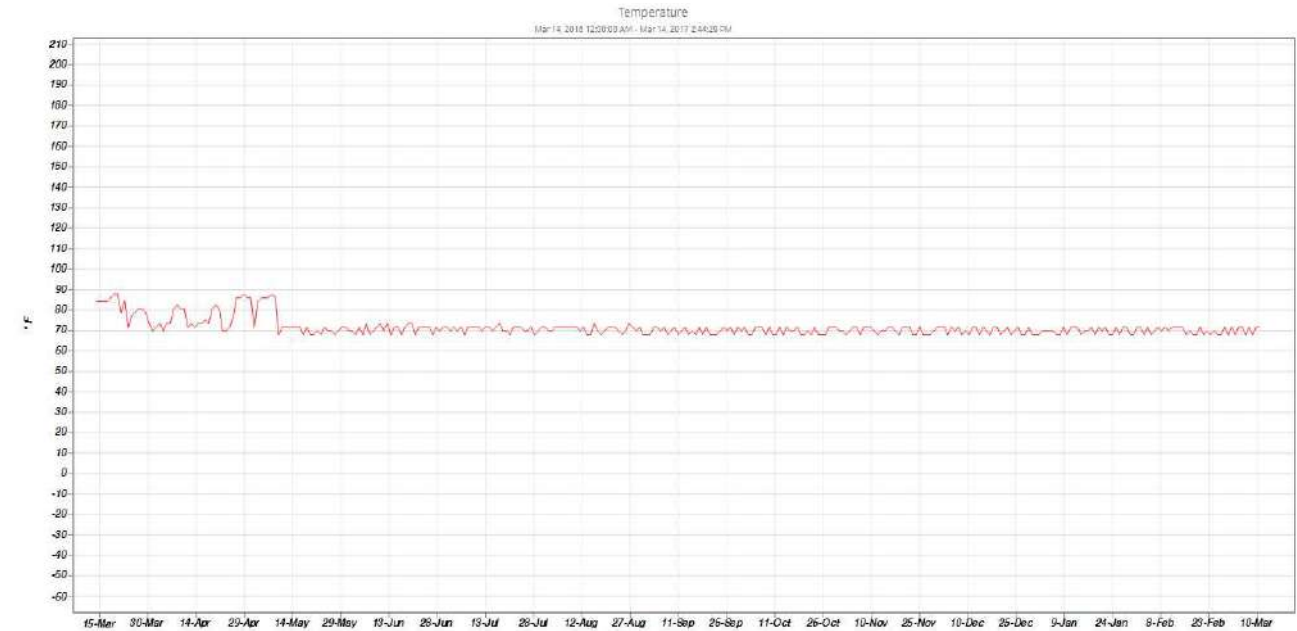
TELECOMMUNICATION TEMPERATURE ASSESSMENT
CASCADE CAMPUS: JACKSON HALL, 1ST FLOOR, IDF 1

Campus	Building	Room	Location	Time	Units	Min Value	Max Value	Avg Value	Last Known Value	Notes
RC	cajhidf1-ups (172.17.255.206)	Temp	CA JH IDF1	2:52:18 PM	° F	66.2	89.6	71.7	69.8	Mid Mar 2016 to May 2016 - Several days of high temp events over 86 °

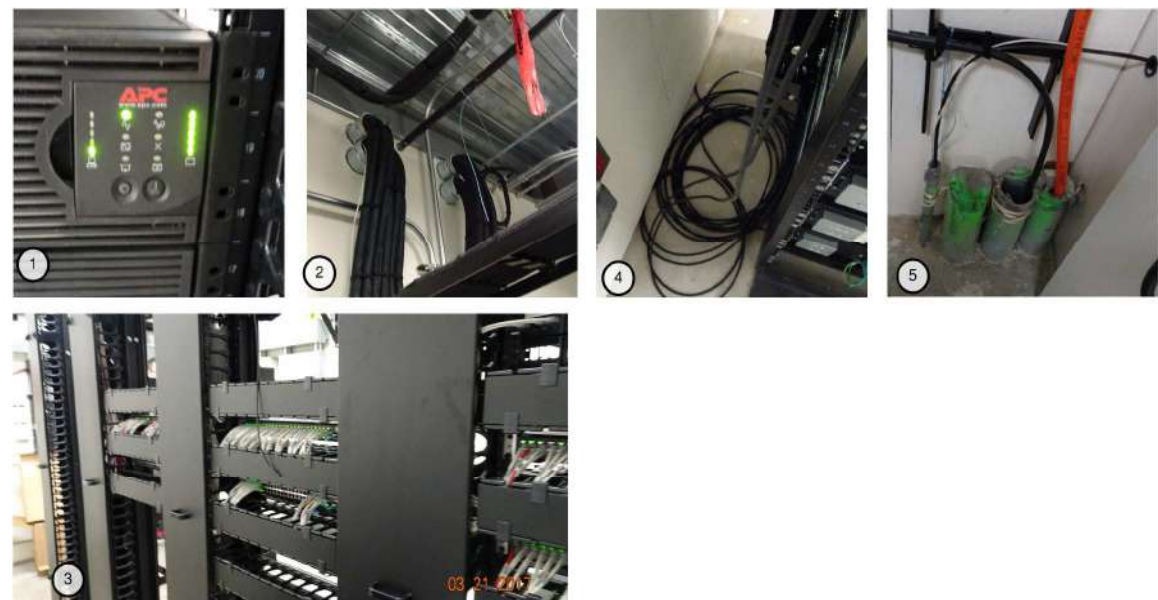
TELECOMMUNICATION ASSESSMENT
CASCADE CAMPUS: LIBRARY, 1ST FLOOR, BDF

- POSITIVES AND NEGATIVES OF THE IMAGES ABOVE...
- 1. Load and Charge good on UPS.
 - 2. Cables not supported at conduit entrance - Fire stop materials not present.
 - 3. Rack management good, excellent room for expansion.
 - 4. Fiber or cable coiled loose on floor.
 - 5. Conduit capacity good, but required Firestop / sealant is not present.

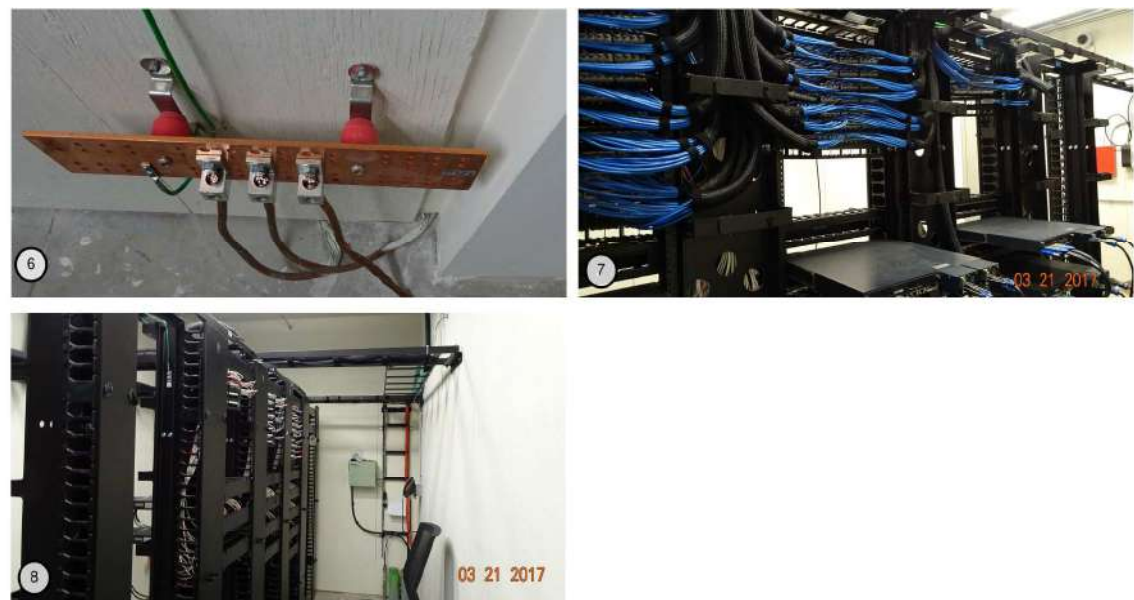
TELECOMMUNICATION ASSESSMENT
SOUTHEAST CAMPUS: LIBRARY, 1ST FLOOR, BDF

- POSITIVES AND NEGATIVES OF THE IMAGES ABOVE...
- 6. System ground conforms to PCC standard.
 - 7. & 8 Rack management good, excellent room for expansion.

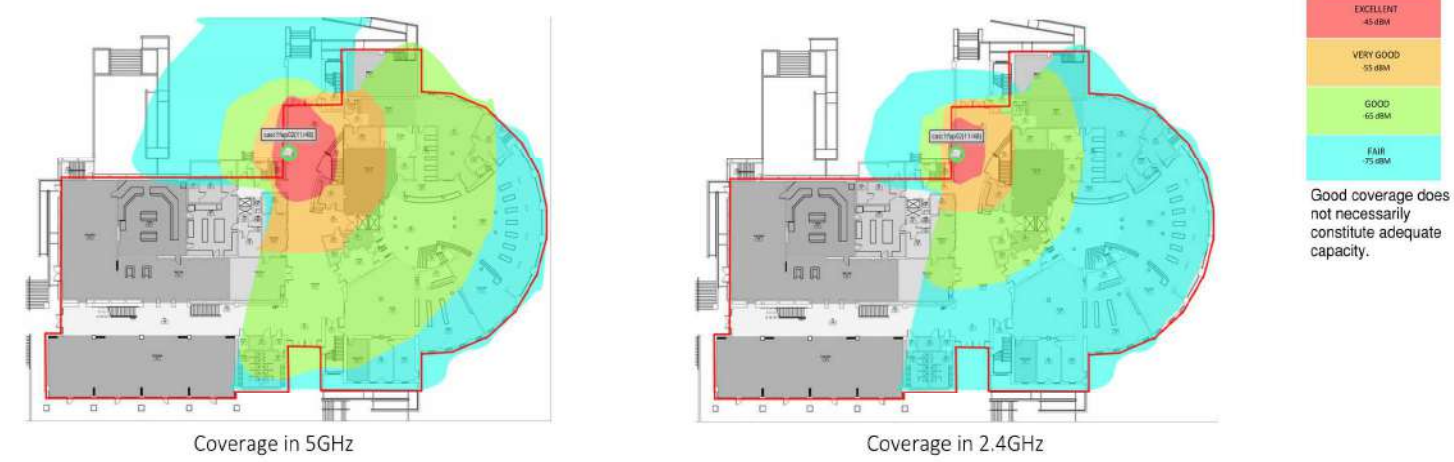
TELECOMMUNICATION ASSESSMENT
SOUTHEAST CAMPUS: LIBRARY, 1ST FLOOR

Campus	Building	Floor	Location	Coverage in 2.4GHz		Coverage in 5GHz	WAP Service Life	Comments
				1	2	3		
CA	Student Center	1st	CASC - 1	2	2	3		Heatmap doesn't show signal from APs on ceiling

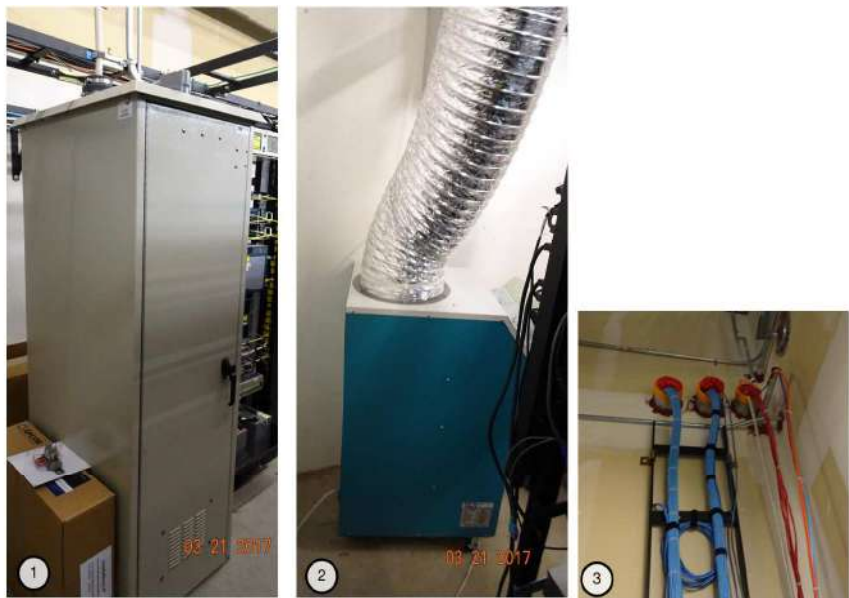
TELECOMMUNICATION ASSESSMENT
CASCADE CAMPUS: MORIARTY ARTS AND HUMANITIES BUILDING, 1ST FLOOR, MDF

- POSITIVES AND NEGATIVES OF THE IMAGES ABOVE...
- 1. NEMA cabinet housing First Responder DAS equipment – horizontal link not 2hr rated.
 - 2. Temporary cooling unit and fan – main HVAC unit shuts off or fails frequently.
 - 3. Incorrect use of Firestop pillows.

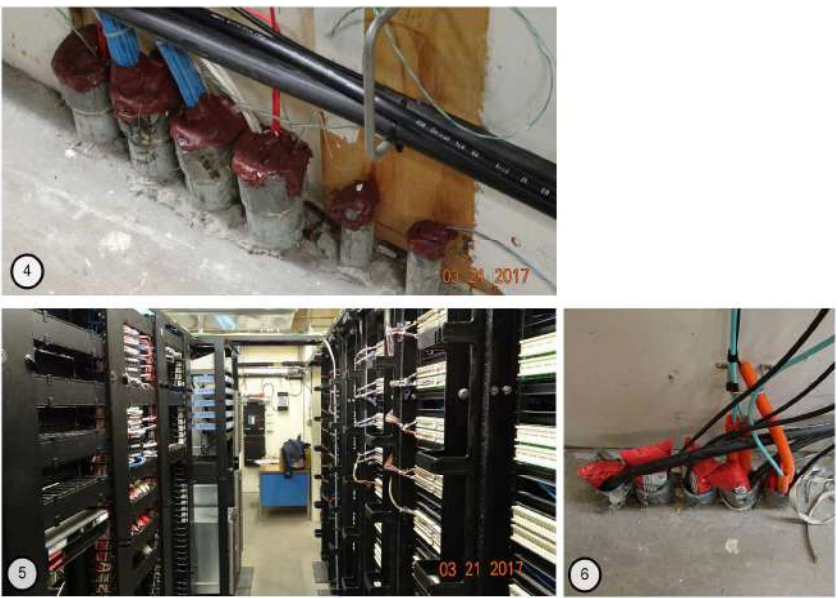
TELECOMMUNICATION ASSESSMENT
CASCADE CAMPUS: MORIARTY ARTS AND HUMANITIES BUILDING, 1ST FLOOR, MDF

- POSITIVES AND NEGATIVES OF THE IMAGES ABOVE...
- 4. Conduit capacity good, Firestop applied correctly.
 - 5. Expansion capacity adequate, good cable management.
 - 6. Incorrect use of Firestop pillows.

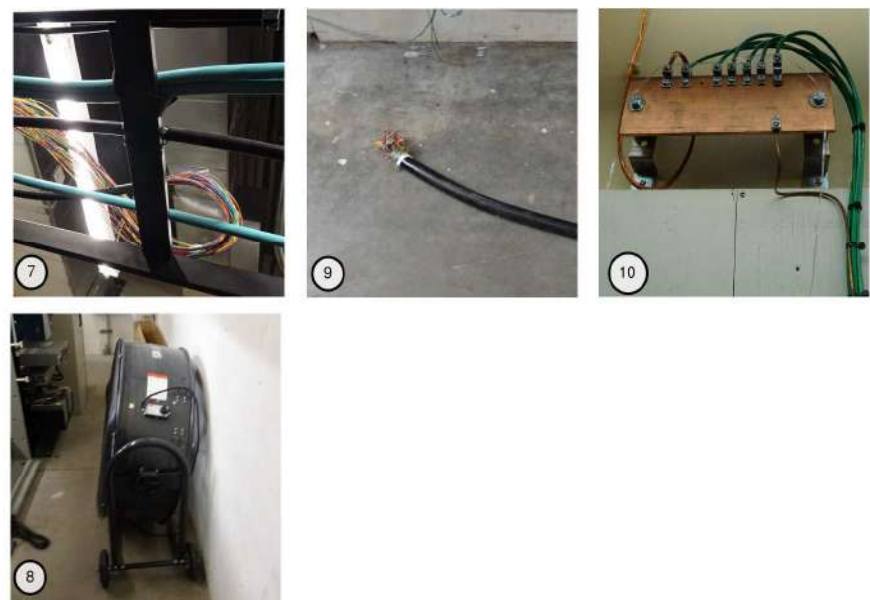
TELECOMMUNICATION ASSESSMENT
CASCADE CAMPUS: MORIARTY ARTS AND HUMANITIES BUILDING, 1ST FLOOR, MDF

7. Bare & unterminated fiber strands coiled on ladder tray – safety hazard.

10. System ground conforms to PCC standard.

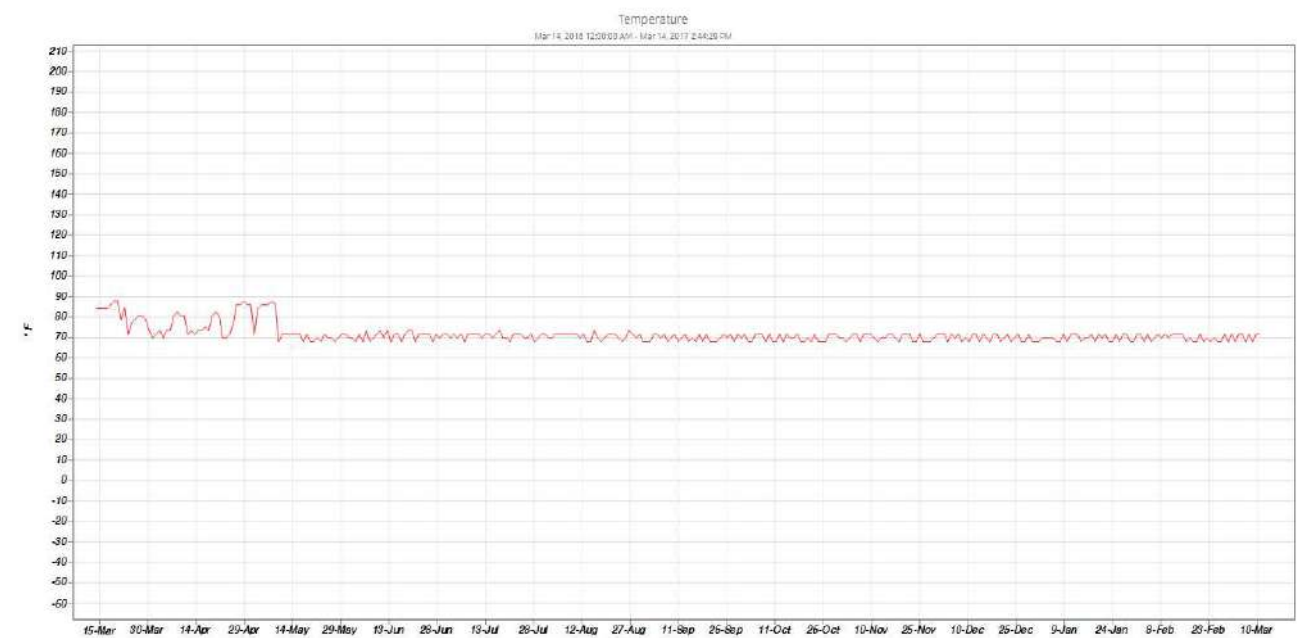
TELECOMMUNICATION TEMPERATURE ASSESSMENT
CASCADE CAMPUS: MORIARTY ARTS & HUMANITIES BUILDING, 1ST FLOOR, MDF

Campus	Building	Room	Location	Time	Unit	Min Value	Max Value	Average Value	Lowest Known Value	Notes
RC	camahmdf-ups (172.17.255.200)	Temp	CA MAH MDF	2:52:18 PM	° F	64.4	95	71.3	69.8	Start of Apr 2016 - Several days of high temp events over 86°

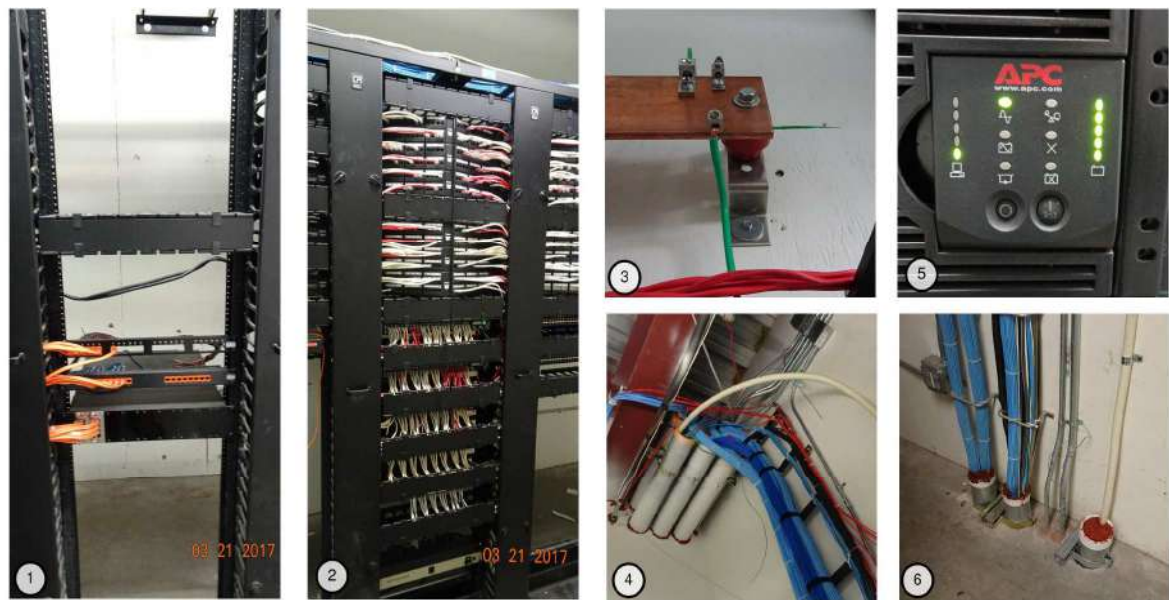
TELECOMMUNICATION ASSESSMENT
CASCADE CAMPUS: MORIARTY ARTS & HUMANITIES BUILDING, 1ST FLOOR, IDF

- POSITIVES AND NEGATIVES OF THE IMAGES ABOVE...
- 1. & 2. Expansion capacity adequate, good cable management.
 - 3. System ground barely conforms to PCC standard; lacks individual connections to required components.
 - 4. Conduits filled beyond recommended capacity – expansion limited – no firestop present.
 - 5. Load and Charge good on UPS.
 - 6. Firestop not properly placed in conduits or around floor penetration.

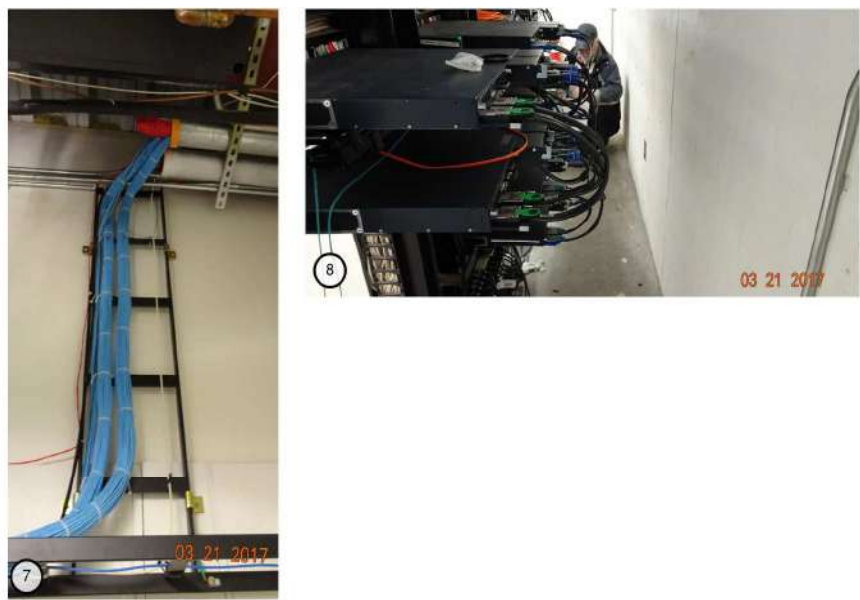
TELECOMMUNICATION ASSESSMENT
CASCADE CAMPUS: MORIARTY ARTS & HUMANITIES BUILDING, 1ST FLOOR, IDF

- POSITIVES AND NEGATIVES OF THE IMAGES ABOVE...
- 7. Cable support great – improper use of Firestop pillows.
 - 8. Clearance behind equipment well under PCC standards.
