FACILITIES PLAN TECHNICAL REPORTS

PORTLAND COMMUNITY COLLEGE
IT Master Plan
Infrastructure Existing Conditions Report

Date: April 17, 2018

Prepared for:
SRG Partnership

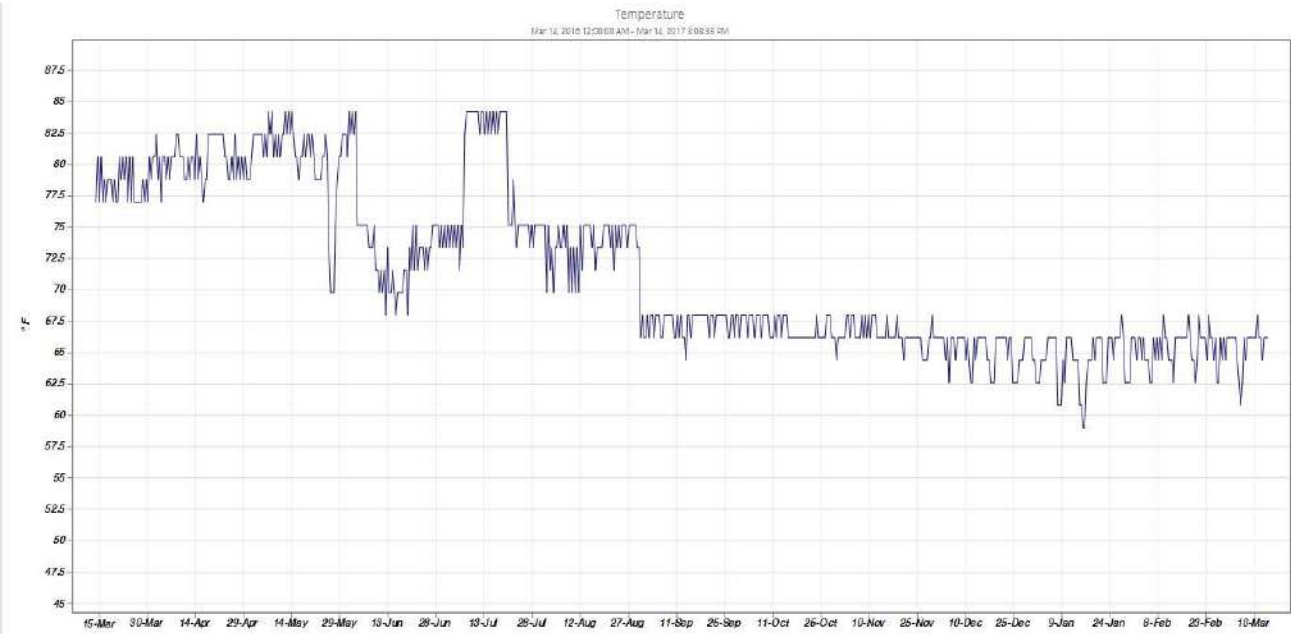
TELECOMMUNICATION TEMPERATURE ASSESSMENT
CASCADE CAMPUS: PARAGON, 1ST FLOOR, MDF

Campus	Building	Room	Location	Time	Units	Min Value	Max Value	Average Value	Last known Value	Notes
RC	capbbdf-ups (172.17.255.250)	Temp	CA PB BDF	2:52:18 PM	° F	62.6	84.2	72.4	68	Mid Mar to mid July 2016 - Many events over 80°

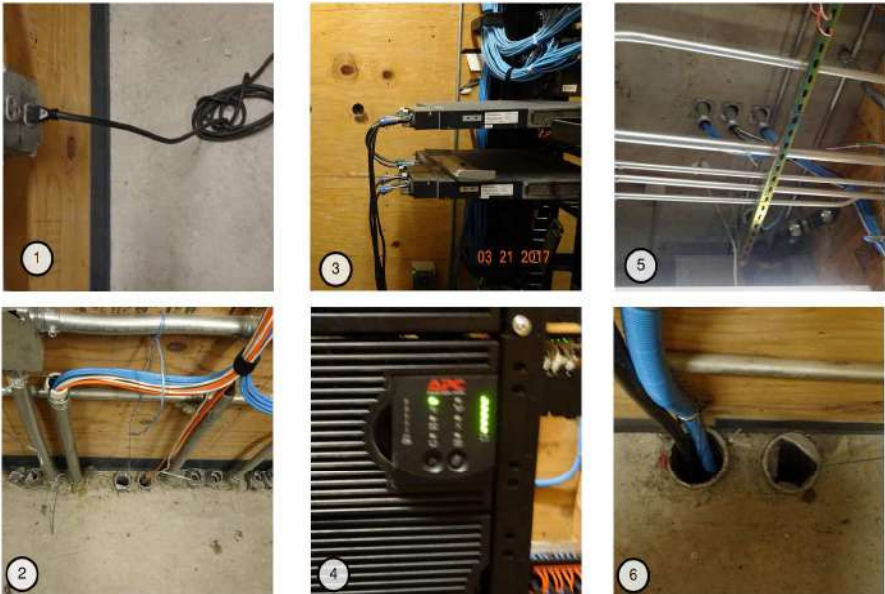
TELECOMMUNICATION ASSESSMENT
CASCADE CAMPUS: PHYSICAL EDUCATION BUILDING, 1ST FLOOR BDF

- POSITIVES AND NEGATIVES OF THE IMAGES ABOVE...
- 1. Cord from UPS in aisle – trip hazard and accidental power disruption possible.
 - 2. & 5. & 6. - Conduit capacity good, but required Firestop / sealant is not present.
 - 3. Space behind rack limited – not to PCC standards.
 - 4. Load and Charge good on UPS.

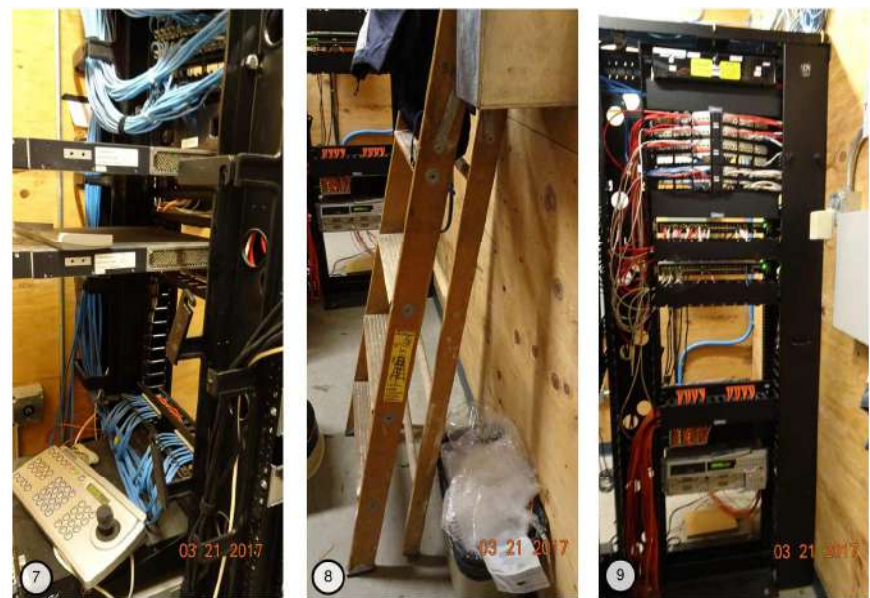
TELECOMMUNICATION ASSESSMENT
CASCADE CAMPUS: PHYSICAL EDUCATION BUILDING, 1ST FLOOR BDF

7. & 9. Expansion capacity adequate, cable management fair.

8. Ladder near racks unsecured – could damage equipment in earthquake.

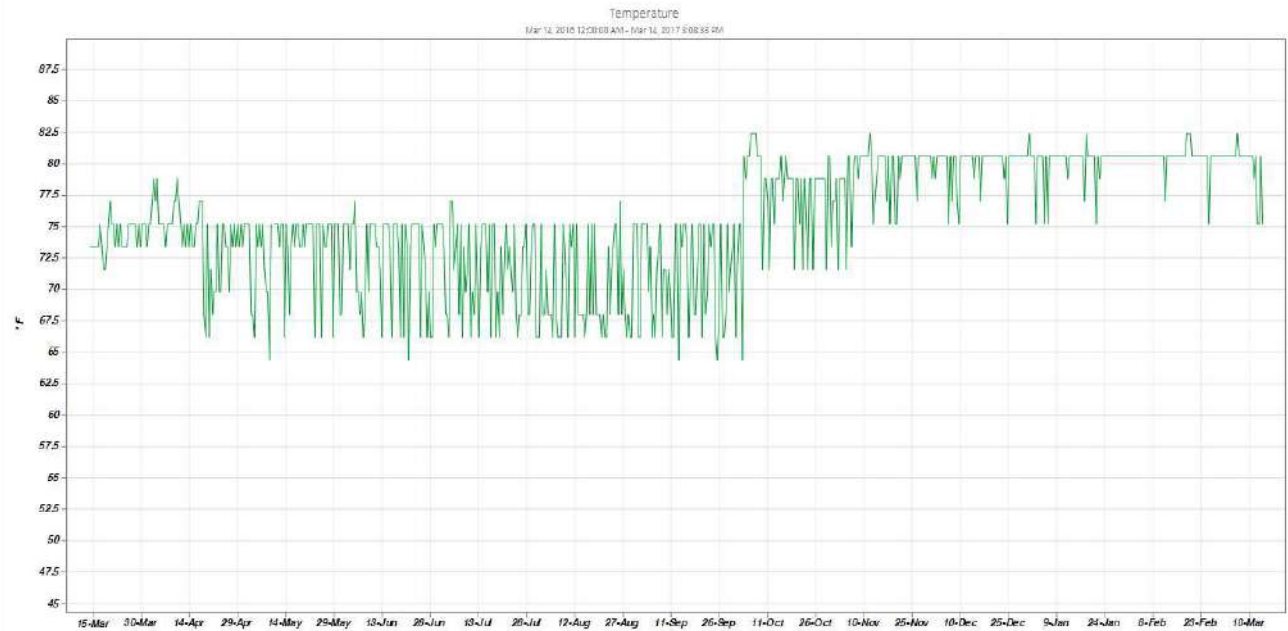
TELECOMMUNICATION TEMPERATURE ASSESSMENT
CASCADE CAMPUS: PHYSICAL EDUCATION BLDG, 1ST FLOOR, BDF

Campus	Building	Room	Location	Time	Units	Min Value	Max Value	Avg Value	Last known Value	Notes
RC	capebdf-ups (172.17.255.232)	Temp	CA PE BDF	2:52:18 PM	° F	64.4	82.4	75.2	80.6	Start of Oct 2016 to Mar 2017 - Many temp events over 86°

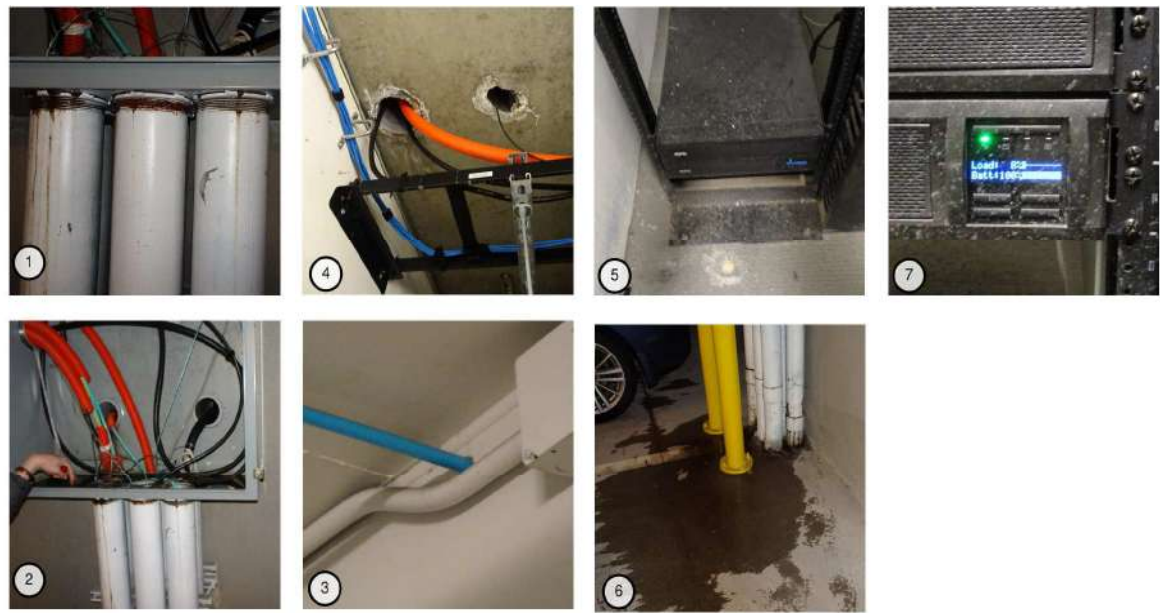
TELECOMMUNICATION ASSESSMENT
CASCADE CAMPUS: UNDERGROUND PARKING, BDF

- 1. & 2. & 6. Water infiltration of communications ducts and pull box.
- 3. First Responder BDA COAX not sleeved through wall, no 2hr rating pathway.
- 5. & 6. & 7. Water, dirt from conduit directly above rack.

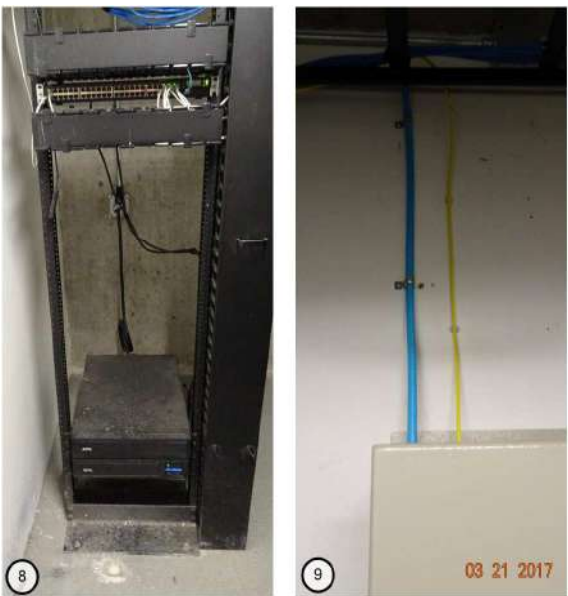
TELECOMMUNICATION ASSESSMENT
CASCADE CAMPUS: UNDERGROUND PARKING, BDF

- 8. Water, dirt from conduit directly above rack.
- 9. First Responder BDA COAX not sleeved through wall, no 2hr rating pathway.

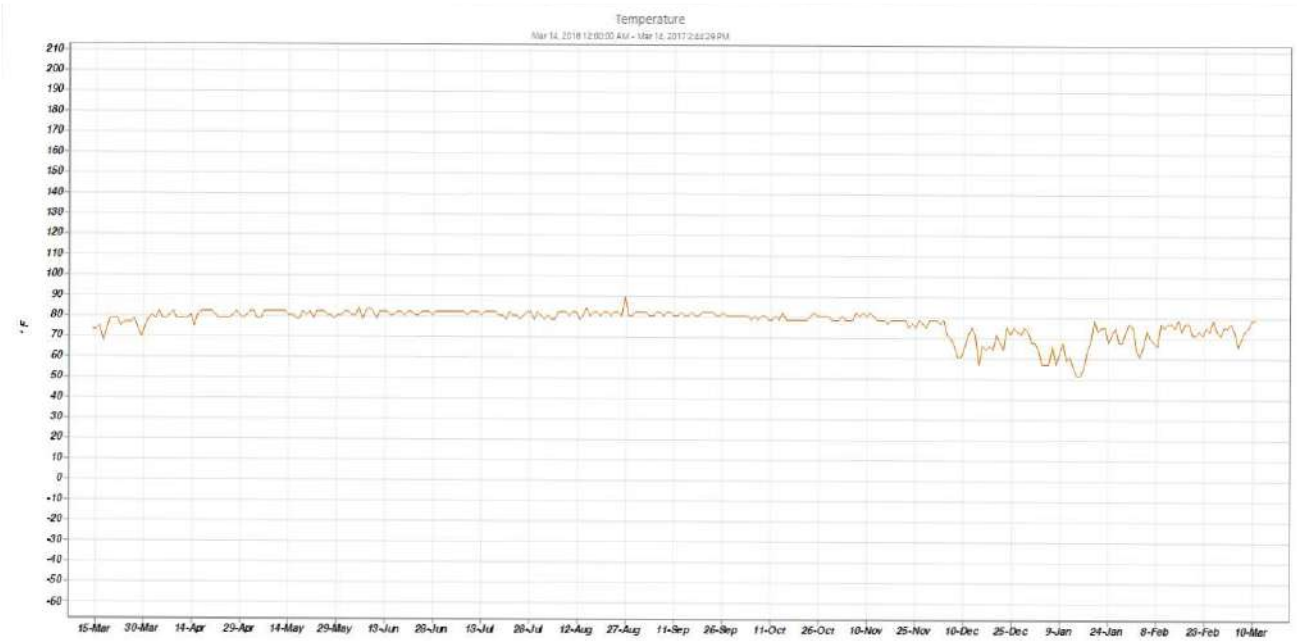
TELECOMMUNICATION TEMPERATURE ASSESSMENT
CASCADE CAMPUS: UNDERGROUND PARKING, BDF TEMPERATURE

Campus	Building	Room	Location	Time	Unit	Min Value	Max Value	Average Value	Last Known Value	Notes
CP	caepbdf-ups (172.17.255.236)	Temp	CA EP BDF	2:52:18 PM	* F	89.8	89.6	78.1	71.6	End of Aug 2016 - (1) High temp event over 86°

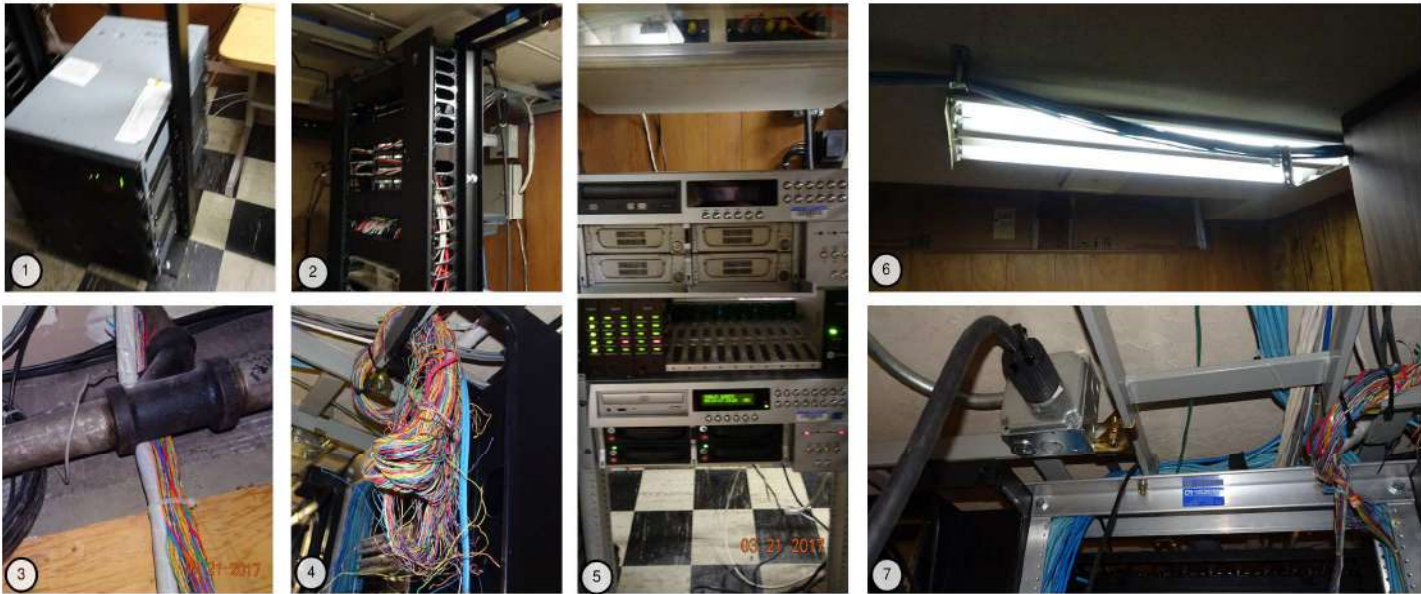
TELECOMMUNICATION ASSESSMENT
CASCADE CAMPUS: PUBLIC SAFTEY, 1ST FLOOR BDF

- POSITIVES AND NEGATIVES OF THE IMAGES ABOVE...
1. Clearance at rack not to standards.

2. Clearance to signal cabinets on wall not to code or PCC Standards.

4. & 5. & 7. Unterminated, unprotected communications cables hazardous.

Source of ground to building not found.

Storage impedes access to equipment.

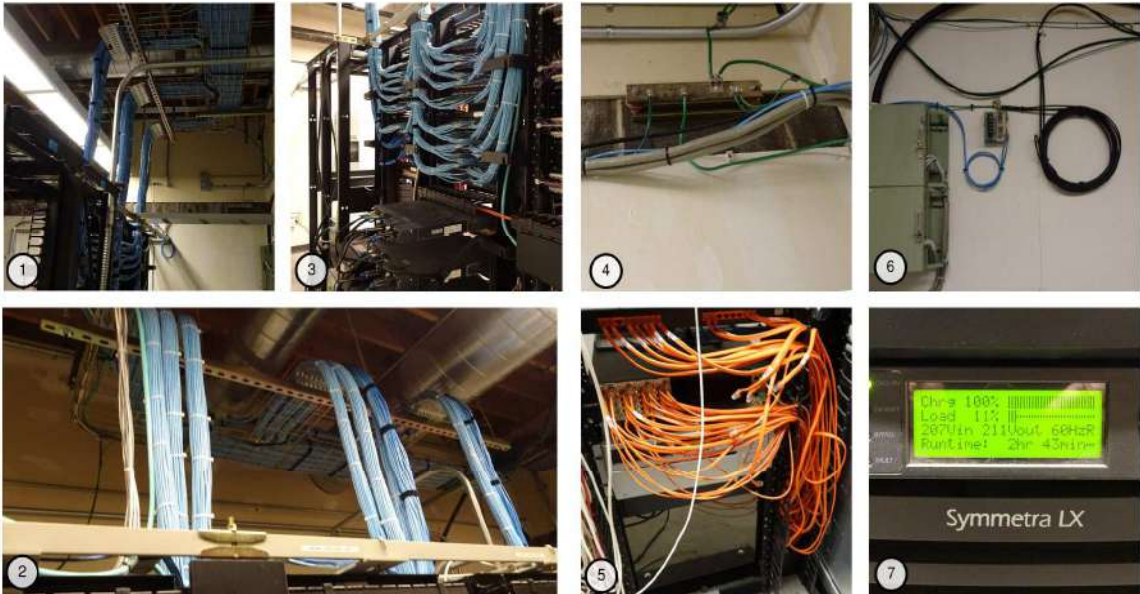
TELECOMMUNICATION ASSESSMENT
CASCADE CAMPUS: PUBLIC SERVICE EDUCATION BUILDING, 1ST FLOOR BDF

- POSITIVES AND NEGATIVES OF THE IMAGES ABOVE...
- 1. & 2. Good cable support and cable tray management with transition plates.
 - 3. Rack management good, excellent room for expansion.
 - 4. System ground conforms to PCC standard.
 - 5. Abandoned patch cords should be removed.
 - 6. Proper circuit protections used for outdoor terminations (Blue Light phones, etc).
 - 7. Load and Charge good on UPS.

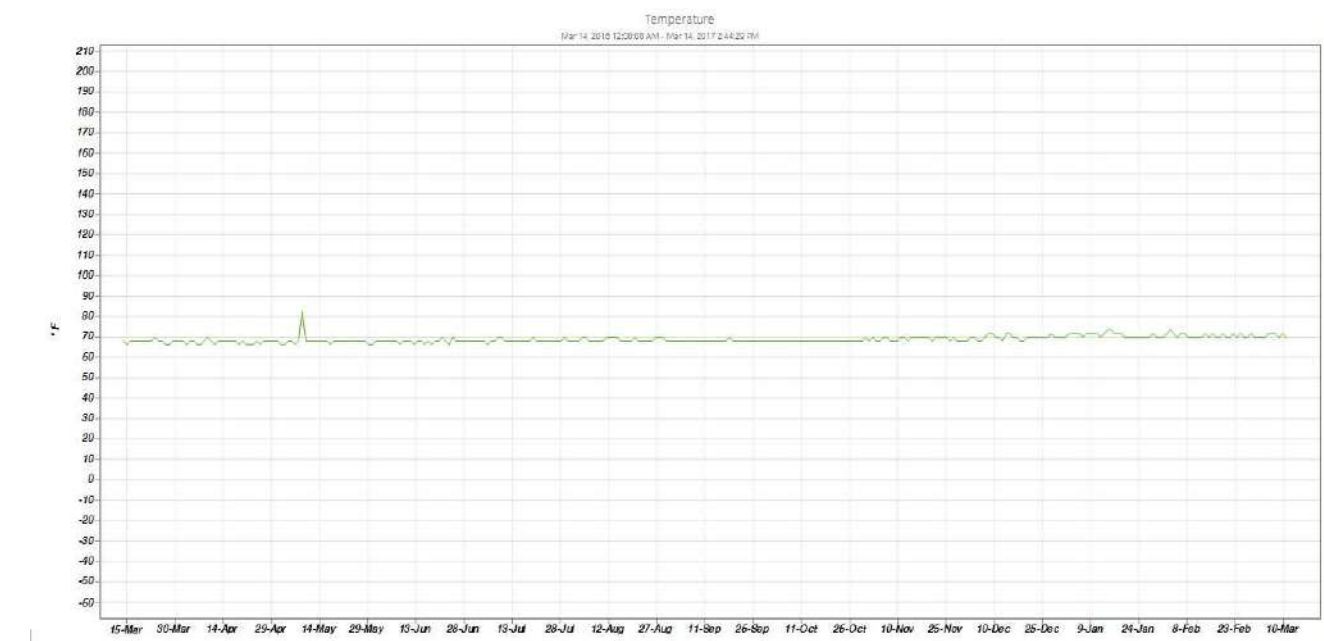
CASCADE CAMPUS: PUBLIC SERVICE EDUCATION BUILDING, 1ST FLOOR, BDF TEMPERATURE

Campus	Building	Room	Location	Time	Units	Min Value	Max Value	Average Value	Last known Value	Notes
RC	capsebdf-ups (172.17.255.208)	Temp	CA PSEB BDF	2:52:18 PM	° F	66.2	86	68.6	69.8	Start of May 2016 - (1) High temp event over 86°

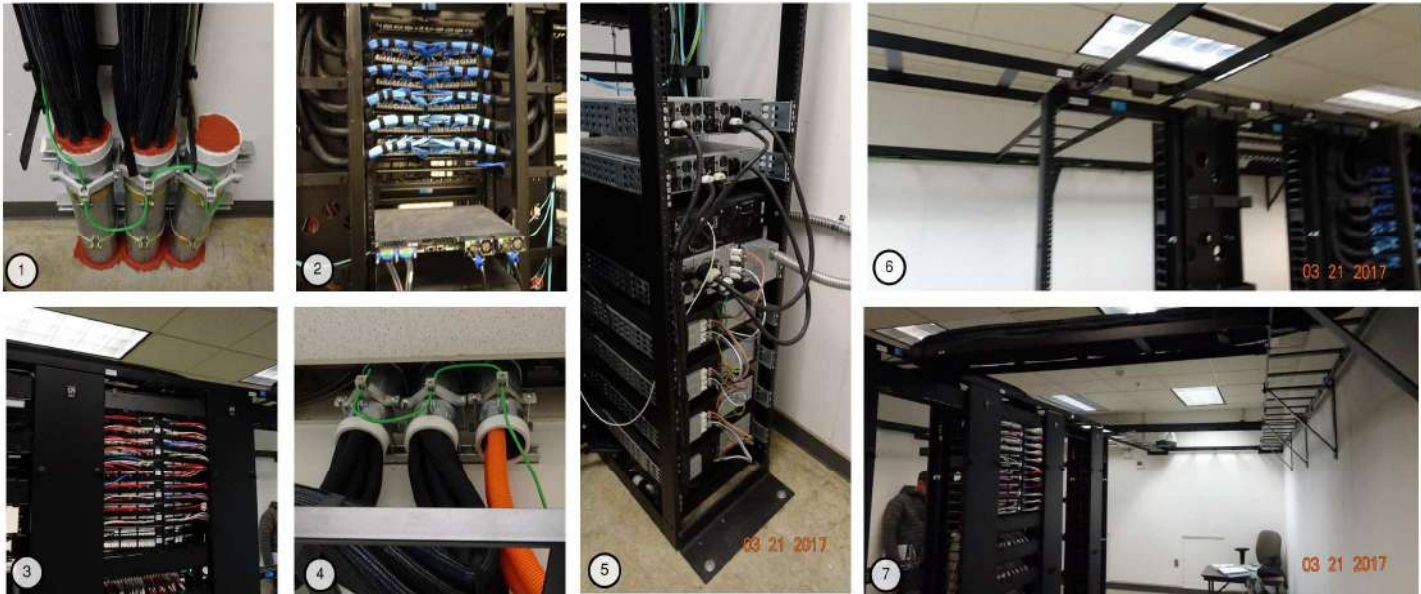
TELECOMMUNICATION ASSESSMENT
CASCADE CAMPUS: STUDENT SERVICES BUILDING, 2ND FLOOR, BDF

- POSITIVES AND NEGATIVES OF THE IMAGES ABOVE...
- 1. & 4. System ground conforms to PCC standard.
 - 2. & 3. Rack management good, excellent room for expansion.
 - 5. & 6. & 7. Rack management good, excellent room for expansion.

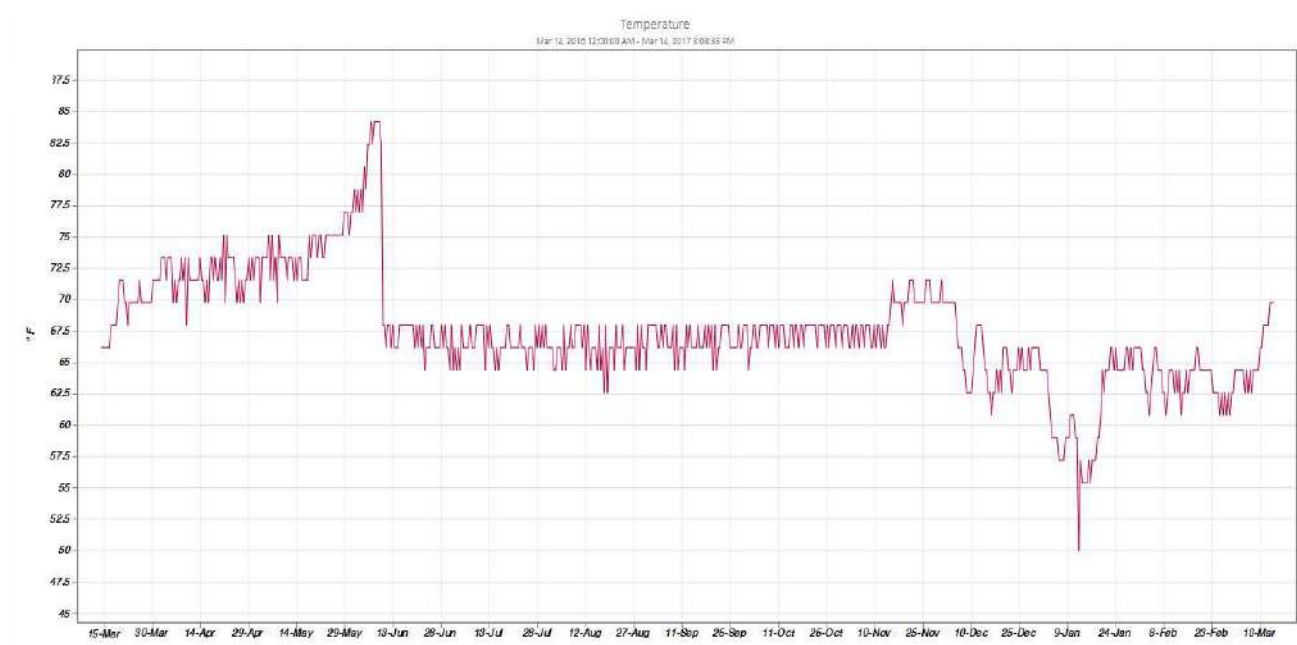
TELECOMMUNICATION TEMPERATURE ASSESSMENT
CASCADE CAMPUS: STUDENT UNION BLDG, 1ST FLOOR, BDF

Campus	Building	Room	Location	Time	Units	Min Value	Max Value	Average Value	Last known Value	Notes
RC	casubdf-ups (172.17.255.247)	Temp	CA SU BDF	2:52:18 PM	* F	60.8	84.2	68.8	68	Start of jun 2016 - (3) Moderate temp events over 80°

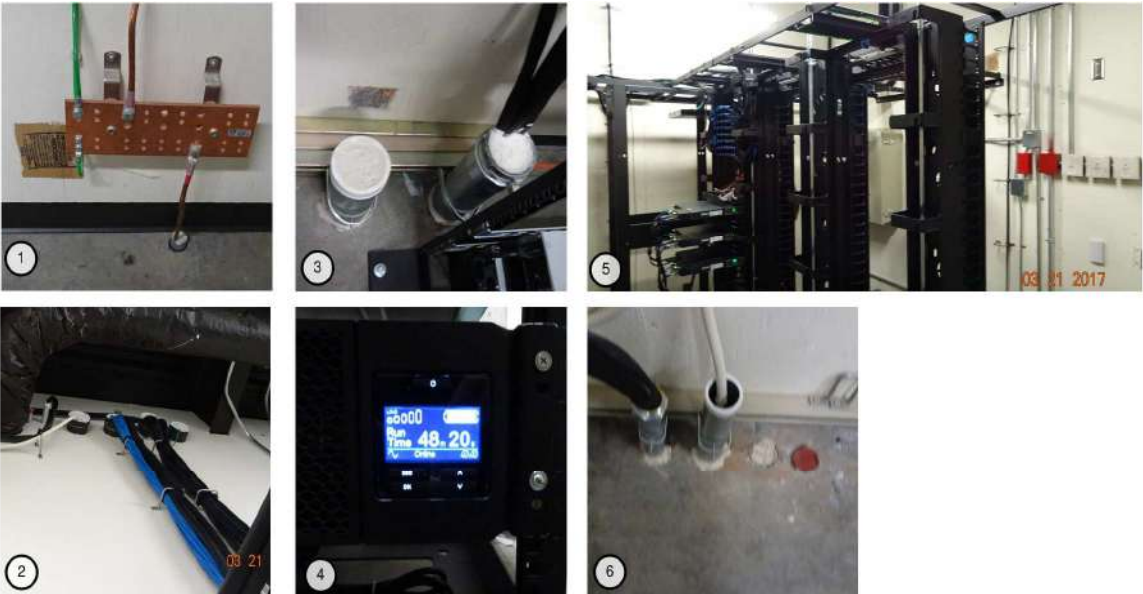
TELECOMMUNICATION ASSESSMENT
CASCADE CAMPUS: STUDENT UNION BUILDING, 2ND FLOOR IDF 1

- POSITIVES AND NEGATIVES OF THE IMAGES ABOVE...
- 1. System ground conforms to PCC standard.
 - 2. & 3. Conduit seal good , sealant is not intumescent fire stop.
 - 4. Load and Charge good on UPS.
 - 5. Rack management good, excellent room for expansion.
 - 6. Fire stop materials not present.

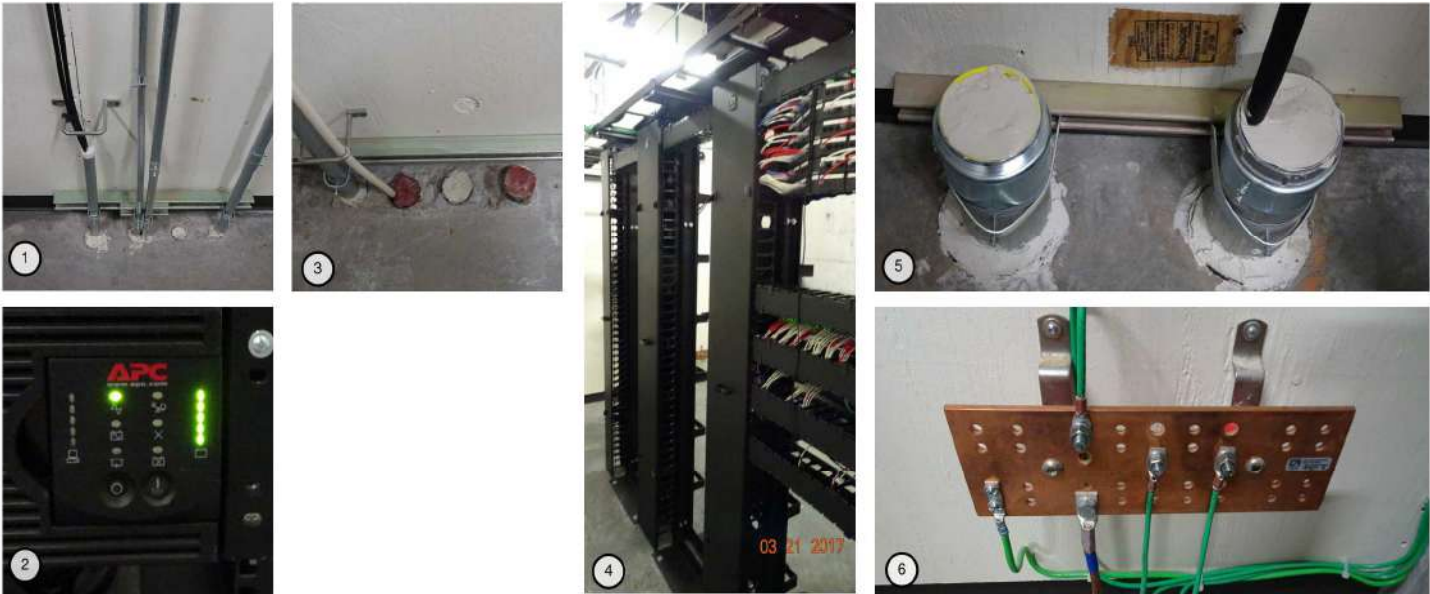
TELECOMMUNICATION ASSESSMENT
CASCADE CAMPUS: STUDENT UNION BUILDING, 3RD FLOOR IDF 2

- POSITIVES AND NEGATIVES OF THE IMAGES ABOVE...
- 1. & 3. & 5. Conduit seal good – sealant is mostly not intumescent fire stop.
 - 2. Load and Charge good on UPS.
 - 4. Rack management good, excellent room for expansion.
 - 6. System ground conforms to PCC standard.

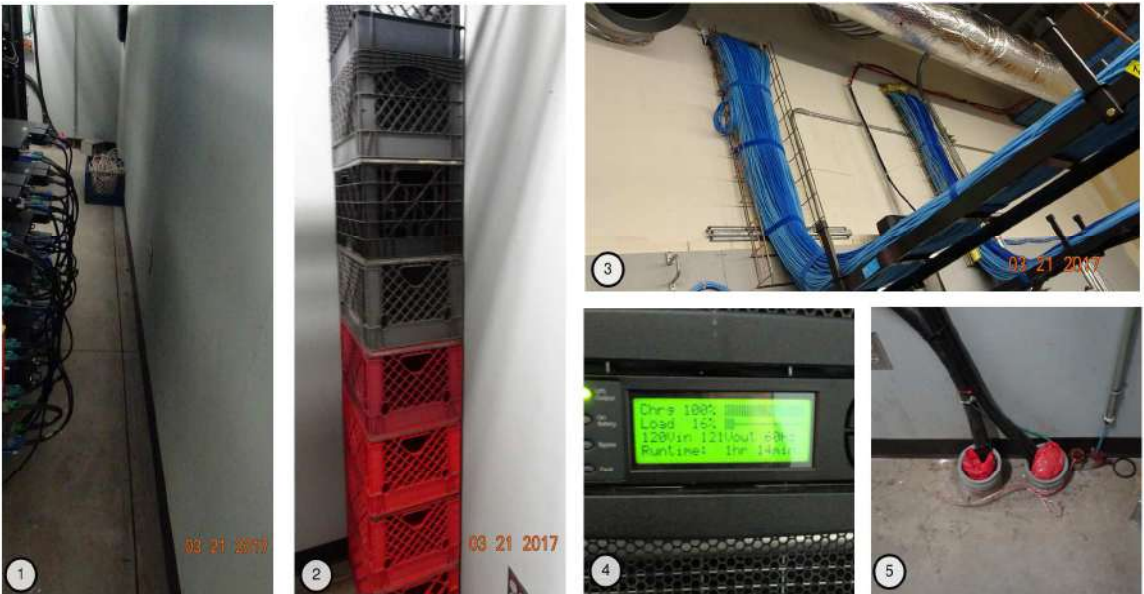
TELECOMMUNICATION ASSESSMENT
CASCADE CAMPUS: TECHNOLOGY EDUCATION BUILDING, 1ST FLOOR BDF

- POSITIVES AND NEGATIVES OF THE IMAGES ABOVE...
- 1. Clearance behind racks not PCC standard.
 - 2. Stacked crates create hazard – personal injury or equipment damage during earthquake.
 - 3. Fire stop materials not present.
 - 4. Load and Charge good on UPS.
 - 5. Incorrect use of Firestop pillows.

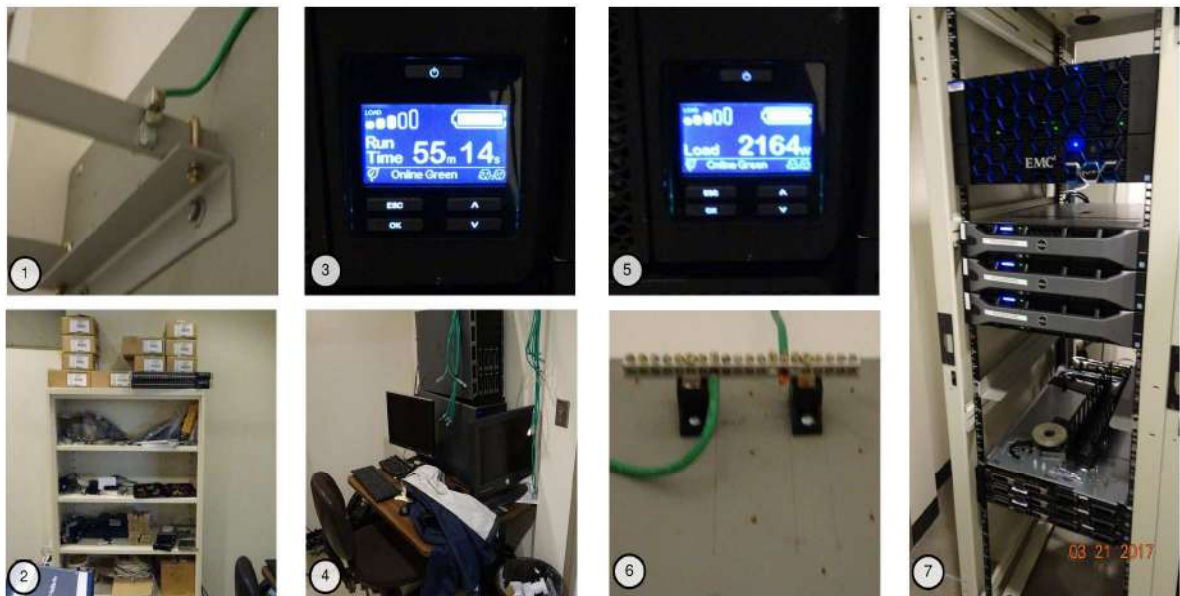
TELECOMMUNICATION ASSESSMENT
CASCADE CAMPUS: TECHNOLOGY EDUCATION BUILDING, 2ND FLOOR, SERVER RM 229

- ANALYSIS ON POSITIVES AND NEGATIVES OF THE IMAGES ABOVE...
- 1. & 6. Ground conductors are undersized and Grounding Buss Bar not approved type.
 - 2. & 4. Items stacked could cause injury or equipment damage in earthquake.
 - 3. & 5. Load and Charge good on UPS.
 - 7. Expansion capacity adequate.

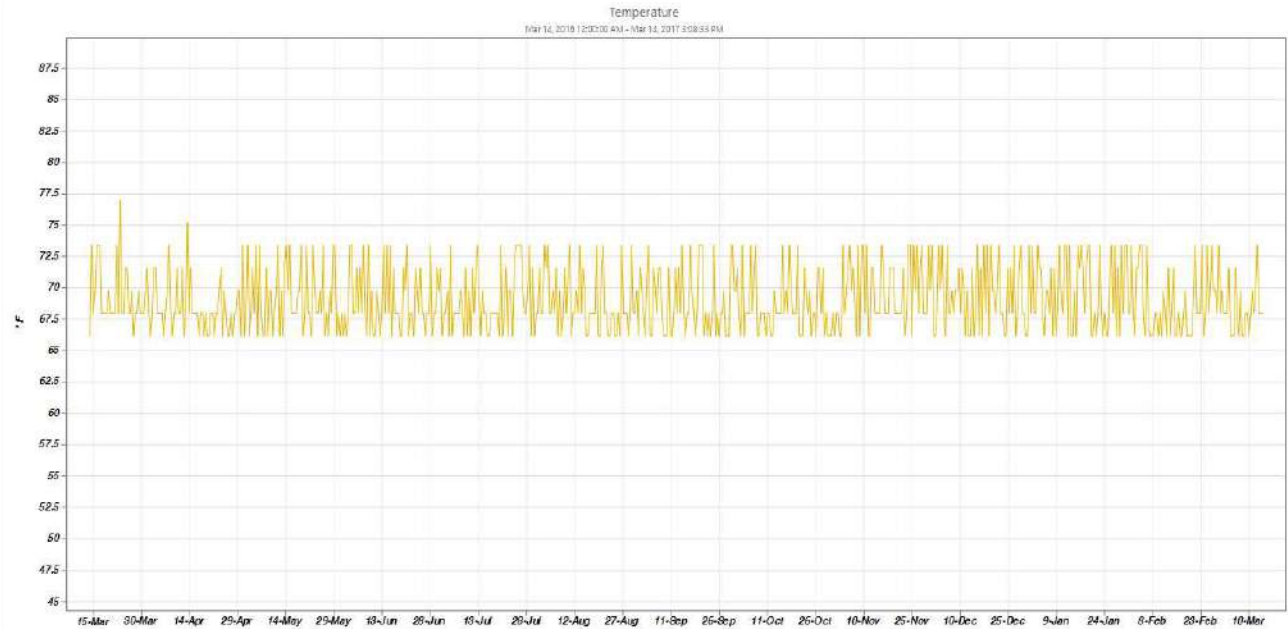
TELECOMMUNICATION TEMPERATURE ASSESSMENT
CASCADE CAMPUS: TERRELL HALL, 1ST FLOOR, BDF

Campus	Building	Room	Location	Time	Units	Min Value	Max Value	Average Value	Last Known Value	Notes
RC	cathbdf-ups (172.17.255.222)	Temp	CA TH BDF	2:52:18 PM	* F	66.2	82.4	70.2	73.4	Table shows moderate temp event over 80° but graph does not

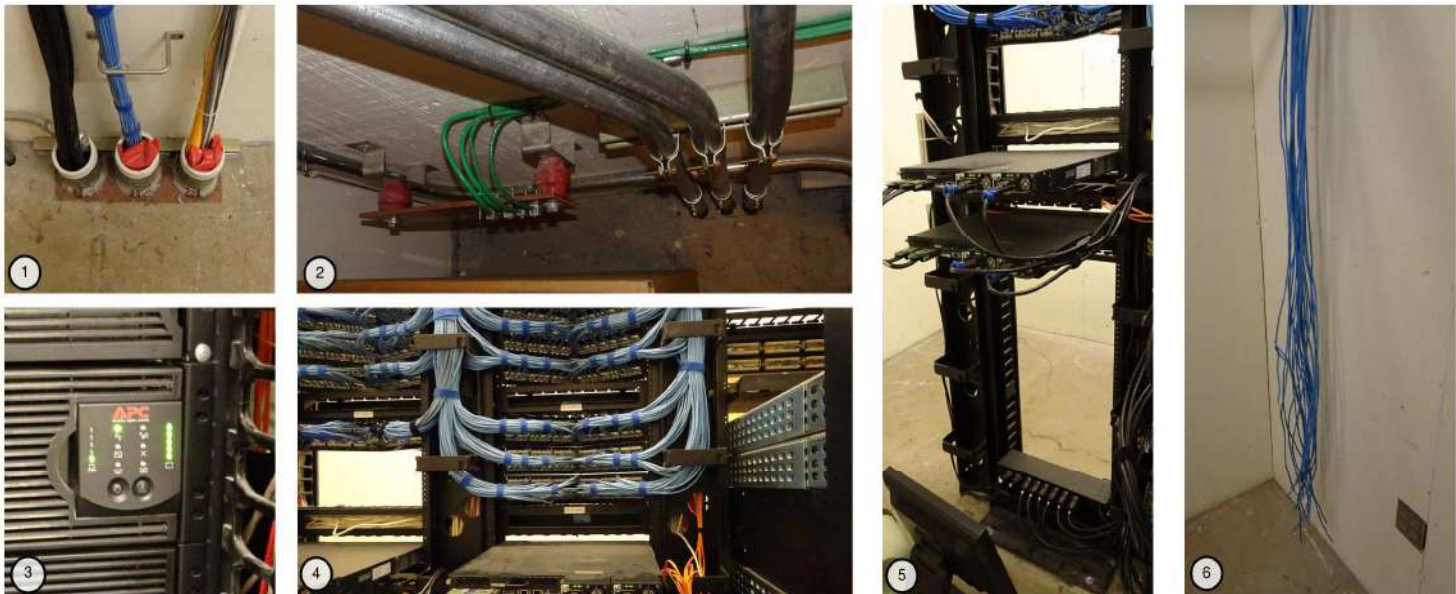
TELECOMMUNICATION ASSESSMENT
CASCADE CAMPUS: TERRELL HALL, 2ND FLOOR, IDF

- POSITIVES AND NEGATIVES OF THE IMAGES ABOVE...
- 1. Incorrect use of Firestop pillows.
 - 2. System ground conforms to PCC standard.
 - 3. Load and Charge good on UPS.
 - 4. & 5. Expansion capacity adequate, good cable management.
 - 6. Unterminated cables (could be work in progress).

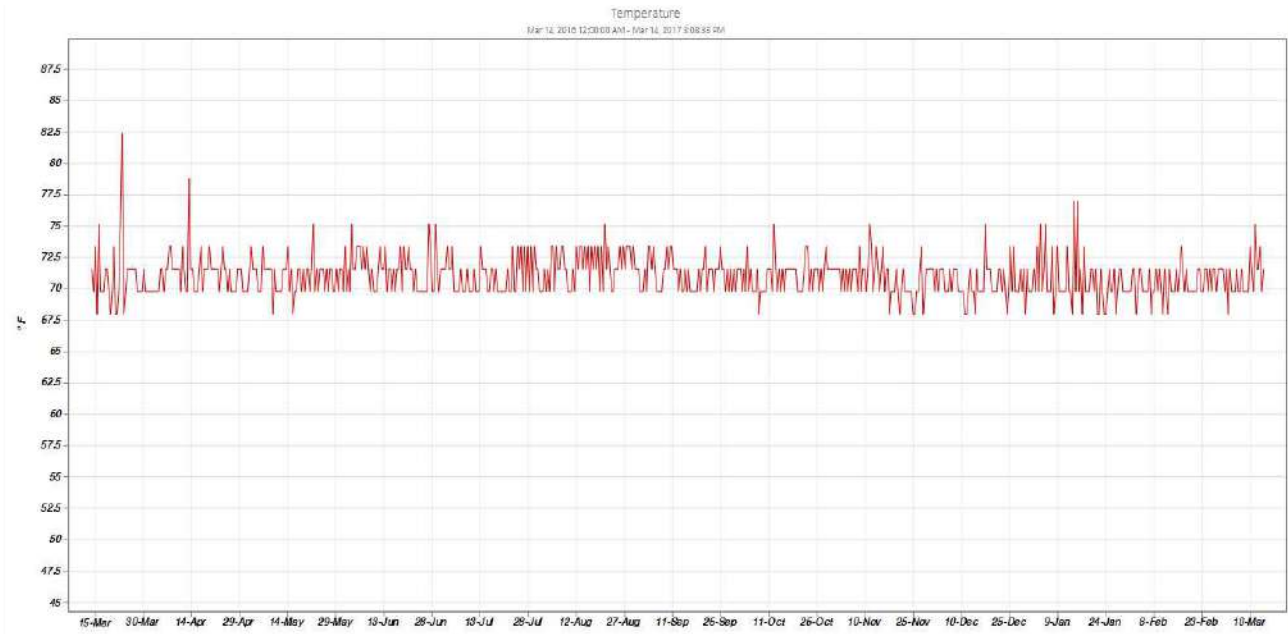
TELECOMMUNICATION TEMPERATURE ASSESSMENT
CASCADE CAMPUS: TARRELL HALL, 2ND FLOOR, IDF

Campus	Building	Room	Location	Time	Units	Min Value	Max Value	Ave per Value	Last known Value	Notes
RC	cathid1-ups (172.17.255.224)	Temp	CA TH IDF1	2:52:18 PM	°F	68	82.4	70.8	69.8	End of Mar 2016 - (1) Moderate temp event over 80°

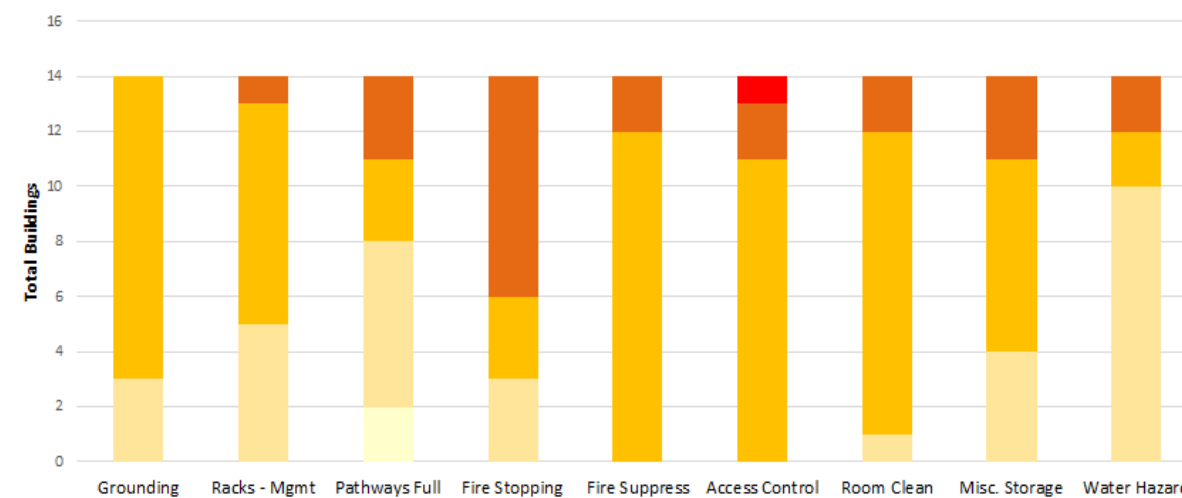
ROCK CREEK CAMPUS: BREAKDOWN

- 65% of the buildings on this campus do not employ effective firestop methods entering or exiting the communications spaces. Recommend proper installation of approved firestop materials.

•20% of the conduits and cable trays entering the communications spaces are filled beyond recommended capacity. This allows no expansion and potentially damages cable in the tray due to excess weight. Recommend removing abandoned cabling, or adding parallel pathways for future expansion. The critical entrance conduits can be further evaluated during a campus wide Outside Plant pathway identification and inventory project.

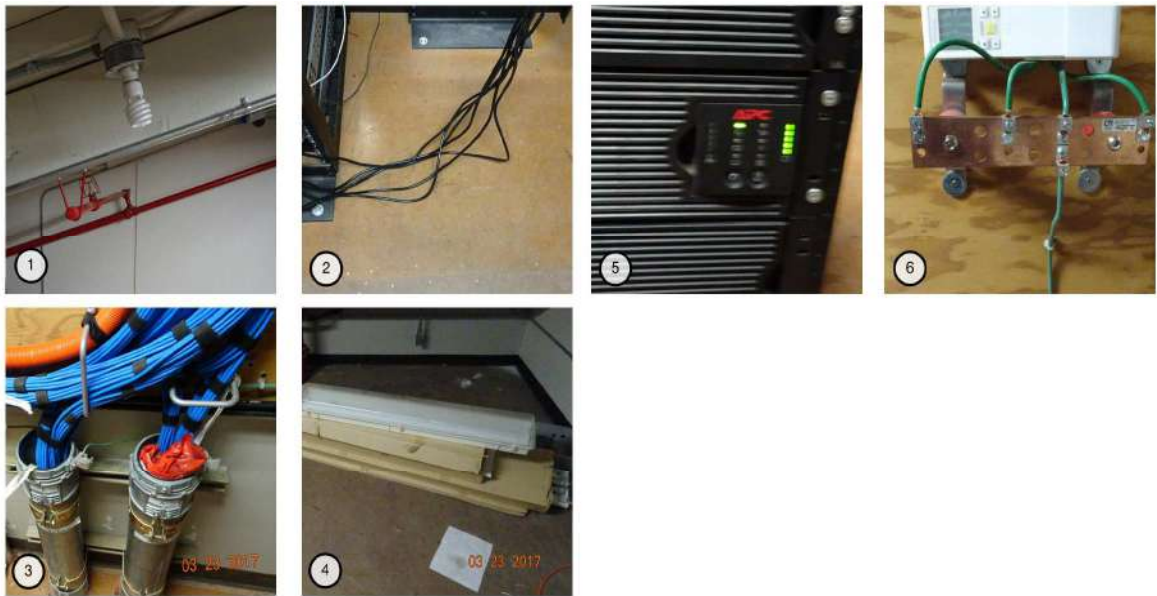
TELECOMMUNICATION ASSESSMENT
ROCK CREEK: BUILDING 1, 2ND FLOOR, BDF

- POSITIVES AND NEGATIVES OF THE IMAGES ABOVE....
1. Unprotected light bulb on low sloped ceiling – personal injury hazard.
 2. Power cables across floor – easy to disconnect equipment, also personal injury hazard.
 3. Firestop materials not present, Incorrect use of Firestop pillows.
 4. Trash, material storage, and dirt adjacent to equipment.
 5. Load and Charge good on UPS.
 6. System ground conforms to PCC standard but connections are not using industry standard lug types.

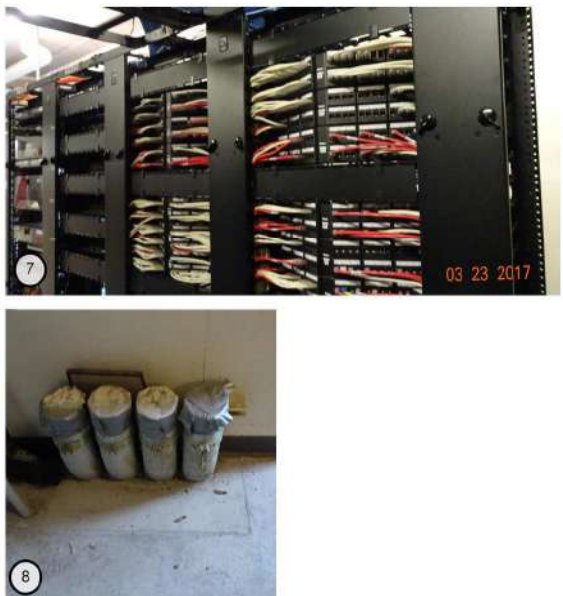
TELECOMMUNICATION ASSESSMENT
ROCK CREEK: BUILDING 2, 1ST FLOOR, MDF

- POSITIVES AND NEGATIVES OF THE IMAGES ABOVE...
- 7. Rack management good, excellent room for expansion.
 - 8. Conduits not sealed properly.
- Not shown: lighting poor throughout.

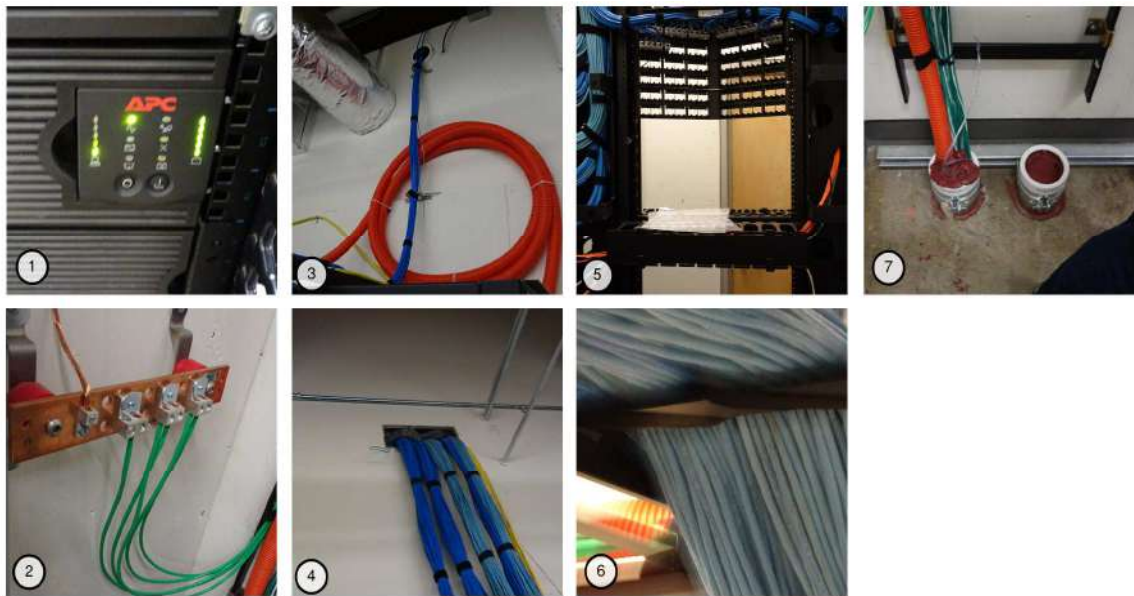
TELECOMMUNICATION ASSESSMENT
ROCK CREEK CAMPUS: BUILDING 2, 2ND FLOOR, IDF 1

- POSITIVES AND NEGATIVES OF THE IMAGES ABOVE...
- 1. Load and Charge good on UPS.
 - 2. System ground conforms to PCC standard but connections are not using industry standard lug types.
 - 3. Fiber spare coil is good practice. Firestop missing from conduit.
 - 4. Cable support poor – fire stop material not present.
 - 5. Expansion capacity adequate, good cable management.
 - 6. Weight of cable bundle at sharp edge could damage cables.
 - 7. Firestop and seal of conduits good.

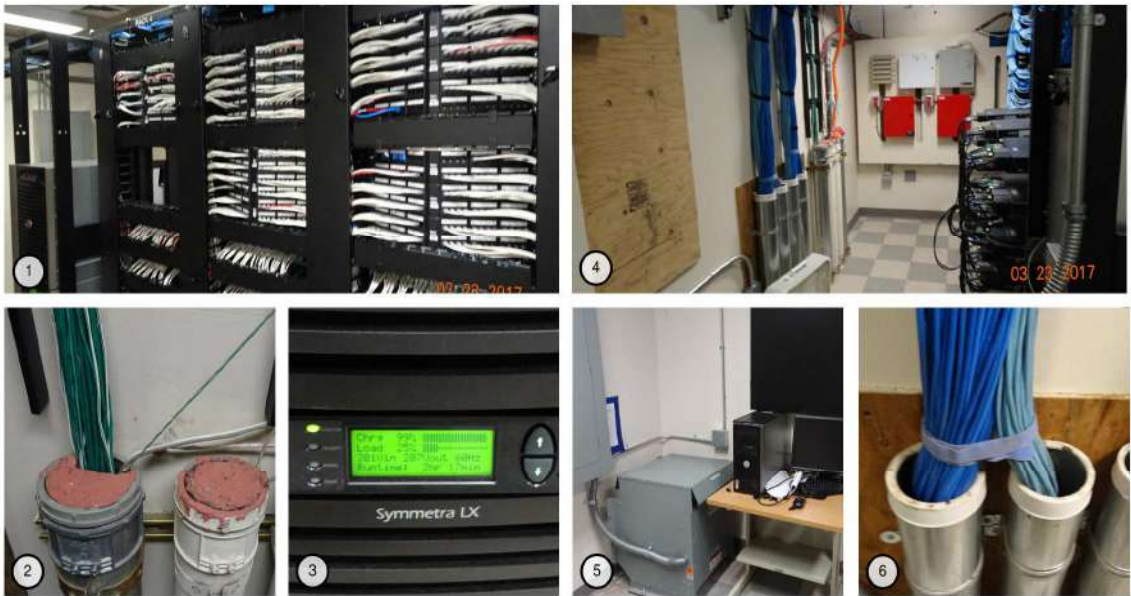
TELECOMMUNICATION ASSESSMENT
ROCK CREEK CAMPUS: BUILDING 2, 2ND FLOOR, IDF 2

- POSITIVES AND NEGATIVES OF THE IMAGES ABOVE...
- 1. Rack management good, excellent room for expansion.
 - 2. Conduit capacity good, Firestop not applied correctly.
 - 3. Load and Charge good on UPS.
 - 4. & 6. Firestop materials not present.
 - 5. Transformer adds heat to room, does not have required clearance – code violation.

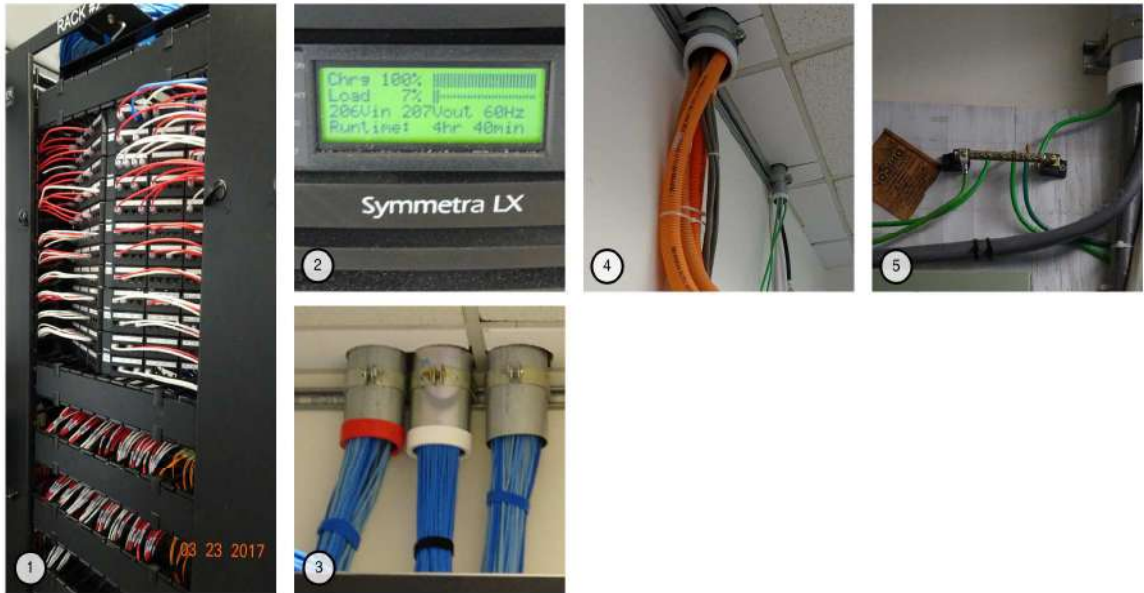
TELECOMMUNICATION ASSESSMENT
ROCK CREEK CAMPUS: BUILDING 3, 1ST FLOOR, BDF

- POSITIVES AND NEGATIVES OF THE IMAGES ABOVE...
- 1. Expansion capacity adequate, good cable management.
 - 2. Load and Charge good on UPS.
 - 3. & 4. Conduits filled beyond recommended capacity – future expansion limited – no Firestop.
 - 5. Grounding Buss Bar not approved type.

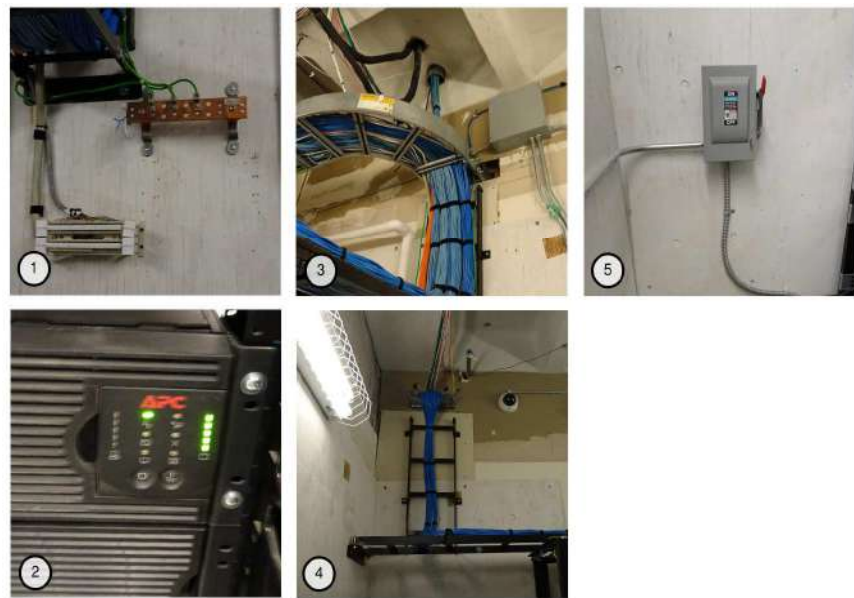
TELECOMMUNICATION ASSESSMENT
ROCK CREEK CAMPUS: BUILDING 3, 1ST FLOOR, IDF1

- POSITIVES AND NEGATIVES OF THE IMAGES ABOVE...
- 1. System ground barely conforms to PCC standard; lacks individual connections to required components.
 - 2. Load and Charge good on UPS.
 - 3. & 4. No Firestop system at cable tray penetration.
 - 5. Power disconnect mounted too low – easy to hit by accident when behind rack.

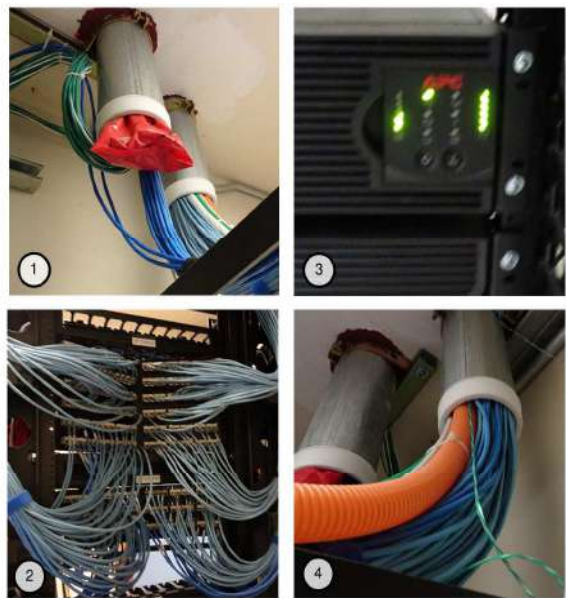
TELECOMMUNICATION ASSESSMENT
ROCK CREEK CAMPUS: BUILDING 3, 1ST FLOOR, IDF2

- POSITIVES AND NEGATIVES OF THE IMAGES ABOVE...
- 1. Incorrect use of Firestop pillows.
 - 2. Expansion capacity adequate, good cable management.
 - 3. Load and Charge good on UPS.
 - 4. Conduits filled beyond recommended capacity – future expansion limited.

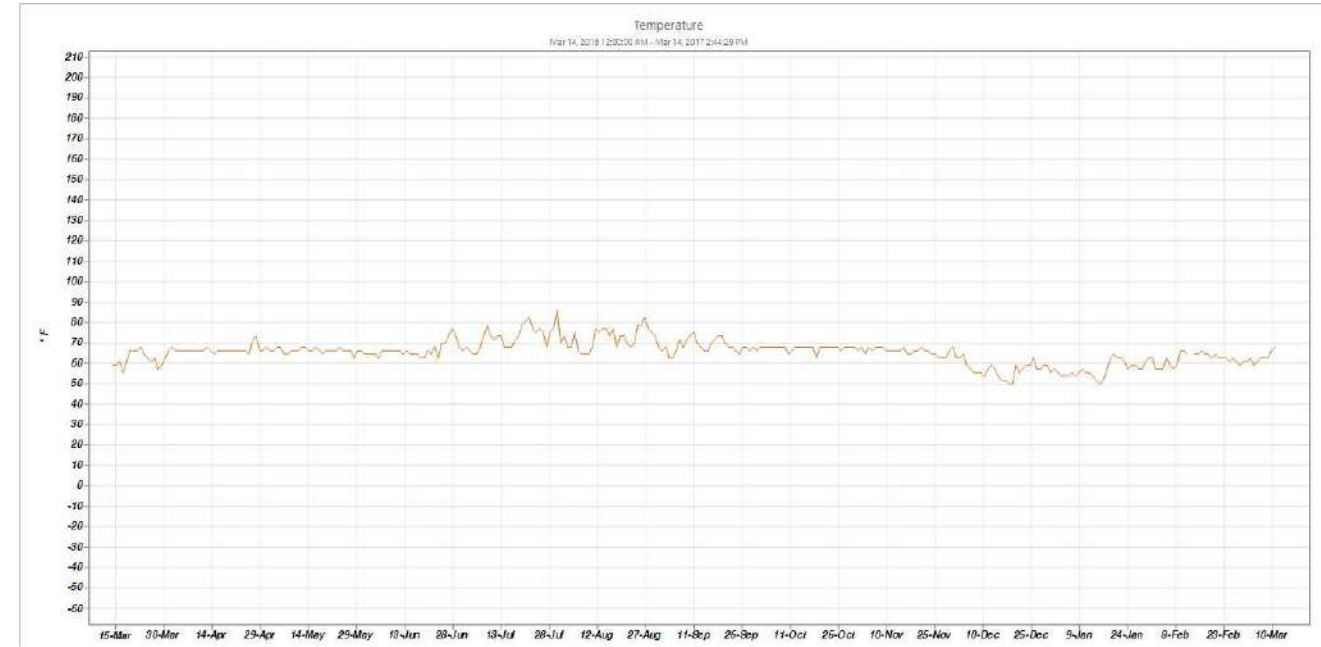
TELECOMMUNICATION TEMPERATURE ASSESSMENT
ROCK CREEK CAMPUS: BUILDING 3, 1ST FLOOR, BDF

Campus	Building	Room	Location	Time	Units	Min Value	Max Value	Average Value	Last known Value	Notes
RC	rcb3bdf-ups (172.18.255.208)	Temp	RC B3 BDF	2:52:18 PM	° F	55.4	86	65.9	60.8	Start of Aug 2016 - (1) High temp event over 86°
