FACILITIES PLAN TECHNICAL REPORTS

PORTLAND COMMUNITY COLLEGE
IT Master Plan
Infrastructure Existing Conditions Report

Date: April 17, 2018

Prepared for:
SRG Partnership

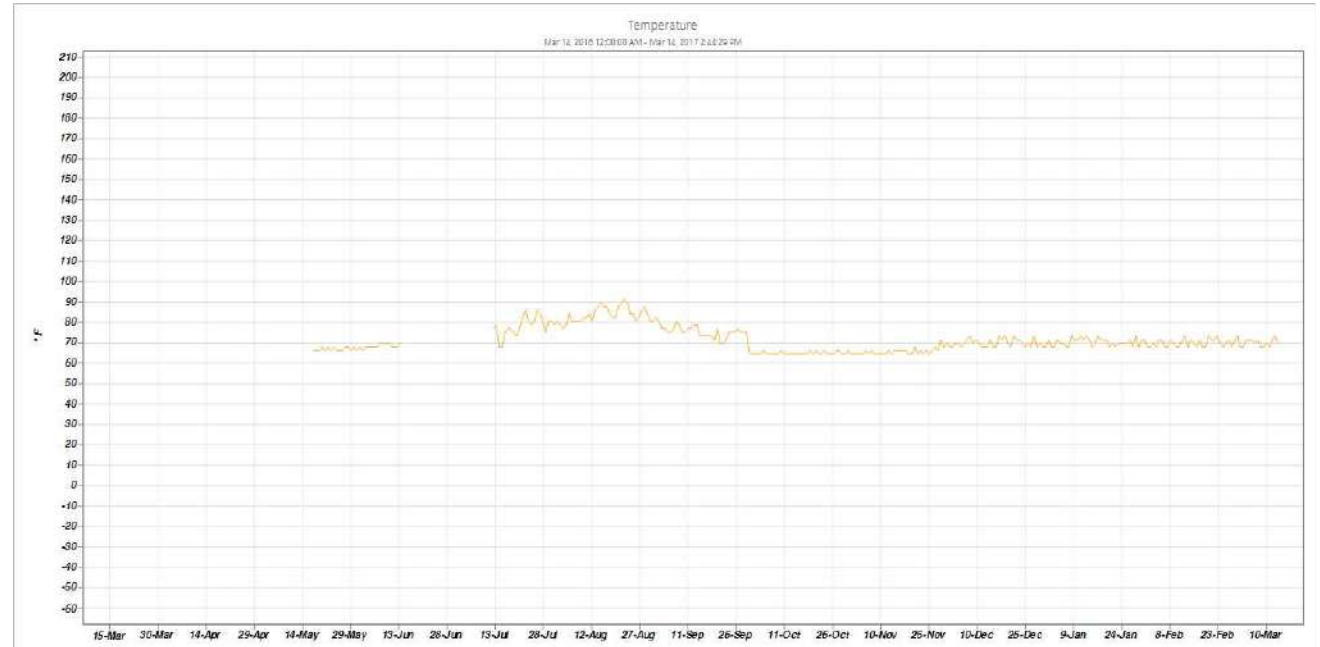
TELECOMMUNICATION ASSESSMENT
ROCK CREEK CAMPUS: BUILDING 3, 1ST FLOOR, IDF 1

Campus	Building	Room	Location	Time	Units	Min Value	Max Value	Average Value	Last known Value	Notes
RC	rcb3idf1-ups (172.18.255.210)	Temp	RC B3 IDF1	2:52:18 PM	° F	62.6	91.4	71.6	68	Mid Jul to Sept 2016 - Several days of high temp events over 86°

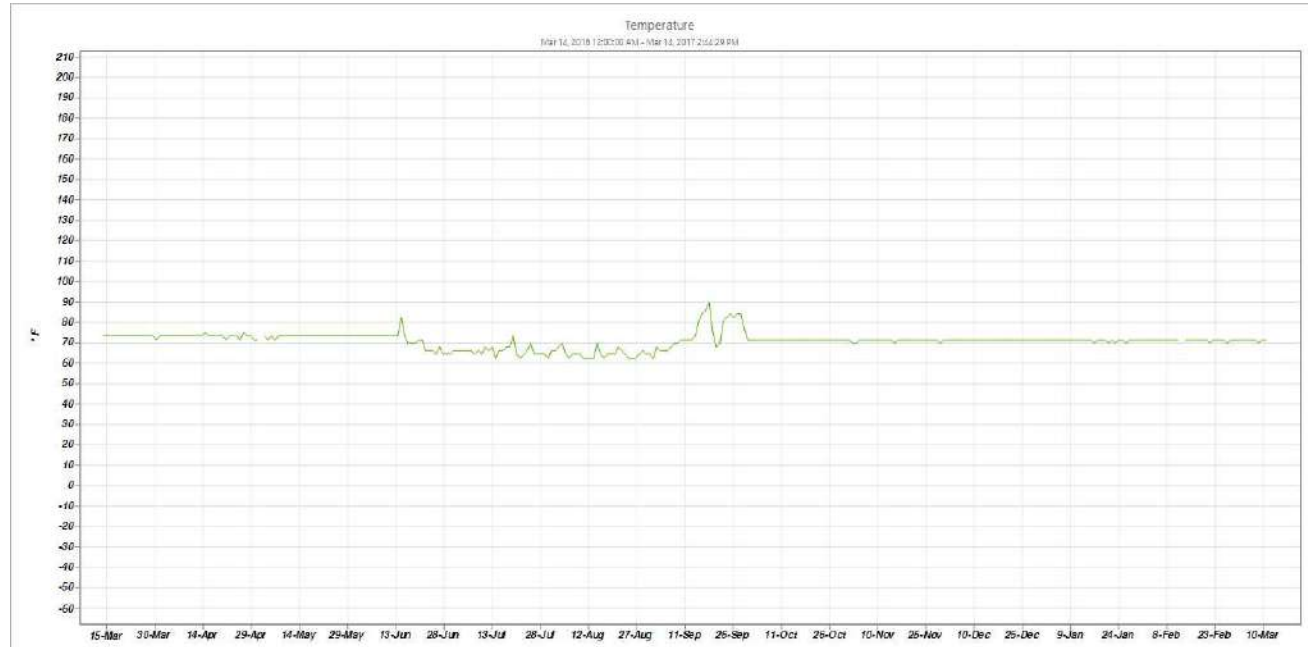
TELECOMMUNICATION ASSESSMENT
ROCK CREEK CAMPUS: BUILDING 3, 1ST FLOOR, IDF 2

Campus	Building	Room	Location	Time	Units	Min Value	Max Value	Average Value	Last known Value	Notes
RC	rcb3idf2-ups (172.18.255.212)	Temp	RC B3 IDF2	2:52:18 PM	° F	60.8	89.6	71.1	71.6	End of Sept 2016 - (1) High temp event over 86°

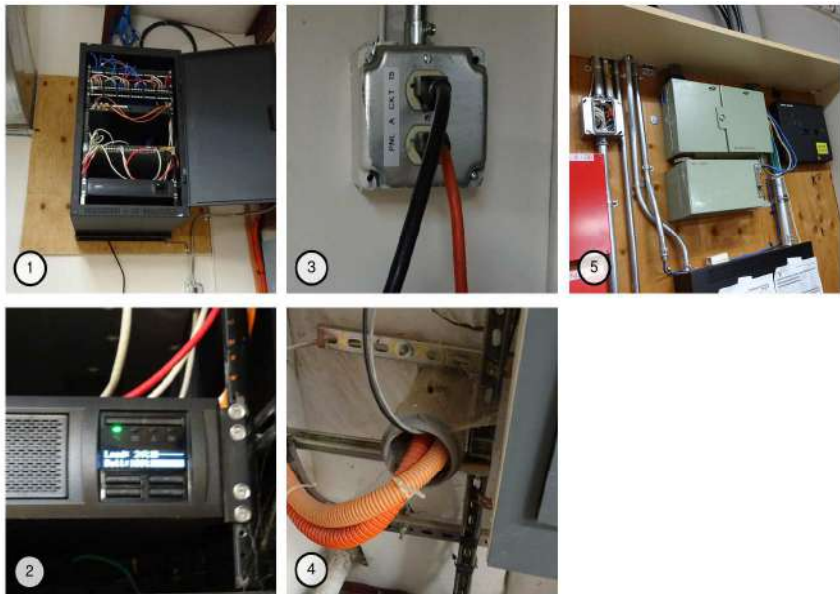
TELECOMMUNICATION ASSESSMENT
ROCK CREEK CAMPUS: BUILDING 4, 1ST FLOOR, BDF

- POSITIVES AND NEGATIVES OF THE IMAGES ABOVE....
- 1. Expansion capacity adequate, fair cable management.
 - 2. Load and Charge good on UPS.
 - 3. Rack grounded to outlet box only – and powered on shared circuit.
 - 4. Firestop materials not present.
 - 5. Open outlet box – needs cover per code.
- Not shown: Bldg lacks generator

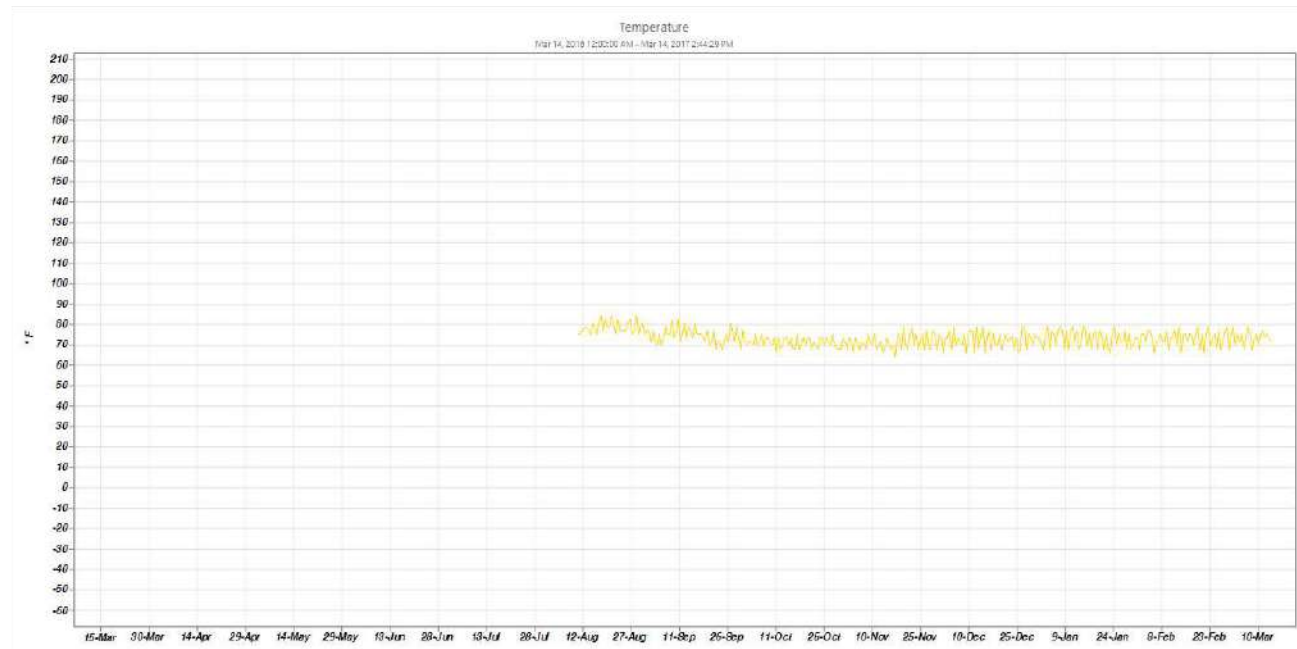
TELECOMMUNICATION ASSESSMENT
ROCK CREEK CAMPUS: BUILDING 4, 1ST FLOOR, BDF

Campus	Building	Room	Location	Time	Units	Min Value	Max Value	Average Value	Last known Value	Notes
RC	rcb4bdf-ups (172.18.255.214)	Temp	RC B4 BDF	2:52:18 PM	* F	62.6	89.6	73.3	68	End of Aug 2016 - (2) High temp events over 86°

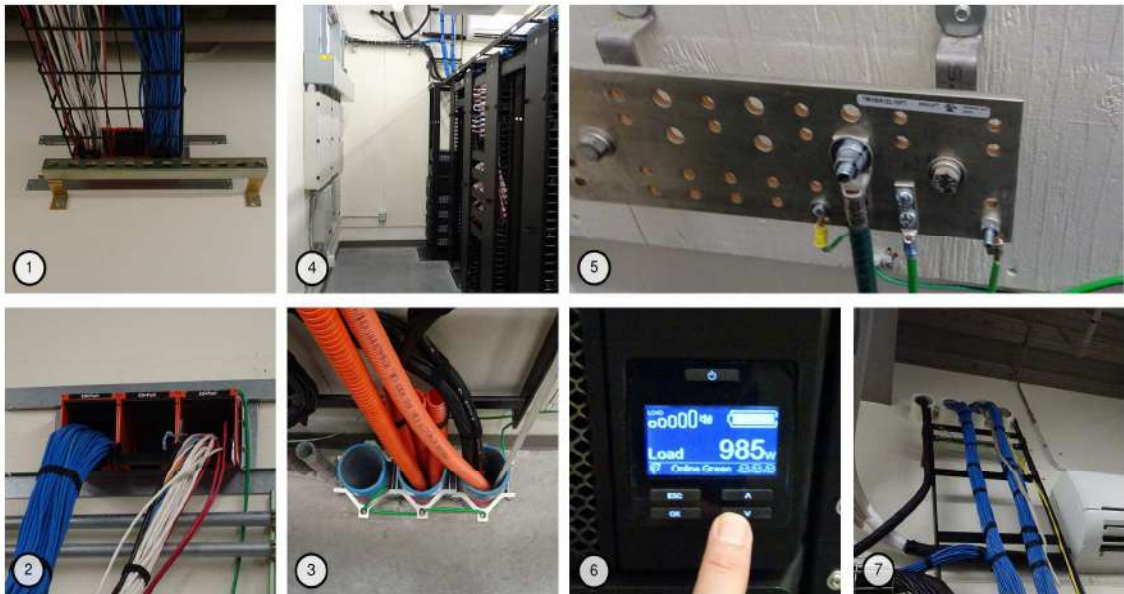
TELECOMMUNICATION ASSESSMENT
ROCK CREEK CAMPUS: BUILDING 5, 1ST FLOOR, BDF

- POSITIVES AND NEGATIVES OF THE IMAGES ABOVE...
- 1. & 2. Firestop systems properly used in conformance with PCC Standards.
 - 3. & 7. Conduit capacity good, but required Firestop / sealant is not present.
 - 4. Rack management good, excellent room for expansion.
 - 5. Grounding is fair, but conductor size and lug clamps are incorrect type / size.
 - 6. Load and Charge good on UPS.

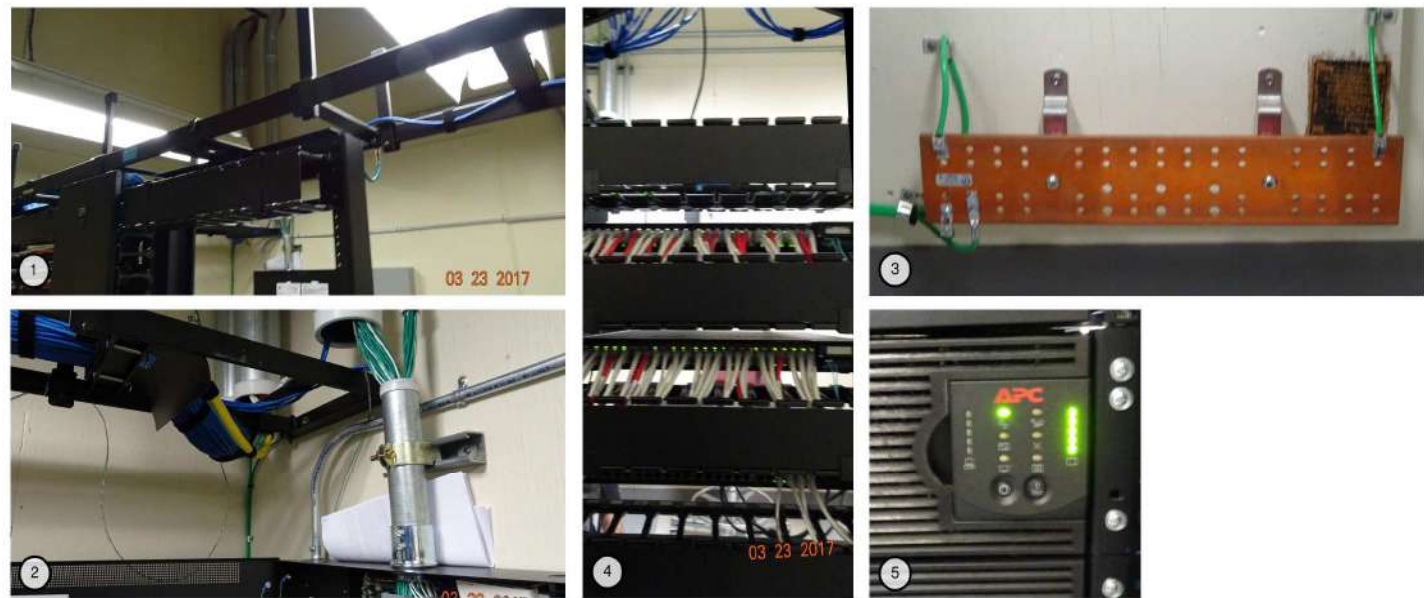
TELECOMMUNICATION ASSESSMENT
ROCK CREEK CAMPUS: BUILDING 6, 1ST FLOOR, BDF

- POSITIVES AND NEGATIVES OF THE IMAGES ABOVE...
1. Overhead cable tray capacity excellent – suitable for expansion.
 2. Conduit capacity good, but required Firestop / sealant is not present.
 3. System ground conforms to PCC standard but connections are not using industry standard lug types.
 4. Cable management good.
 5. Load and Charge good on UPS.

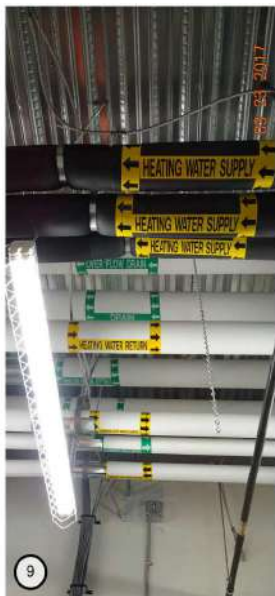
TELECOMMUNICATION ASSESSMENT
ROCK CREEK CAMPUS: BUILDING 7, 1ST FLOOR, IDF 3

- POSITIVES AND NEGATIVES OF THE IMAGES ABOVE...
- 9. Water pipes directly over equipment racks with no pan. Extreme water hazard.

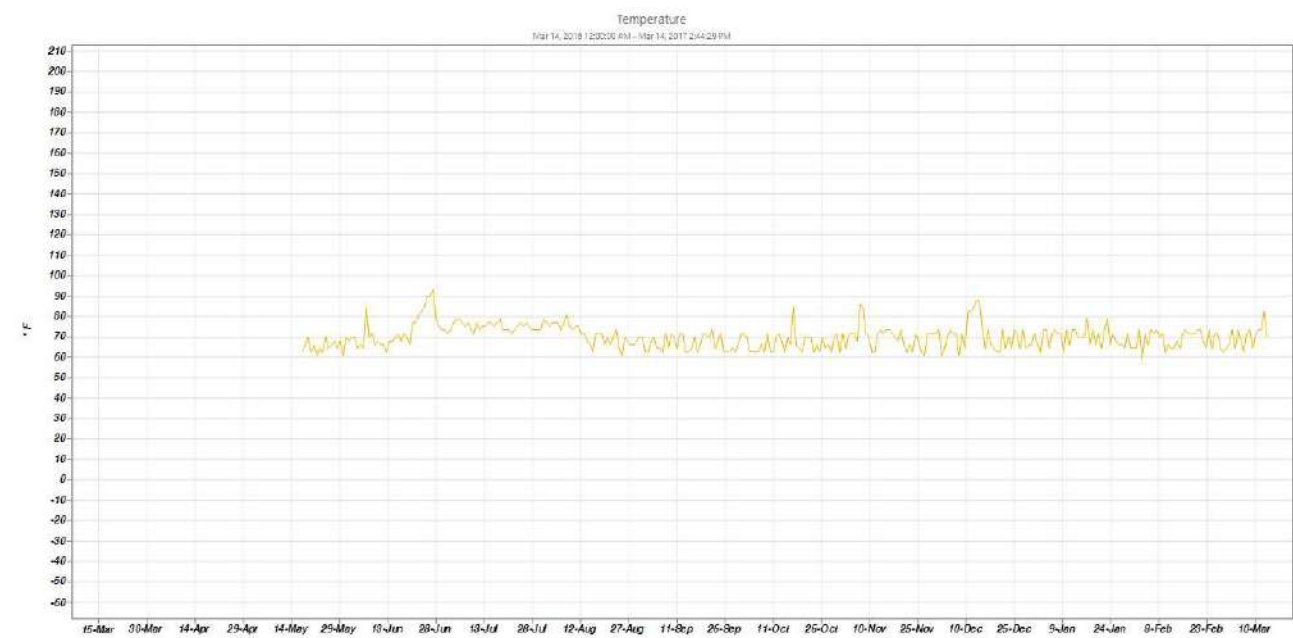
TELECOMMUNICATION TEMPERATURE ASSESSMENT
ROCK CREEK CAMPUS: BUILDING 7, 1ST FLOOR, BDF

Campus	Building	Room	Location	Time	Units	Min Value	Max Value	Avg Value	Last known Value	Notes
RC	rcb7bdf-ups (172.18.255.222)	Temp	RC B7 BDF	2:52:18 PM	° F	57.2	93.2	70.3	73.4	June, Nov, and Dec 2016 - (4) High temp events over 86°

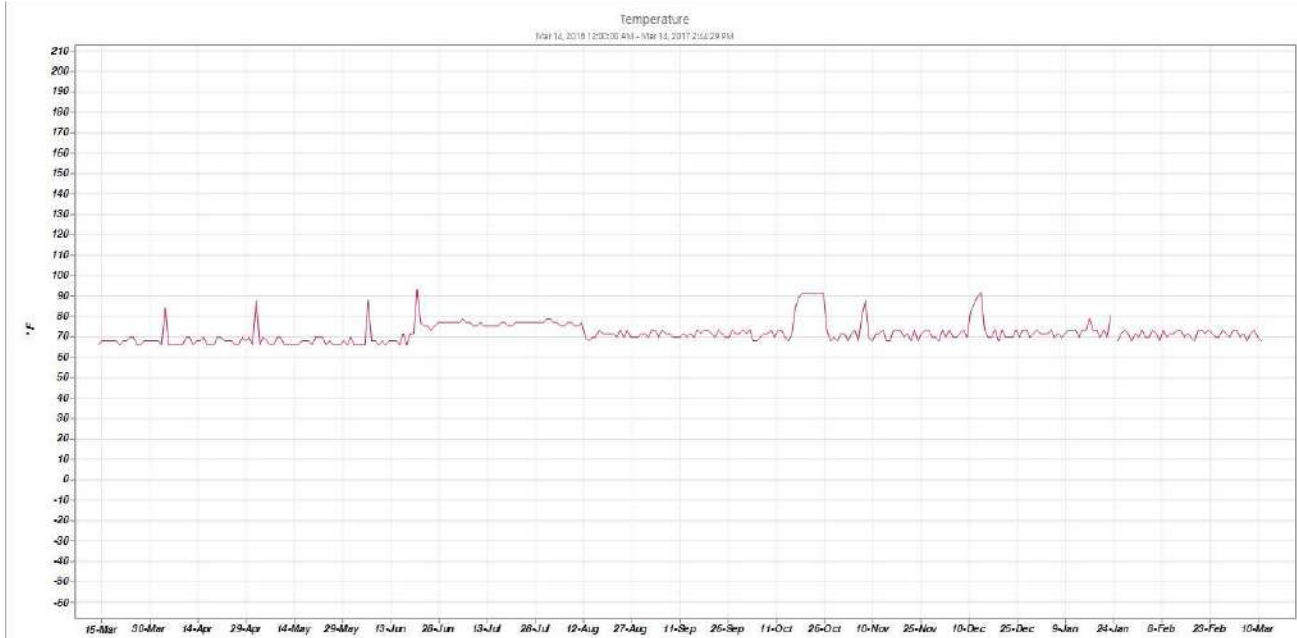
TELECOMMUNICATION TEMPERATURE ASSESSMENT
ROCK CREEK CAMPUS: BUILDING 7, 1ST FLOOR, IDF 3

Campus	Building	Room	Location	Time	Units	Min Value	Max Value	Avg Value	Last known Value	Notes
RC	rcb7idf3-ups (172.18.255.227)	Temp	RC B7 IDF3	2:52:18 PM	° F	66.2	93.2	72.2	73.4	All of 2016 - (6) High temp events over 86°

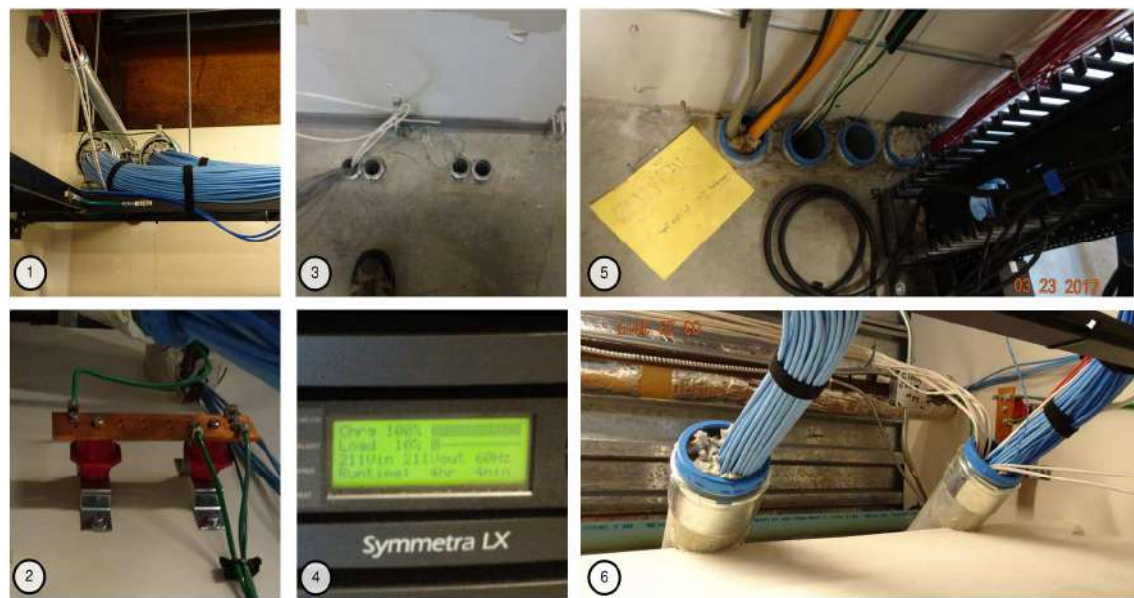
TELECOMMUNICATION ASSESSMENT
ROCK CREEK CAMPUS: BUILDING 7, 2ND FLOOR, IDF 1

- POSITIVES AND NEGATIVES OF THE IMAGES ABOVE...
- 1. Conduits filled beyond recommended capacity – future expansion limited.
 - 2. System ground barely conforms to PCC standard; lacks individual connections to required components.
 - 3. & 5. & 6. Firestop materials not present.
 - 4. Load and Charge good on UPS.

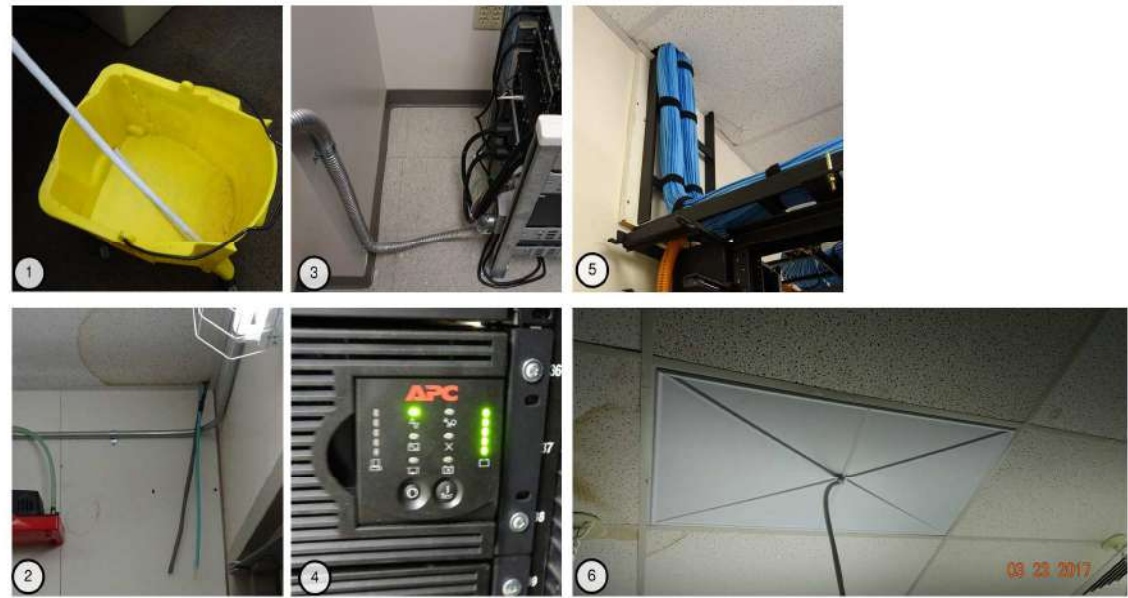
TELECOMMUNICATION ASSESSMENT
ROCK CREEK CAMPUS: BUILDING 7, 2ND FLOOR, IDF 2

- POSITIVES AND NEGATIVES OF THE IMAGES ABOVE...
- 1. & 6. Water collection system for roof leak adjacent to IDF.
 - 2. Evidence of water leak inside IDF.
 - 3. Electrical feed to rack not to code.
 - 4. Load and Charge good on UPS.
 - 5. Firestop materials not present.

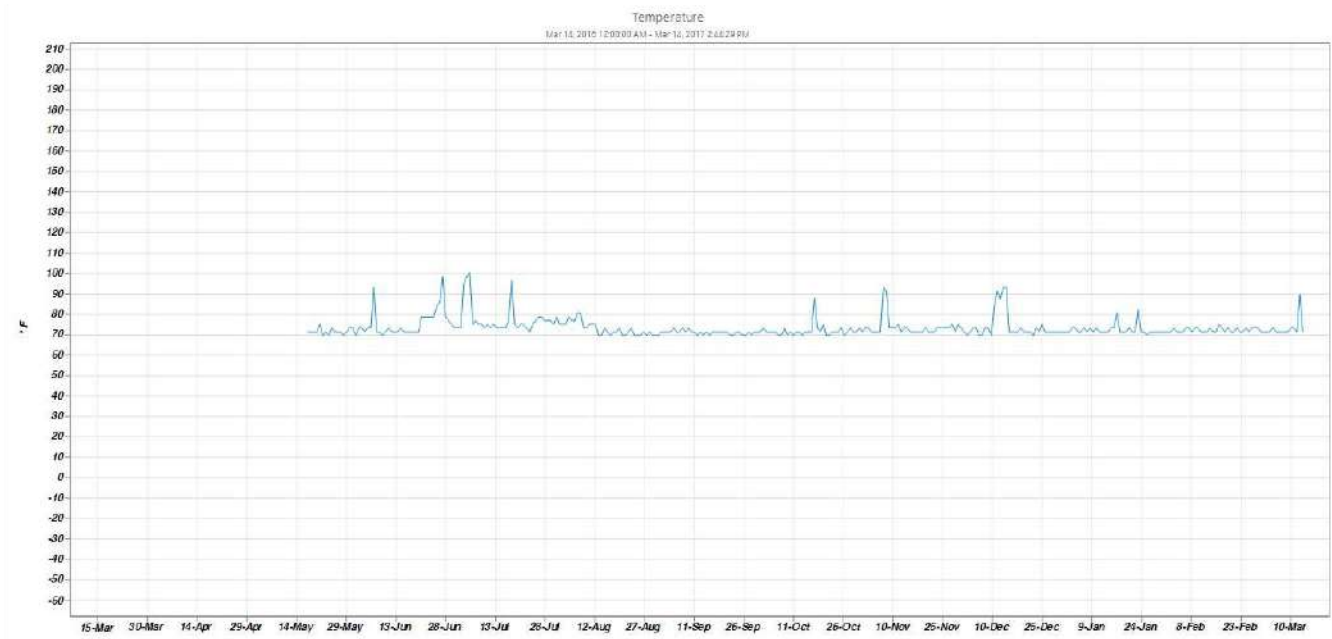
TELECOMMUNICATION TEMPERATURE ASSESSMENT
ROCK CREEK CAMPUS: BUILDING 7, 1ST FLOOR, IDF 1

Campus	Building	Room	Location	Time	Units	Min Value	Max Value	Average Value	Last known Val	Notes
RC	rcb7idf1-ups (172.18.255.224)	Temp	RC B7 IDF1	2:52:18 PM	° F	68	104	73.6	71.6	All of 2016 - (7) High temp events over 86°

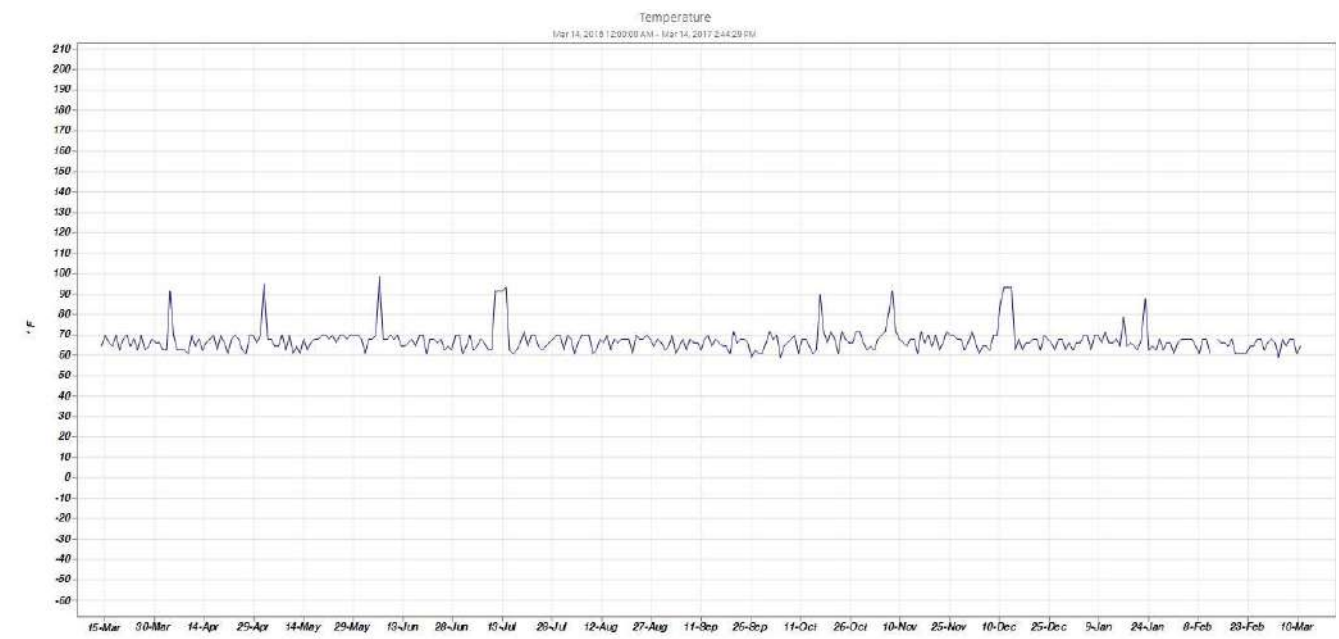
TELECOMMUNICATION TEMPERATURE ASSESSMENT
ROCK CREEK CAMPUS: BUILDING 7, 1ST FLOOR, IDF 2

Campus	Building	Room	Location	Time	Units	Min Value	Max Value	Average Value	Last known Val	Notes
RC	rcb7idf2-ups (172.18.255.226)	Temp	RC B7 IDF2	2:52:18 PM	° F	57.2	102	68	69.8	All of 2016 - (8) High temp events over 86°

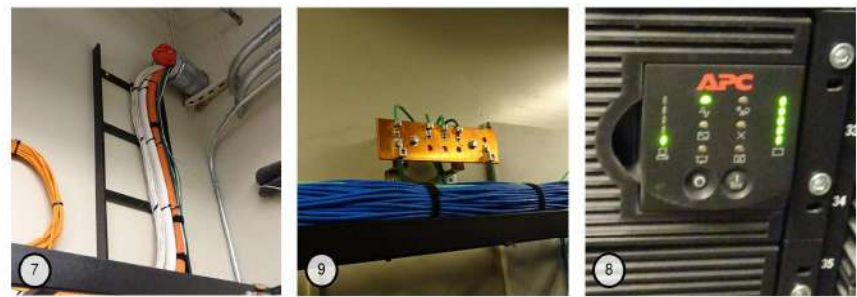
TELECOMMUNICATION ASSESSMENT
ROCK CREEK CAMPUS: BUILDING 9, 1ST FLOOR, IDF 1

7. Conduits filled beyond recommended capacity; Incorrect use of Firestop pillows.

9. System ground conforms to PCC standard.

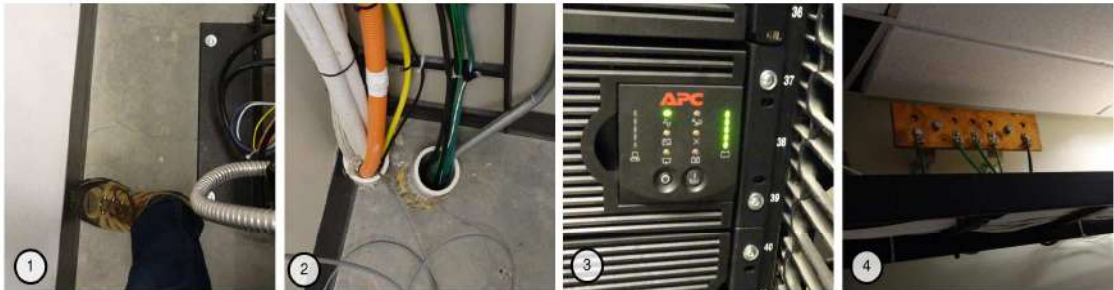
TELECOMMUNICATION ASSESSMENT
ROCK CREEK CAMPUS: BUILDING 9, 2ND FLOOR, IDF 2

- POSITIVES AND NEGATIVES OF THE IMAGES ABOVE...
- 1. less than 1ft clearance behind rack – not to PCC Standards.
 - 2. HVAC lines sharing conduit with fiber, voice, and data lines – code violation. Firestop not present.
 - 3. Load and Charge good on UPS.
 - 4. System ground conforms to PCC standard.

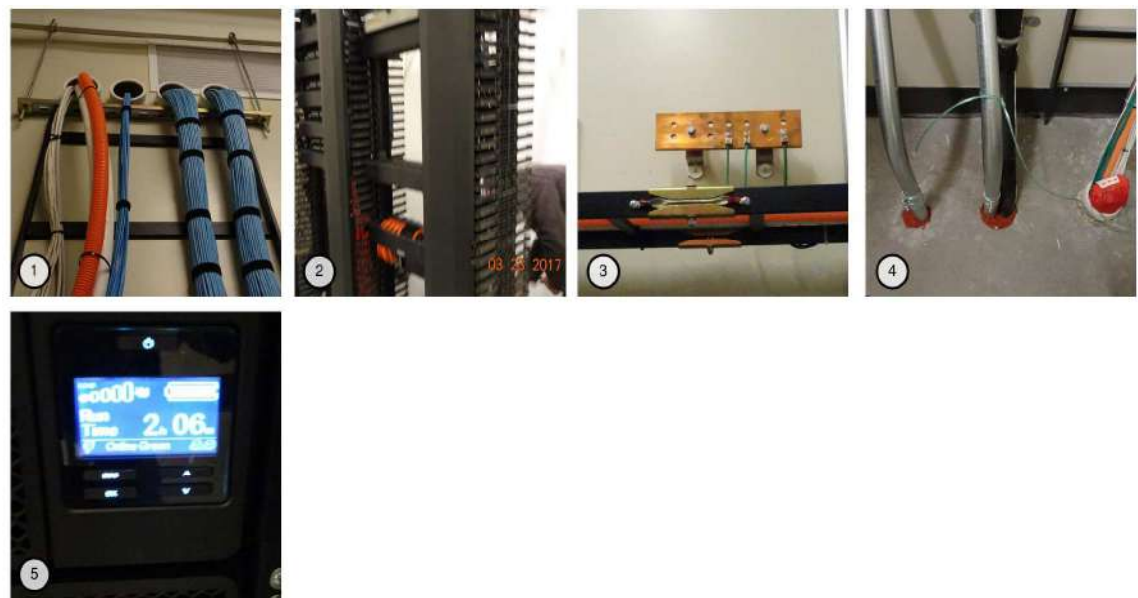
TELECOMMUNICATION ASSESSMENT
ROCK CREEK CAMPUS: BUILDING 9, 2ND FLOOR, IDF 3

- POSITIVES AND NEGATIVES OF THE IMAGES ABOVE...
- 1. Conduit capacity good, but required firestop / sealant is not present.
 - 2. Rack management good, excellent room for expansion.
 - 3. System ground barely conforms to PCC standard; lacks individual connections to required components.
 - 4. Incorrect use of Firestop pillows.
 - 5. Load and Charge good on UPS.

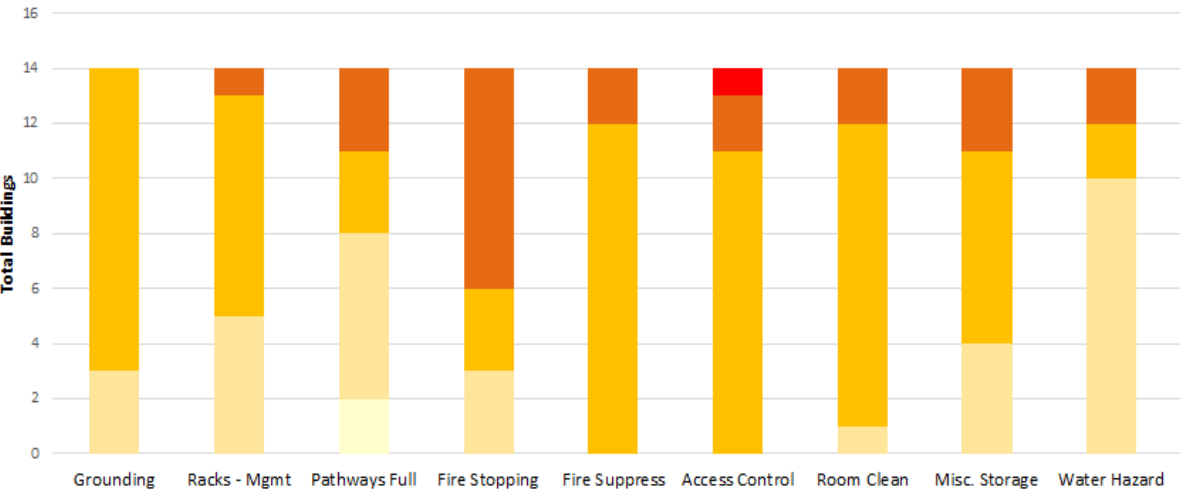
TELECOMMUNICATION ASSESSMENT
SOUTHEAST CAMPUS: BREAKDOWN

•50% of the buildings on this campus do not employ effective firestop methods entering or exiting the communications spaces. Recommend proper installation of approved firestop materials.

•20% of the conduits and cable trays entering the communications spaces, are filled beyond recommended capacity. This allows no expansion and potentially damages cable in the tray due to excess weight. Recommend removing abandoned cabling, or adding parallel pathways for future expansion. The critical entrance conduits can be further evaluated during a campus wide Outside Plant pathway identification and inventory project.

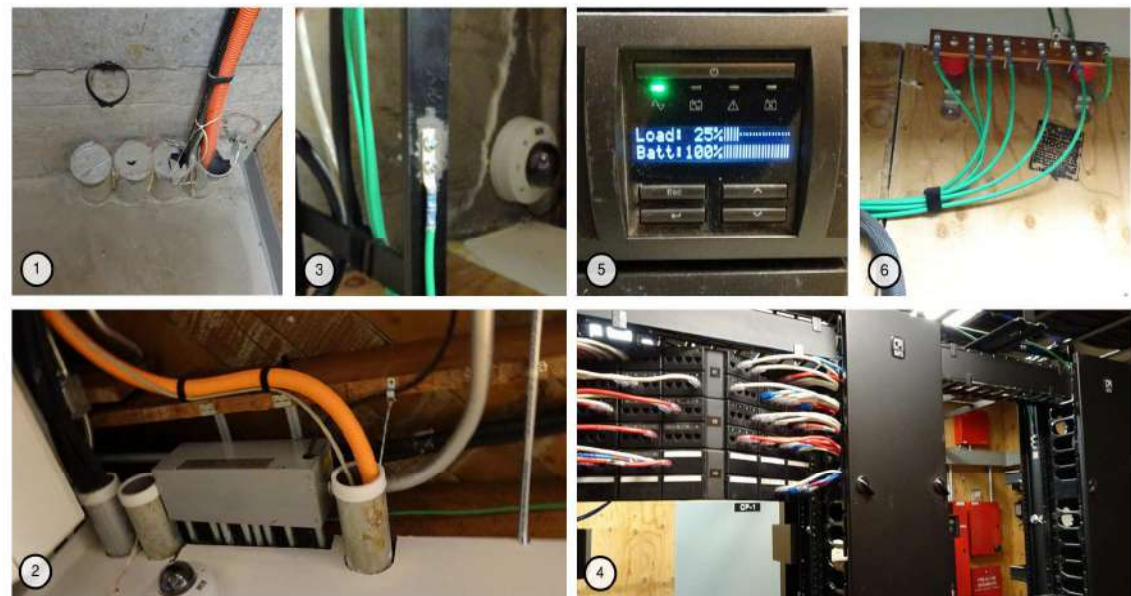
TELECOMMUNICATION ASSESSMENT
SOUTHEAST CAMPUS: ADMINISTRATION BUILDING, 1ST FLOOR, BDF

- POSITIVES AND NEGATIVES OF THE IMAGES ABOVE...
- 1. Conduit capacity good, but required Firestop / Sealant is not present.
 - 2. Fire stop materials not present.
 - 3. & 6 System ground conforms to PCC standard.
 - 4. Rack management good, excellent room for expansion.
 - 5. UPS load good, but unit is over 10 years old.

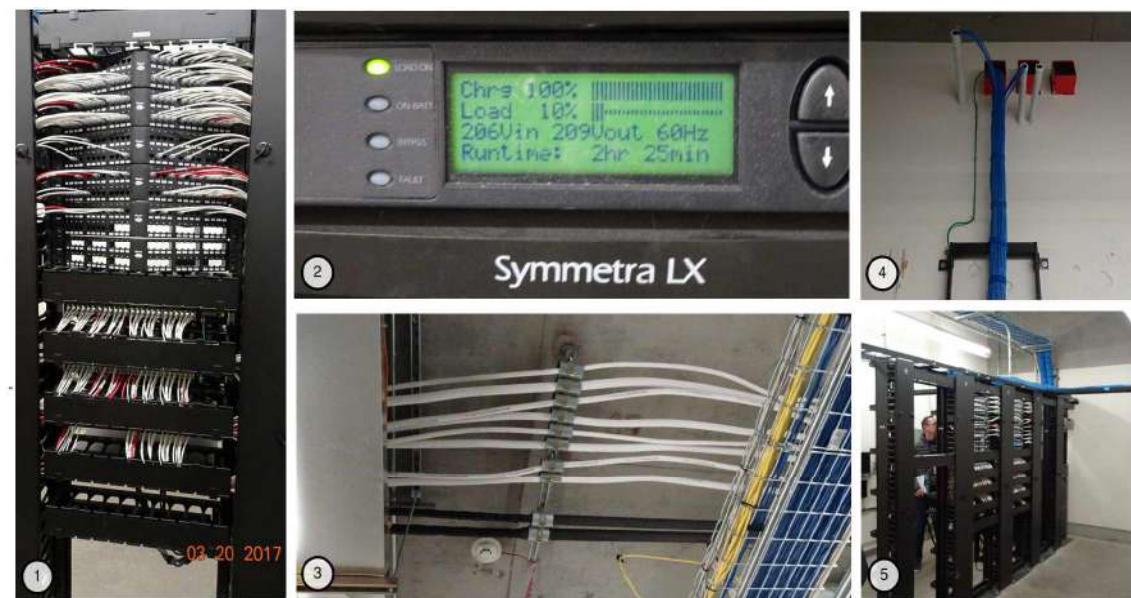
TELECOMMUNICATION ASSESSMENT
SOUTHEAST CAMPUS: LEARNING CENTER, 1ST FLOOR, BDF

- POSITIVES AND NEGATIVES OF THE IMAGES ABOVE...
- 1. &5. Rack management good, excellent room for expansion.
 - 2. UPS load good, unit is less than 4 years old.
 - 3. Multiple water lines above rack systems – potential water hazard.
 - 4. Fire stop systems in place – conforms to PCC standards.

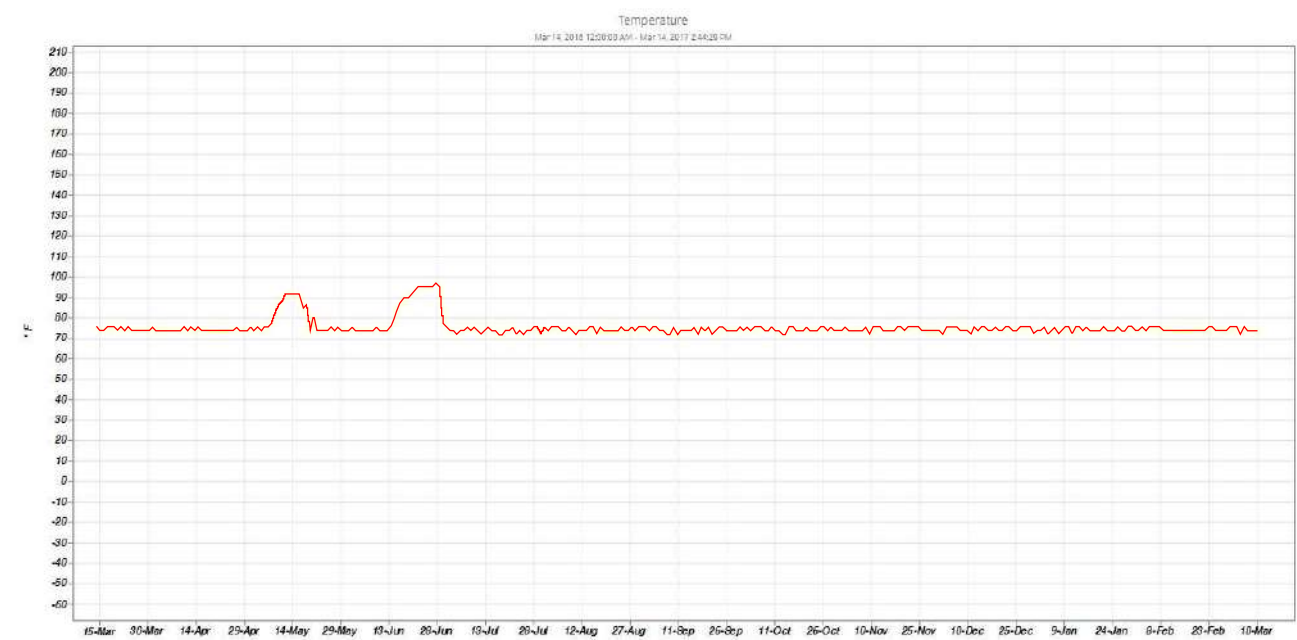
TELECOMMUNICATION TEMPERATURE ASSESSMENT
SOUTHEAST CAMPUS: LEARNING CENTER. BDF

Campus	Building	Room	Location	Time	Units	Min Value	Max Value	Average Value	Last known Value	Notes
SE	selcbdf-ups (172.19.255.249)	Temp	SE LC BDF	2:52:18 PM	° F	71.6	96.8	74.9	73.4	Mid May to end of June 2016 - Several high temp events over 86°

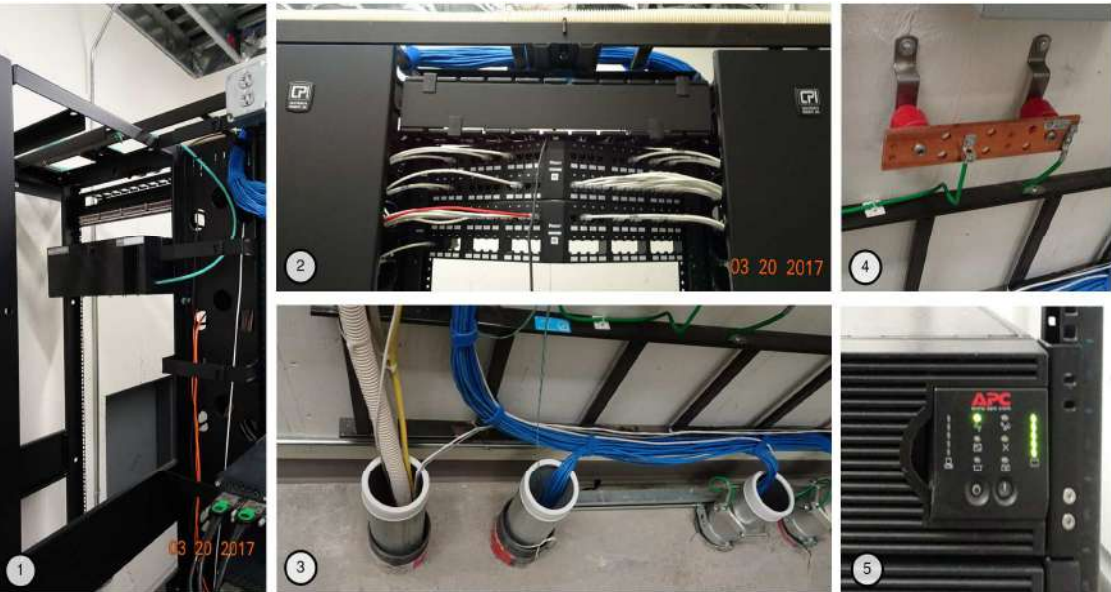
TELECOMMUNICATION ASSESSMENT
SOUTHEAST CAMPUS: LEARNING CENTER, 3RD FLOOR, IDF1

- POSITIVES AND NEGATIVES OF THE IMAGES ABOVE...
- 1. &2. Rack management good, excellent room for expansion.
 - 3. Conduit capacity good, but required Firestop / Sealant is not present.
 - 4. System ground barely conforms to PCC standard; lacks individual connections to required components.
 - 5. UPS load good, unit is 8 years old.

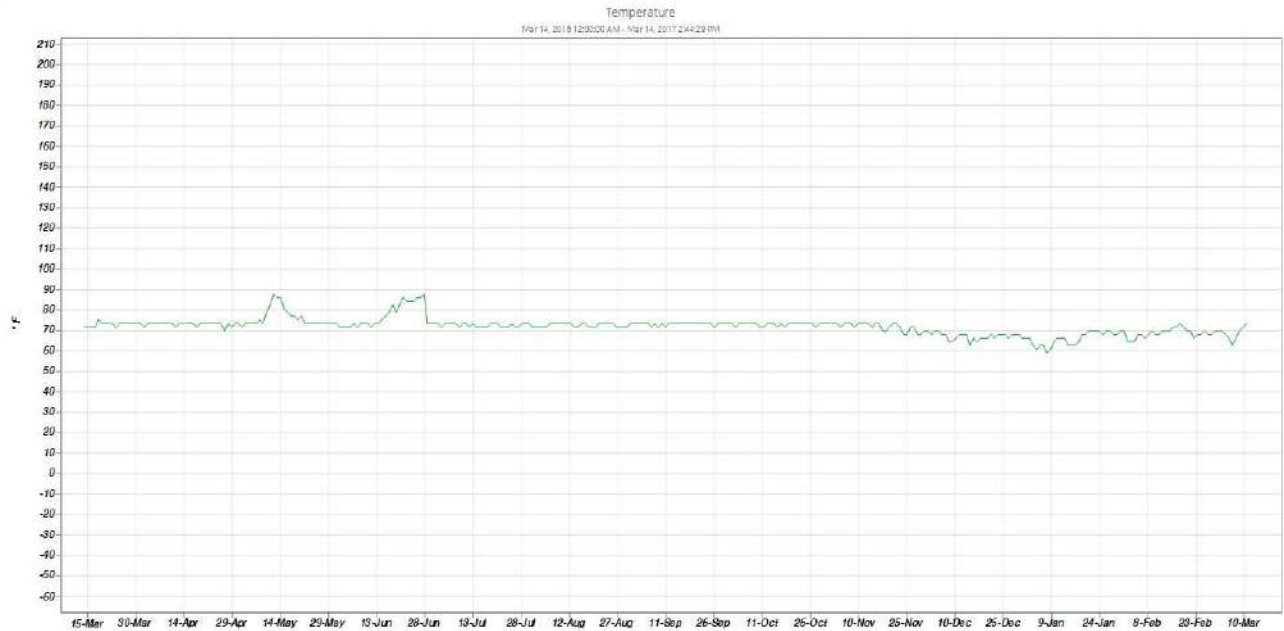
TELECOMMUNICATION TEMPERATURE ASSESSMENT
SOUTHEAST CAMPUS: LEARNING CENTER, IDF 1

Campus	Building	Room	Location	Time	Units	Min Value	Max Value	Average Value	Last known Value	Notes
SY	selcidf1-ups (172.19.255.248)	Temp	SE LC IDF1	2:52:18 PM	° F	68	91.4	72.6	69.8	Mid May to end of June 2016 - Several high temp events over 86°

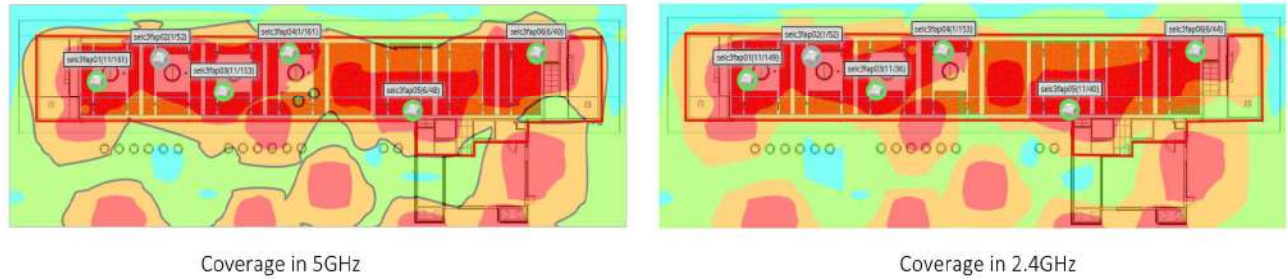
TELECOMMUNICATION ASSESSMENT
SOUTHEAST CAMPUS: LEARNING CENTER, 3RD FLOOR

Campus	Building	Floor	Location	Coverage in 2.4GHz	Coverage in 5GHz	WAP Service Life	Comments
SE	Learning Commons	3rd	SELC - 3	1	1	3	AP-134's here, rest of building has 224's

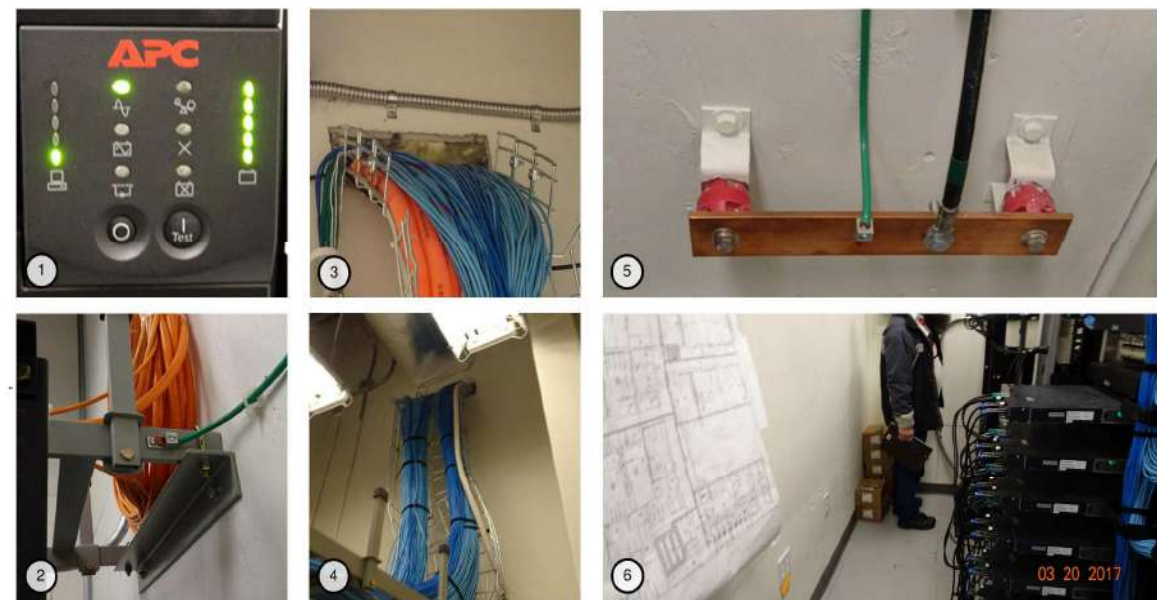
TELECOMMUNICATION ASSESSMENT
SOUTHEAST CAMPUS: MT. TABOR HALL, 1ST FLOOR, IDF1

- POSITIVES AND NEGATIVES OF THE IMAGES ABOVE...
- 1. UPS load good, unit is approaching 3 years old.
 - 2. & 5 System ground barely conforms to PCC standard; lacks individual connections to required components.
 - 3. & 4 Pathway at wall penetrations not utilizing industry approved methods, fire stop not present.
 - 6. Boxes and storage on floor.

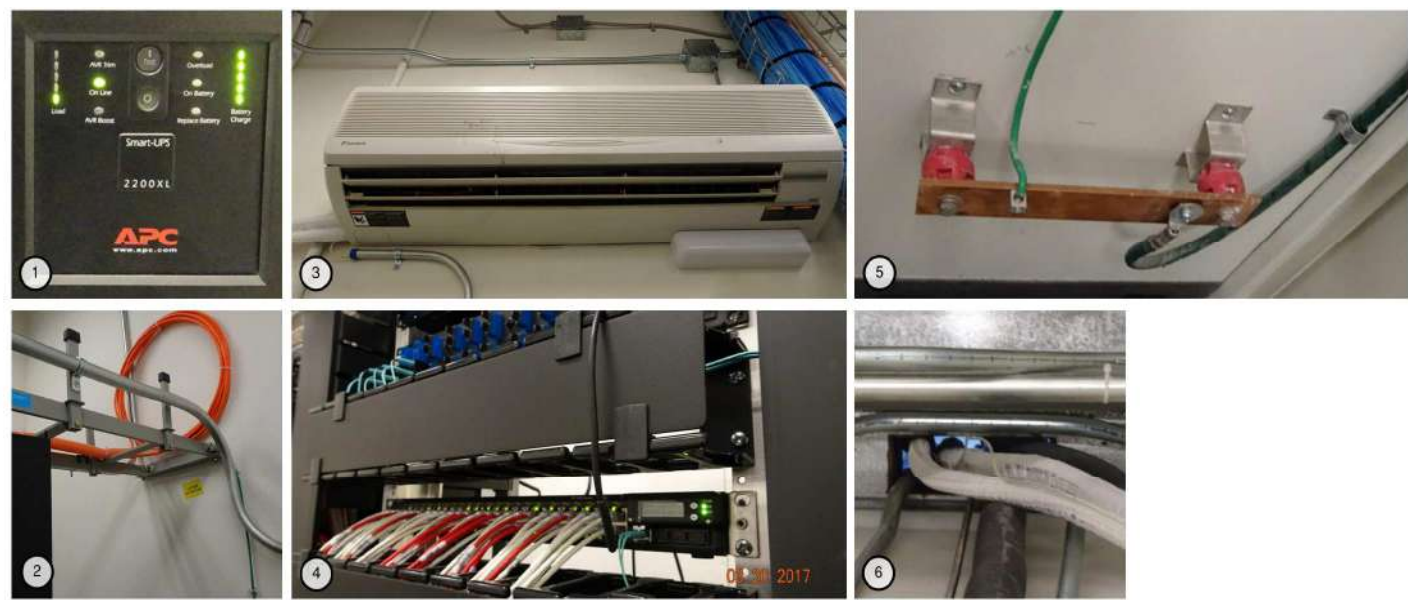
TELECOMMUNICATION ASSESSMENT
SOUTHEAST CAMPUS: MT. TABOR HALL, 1ST FLOOR, IDF2

- POSITIVES AND NEGATIVES OF THE IMAGES ABOVE...
- 1. UPS load good, unit is over 7 years old.
 - 2. Good example of service loop for Fiber Optic cable.
 - 3. Typical split system wall mounted unit.
 - 4. Rack management good, good room for expansion.
 - 5. System ground barely conforms to PCC standard; lacks individual connections to required components.
 - 6. Penetration to floor above shared with other services – fire stop not present.

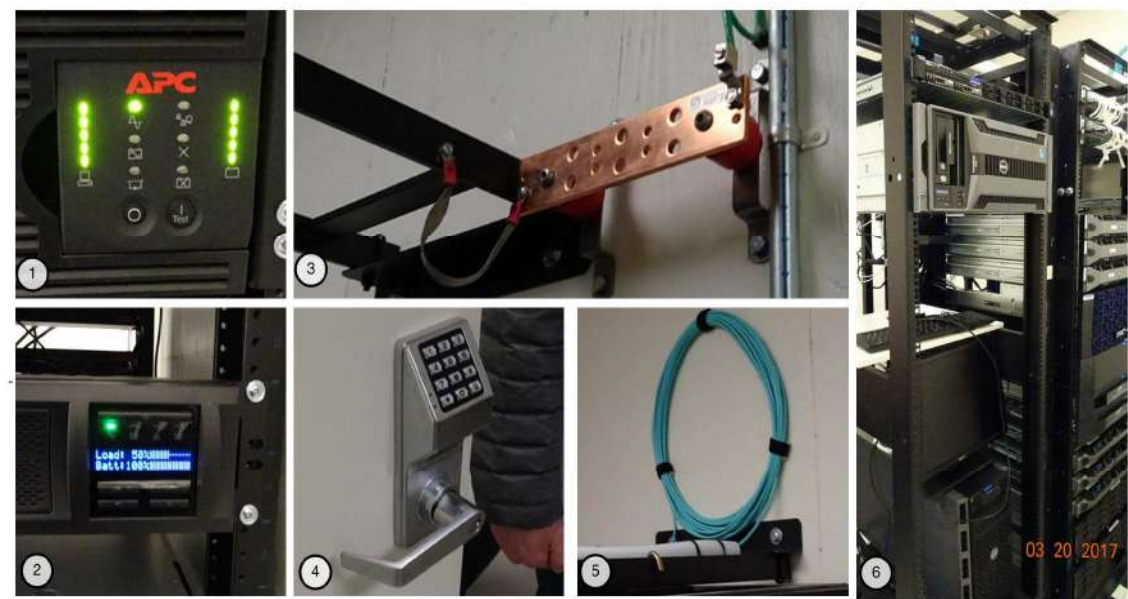
TELECOMMUNICATION ASSESSMENT
SOUTHEAST CAMPUS: MT. TABOR HALL, 1ST FLOOR, SERVER RM 114

- POSITIVES AND NEGATIVES OF THE IMAGES ABOVE...
- 1. UPS load higher than recommended – allows no headroom. Unit is approaching 3 years old.
 - 3. System ground barely conforms to PCC standard; lacks individual connections to required components.
 - 4. Entry access secure, but not PCC standard system.
 - 5. Good example of service loop for Fiber Optic cable.
 - 6. Good rack management, good room for expansion.

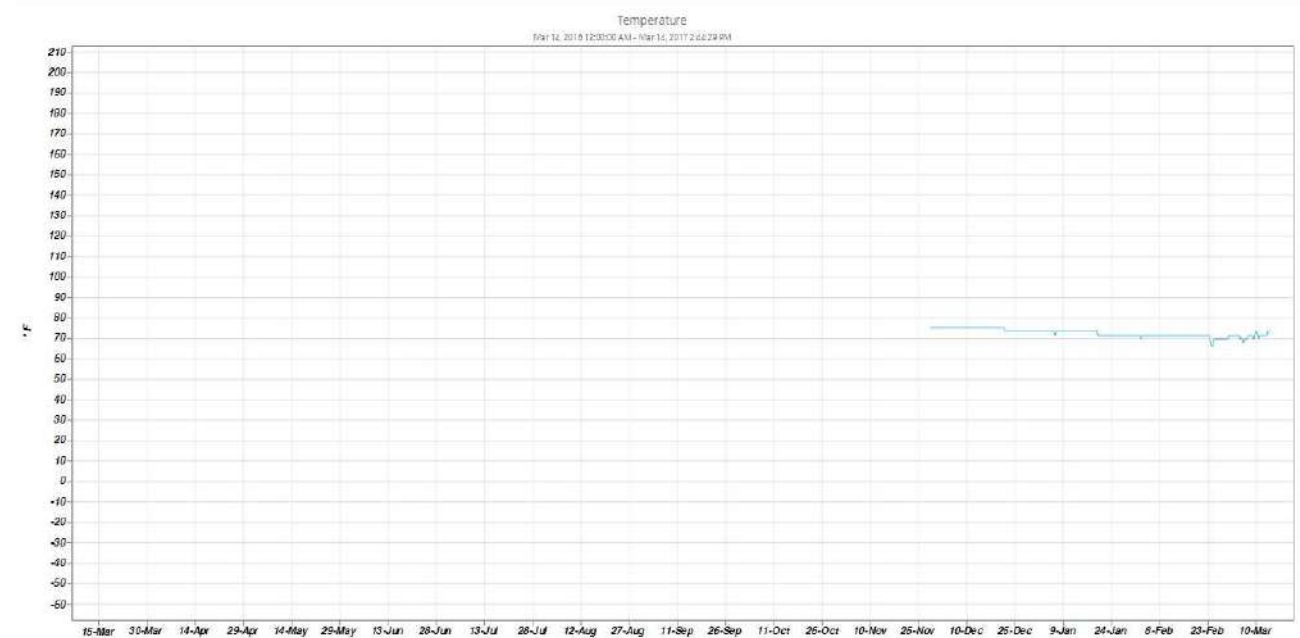
TELECOMMUNICATION TEMPERATURE ASSESSMENT
SOUTHEAST CAMPUS: MT. TABOR HALL, RM 114

Campus	Building	Room	Location	Time	Unit	Min Value	Max Value	Average Value	Least known Val	Notes
SY	semt114.srvr-ups (172.19.255.207)	Temp	SE MT 114	2:52:18 PM	° F	71.6	98.6	76.4	80.6	Max of 98° shown in table, graph missing data before Dec 2016

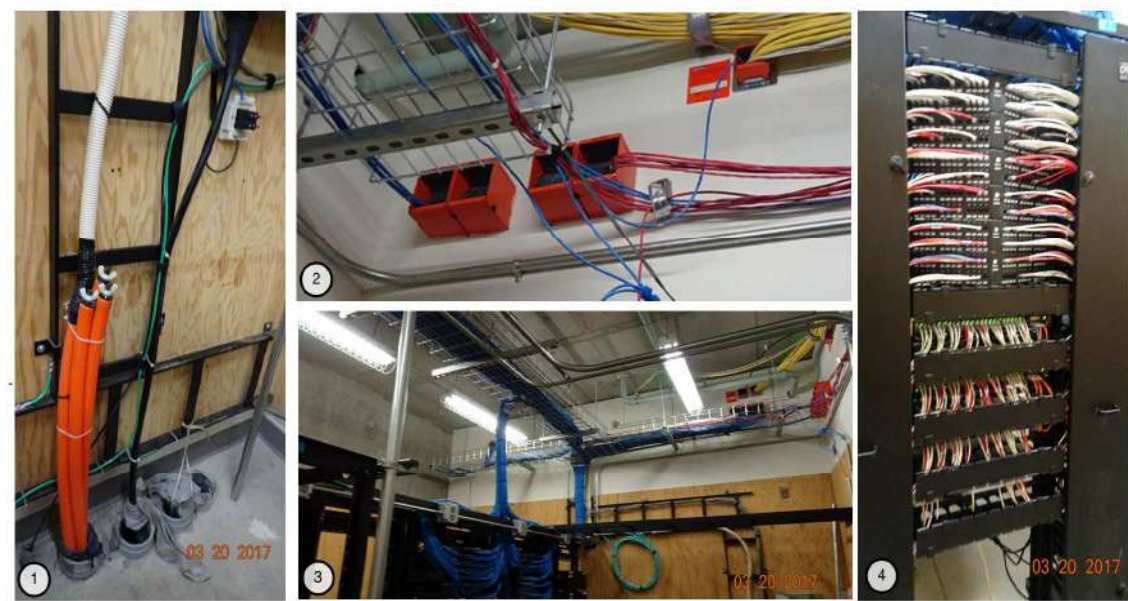
TELECOMMUNICATION ASSESSMENT
SOUTHEAST CAMPUS: STUDENT CENTER, 1ST FLOOR, BDF

- POSITIVES AND NEGATIVES OF THE IMAGES ABOVE...
1. Conduit capacity good, but required firestop / sealant is not present.
 2. Fire stop systems in place – conforms to PCC standards.
 3. Cable tray at good capacity with appropriate room left for expansion.
 4. Rack management good, fair room for expansion.

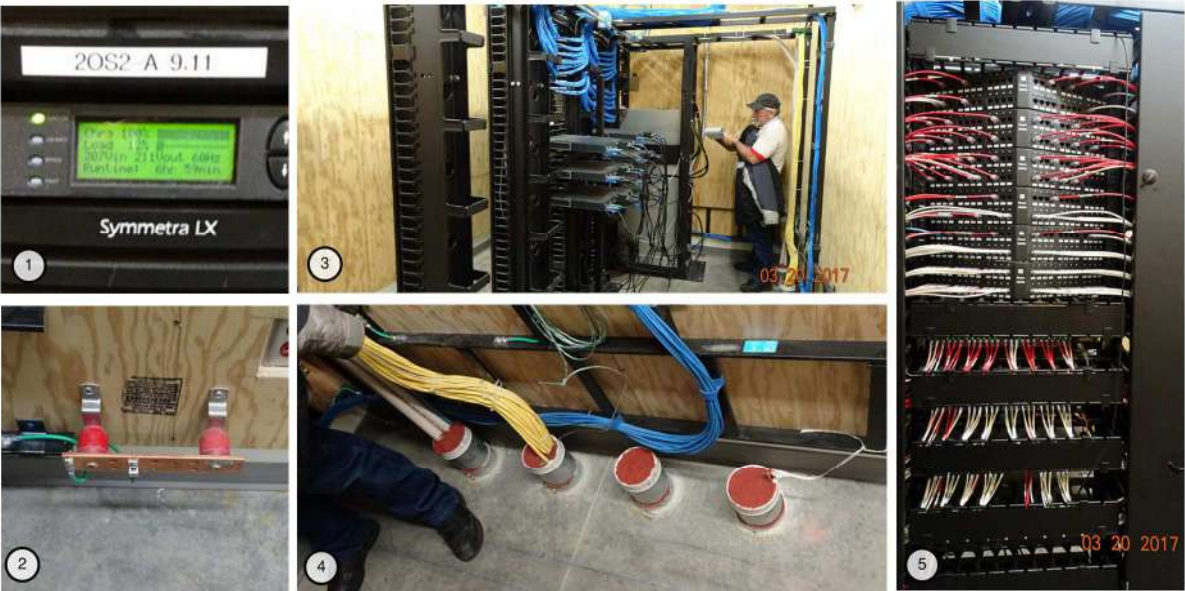
TELECOMMUNICATION ASSESSMENT
SOUTHEAST CAMPUS: STUDENT CENTER, 2ND FLOOR, IDF1

- POSITIVES AND NEGATIVES OF THE IMAGES ABOVE...
- 1. UPS load good, unit is close to four years old.
 - 2. System ground barely conforms to PCC standard; lacks individual connections to required components.
 - 3. & 5. Rack management very good, sufficient room for expansion.
 - 4. Conduit capacities excellent with lots of room for expansion. Fire stop method to PCC standard.
