FACILITIES PLAN TECHNICAL REPORTS

PORTLAND COMMUNITY COLLEGE
IT Master Plan
Infrastructure Existing Conditions Report

Date: April 17, 2018

Prepared for:
SRG Partnership

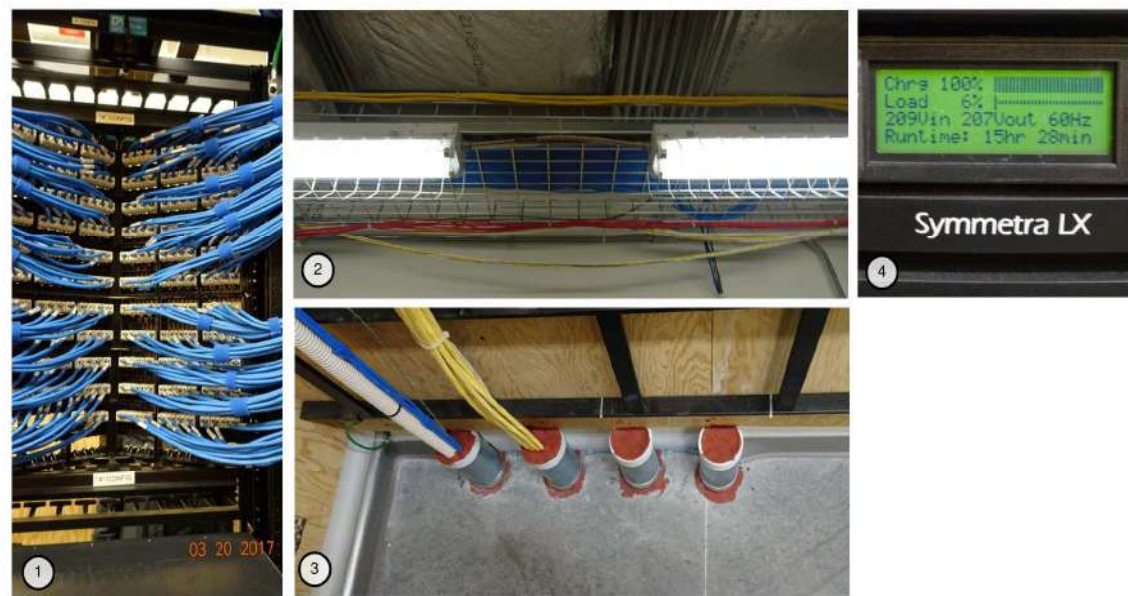
TELECOMMUNICATION ASSESSMENT
SOUTHEAST CAMPUS: STUDENT CENTER, 3RD FLOOR, IDF2

- POSITIVES AND NEGATIVES OF THE IMAGES ABOVE...
- 1. Rack management very good, sufficient room for expansion.
 - 2. Proximity of data cables to fluorescent light fixture not to standards – should be moved or shielded from EMI.
 - 3. Conduit capacities excellent with lots of room for expansion. Fire stop method to PCC standard.
 - 4. 1 UPS load good, unit is close to three years old.

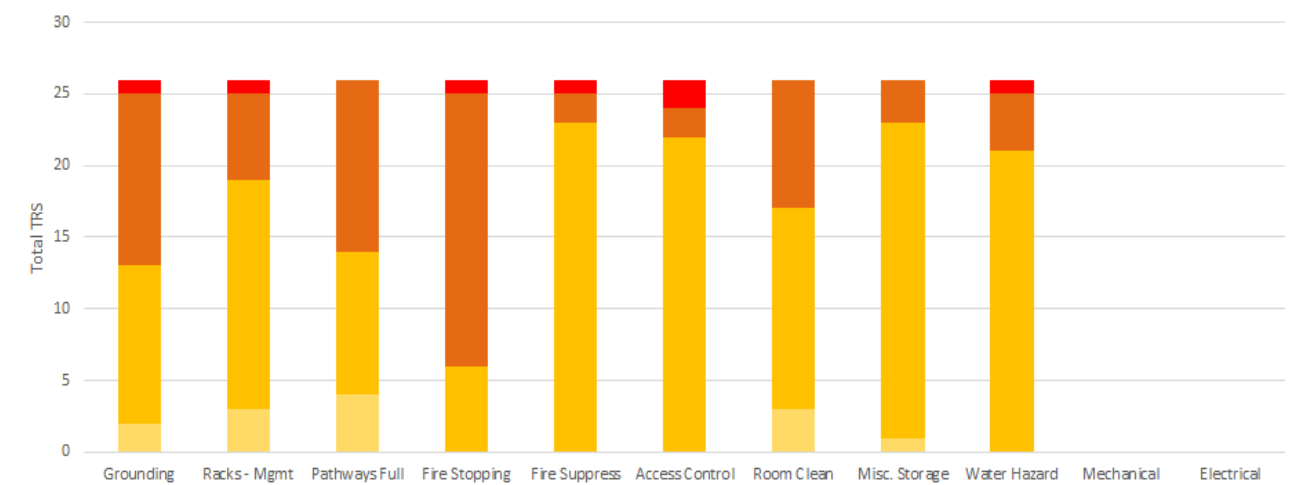
TELECOMMUNICATION ASSESSMENT
SYLVANIA CAMPUS: BREAKDOWN

•75% of the buildings on this campus do not employ effective firestop methods entering or exiting the communications spaces. Recommend proper installation of approved firestop materials.

•45% of the conduits and cable trays entering the communications spaces, and the trays located in tunnel areas between buildings, are filled beyond recommended capacity. This allows no expansion and potentially damages cable in the tray due to excess weight. Recommend removing abandoned cabling, or adding parallel pathways for future expansion. The critical entrance conduits can be further evaluated during a campus wide Outside Plant pathway identification and inventory project.

*50% of the buildings have ground bus bars and ground conductors that are out of compliance with NEC codes or PCC Standards. Recommend electrical contractors perform testing on ground systems flagged as "less than compliant" and visually inspect the bonding connections to system ground, and recommend corrective measures.

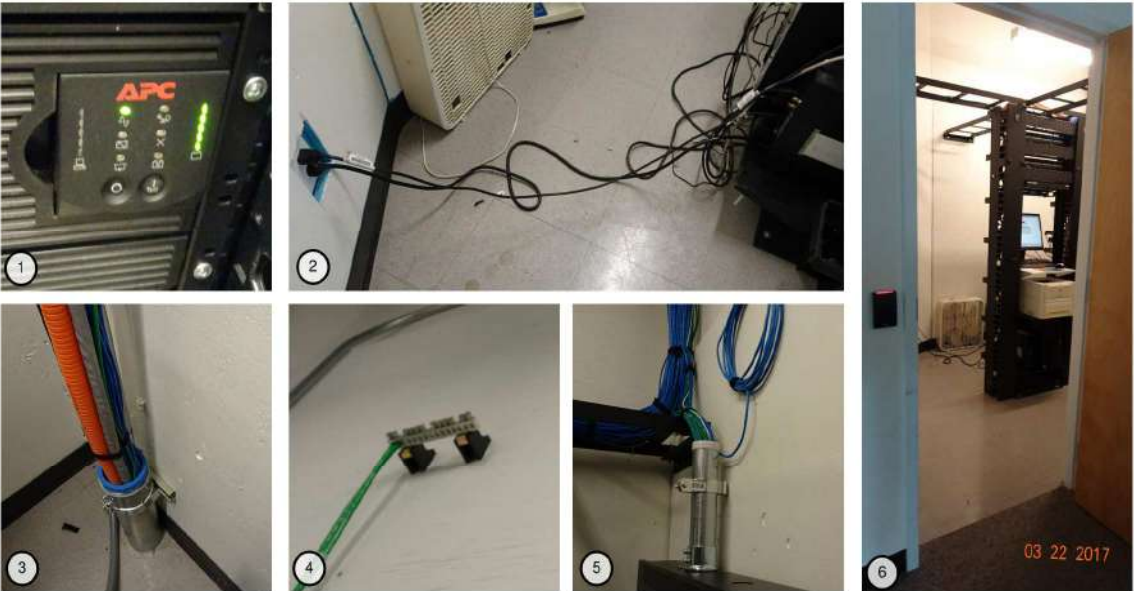
TELECOMMUNICATION ASSESSMENT
SYLVANIA CAMPUS: BOOKSTORE, 1ST FLOOR, BDF

- POSITIVES AND NEGATIVES OF THE IMAGES ABOVE...
- 1. Load Less than 17% utilization.
 - 2. Cooling not sufficient in room – fan power cords create trip hazard.
 - 3. Conduits filled beyond recommended capacity – future expansion limited. Firestop missing.
 - 4. Grounding Buss Bar not approved type.
 - 5. Cable not supported in corner.
 - 6. Entry Access control in place.

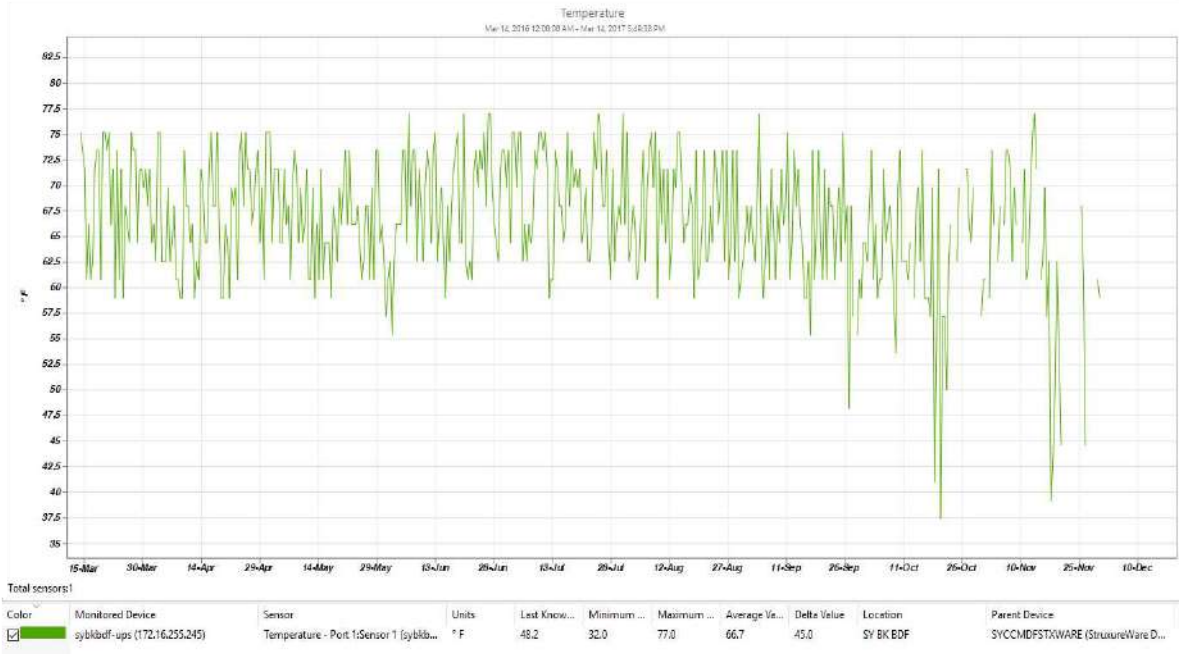
TELECOMMUNICATION TEMPERATURE ASSESSMENT
SYLVANIA CAMPUS: BOOKSTORE, 1ST FLOOR, BDF

Campus	Building	Room	Location	Time	Units	Min Val	Max Val	Average Value	Last Known Value	Notes
SY	sybkbd-f-ups (172.16.255.245)	Temp	SY BK BDF	2:52:18 PM	° F	32	77	66.8	Unplugged	End of Sept to Dec 2016 - Several low temp events and no current data

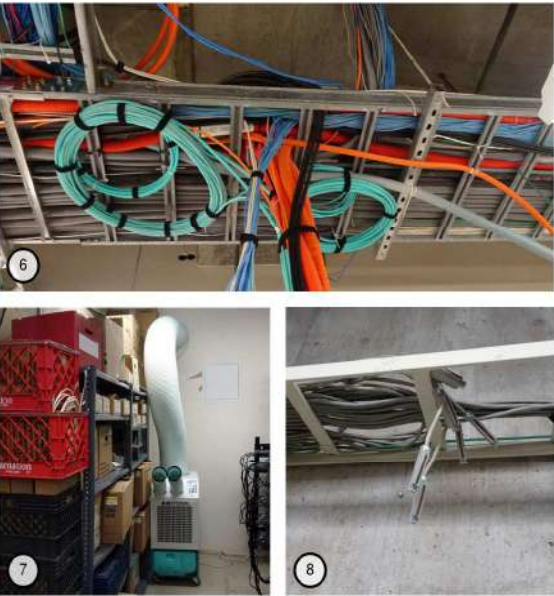
TELECOMMUNICATION ASSESSMENT
SYLVANIA CAMPUS: COLLEGE CENTER, 1ST FLOOR, MDF

- POSITIVES AND NEGATIVES OF THE IMAGES ABOVE...
- 6. Cable tray no room for expansion.
 - 7. Storage not stable in the event of an earthquake – potential personal injury
 - 8. Abandoned cables not removed

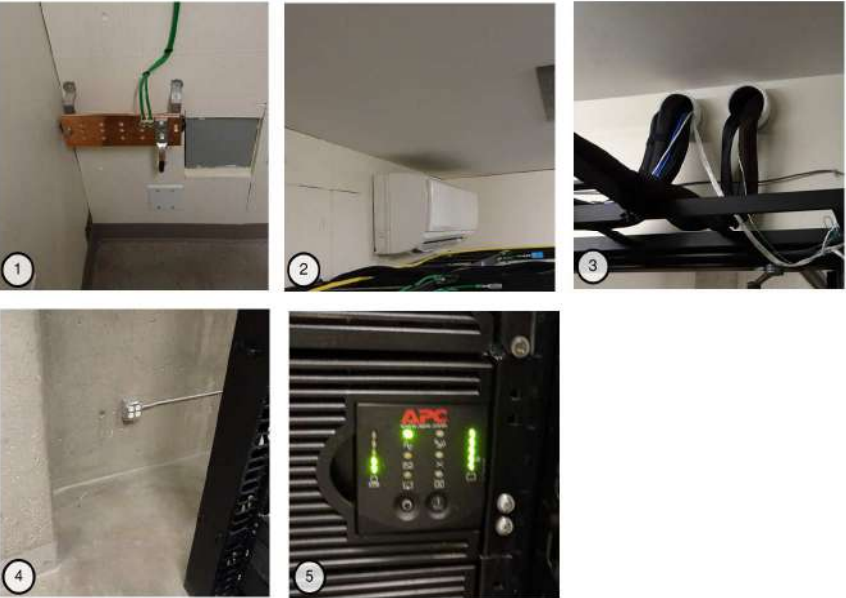
TELECOMMUNICATION ASSESSMENT
SYLVANIA CAMPUS: COLLEGE CENTER, 2ND FLOOR, IDF 1

- POSITIVES AND NEGATIVES OF THE IMAGES ABOVE...
- 1. System ground barely conforms to PCC standard; lacks individual connections to required components.
 - 2. Airflow restricted due to Split system placement.
 - 3. Firestop materials not present.
 - 4. Clearance behind rack not to PCC Standard.
 - 5. Load less than 50% utilization.

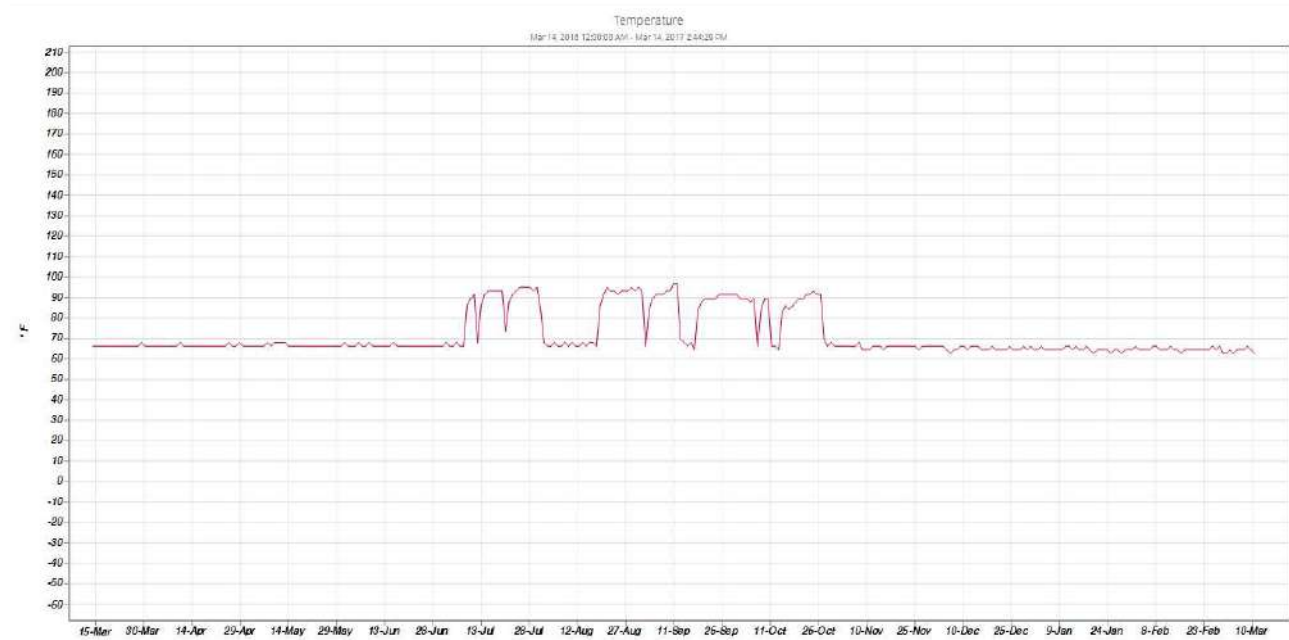
TELECOMMUNICATION TEMPERATURE ASSESSMENT
SYLVANIA CAMPUS: COLLEGE CENTER, 2ND FLOOR, IDF 2

Campus	Building	Room	Location	Time	Units	Min Value	Max Value	Average Value	Last known Value	Notes
SY	syccidf2-ups (172.16.255.252)	Temp	SY CC IDF2	2:52:18 PM	°F	62.6	96.8	71.8	66.2	Start of Jul to end of Oct 2016 - Many high temp events over 86°

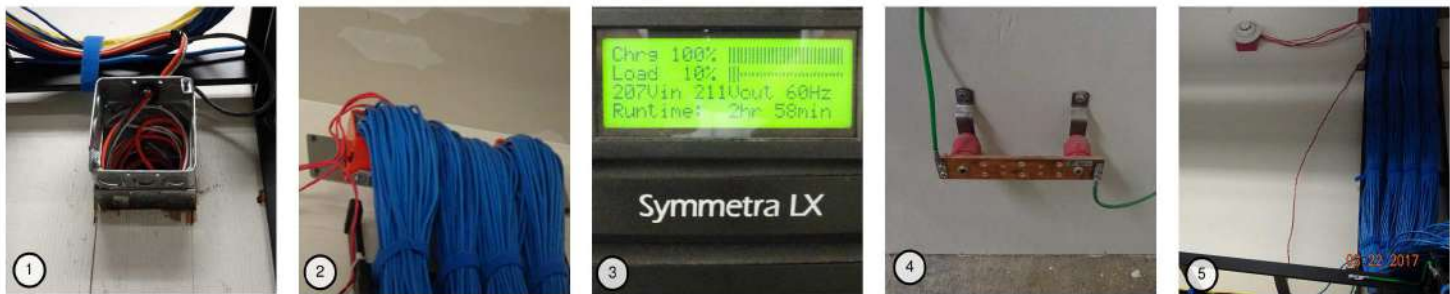
TELECOMMUNICATION ASSESSMENT
SYLVANIA CAMPUS: COLLEGE CENTER, 2ND FLOOR, IDF 3

- POSITIVES AND NEGATIVES OF THE IMAGES ABOVE...
- 1. Electrical J-Box open – code violation.
 - 2. Fire stop assemblies filled – (4" units were specified, but 2" units were installed).
 - 3. Load and Charge good on UPS.
 - 4. System ground barely conforms to PCC standard; lacks individual connections to required components.
 - 5. Fire Life Safety conductors not in continuous conduit.

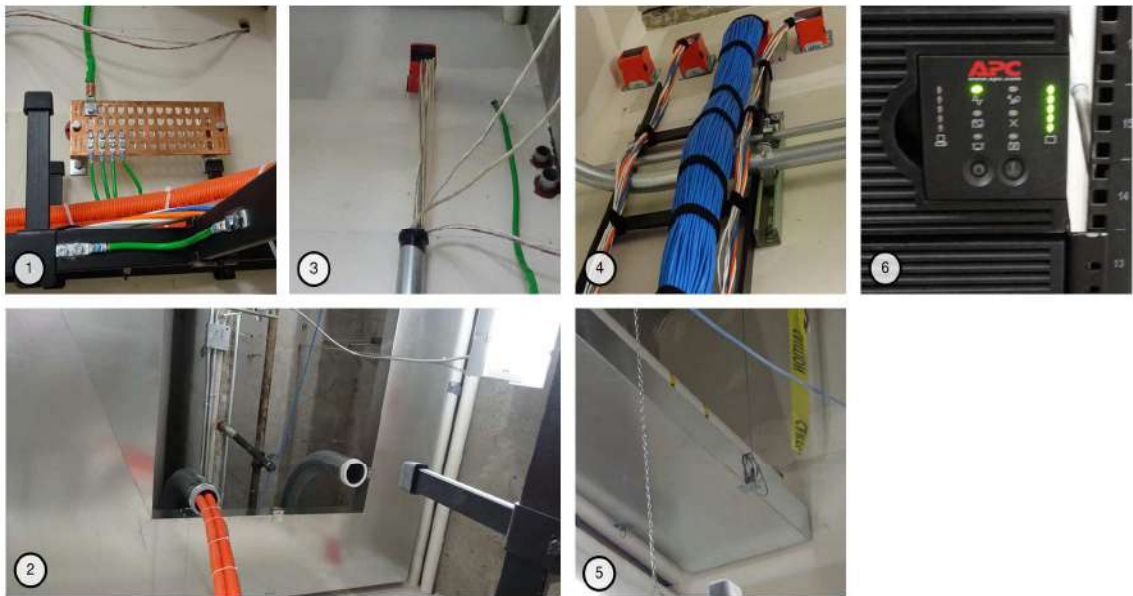
TELECOMMUNICATION ASSESSMENT
SYLVANIA CAMPUS: COLLEGE CENTER, 2ND FLOOR, IDF 4

- POSITIVES AND NEGATIVES OF THE IMAGES ABOVE...
- 1. System ground conforms to PCC standard.
 - 2. & 5 Perimeter of room has tray – several water pipes in room.
 - 3. Fire stop systems not used – other penetrations lack fire stop materials.
 - 4. Good cable supports and use of fire stop systems.
 - 6. Load and Charge good on UPS.

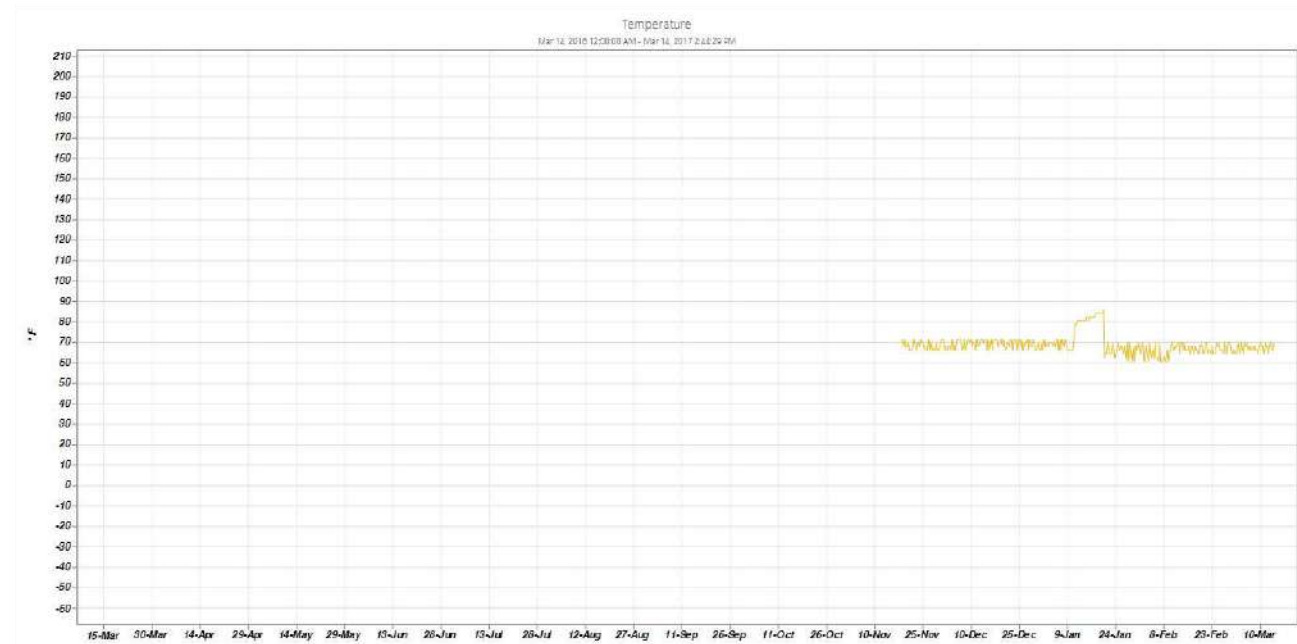
TELECOMMUNICATION TEMPERATURE ASSESSMENT
SYLVANIA CAMPUS: COLLEGE CENTER. 2ND FLOOR. IDF 4

Campus	Building	Room	Location	Time	Units	Min Value	Max Value	Average Value	Lowest Known Value	Notes
SY	syccid4-ups (172.16.255.228)	Temp	SY CC IDF4	2:52:18 PM	* F	60.8	86	68.9	66.2	End of Jan 2016 - (1) High temp event over 86°

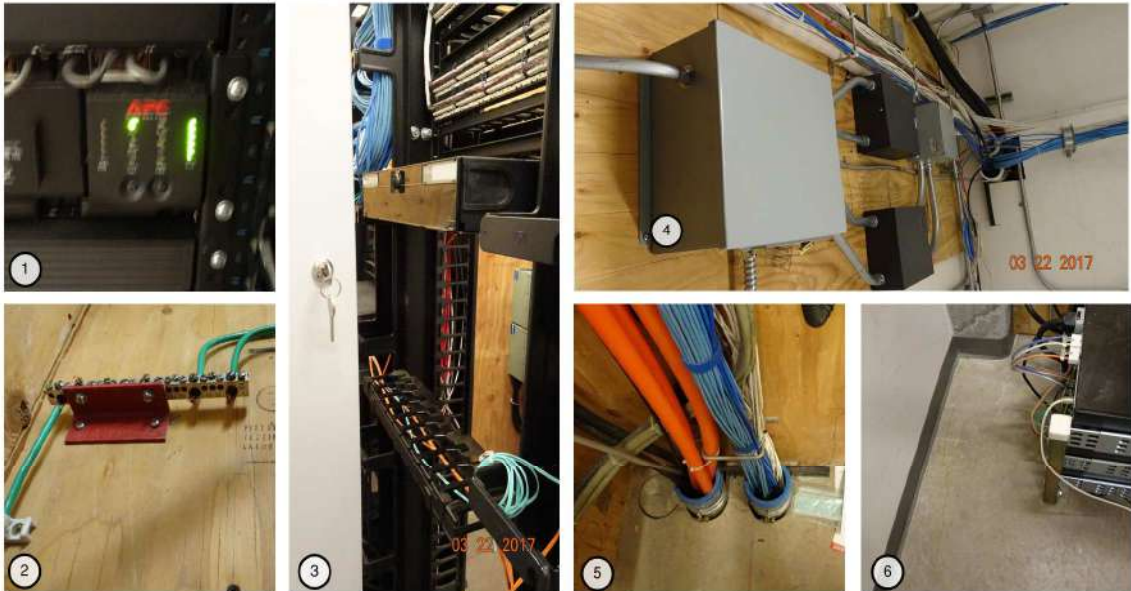
TELECOMMUNICATION ASSESSMENT
SYLVANIA CAMPUS: COLLEGE SERVICES, 2ND FLOOR, BDF

- POSITIVES AND NEGATIVES OF THE IMAGES ABOVE....
1. Load and Charge good on UPS.
 2. Grounding Buss Bar not approved type.
 3. Expansion capacity adequate, good cable management.
 4. & 5. Fire stop materials not present.
 6. Clearance behind rack not to PCC Standard.

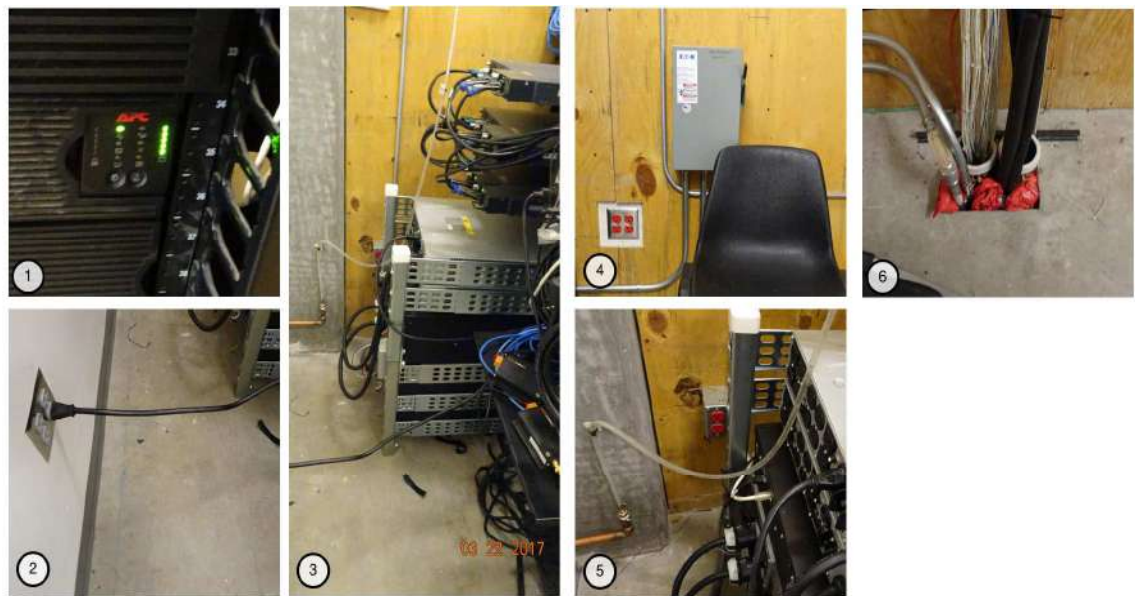
TELECOMMUNICATION ASSESSMENT
SYLVANIA CAMPUS: COLLEGE SERVICES, 3RD FLOOR IDF 1

- POSITIVES AND NEGATIVES OF THE IMAGES ABOVE...
- 1. Load and Charge good on UPS.
 - 2. Power cord to equipment is trip hazard - potential for personal injury or equipment outage.
 - 3. & 5 Water condensate (clear tube) run over and around active equipment (Water Hazard).
 - 4. Power disconnect mounted low – easy to get caught on and shut power down.
 - 6. Fire stop in conduits not present.

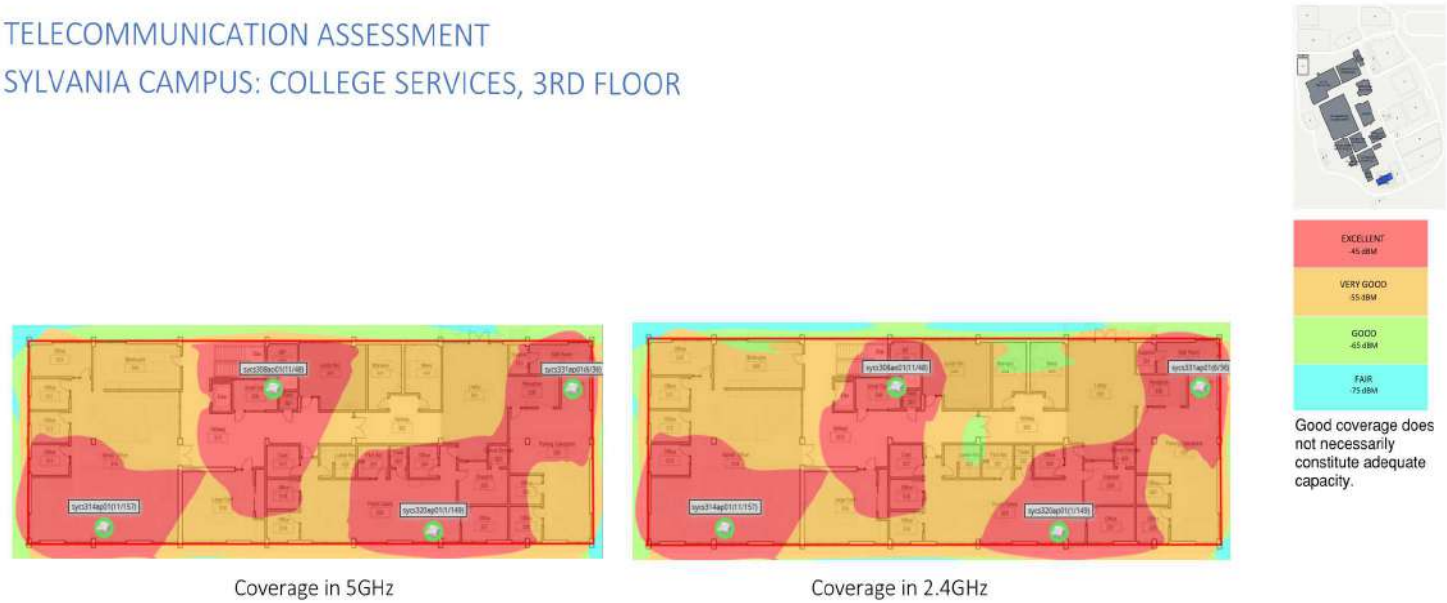
TELECOMMUNICATION ASSESSMENT
SYLVANIA CAMPUS: COLLEGE SERVICES, 3RD FLOOR

Campus	Building	Floor	Location	Coverage in 2.4Ghz	Coverage in 5Ghz	WAP Service Life	Comments
				1	1	3	
SY	Campus Services Building	3rd	SYCSB - 3				5ghz coverage better than 2.4

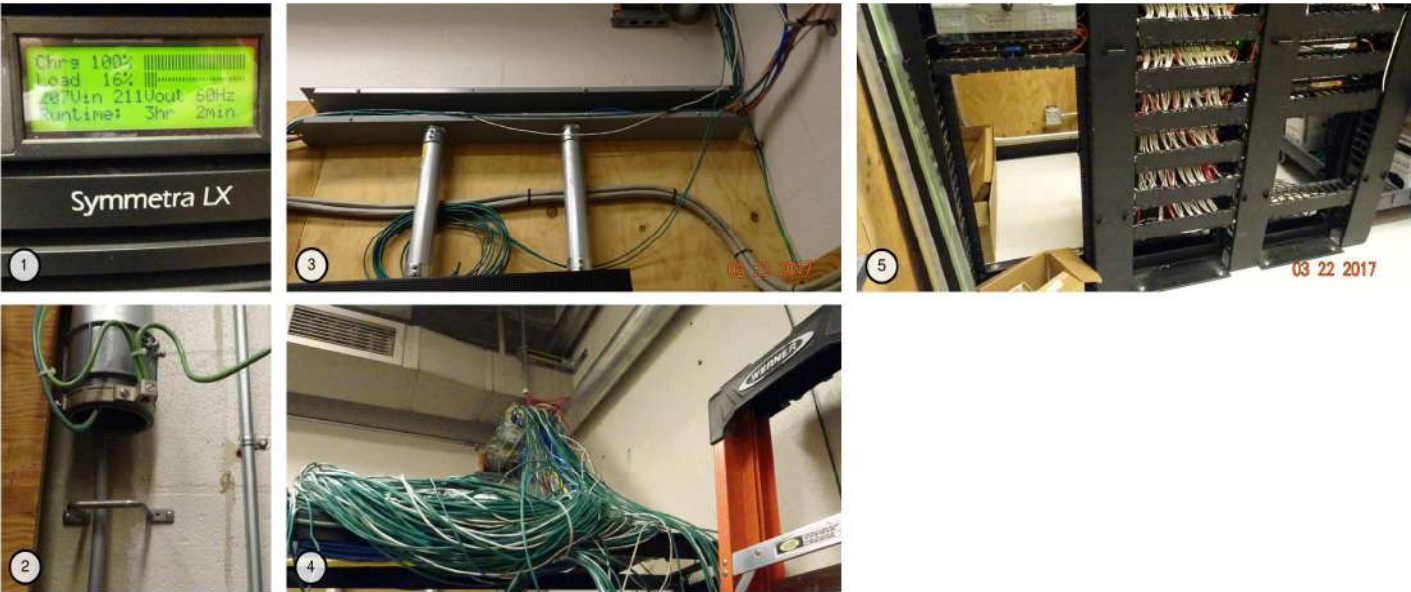
TELECOMMUNICATION ASSESSMENT
SYLVANIA CAMPUS: COMM.TECH, 1ST FLOOR, BDF

- POSITIVES AND NEGATIVES OF THE IMAGES ABOVE...
- 1. Load and Charge good on UPS.
 - 2. Conduit ground present per standards.
 - 3. & 4 – Cable management poor on basket tray transition to ladder tray.
 - 5. Expansion capacity adequate, good cable management.

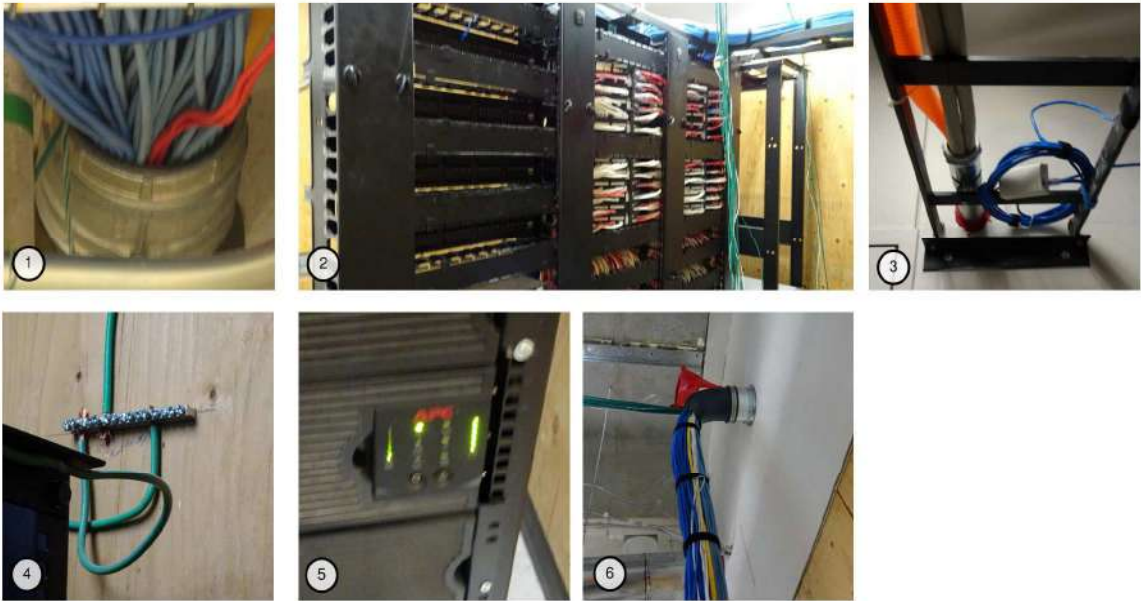
TELECOMMUNICATION ASSESSMENT
SYLVANIA CAMPUS: COMM.TECH, 2ND FLOOR, IDF 1

- POSITIVES AND NEGATIVES OF THE IMAGES ABOVE....
1. Conduits filled beyond recommended capacity – future expansion limited.
 2. Rack management good, excellent room for expansion.
 3. & 6. Conduits filled beyond recommended capacity – future expansion limited.
 4. Grounding Buss Bar not approved type.
 5. Load and Charge good on UPS.

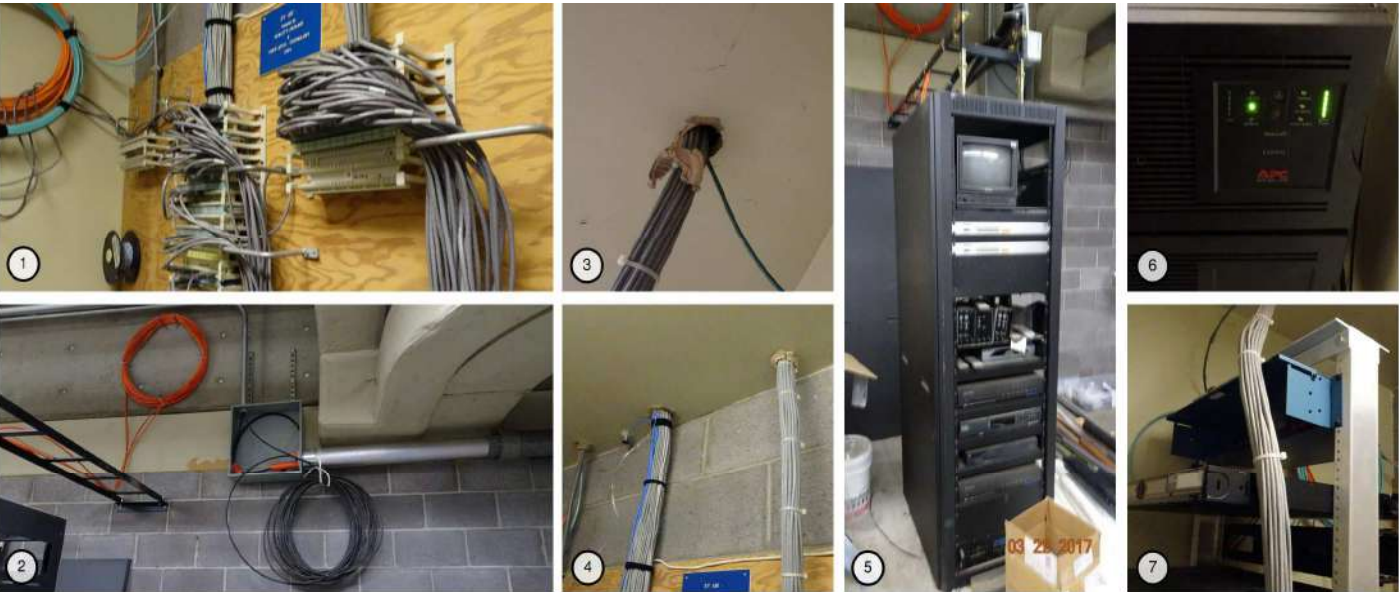
TELECOMMUNICATION ASSESSMENT
SLYVANIA CAMPUS: HEAT PLANT, 1ST FLOOR, BDF

- POSITIVES AND NEGATIVES OF THE IMAGES ABOVE...
- 1. Copper cables not managed or supported properly -cannot access connection points.
 - 2. Spare fiber optics coil not supported and protected, pull box open.
 - 3. & 4. Cable penetrations lack sleeves and fire stop materials.
 - 5. Distance Learning rack in an unsecured, dusty environment – Cabinet contains fiber to the street.
 - 6. Load and Charge good on UPS.
 - 7. Station cable not supported.

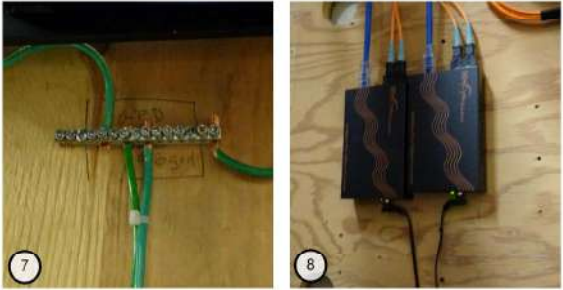
TELECOMMUNICATION ASSESSMENT
SYLVANIA CAMPUS: HEALTH TECHNOLOGIES, 2ND FLOOR, IDF 1

- POSITIVES AND NEGATIVES OF THE IMAGES ABOVE...
- 7. Grounding Buss Bar not approved type.
 - 8. Fiber optic transceivers are positioned so the power cable can be accidentally pulled out.

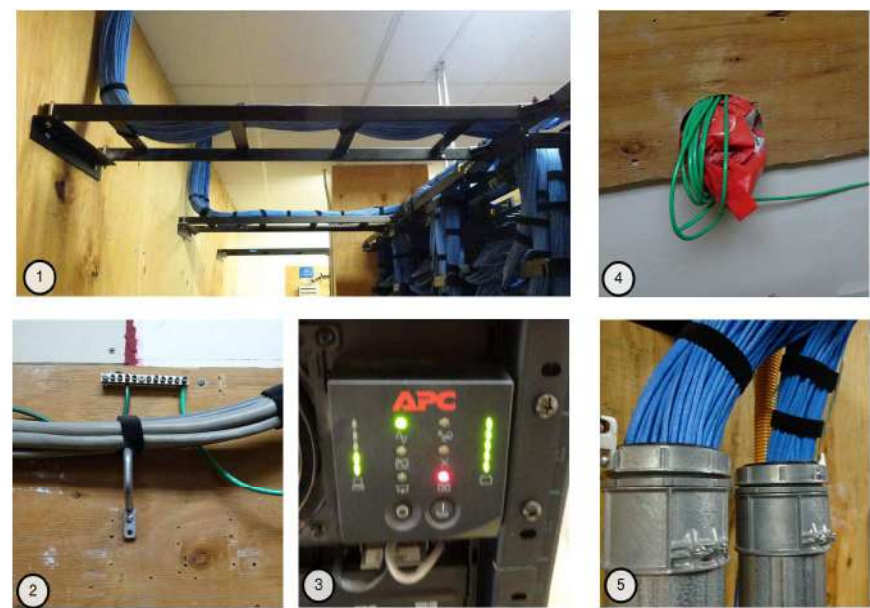
TELECOMMUNICATION ASSESSMENT
SYLVANIA CAMPUS: HEALTH TECHNOLOGIES, 3RD FLOOR, IDF 2

- POSITIVES AND NEGATIVES OF THE IMAGES ABOVE...
- Overhead cable tray capacity excellent – suitable for expansion.
 - Grounding Buss Bar not approved type.
 - UPS indicated bad battery.
 - Incorrect use of Firestop pillows.
 - Conduits filled beyond recommended capacity.

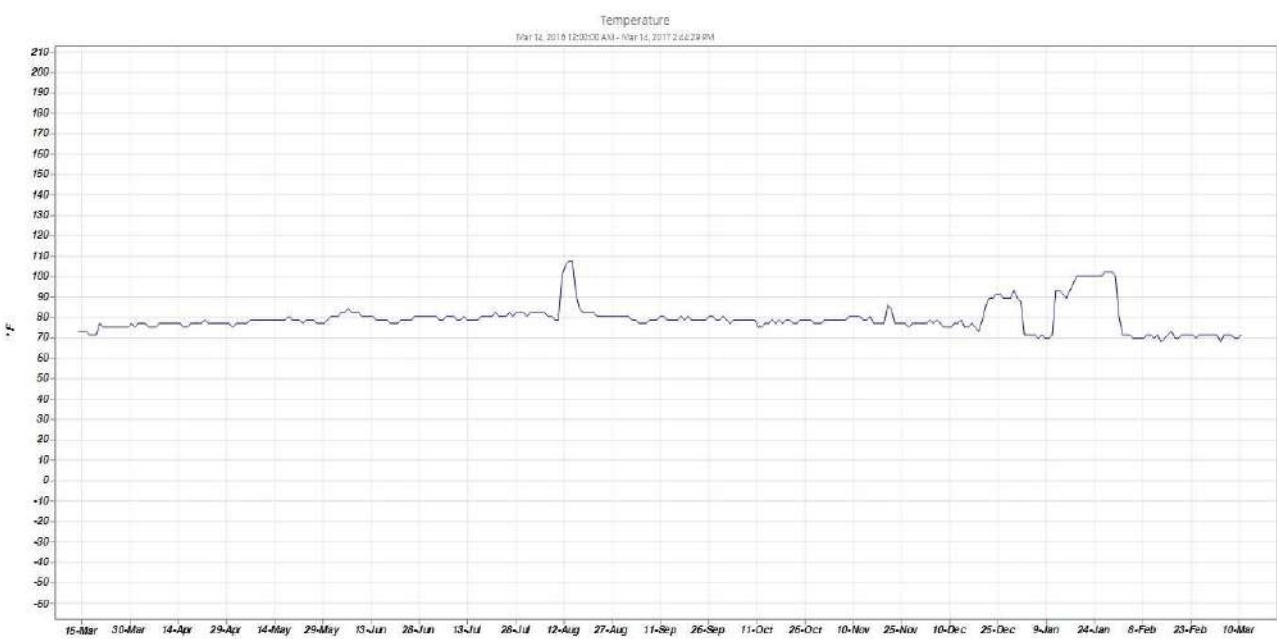
TELECOMMUNICATION TEMPERATURE ASSESSMENT
SYLVANIA CAMPUS: COLLEGE CENTER, 3RD FLOOR, IDF 2

Campus	Building	Room	Location	Time	Units	Min Value	Max Value	Average Value	Lowest Known Value	Notes
SY	syhtidf2-ups (172.16.255.248)	Temp	SY HT IDF2	2:52:18 PM	* F	69.8	108	78.3	77	Mid Aug 2016 to Start of Feb 2017 - Several high temp events over 86°

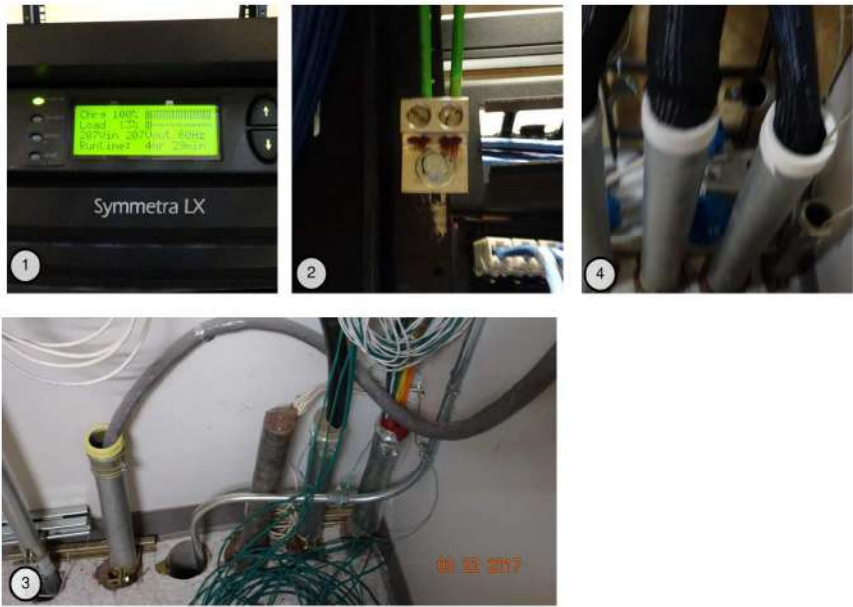
TELECOMMUNICATION ASSESSMENT
SYLVANIA CAMPUS: LIBRARY, 2ND FLOOR, BDF

- POSITIVES AND NEGATIVES OF THE IMAGES ABOVE...
- 1. Load and Charge good on UPS.
 - 2. Grounding is fair, but conductor size and lug clamps are incorrect type / size.
 - 3. Conduit capacity fair, but required firestop / sealant is not present.
 - 4. Conduits filled beyond recommended capacity.

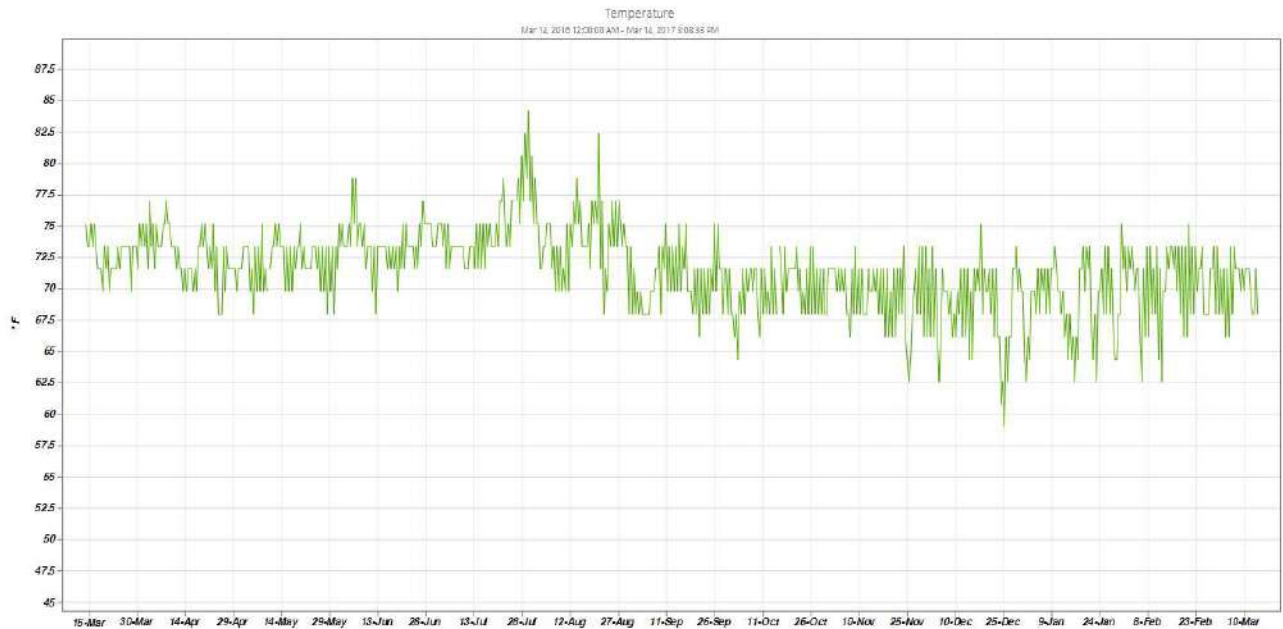
TELECOMMUNICATION TEMPERATURE ASSESSMENT
SYLVANIA CAMPUS: PERFORMING ARTS CENTER, 1ST FLOOR, BDF

Campus	Building	Room	Location	Time	Units	Min Value	Max Value	Average Value	Last Known Value	Notes
SY	sypacbfd-ups (172.16.255.244)	Temp	SY PAC BDF	2:52:18 PM	° F	62.6	84.2	71.6	69.8	End of Jul to end of Aug 2016 - Several moderate temp events over 80°

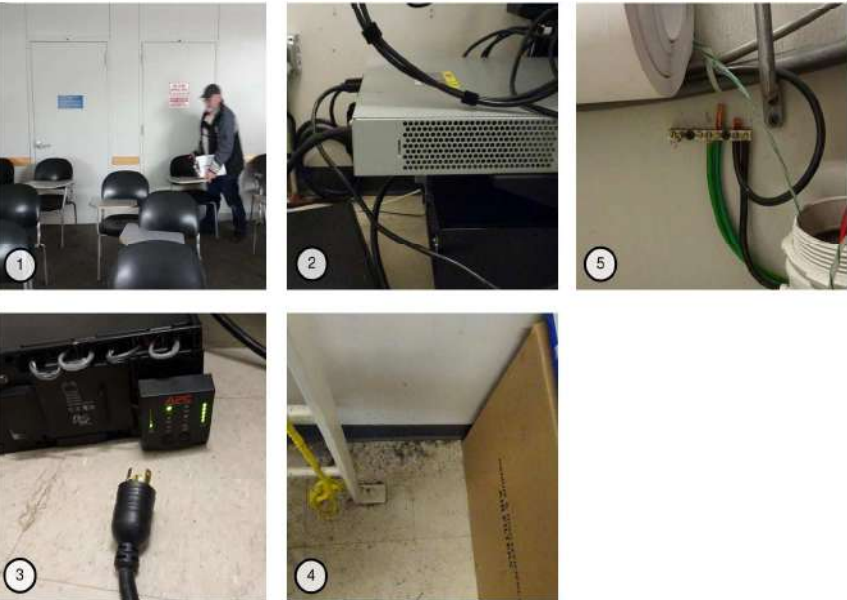
SLYVANIA CAMPUS: SMALL CLASSROOM BUILDING, 2ND FLOOR, BDF

- POSITIVES AND NEGATIVES OF THE IMAGES ABOVE...
- 1. No Access control – door obstructed.
 - 2. & 3. Equipment not mounted – potential damage in the event of an earthquake.
 - 4. Dirt in room – harmful for equipment.
 - 5. Ground conductors are undersized and Grounding Buss Bar not approved type.
- Not shown – no cooling in room.

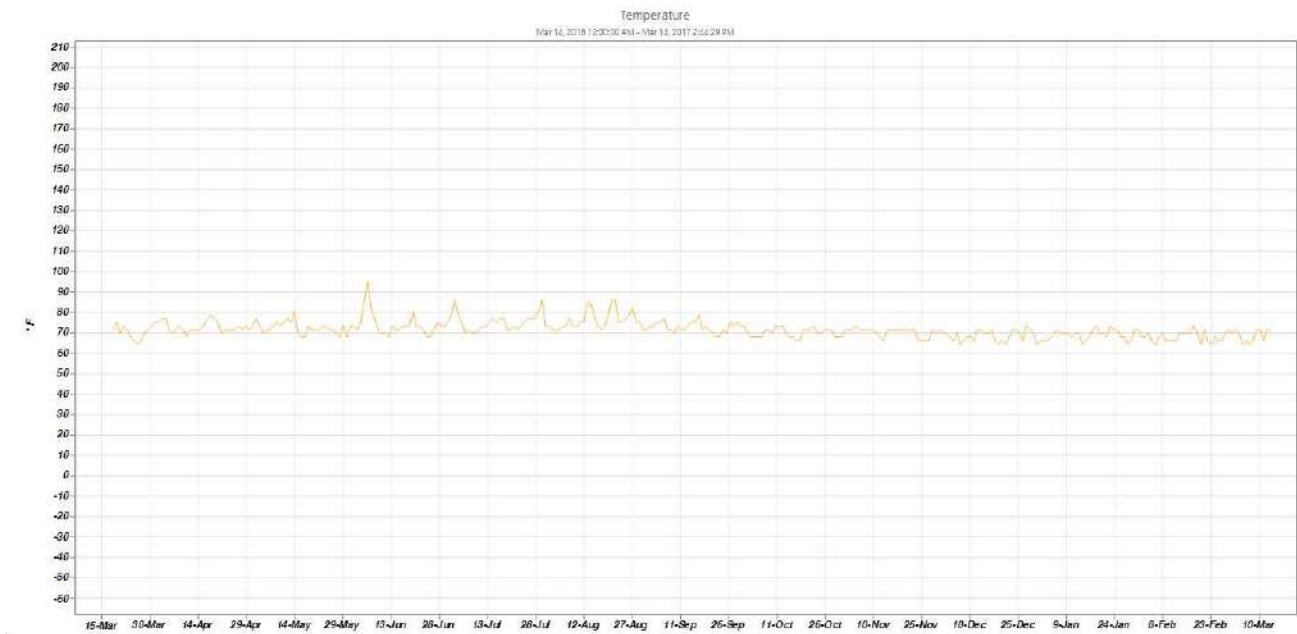
SLYVANIA CAMPUS: SMALL CLASSROOM, 2ND FLOOR, BDF

Campus	Building	Room	Location	Time	Units	Min Value	Max Value	Average Value	Least Known Value	Notes
SY	syscbdf-ups (172.16.255.233)	Temp	SY SC BDF	2:52:18 PM	° F	64.4	95	71.3	66.2	Start of June to end of Aug 2016 - (5) High temp events over 86°

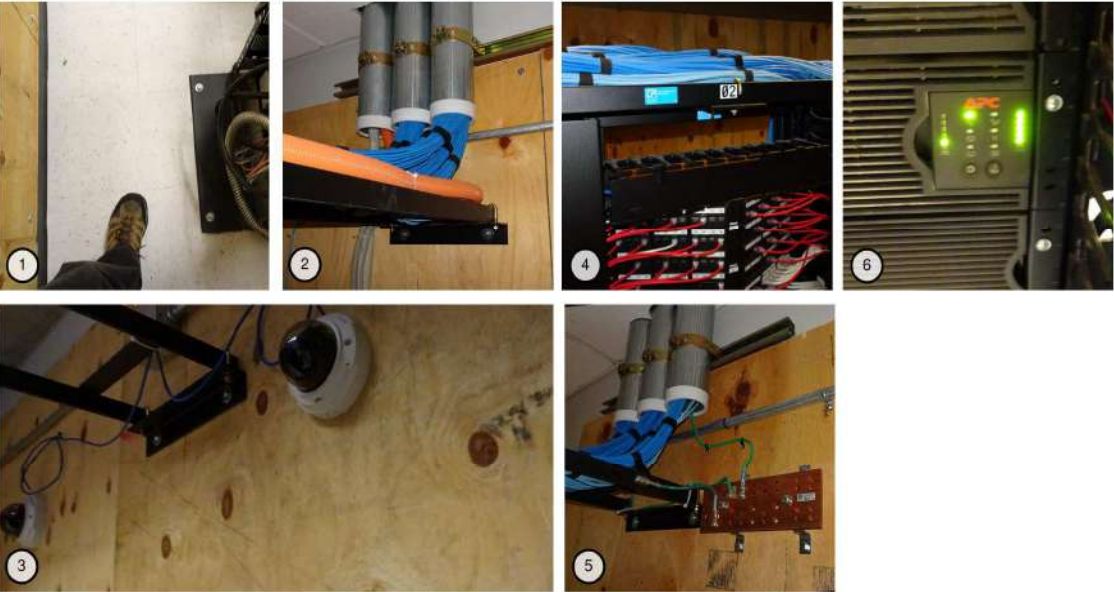
TELECOMMUNICATION ASSESSMENT
SYLVANIA CAMPUS: SOCIAL SCIENCE, 2ND FLOOR, IDF 1

- POSITIVES AND NEGATIVES OF THE IMAGES ABOVE...
- 1. Clearance behind rack not to PCC Standard.
 - 2. Conduits filled beyond recommended capacity – future expansion limited. Required firestop not present.
 - 3. Good camera placements.
 - 4. Expansion capacity adequate, good cable management.
 - 5. System ground conforms to PCC standard.
 - 6. Load and Charge good on UPS.

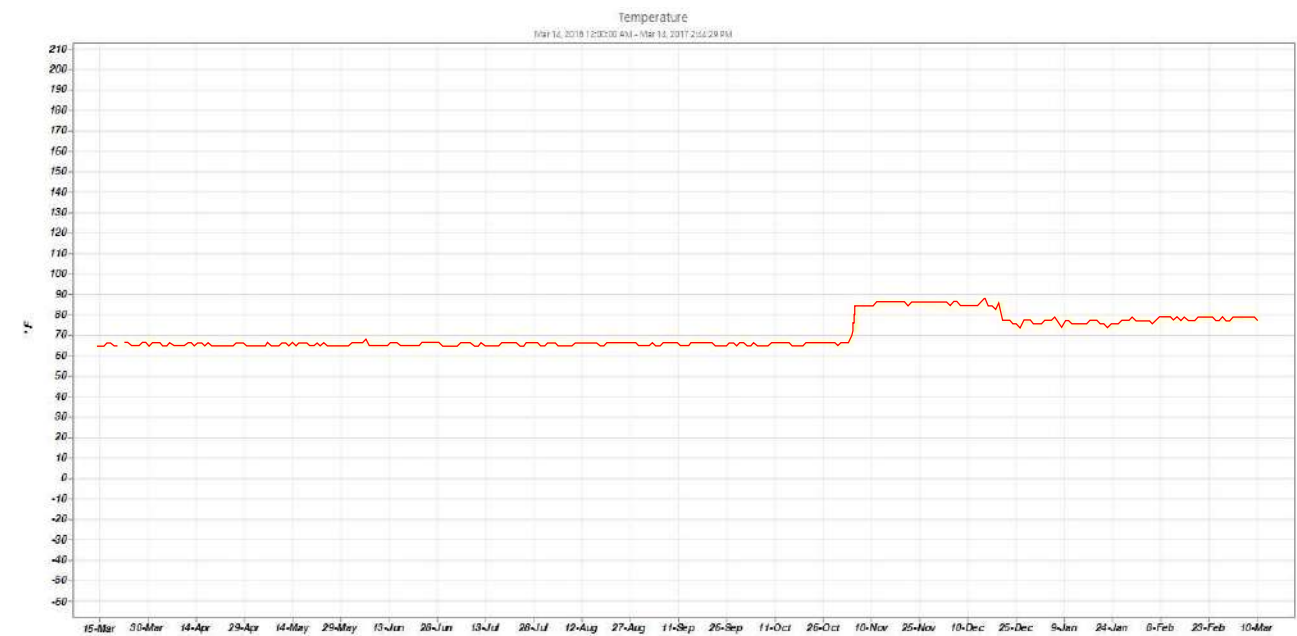
TELECOMMUNICATION TEMPERATURE ASSESSMENT
SYLVANIA CAMPUS: SOCIAL SCIENCE, 2ND FLOOR, IDF 1

Campus	Building	Room	Location	Time	Units	Min Value			Max Value			Average Value	Last Known Value	Notes
						Min	Max	Avg	Min	Max	Avg			
SY	syssidf1-ups (172.16.255.234)	Temp	SY SS IDF1	2:52:18 PM	° F	64.4	87.8	72.6	87.8					Mid Nov to Mid Dec 2016 - Several high temp events over 86°

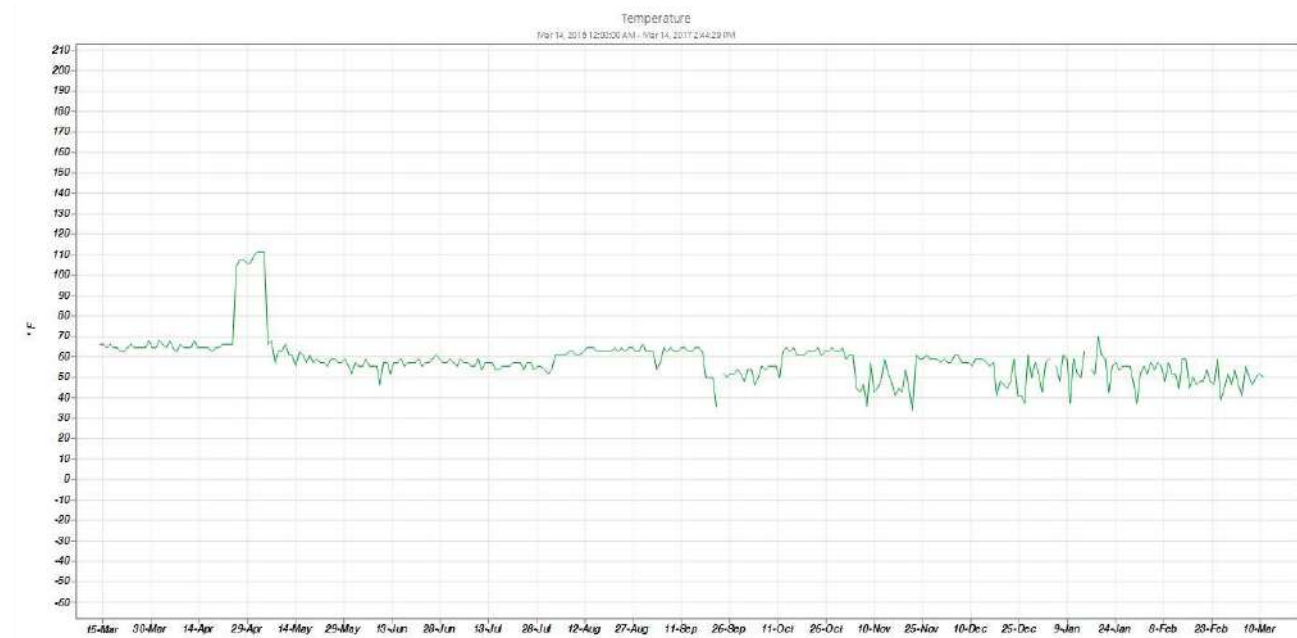
TELECOMMUNICATION TEMPERATURE ASSESSMENT
SYLVANIA CAMPUS: SCIENCE AND TECHNOLOGY, 2ND FLOOR, BDF

Campus	Building	Room	Location	Time	Units	Min Value	Max Value	Average Value	Lowest Known Value	Notes
SY	systbdf-ups (172.16.255.237)	Temp	SY ST BDF	2:52:18 PM	° F	33.8	113	60.8	60.8	End of Apr to start of May 2016 - Several high temp events over 86°

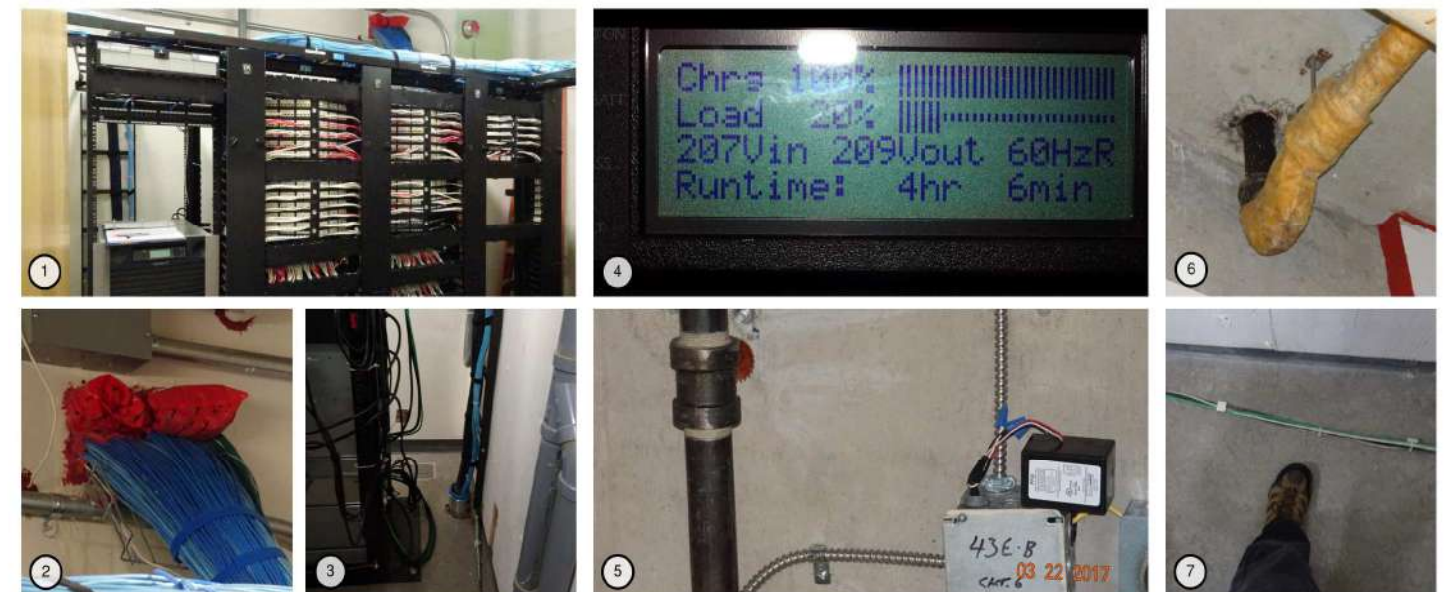
SLYVANIA CAMPUS: SCIENCE AND TECHNOLOGY, 3RD FLOOR, IDF 3

1. Rack management good, excellent room for expansion
2. Correct application of Fire stop pillows
3. Clearance behind rack not to PCC Standard
4. Load and Charge good on UPS
5. Sprinkler head too close to electrical box and device wiring
6. Roof drains over equipment
7. Loose cables on floor – trip hazard

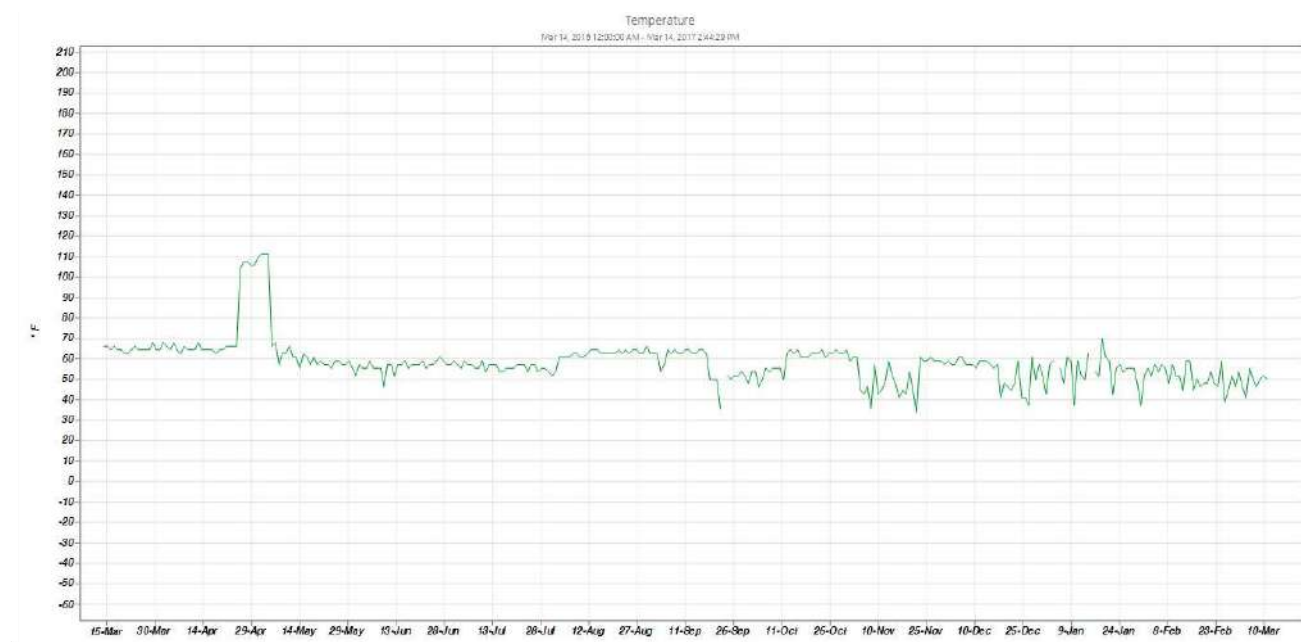
TELECOMMUNICATION TEMPERATURE ASSESSMENT
SLYVANIA CAMPUS: SCIENCE AND TECHNOLOGY, 2ND FLOOR, IDF 3

Campus	Building	Room	Location	Time	Units	Min Value	Max Value	Average Value	Last known Value	Notes	LEGEND		
											SEVERE TEMP ISSUES	MODERATE TEMP ISSUES	SPECIAL CONSIDERATION
SY	systidf3-ups (172.16.255.236)	Temp	SY ST IDF3	2:52:18 PM	" F	69.8	91.4	78.4	71.6	Mid Apr to mid Nov 2016 - Many high temp events over 86°

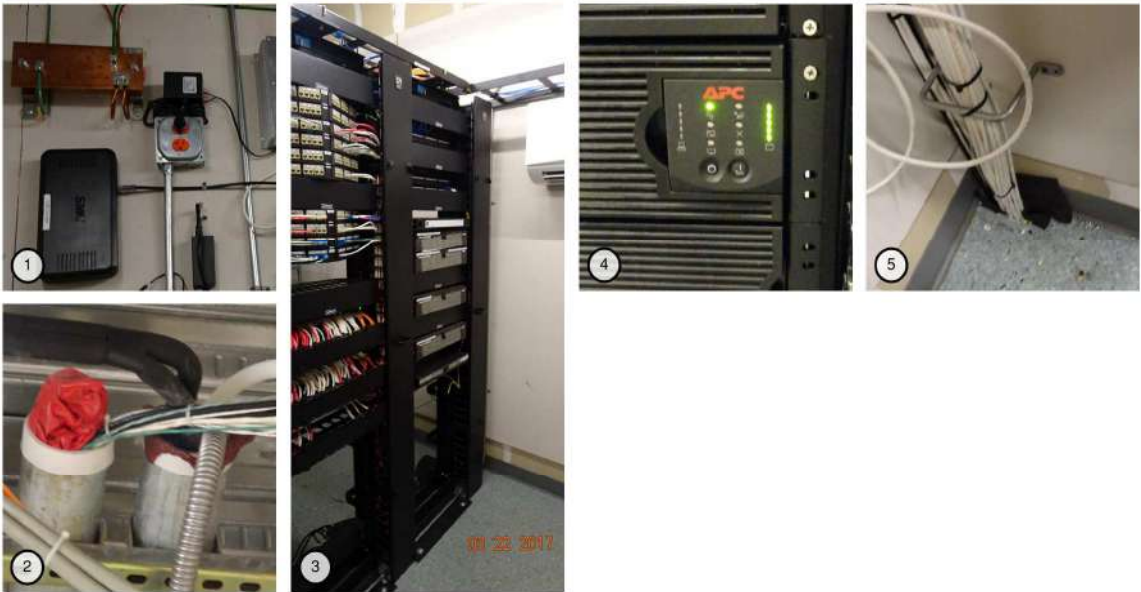
TELECOMMUNICATION ASSESSMENT
SYLVANIA CAMPUS: TECHNOLOGY CLASSROOM, 1ST FLOOR BDF

- POSITIVES AND NEGATIVES OF THE IMAGES ABOVE...
- 1. System ground conforms to PCC standard.
 - 2. Chiller lines, condensate tube, electrical flex sharing same conduit – code violation. Incorrect use of Firestop pillows.
 - 3. Expansion capacity adequate, good cable management.
 - 4. Load and Charge good on UPS.
 - 5. Sleeves and fire stop materials not present.
