FACILITIES PLAN TECHNICAL REPORTS

PORTLAND COMMUNITY COLLEGE
IT Master Plan
Infrastructure Existing Conditions Report

Date: April 17, 2018

Prepared for:
SRG Partnership

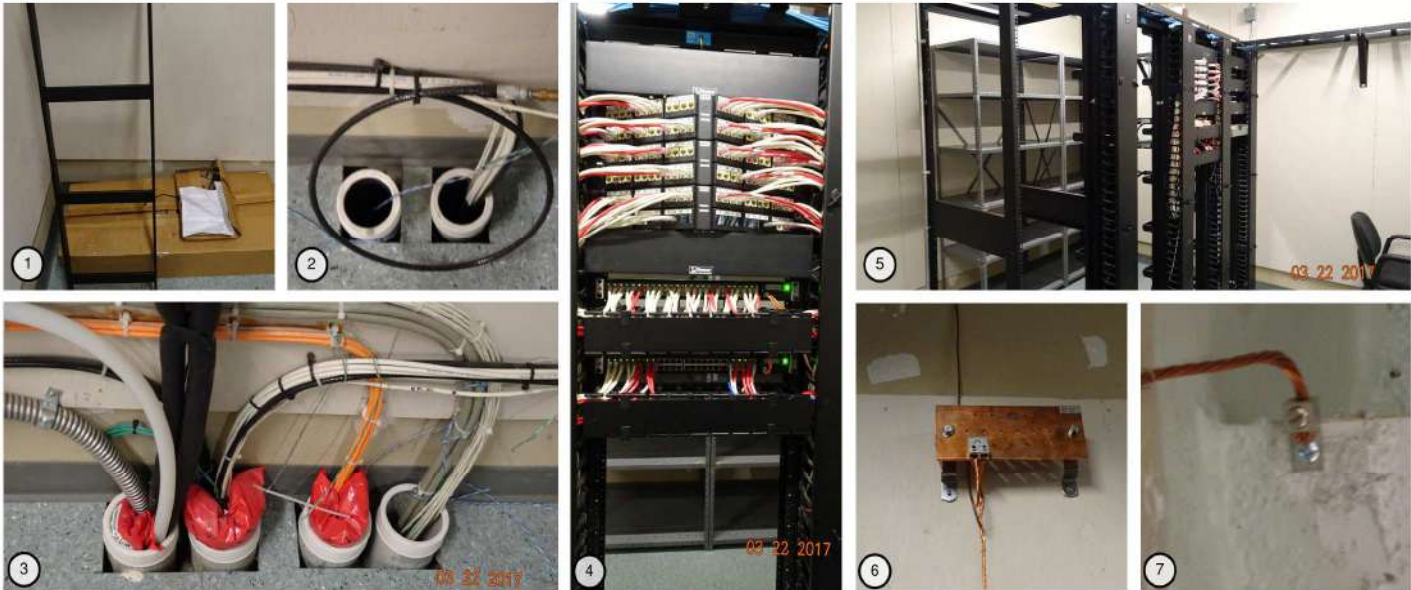
TELECOMMUNICATION ASSESSMENT
SYLVANIA CAMPUS: TECHNOLOGY CLASSROOM, 2ND FLOOR, IDF 1

- POSITIVES AND NEGATIVES OF THE IMAGES ABOVE...
- 1. Ladder tray leaning up – potential personal injury or equipment damage in the event of an earthquake.
 - 2. & 3. Fire stop or sealant materials not present.
 - 4. & 5. Rack management good, excellent room for expansion.
 - 6. System ground lacks individual connections to required components.
 - 7. Bond to building steel not approved method.

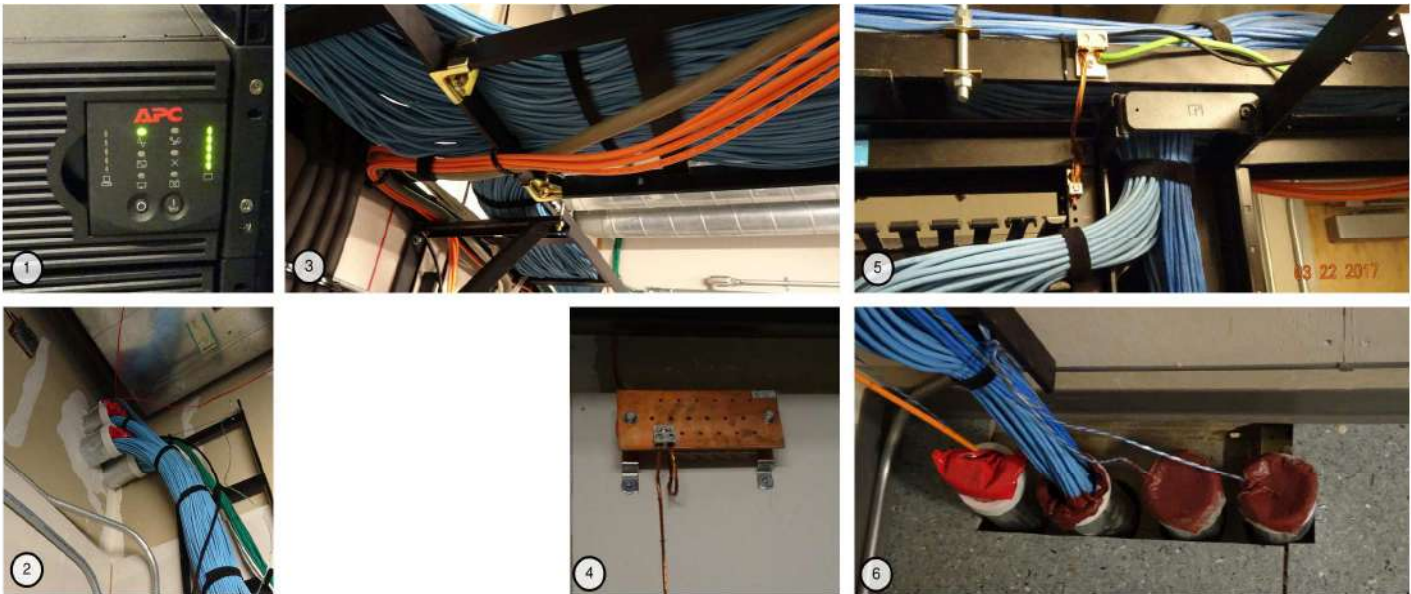
TELECOMMUNICATION ASSESSMENT
SYLVANIA CAMPUS: TECHNOLOGY CLASSROOM, 3RD FLOOR, IDF 2

- POSITIVES AND NEGATIVES OF THE IMAGES ABOVE...
- 1. Load and Charge good on UPS
 - 2 Incorrect use of Firestop pillows
 - 3 Cable tray loading exceeds recommended capacity – Cables and fiber routed under tray not supported
 - 4 & 5 System ground lacks individual connections to required components
 - 6. Firestop not properly placed in conduits or around floor penetration

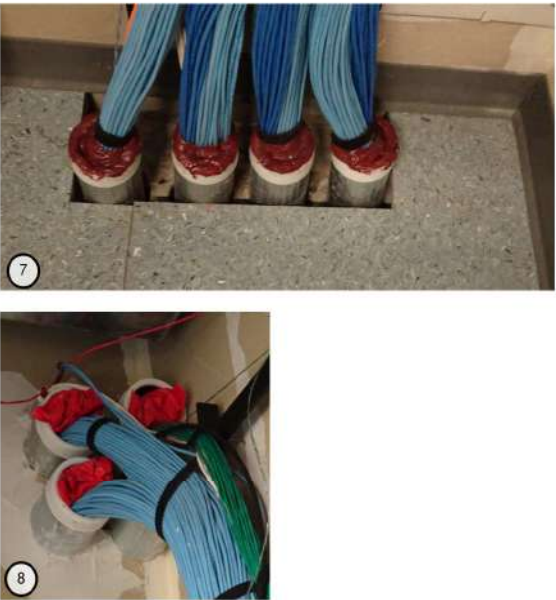
TELECOMMUNICATION ASSESSMENT
SYLVANIA CAMPUS: TECHNOLOGY CLASSROOM, 3RD FLOOR, IDF 2

- POSITIVES AND NEGATIVES OF THE IMAGES ABOVE...
- 7. & 8. Fire stop not properly placed in conduits or around floor penetration

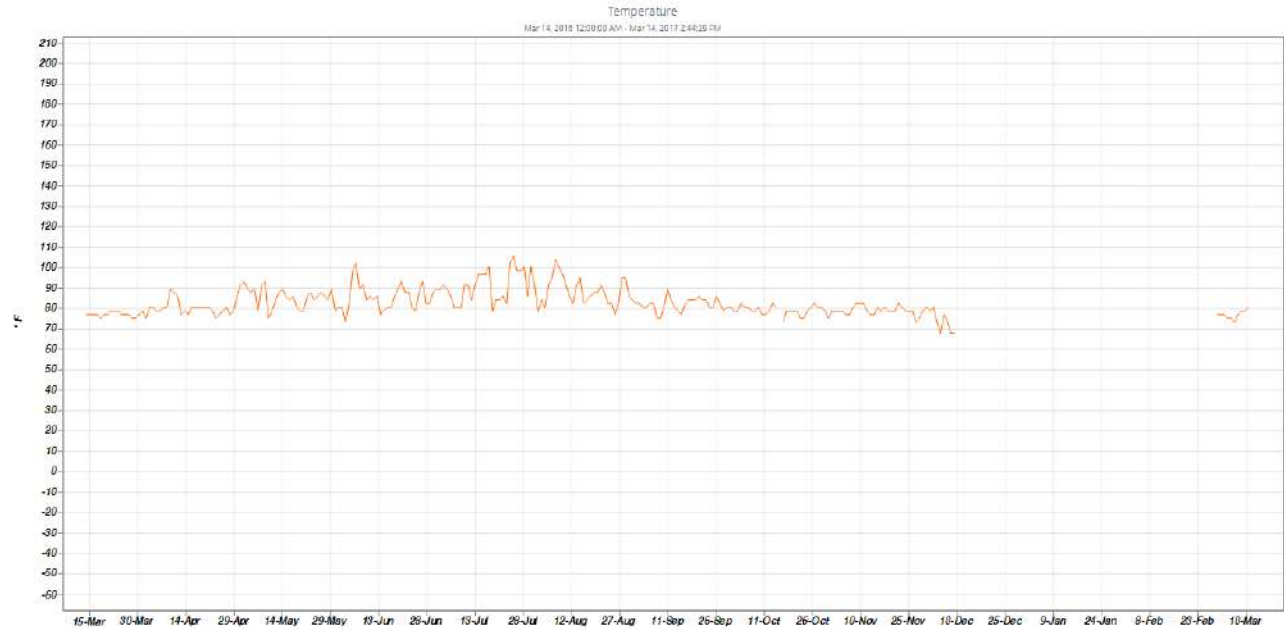
TELECOMMUNICATION TEMPERATURE ASSESSMENT
CAPITAL PARK: CAPITAL PARK, MDF

Campus	Building	Room	Location	Time	Units	Min Value	Max Value	Average Value	Last Known Value	Notes
RC	cpmdf-ups (172.23.63.240)	Temp	Capitol Park	2:52:18 PM	°F	62.6	106	81.4	77	Start of Apr to Oct 2016 - Many days of high temp events over 86°

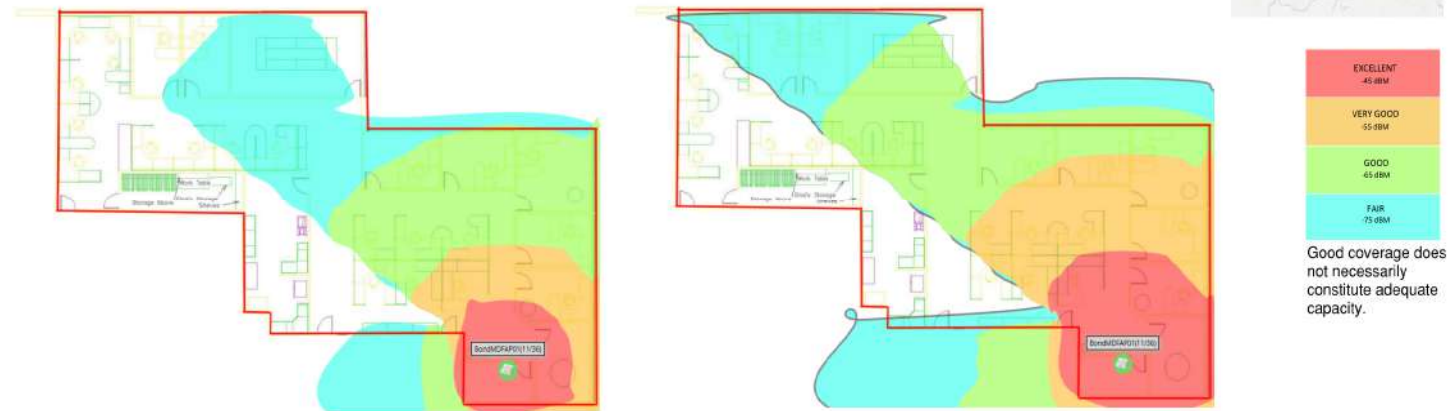
TELECOMMUNICATION ASSESSMENT
CAPITAL PARK CAMPUS: CAPITAL PARK, 1ST FLOOR

Campus	Building	Floor	Location	Coverage in 2.4GHz	Coverage in 5GHz	WAP Service Life	Comments
CP (Capitol Park)	Building 1	2nd	CBB1 - 1	3	3	3	Only 1 AP, bad coverage

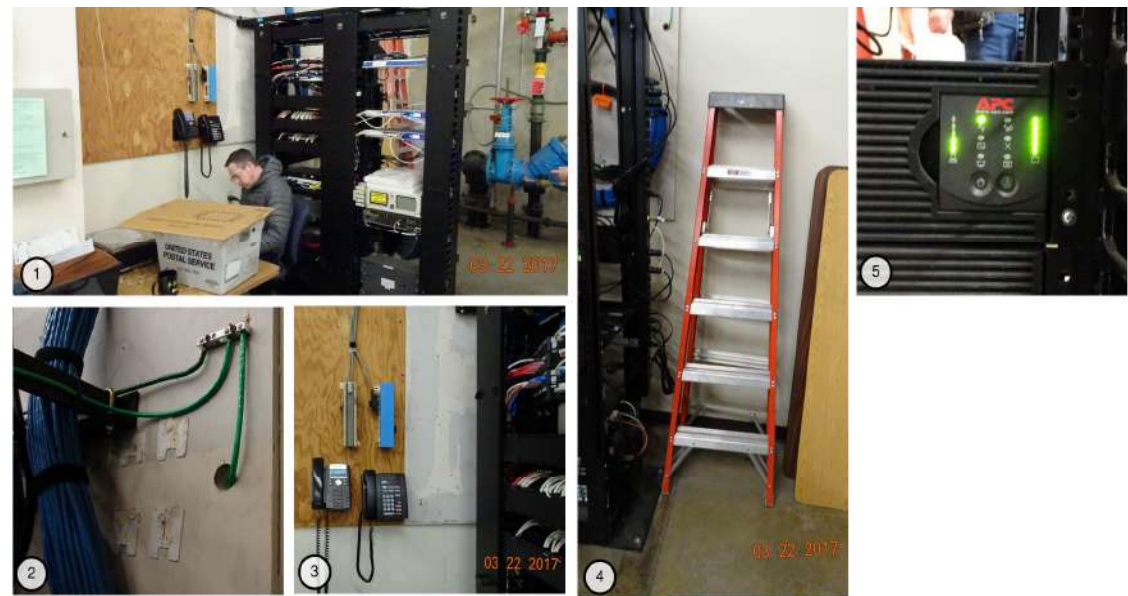
CENTRAL DISTRIBUTION: CENTRAL DISTRIBUTION, 1ST FLOOR, MDF

- POSITIVES AND NEGATIVES OF THE IMAGES ABOVE...
- 1. No access control or security for equipment. Cable management & expansion good. Drains and valves present in room - water danger.
 - 2. Grounding Buss Bar not approved type
 - 3. & 1 Clearance at rack for workspace limited – easy to bump into equipment or cables
 - 4. Ladder and adjacent objects could fall and damage equipment during earthquake.
 - 5. Load and Charge good on UPS
- Not shown – Drywall dust and dirt adjacent to equipment

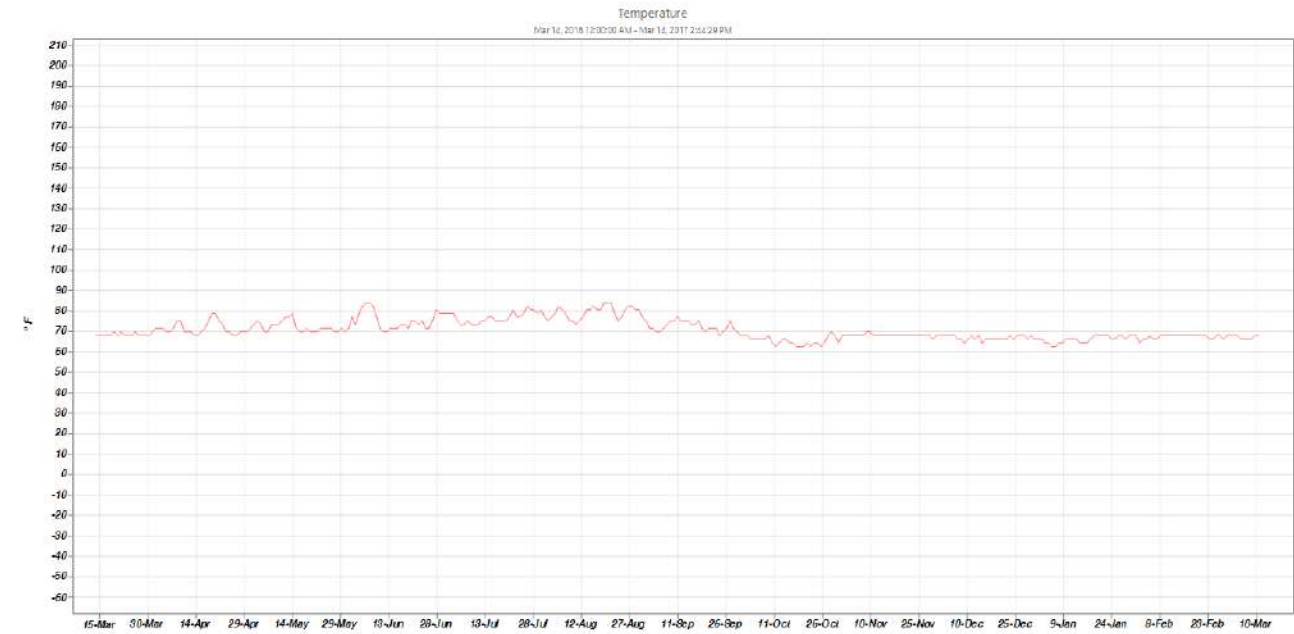
CENTRAL DISTRIBUTION: CENTRAL DISTRIBUTION, MDF TEMPERATURE

Campus	Building	Room	Location	Time	Units	Min Value	Max Value	Avg Value	Last Known Value	Notes
RC	cdmfd-ups (172.23.191.242)	Temp	CD MDF	2:52:18 PM	° F	60.8	86	70.7	66.2	Start of June and Mid Aug 2016 - Several days of high temp events over 86°

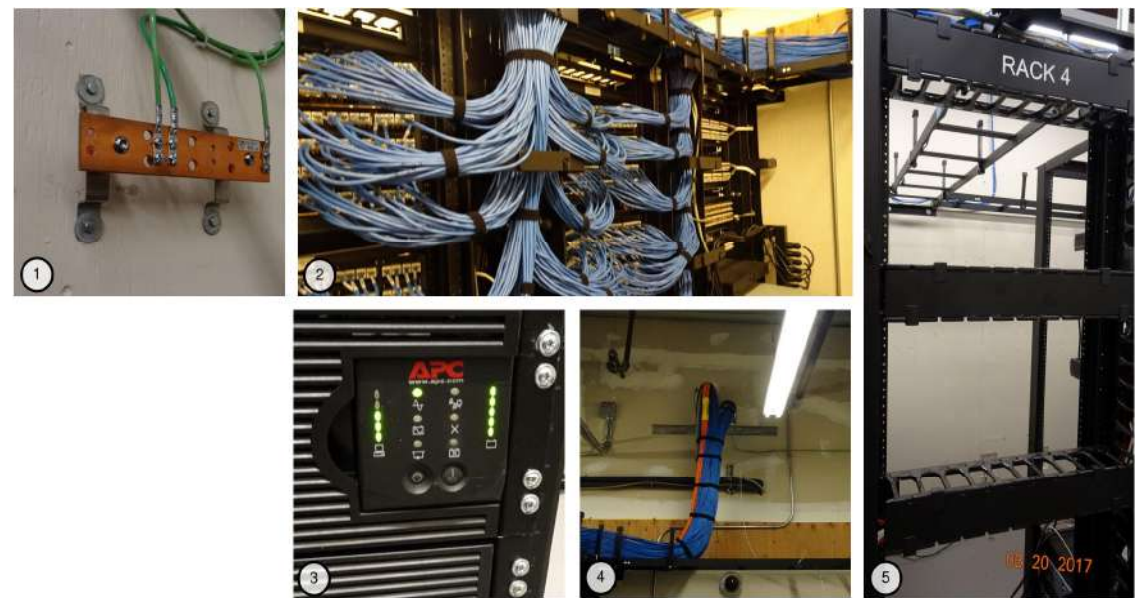
TELECOMMUNICATION ASSESSMENT
CLIMB CENTER: CLIMB CENTER, 2ND FLOOR, MDF

- POSITIVES AND NEGATIVES OF THE IMAGES ABOVE...
- 1. System ground barely conforms to PCC standard; lacks individual connections to required components.
 - 2. & 5 Rack management good, excellent room for expansion.
 - 3. Load approaching recommended headroom on UPS.
 - 4. Cable support poor.

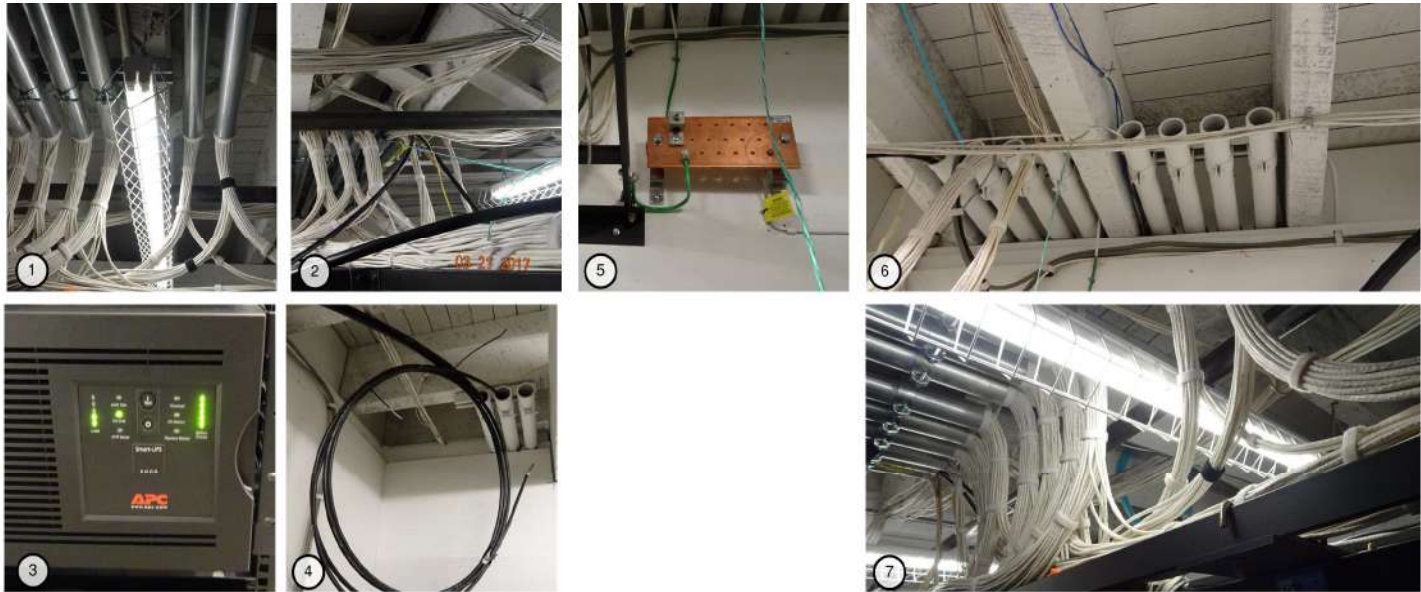
TELECOMMUNICATION ASSESSMENT
DOWNTOWN CENTER: DOWNTOWN CENTER, BASEMENT, IDF

- POSITIVES AND NEGATIVES OF THE IMAGES ABOVE...
- 1. & 2, & 7 – Data cables too close to light fixtures – Electro-magnetic interference may introduce errors.
 - 3 Load and Charge good on UPS.
 - 4. Loose unterminated fiber optic cable.
 - 5. System ground barely conforms to PCC standard; lacks individual connections to required components.
 - 6. Fire stop materials not present.

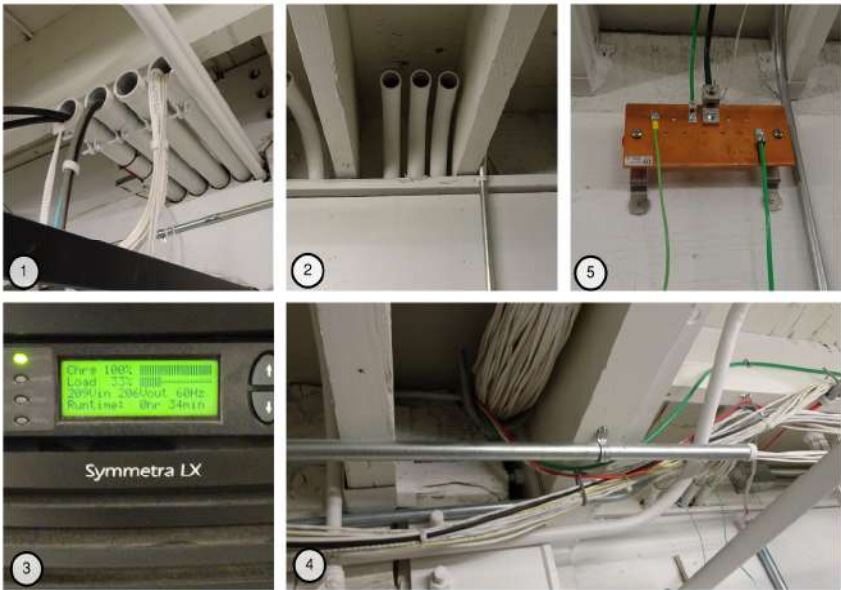
TELECOMMUNICATION ASSESSMENT
DOWNTOWN CENTER: DOWNTOWN CENTER, 3RD FLOOR, MDF

- POSITIVES AND NEGATIVES OF THE IMAGES ABOVE...
- 1. Cables lack support – Fire stop materials not present.
 - 2. Spare conduits to floors below – good expansion. Conduits not firestopped.
 - 3. Load and Charge good on UPS.
 - 4. Bridle ring cable supports induce bends and deformities in data cables, affecting performance.
 - 5. System ground barely conforms to PCC standard; lacks individual connections to required components.

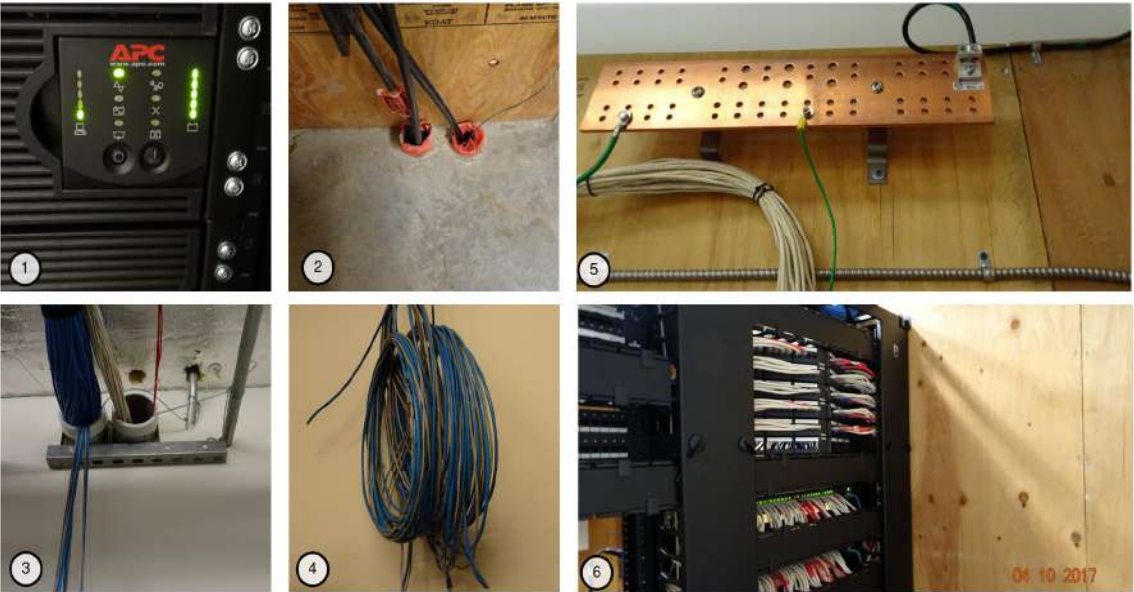
TELECOMMUNICATION ASSESSMENT
HILLSBORO CENTER: HILLSBORO CENTER, 1ST FLOOR, MDF

- POSITIVES AND NEGATIVES OF THE IMAGES ABOVE...
- 1. Load and Charge good on UPS
 - 2. & 3 Conduit capacity good, but required firestop / sealant is not present
 - 4. Unterminated cables hanging – possible work in progress
 - 5. System ground lacks individual connections to required components and conductor is undersized
 - 6. Expansion capacity adequate, good cable management

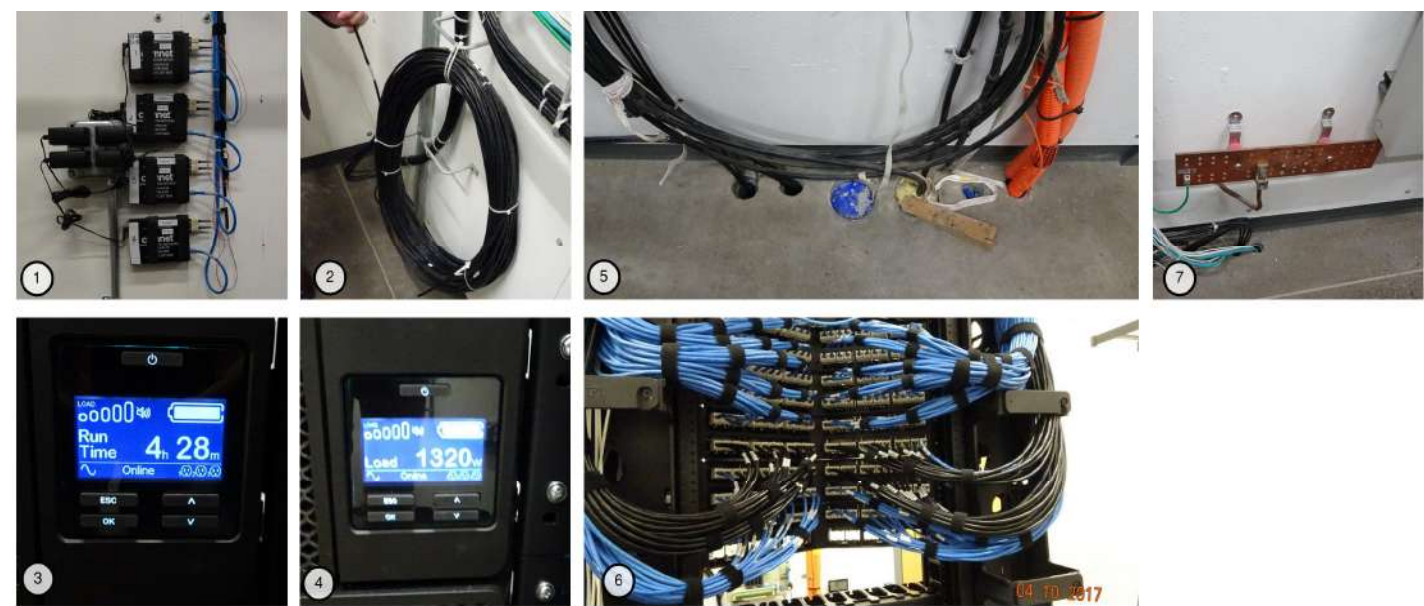
TELECOMMUNICATION ASSESSMENT
NEWBERG CENTER: NEWBERG CENTER, 1ST FLOOR, BDF

- POSITIVES AND NEGATIVES OF THE IMAGES ABOVE...
- 1. Fiber optics transceivers not protected – power easily disconnected.
 - 2. Spare fiber feeds to street – previous carrier.
 - 3. & 4 Load and Charge good on UPS.
 - 5. & 7 Cables through floor system – no sleeves or fire stop present.
 - 6. Expansion capacity adequate, good cable management.
 - 7. System ground barely conforms to PCC standard; lacks individual connections to required components.

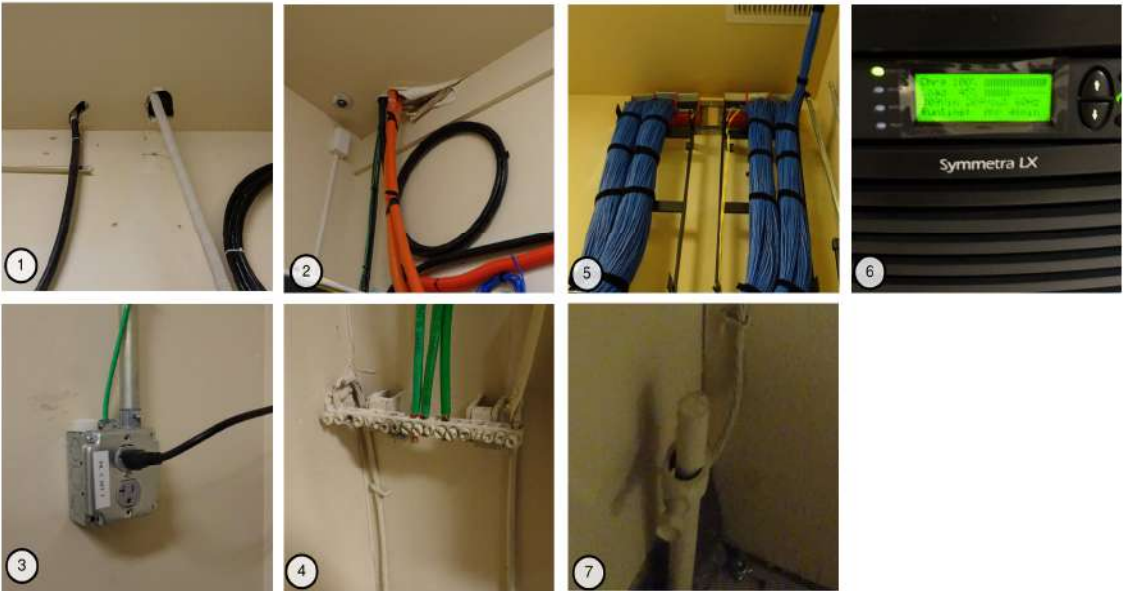
TELECOMMUNICATION ASSESSMENT
PORTLAND METRO CENTER: PORTLAND METRO CENTER, 1ST FLOOR B1, MDF

- POSITIVES AND NEGATIVES OF THE IMAGES ABOVE...
- 1 & 2 Cables and conduits penetrate ceiling - required firestop and sleeve not present.
 - 3 Ground wire not tied to correct ground source.
 - 4. Grounding Buss Bar not approved type.
 - 5. Firestop systems properly used in conformance with PCC Standards.
 - 6. Load and Charge good on UPS.
 - 7. Ground clamps at rod not approved type.

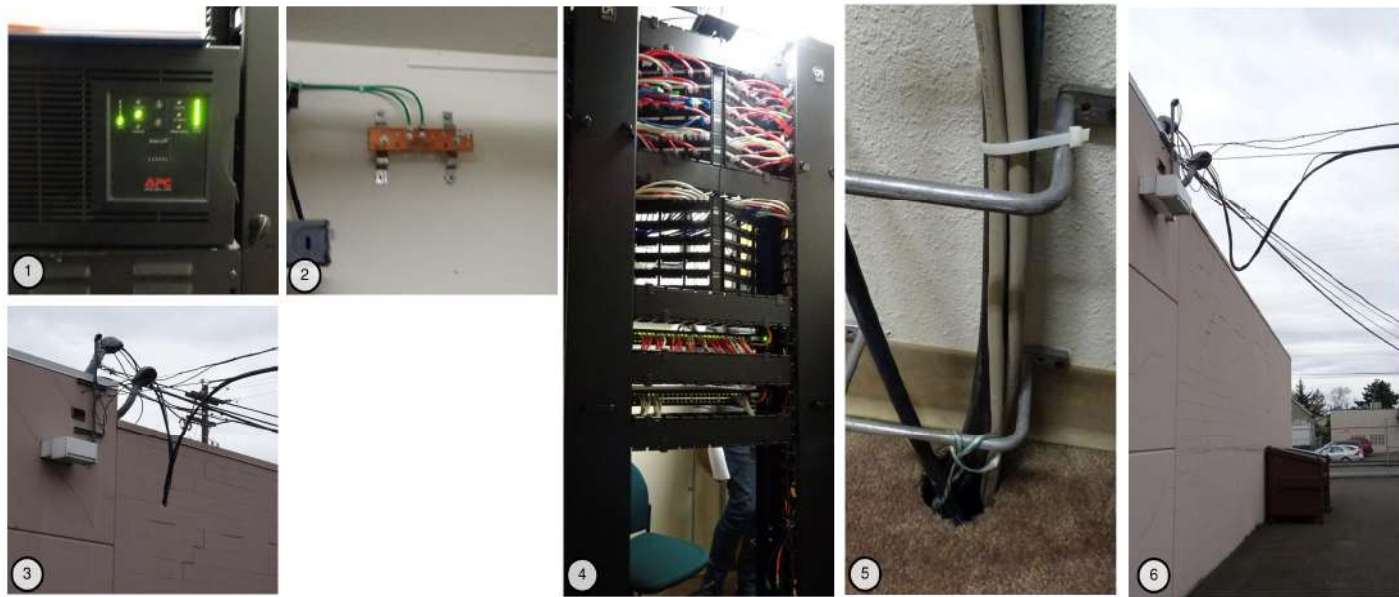
TELECOMMUNICATION ASSESSMENT
PORTLAND METRO CENTER: PORTLAND METRO CENTER, 1ST FLOOR B2, BDF

- ANALYSIS ON POSITIVES AND NEGATIVES OF THE IMAGES ABOVE...
- 1. Load and Charge good on UPS.
 - 2. System ground barely conforms to PCC standard: lacks individual connections to required components.
 - 3. & 6 – Outside overhead feed between B1 & B2 not supported well – hazard of being damaged by trash truck.
 - 4. Expansion capacity adequate, good cable management.
 - 5. Carpet in BDF not recommended – fire stop materials not present.

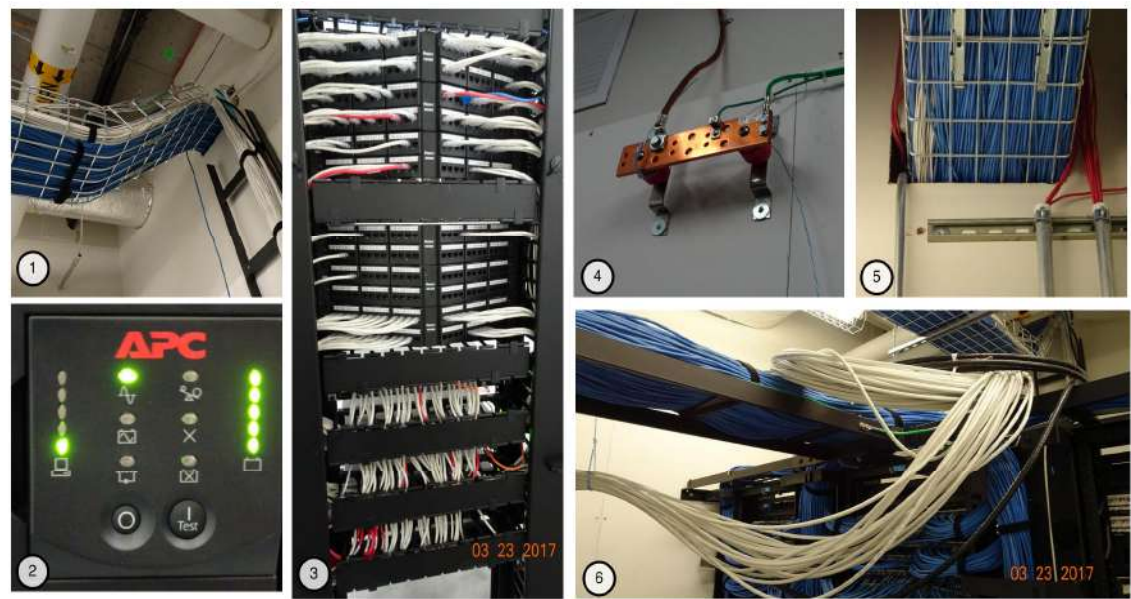
TELECOMMUNICATION ASSESSMENT
WILLOW CREEK: WILLOW CREEK, 2ND FLOOR, IDF 1

- POSITIVES AND NEGATIVES OF THE IMAGES ABOVE...
- 1. & 5 No firestop system at cable tray penetration.
 - 2. Load and Charge good on UPS.
 - 3. Expansion capacity adequate, good cable management.
 - 4. System ground conforms to PCC standard.
 - 6. Cable tray loading exceeds recommended capacity.

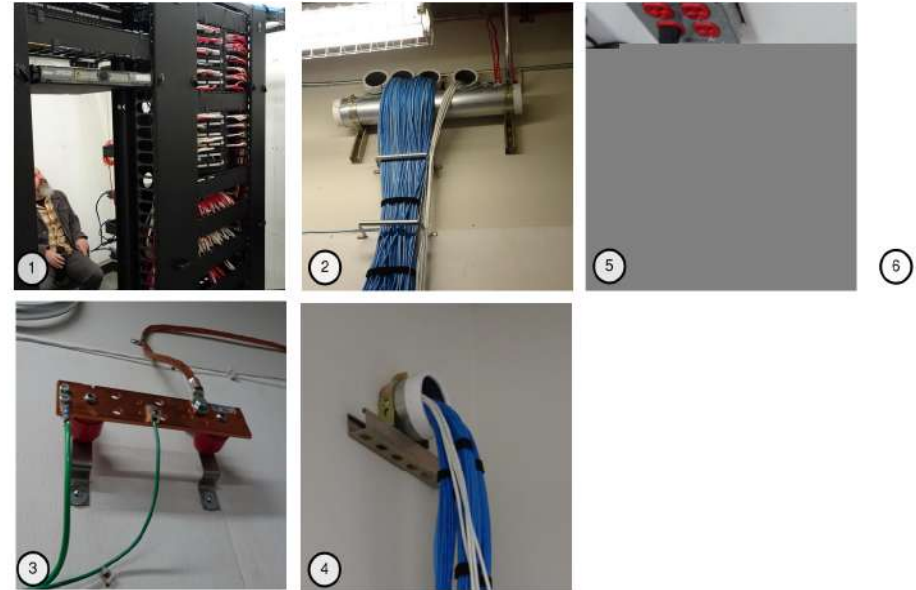
TELECOMMUNICATION ASSESSMENT
WILLOW CREEK: WILLOW CREEK, 2ND FLOOR, IDF 2

- POSITIVES AND NEGATIVES OF THE IMAGES ABOVE...
- 1. Rack management good, excellent room for expansion.
 - 2.& 4 Fire stop materials not present.
 - 3. System ground barely conforms to PCC standard; lacks individual connections to required components.
 - 5. Dirt in room bad for equipment – tape as conduit sealant not good practice.
 - 6. Power cord presents trip hazard.

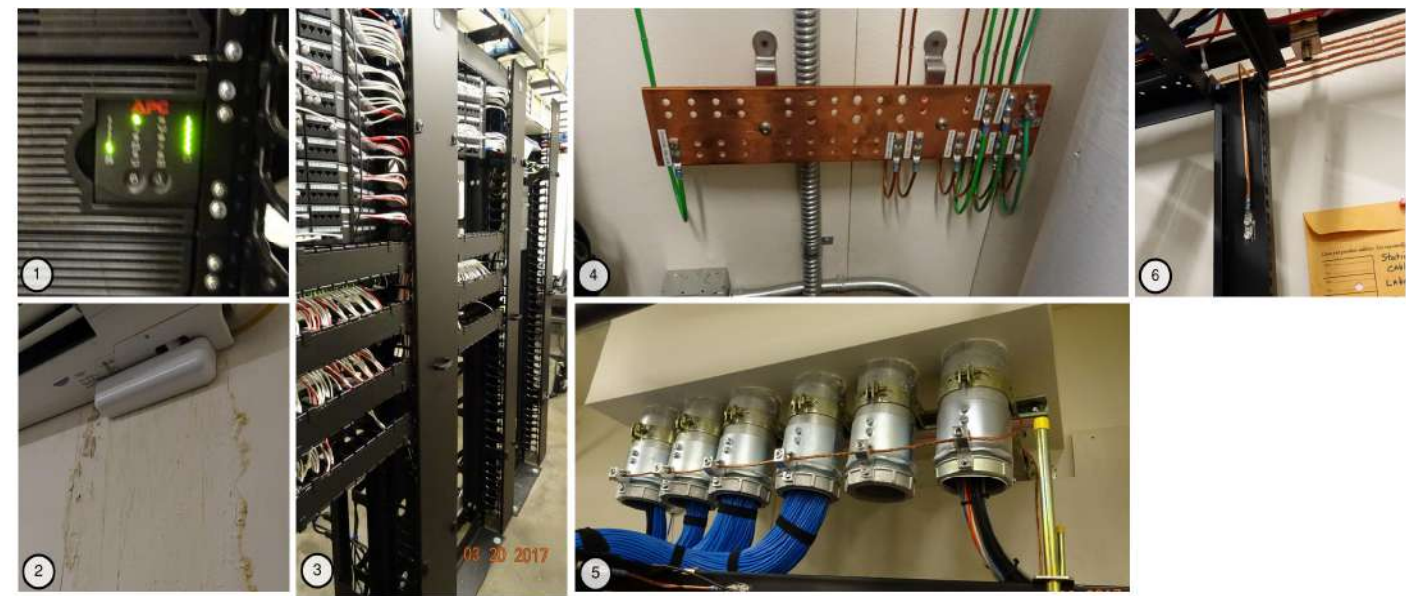
TELECOMMUNICATION ASSESSMENT
SWAN ISLAND: SWAN ISLAND, 1ST FLOOR, MDF

- POSITIVES AND NEGATIVES OF THE IMAGES ABOVE...
- 1. Load and Charge good on UPS.
 - 2. Evidence of water leak – wall damaged.
 - 3. Rack management good, excellent room for expansion.
 - 4, 5, & 6 System ground conforms to PCC standard.
