FACILITIES PLAN TECHNICAL REPORTS
Building Summary

# **CASCADE**

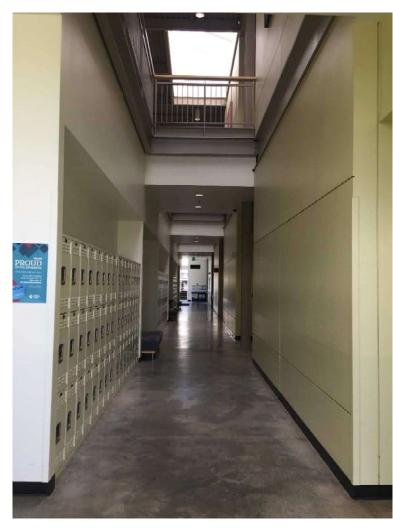
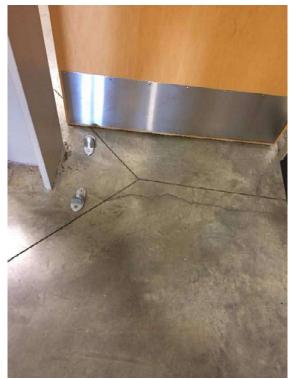
The building exhibits signs of use and required maintenance typical of a structure of this vintage and construction type. The first-floor concrete slab-on-grade exhibits areas of cracking exceeding what we would expect for a building of this use and vintage; see adjacent photos. Cracking likely occurred during construction. We recommend repairing the cracks to avoid long term maintenance and possible tripping hazards.

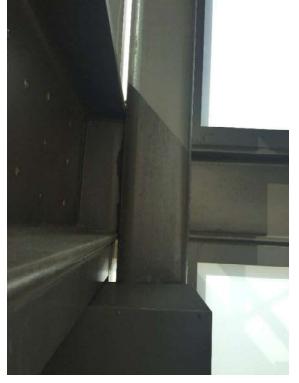
The stair tower exhibited signs of moisture accumulation. We recommend addressing the moisture to avoid long term maintenance issues. The building exhibits signs of use and required maintenance typical of a structure of this vintage and construction type.

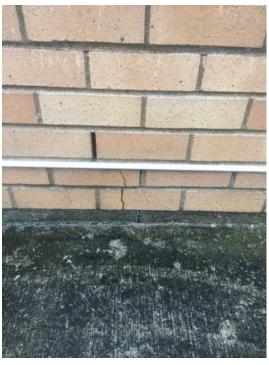
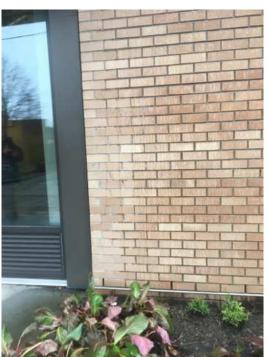
The building exhibits signs of use and required maintenance typical of a structure of this vintage and construction type. Photographs show typical maintenance conditions observed.

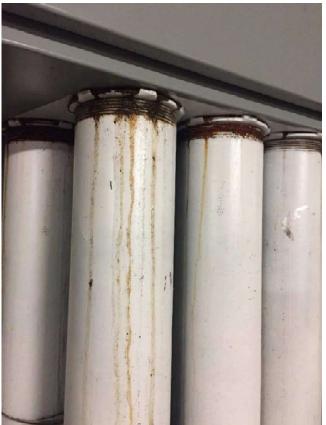
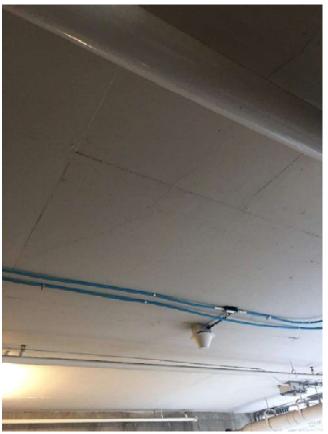
Cracking in the post tensioned concrete slab was observed at the southern end of the garage and water intrusion is apparent in some areas of the garage. We recommend addressing the issues to help avoid long term maintenance issues.

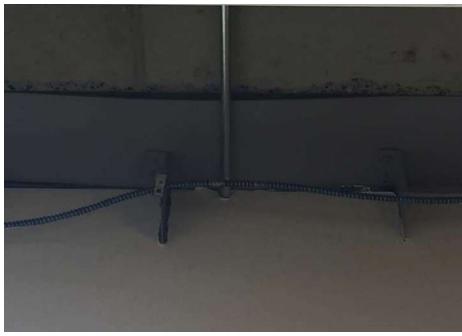
We noted spalling and deflection along slab edge closure elements at the underside of the floors shown in the photo below. It appears to be non-structural. We recommend further investigation of the deflecting plate.

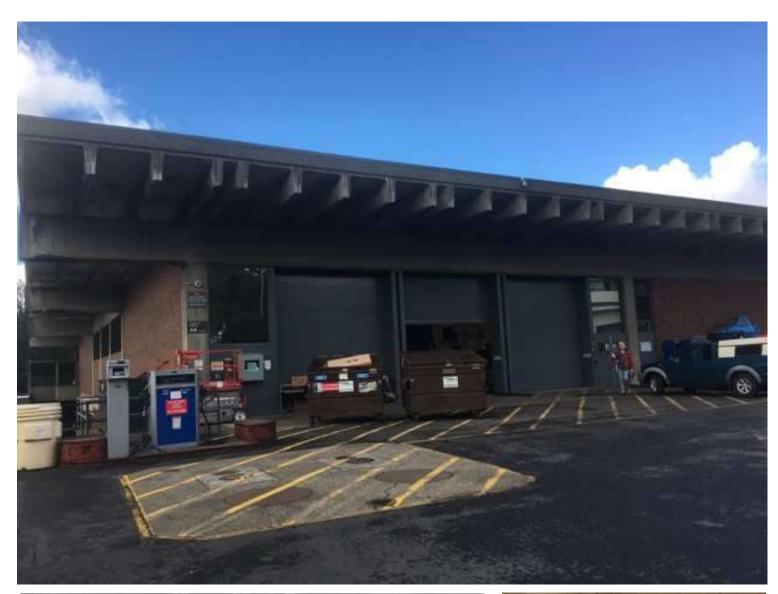
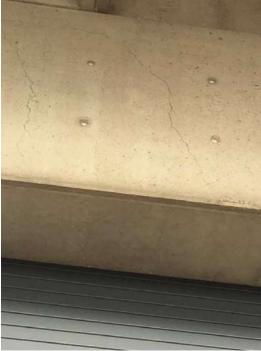
The building exhibits signs of use and required maintenance typical of a structure of this vintage and construction type. Visible cracking was observed at some of the exterior concrete girders. Interior conditions were not visible. We recommend a maintenance and repair program to seal existing cracks to avoid water intrusion and further deterioration.

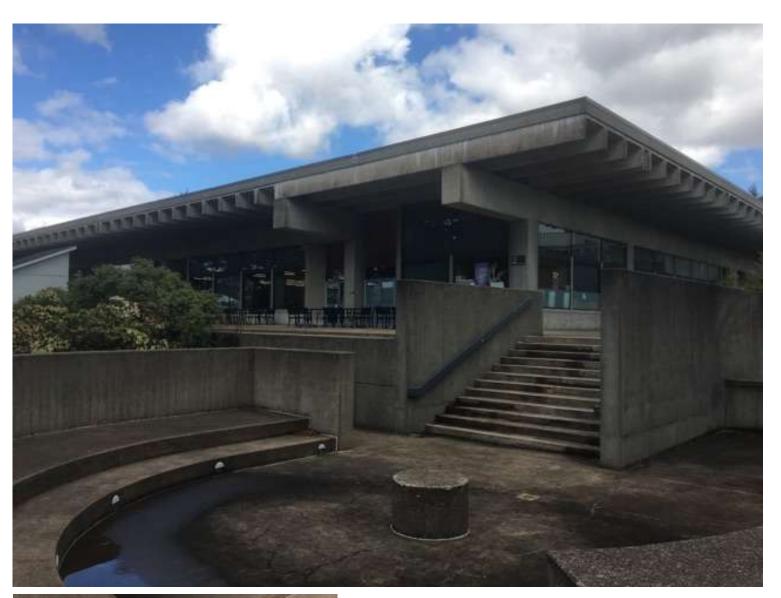
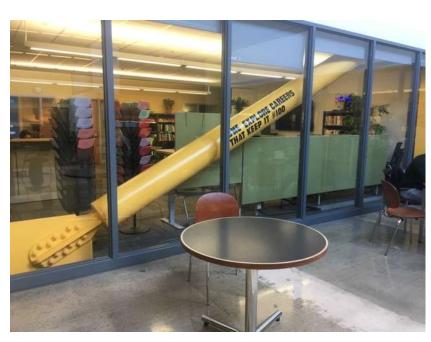
The building exhibits signs of use and required maintenance typical of a structure of this vintage and construction type. Visible cracking was observed at some of the exterior concrete girders. Interior conditions were not visible. We recommend a maintenance and repair program to seal existing cracks to avoid water intrusion and further deterioration.

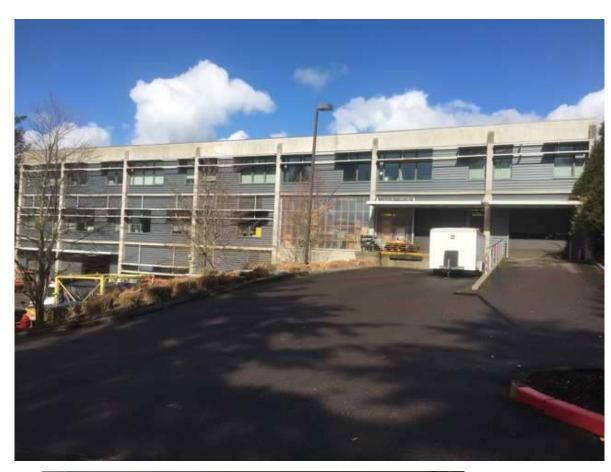
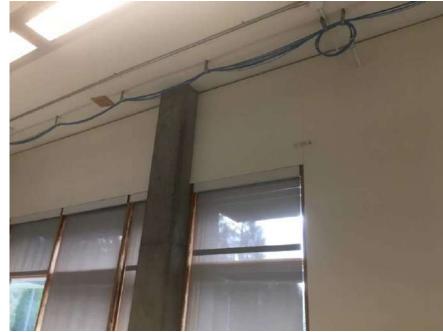
The building exhibits signs of use and required maintenance atypical of a structure of this vintage and construction type. Elevated floor slabs are visibly deflected with visible cracking. Anecdotal evidence suggests that movement continues to occur. Doors are repaired to maintain operability. Sheetrock walls, soffits, and ceilings are continuously repaired. We recommend further investigating the structural condition of the building.

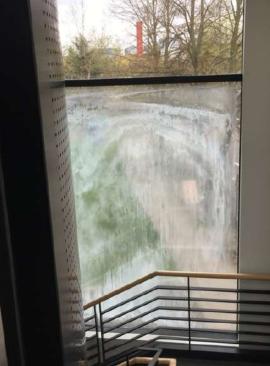
We noted signs of water damage at exterior brick veneer and foggy windows. Staff on-site indicated some deflection concerns above and below roof 201. We could not verify the deflections anecdotally described during our visit. In general, the building exhibits signs of use and required maintenance typical of a structure of this vintage and construction type.

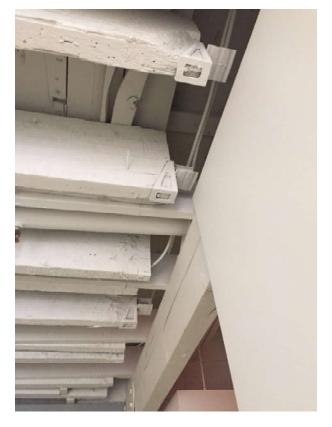
During our walkthrough, we noted the lack of support at the ends of some of the existing floor joists. It is unclear how the joists are currently supported. We recommend further investigation and the addition of a beam or wall to support the joists.

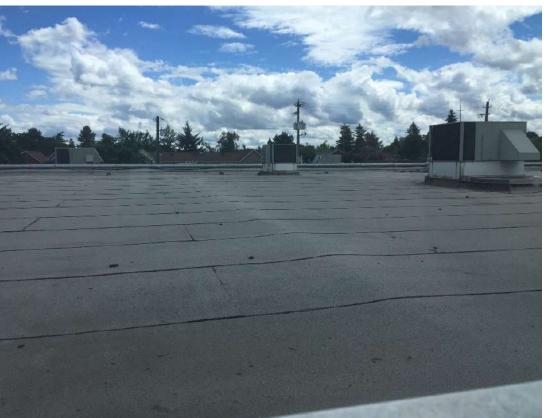
The building exhibited signs of settlement and differential shrinkage of framing typical of buildings of this type and vintage. The roof, shown below, is crowned at points of support which may lead to ongoing maintenance. In general, the building exhibits signs of use and required maintenance typical of a structure of this vintage and construction type.

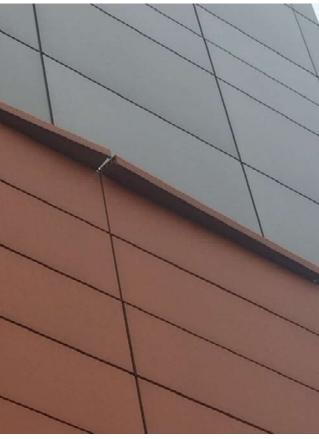
While conducting a walkthrough, we noted lose terra cotta siding shown in the adjacent photo. We alerted maintenance personnel to the issue. We also noted signs of deflection within the floor slabs at approximately the mid-point of the building plan. It is unclear what is causing the deflection shown in the adjacent photo. We recommend further study of the floor deflections.
