FACILITIES PLAN TECHNICAL REPORTS

# Civil Site Accessibility and Utilities

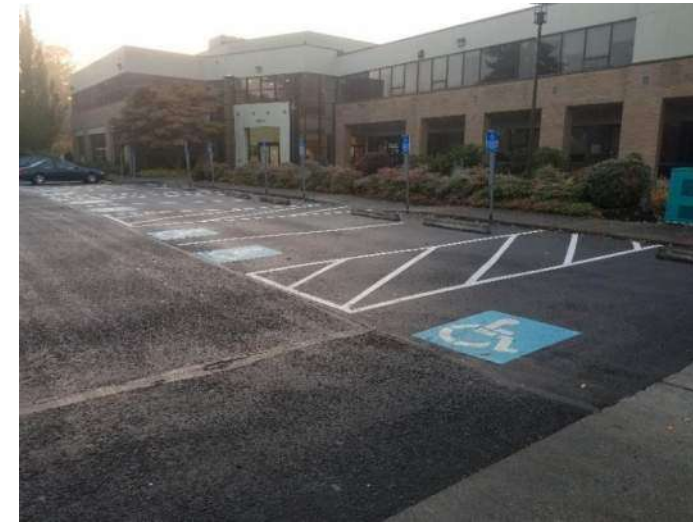
### Cascade 1

Keynote 5 - [Table 2](#)

ACC 2: S6, A3, S7, S8, A4, S9, S10, A5, S11, S12, A6, S13 - [Table 5](#)

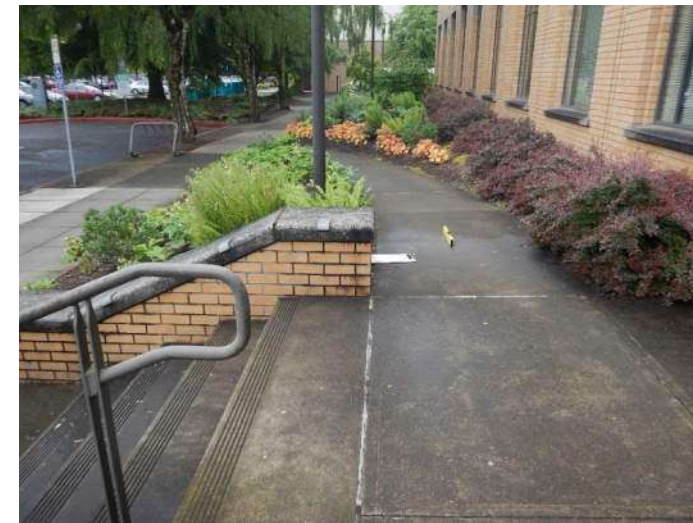
### Cascade 2

Keynote 6 - [Table 2](#)

Ramp NE of SSB building North Entrance

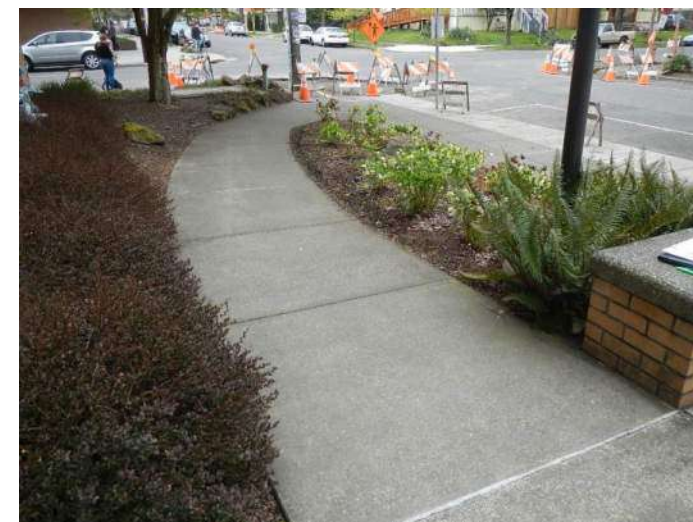
Keynote 6 - [Table 2](#)

Ramp NW of SSB building North Entrance

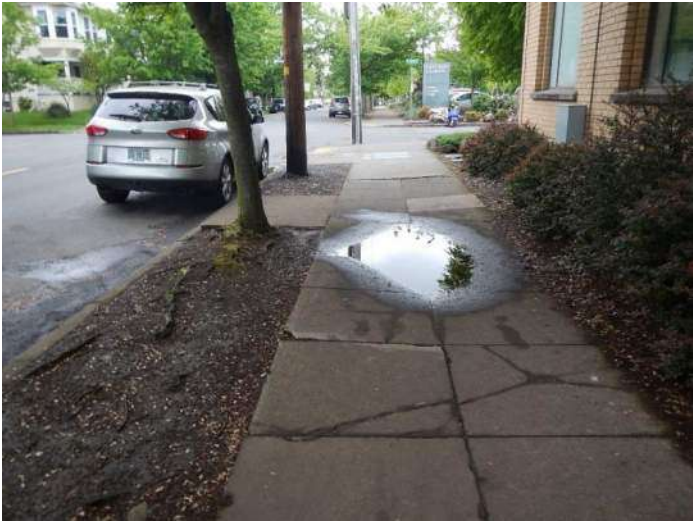
**Cascade 4**  
Keynote 8 - [Table 2](#)

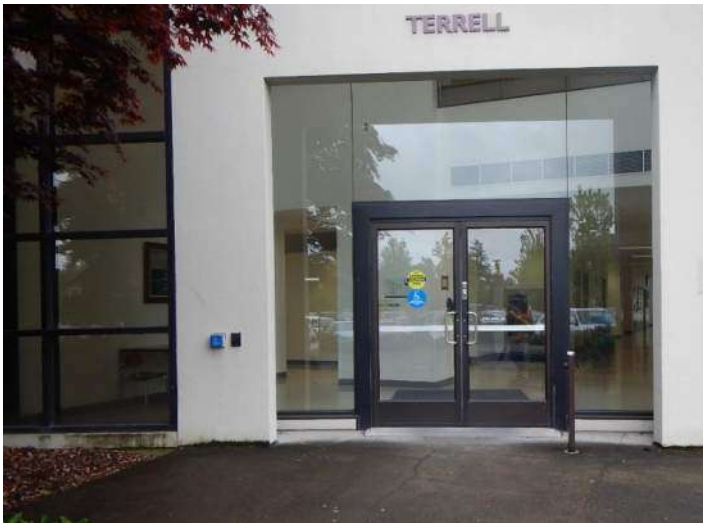
**Cascade 5**  
Keynote 9 - [Table 2](#)

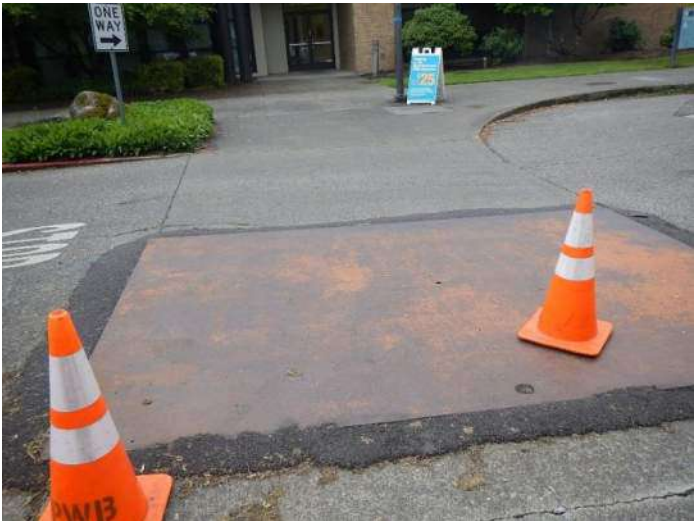
**Cascade 6**  
Keynote 4 - [Table 2](#)

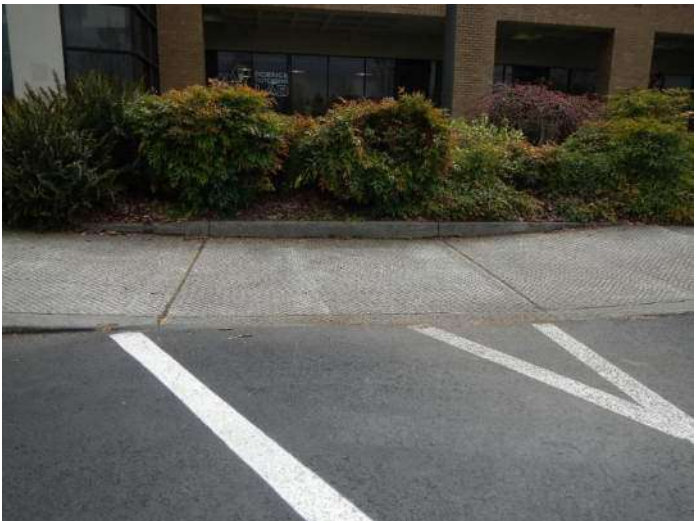
**Cascade 7**  
Curb Ramp 1 - [Table 3](#)

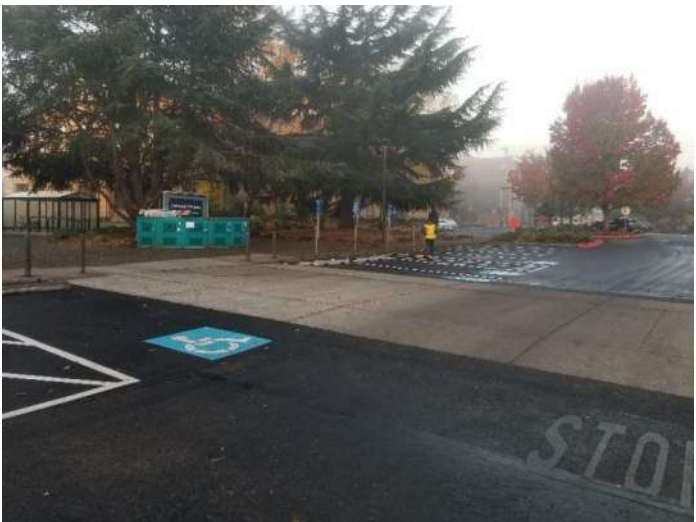
**Cascade 8**  
Curb Ramp 2 - [Table 3](#)

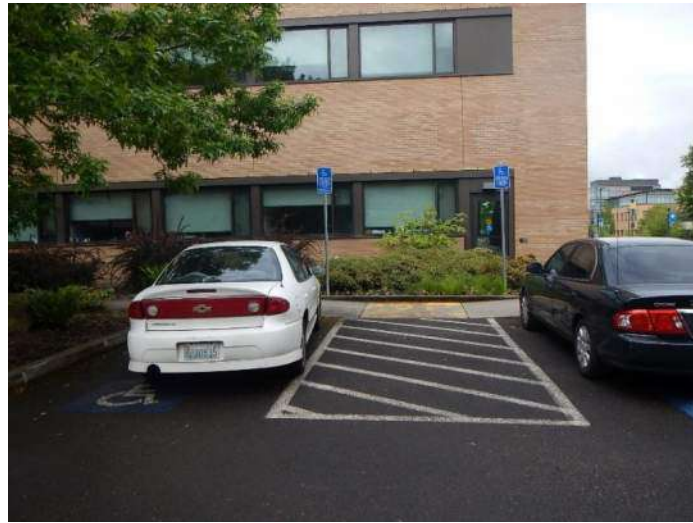
**Cascade 9**Curb Ramp 5 - [Table 3](#)ACC 3: S16, A8, S17 - [Table 5](#)

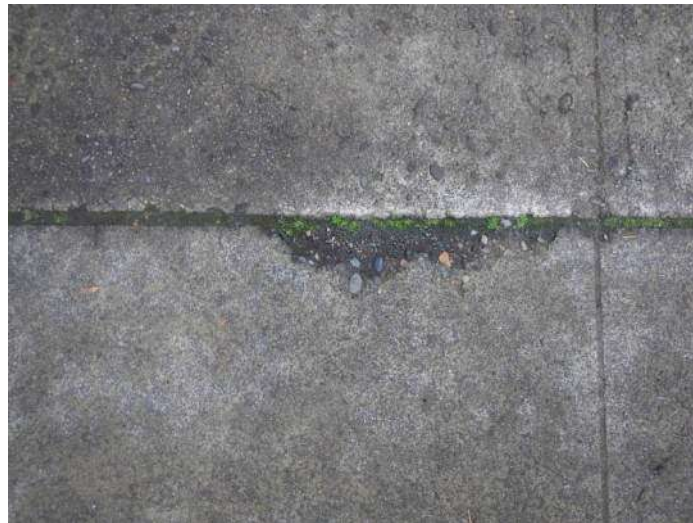
Obstruction Number	Type of Non-Compliance	Description	Severity
H2	Hole	½" Hole at Joint <a href="#">Photo: Cascade 10</a>	A
H3	Hole	Hole from cracking in concrete <a href="#">Photo: Cascade 26</a>	A
H4	Holes	Caused by exposed, rough aggregate <a href="#">Photo: Cascade 3</a>	B

**Cascade 10**Hole 2 - [Table 4](#)

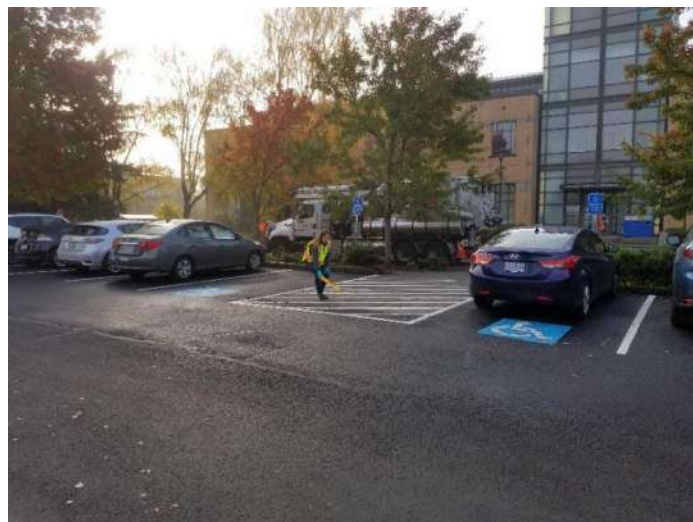
**Cascade 11**ACC 1: S1, A1, S2 - [Table 5](#)

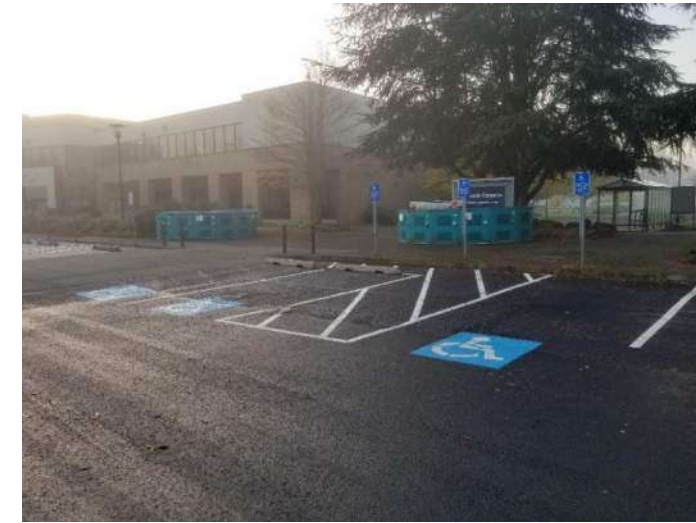
**Cascade 12**ACC 2: S3, A2, S4, S5 - [Table 5](#)

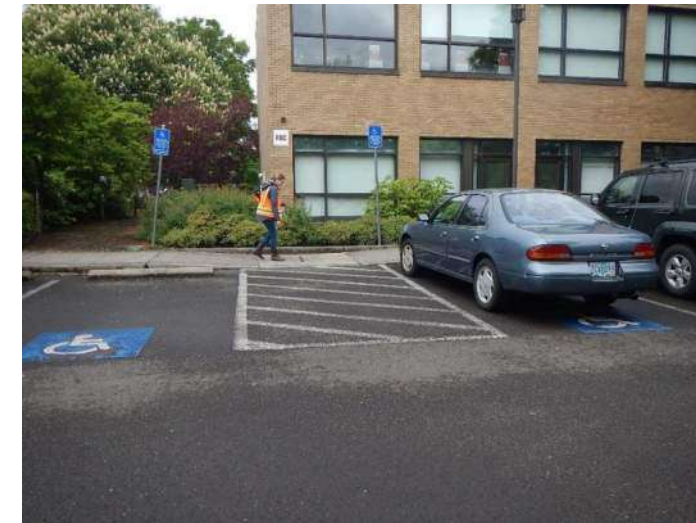
**Cascade 13**ACC 3: S14, A7, S15 - [Table 5](#)

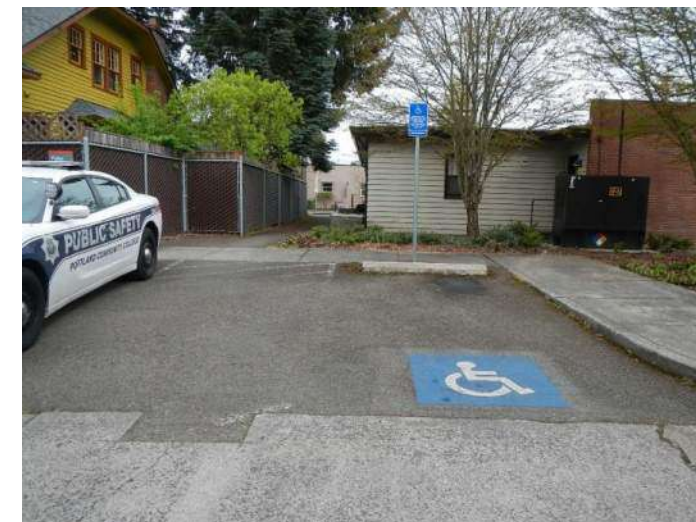
**Cascade 14**ACC 3: A9, S18 - [Table 5](#)

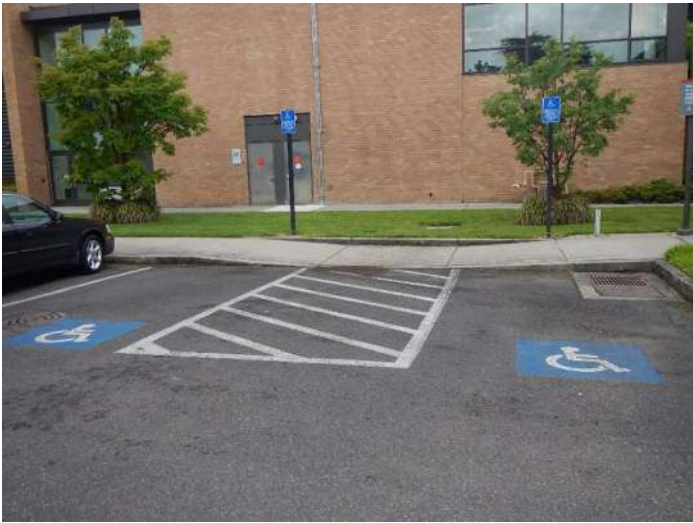
**Cascade 15**  
ACC 6: S19, A10, S20 - [Table 5](#)

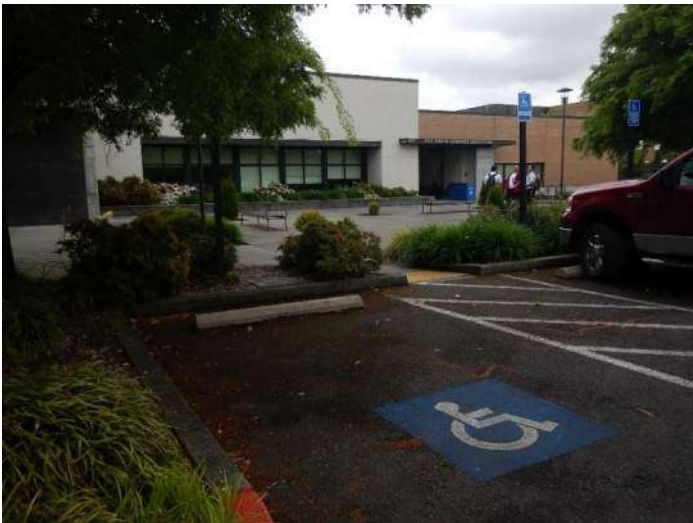
**Cascade 16**  
ACC 7: S21, A11, S22 - [Table 5](#)

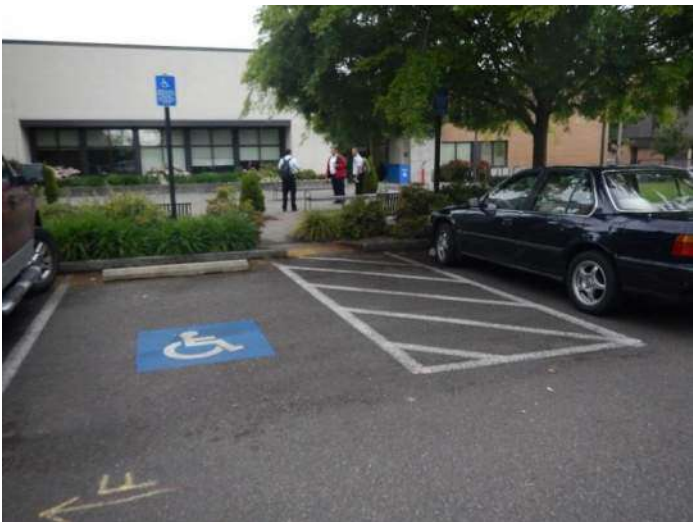
**Cascade 17**  
ACC 7: S23, A12, S24 - [Table 5](#)

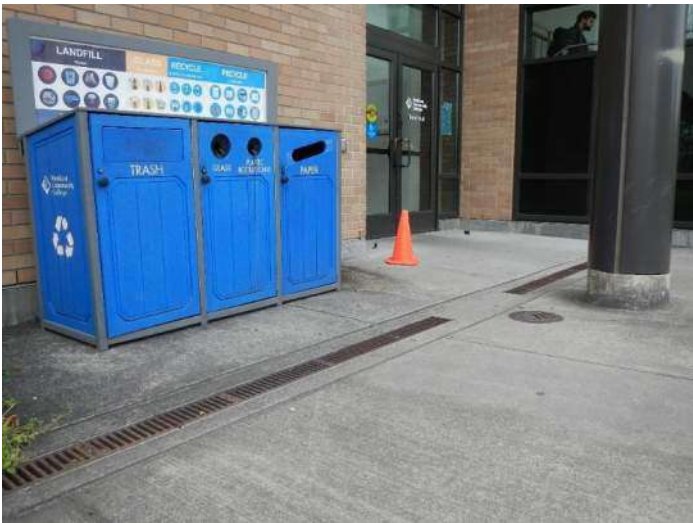
**Cascade 19**  
Keynote 2 - [Table 2](#)  
Trash receptacle slope in front of TH building

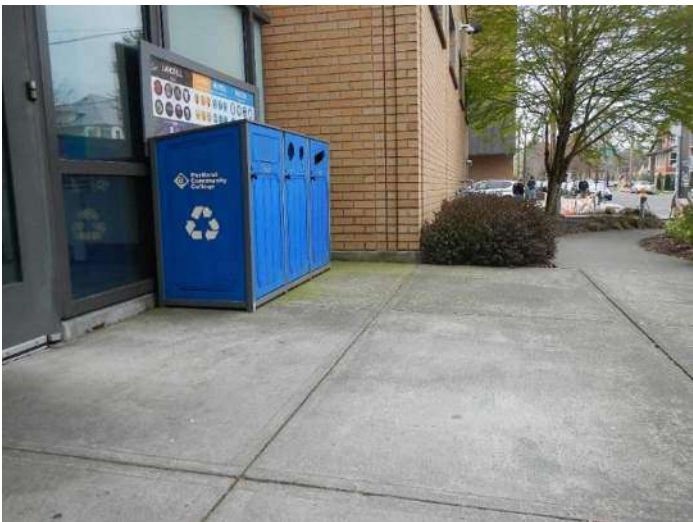
**Keynote 2**  
Trash receptacle slope in front of SSB building

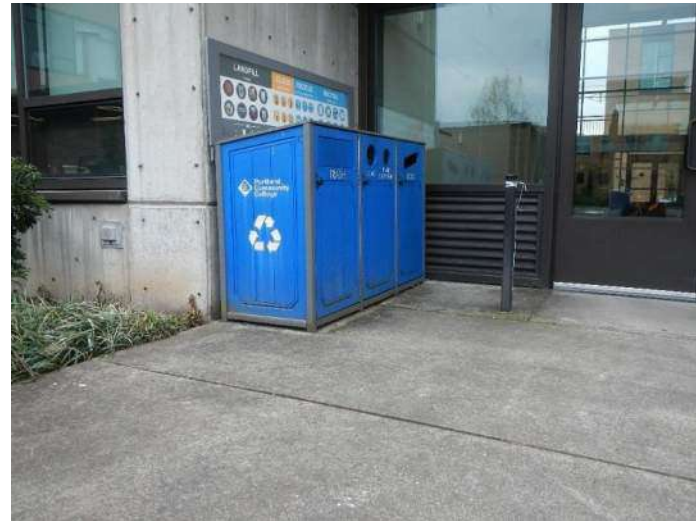
**Keynote 2**  
*Trash receptacle slope in front of  
MAHB building*

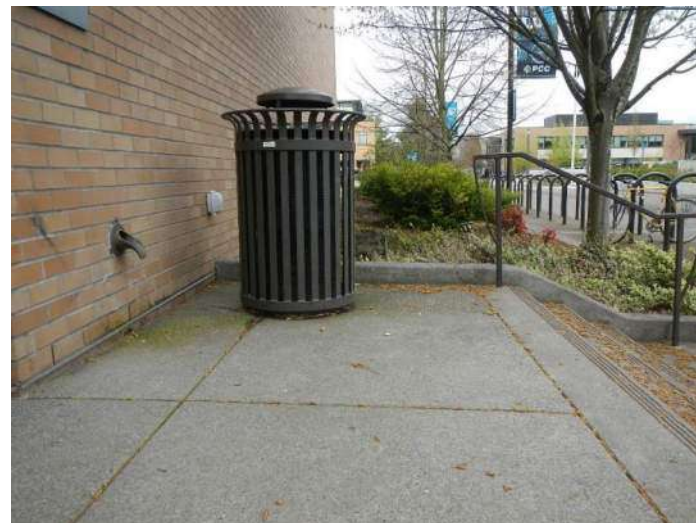
**Keynote 2**  
*Trash receptacle slope by MAHB  
building side entry*

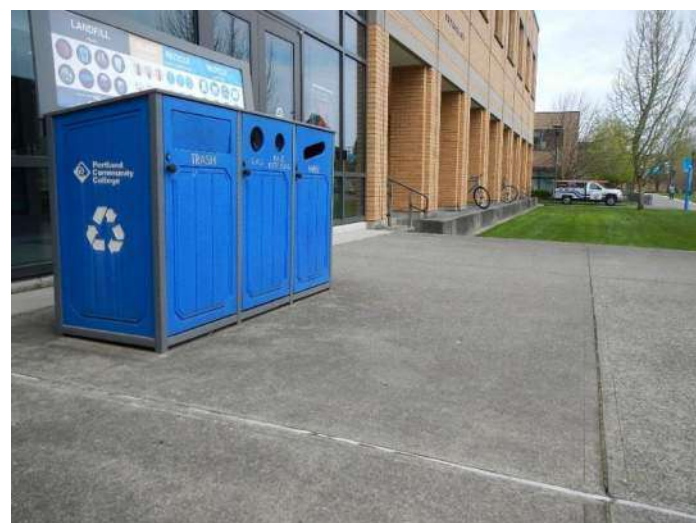
**Keynote 2**  
*Trash receptacle slope by SSB  
building south entry*

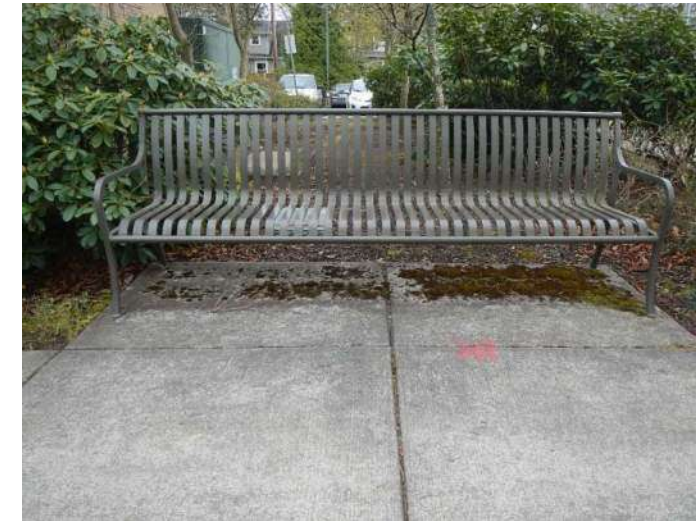
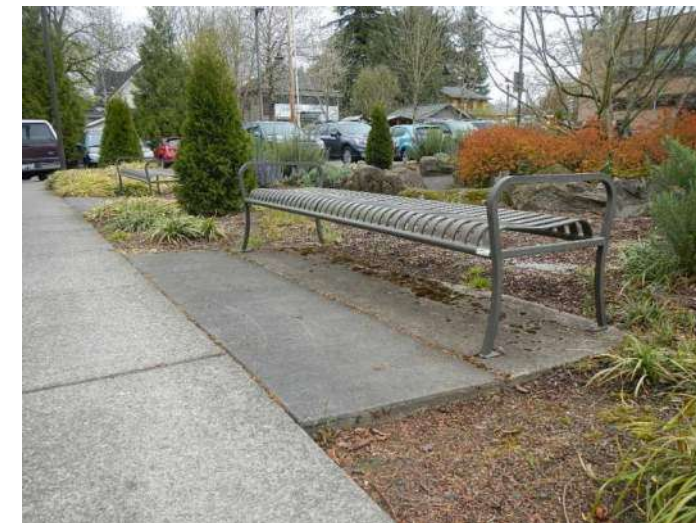
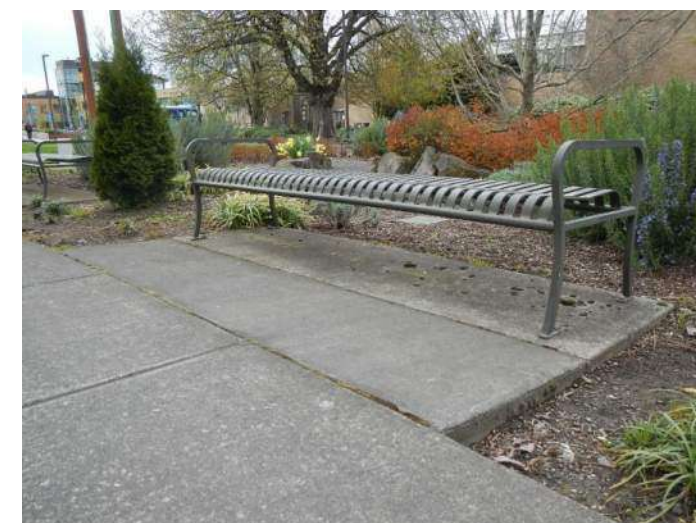
Keynote	Type of Non-Compliance	Description	Severity
3	Cross Slope	Non-compliant cross slope at bench <a href="#">Photo: Cascade 20</a> (not all benches with inadequate cross slopes are pictured)	A
4	Steel plate	Steel plate with slippery surface <a href="#">Photo: Cascade 6</a>	B
5	Accessible Route	No route from stalls to curb <a href="#">Photo: Cascade 1</a>	A
6	Ramp	No landing or handrail on ramp <a href="#">Photo: Cascade 2</a>	C
7	Obstruction	Exposed aggregate on concrete surface <a href="#">Photo: Cascade 3</a>	B
8	Accessible Route	Ponding along sidewalk <a href="#">Photo: Cascade 4</a>	A
9	Accessible Entrance	Non-compliant slope at automatic door button <a href="#">Photo: Cascade 5</a>	B
10	Edge Protection	No edge protection protruding past handrail on ramp <a href="#">Photo: Cascade 21</a>	A
11	Vault Lid	Vauld lid with slippery surface <a href="#">Photo: Cascade 22</a>	B

**Cascade 20:**  
*Keynote 3A - [Table 2](#)  
Benches between JH and TEB  
buildings*

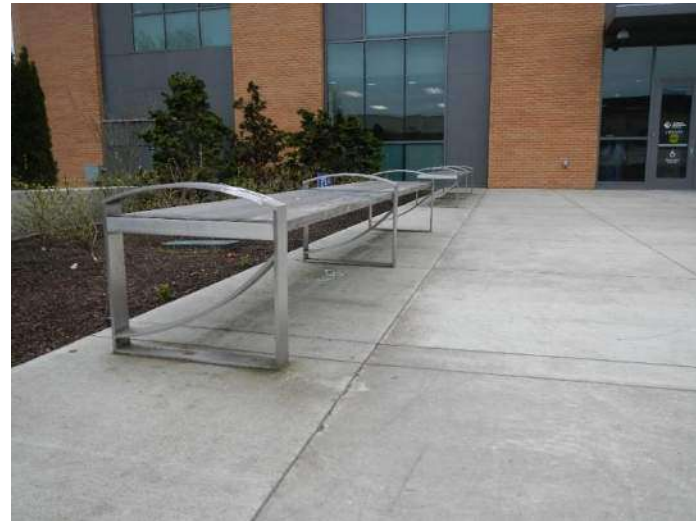
**Keynote 3**  
*Bench in front of Library with non-compliant cross slope*

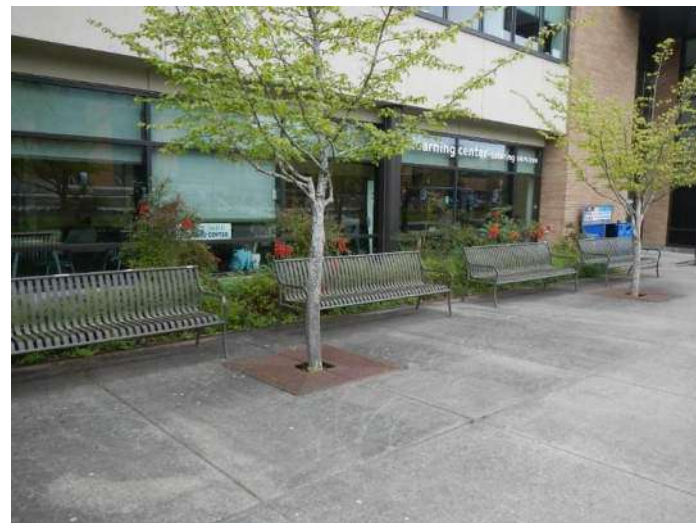
**Keynote 3**  
*Bench by TH building with non-compliant cross slope*

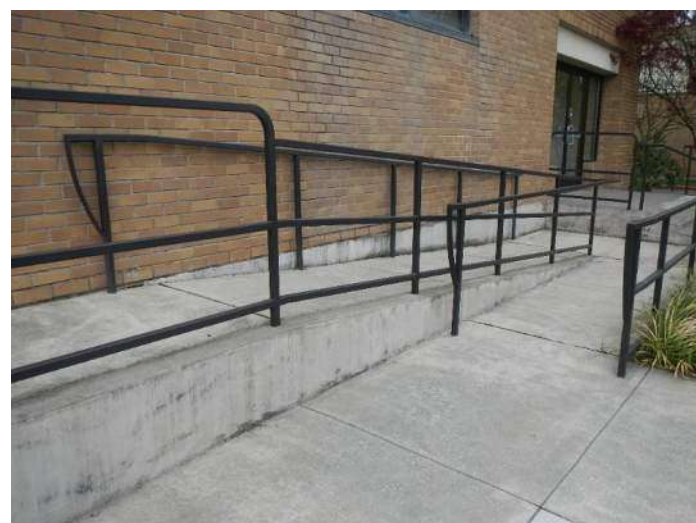
**Cascade 21**  
*Keynote 10 - [Table 2](#)*

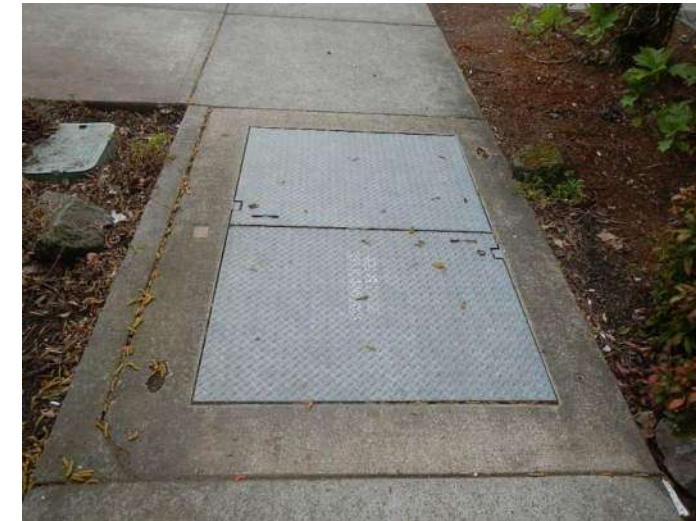
**Cascade 22**  
*Keynote 11 - [Table 2](#)*

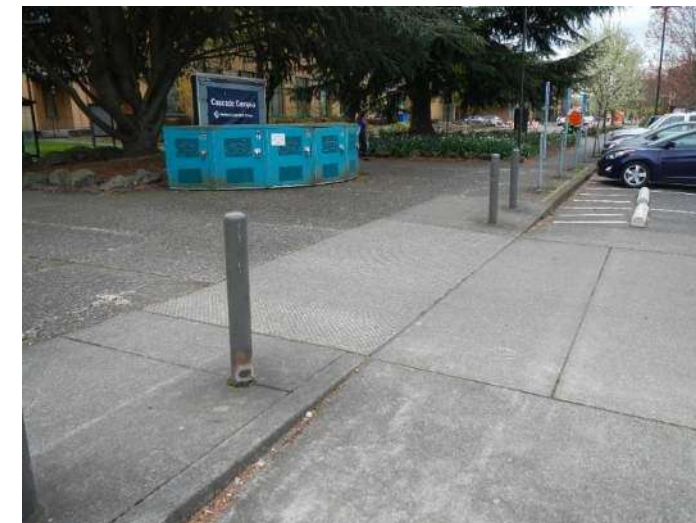
**Cascade 23**  
*Curb Ramp 3 - [Table 3](#)*

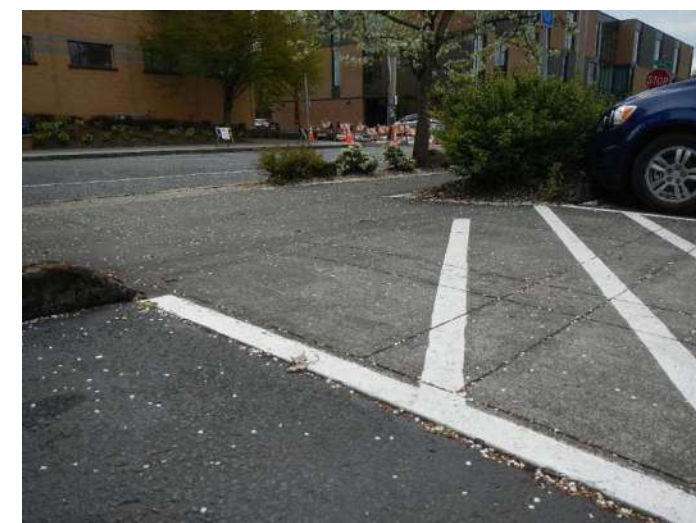
**Cascade 24**  
*Curb Ramp 4 - [Table 3](#)*

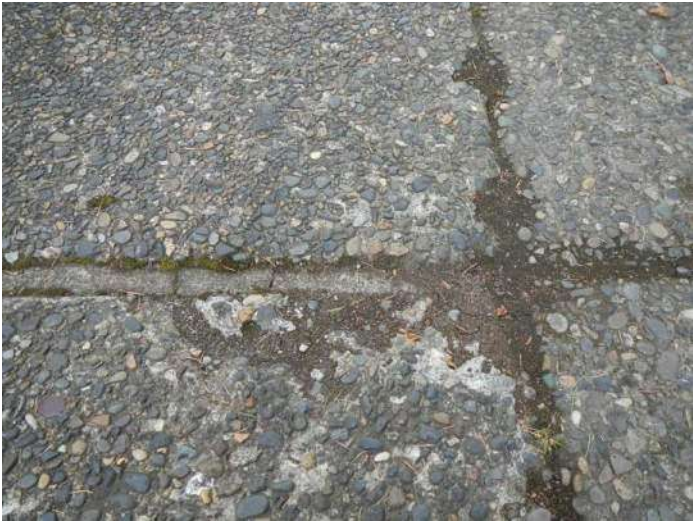
**Cascade 25**  
Hole 1A - [Table 4](#)

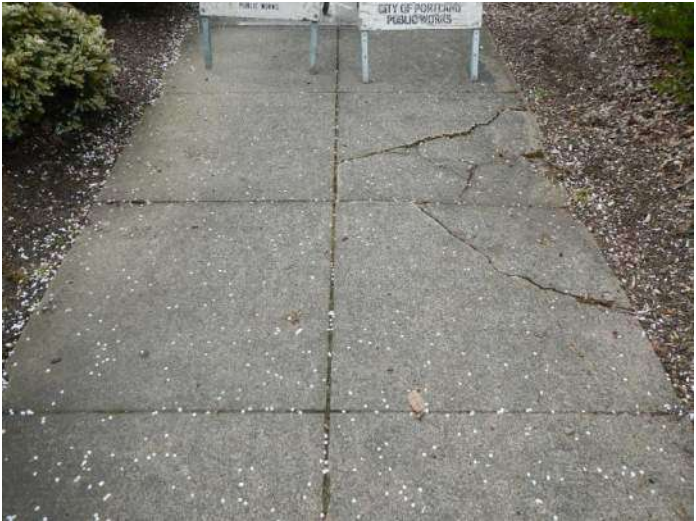
**Cascade 26**  
Hole 3 - [Table 4](#)

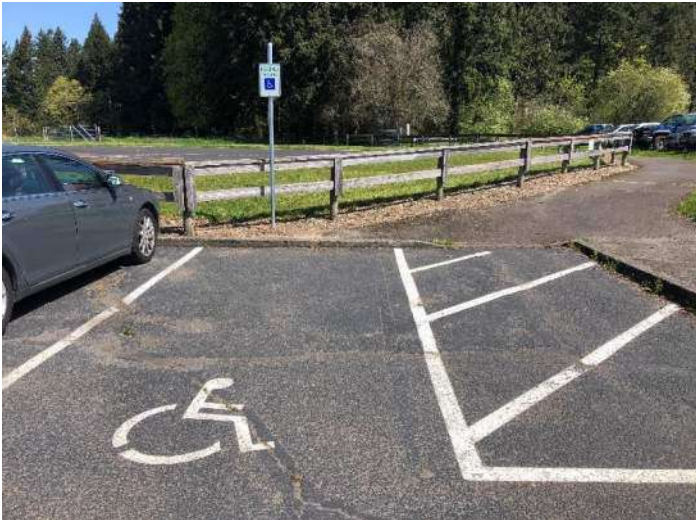
Keynote	Type of Non-Compliance	Description	Severity
1	Location of Stalls	The ADA stall should be placed in closer proximity to the building <a href="#">Photo: Rock Creek 1</a>	B
2	Holes, Lips, Obstruction, Slopes	Route contains non-compliant holes, obstructions, and no clearly defined path <a href="#">Photo: Rock Creek 3</a>	C
3	Running Slope	Handrails required where running slope exceeds 5% <a href="#">Photo: Rock Creek 4</a> (not all ramps with inadequate running slopes are pictured)	A
4	Cross Slope	Cross slopes adjacent to trench drain exceed compliance <a href="#">Photo: Rock Creek 30</a>	B
5	Accessible Route	No clearly identified accessible route across parking lot <a href="#">Photo: Rock Creek 2</a>	C
6	No Evaluation Necessary	The use of Building 1 is for public safety personnel only, therefore it is not necessary to have accessible entrances for students	N/A

**Rock Creek 1**  
Keynote 1 - [Table 6](#)  
ACC 1: A1, S1 - [Table 9](#)

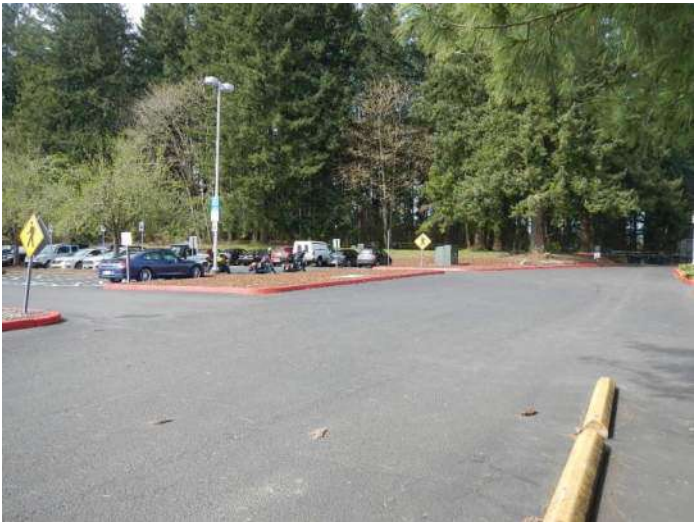
**Rock Creek 2**  
Keynote 5 - [Table 6](#)

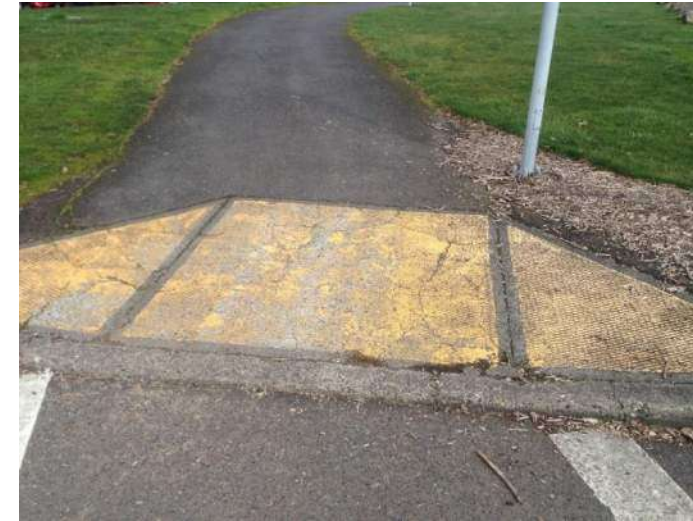
**Rock Creek 5**  
Curb Ramp 1 - [Table 7](#)

Ramp Number	Type of Non-Compliance	Description	Severity
1	No Landing Cross Slope (Ramp) Lip Concrete Condition	Concrete in poor condition <a href="#">Photo: Rock Creek 5</a>	C A A A
2	No Domes Cross Slope (Ramp)	<a href="#">Photo: Rock Creek 6</a>	C C
3	Cross Slope (Ramp) Flare Slope	<a href="#">Photo: Rock Creek 7</a>	B
4	No Domes Cross Slope (Landing) Cross Slope (Ramp) Flare Slope Running Slope (Ramp)	<a href="#">Photo: Rock Creek 8</a>	C
5	No Domes Cross Slope (Ramp) Running Slope (Landing)	Concrete in poor condition <a href="#">Photo: Rock Creek 9</a>	C

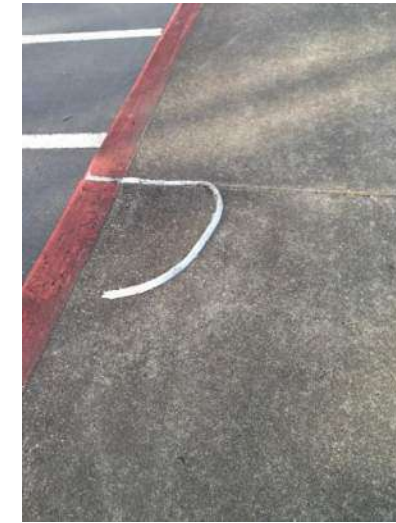
**Southeast 7**Hole 1, Hole 2, Hole 3, Hole 4, Hole 5 - [Table 12](#)

Obstruction Number	Type of Non-Compliance	Description	Severity
H1, H2, H3, H4, H5	Hole	Holes along the concrete sidewalk at the joints due to failure of adhesive connection <a href="#">Photo: Southeast 7</a>	A

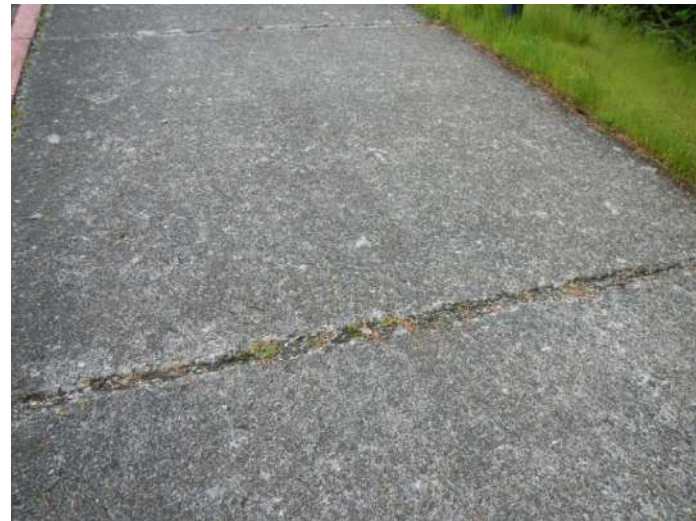
**Sylvania 1**Keynote 1 - [Table 14](#)

Keynote	Type of Non-Compliance	Description	Severity
1	Non-compliant slope	Cross slope at joint exceeds regulations <a href="#">Photo: Sylvania 1</a>	B
2	Obstruction at Joints	Obstructions caused by cracking at concrete joints <a href="#">Photo: Sylvania 2</a>	A
3	Accessible Route	No clearly identified accessible route across parking lot <a href="#">Photo: Sylvania 3</a> (not all areas are pictured)	A
4	Ramp Landing	Landing in middle of ramp has non-compliant cross slope, running slope and a lip <a href="#">Photo: Sylvania 4</a>	C
5	Hand Rail on One Side Only (Level 1)	Handrail is required to be on both sides of ramp <a href="#">Photo: Sylvania 5</a>	A
6	No Accessible Route	No route to the bus stop <a href="#">Photo: Sylvania 6</a>	C
7	No clearly identified route	No route from ADA stalls to sidewalk <a href="#">Photo: Sylvania 7</a>	C
8	No Handrail	Handrail is required on both sides of ramp <a href="#">Photo: Sylvania 11</a>	C

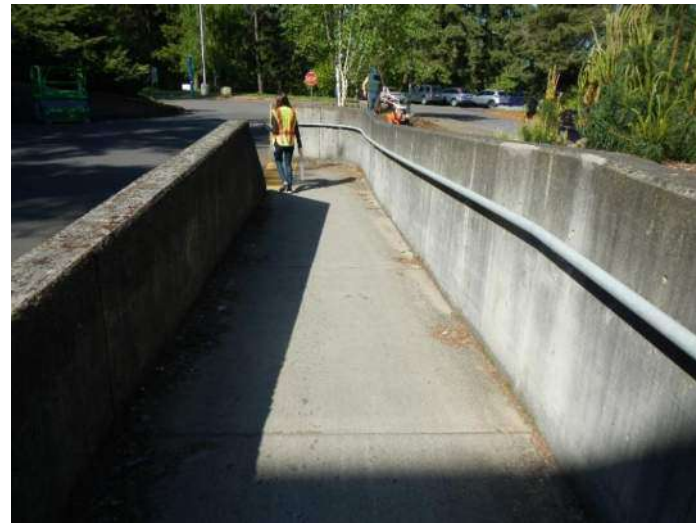
**Sylvania 5**

Keynote 5 - [Table 14](#)  
Ramp located just west of SS Building

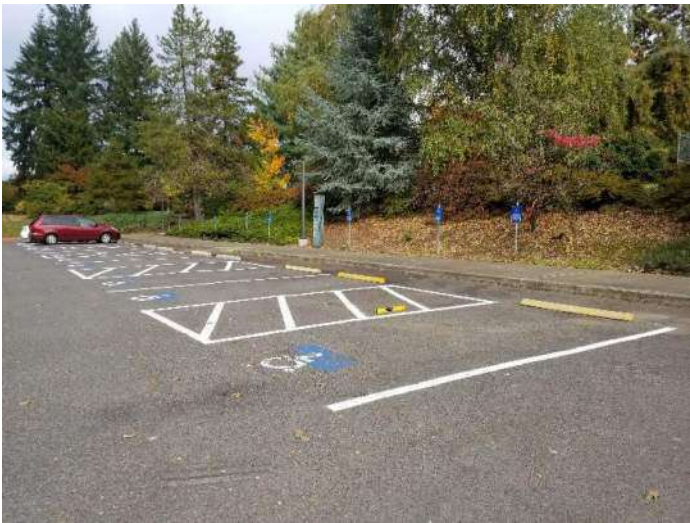
**Sylvania 36**  
Loading Zone L1 - [Table 17](#)

Park-ing Lot	Stall/Aisle Number	Compliant ADA sign?	Compliant Slopes?*	Comments
P1	L1	Loading Zone Sign	6.6	<a href="#">Photo: Sylvania 36</a>
P2				
ACC 1	S1	No	5.2	<a href="#">Photo: Sylvania 37</a>
	A1	-	5.1	<a href="#">Photo: Sylvania 37</a>
	S2	No	5.1	Temporary Permit Sign <a href="#">Photo: Sylvania 37</a>
	S3	No	6.3	<a href="#">Photo: Sylvania 37</a>
	A2	-	4.4	<a href="#">Photo: Sylvania 37</a>
	S4	No	4.7	<a href="#">Photo: Sylvania 37</a>
	S5	-	4.9	<a href="#">Photo: Sylvania 37</a>
	A3	No	5.5	<a href="#">Photo: Sylvania 37</a>
	S6	Missing ADA sign	4.0	<a href="#">Photo: Sylvania 37</a>
	S7	No	4.7	<a href="#">Photo: Sylvania 37</a>
	A4	-	5.2	<a href="#">Photo: Sylvania 37</a>

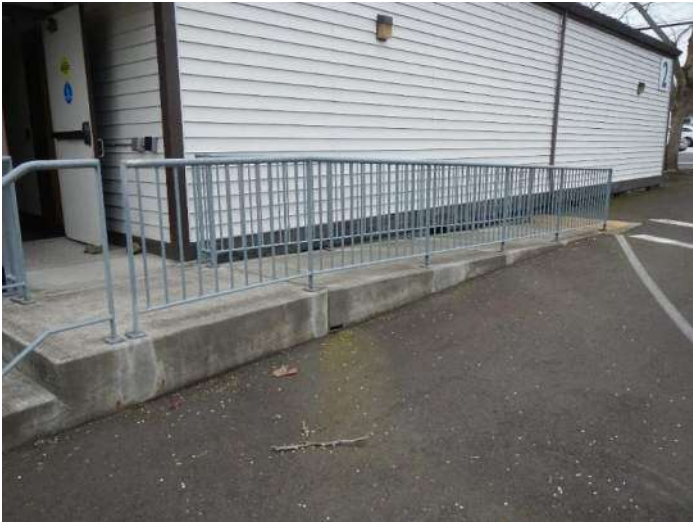
**Metro 1**  
Keynote 1 - [Table 23](#)

Keynote	Type of Non-Compliance	Description	Severity
1	Non-compliant cracking	Cracking in concrete has created non-compliant holes <a href="#">Photo: Metro 1</a>	B
2	Edge protection	Edge of concrete does not protrude 6" beyond handrail <a href="#">Photo: Metro 2</a>	A
3	Width	Non-compliant width between bench and edge of sidewalk <a href="#">Photo: Metro 3</a>	B
4	Bench	Non-compliant bench seat height <a href="#">Photo: Metro 3</a>	A
5	Accessible Entrance	Marked as ADA entrance, but no automatic door <a href="#">Photo: Metro 4</a>	A
6	Accessible Sign	Unreadable due to dirt <a href="#">Photo: Metro 5</a>	B
7	Accessible Entrance	Marked as ADA entrance, but sign notifies disabled users to enter on Killingsworth St. <a href="#">Photo: Metro 6</a>	A

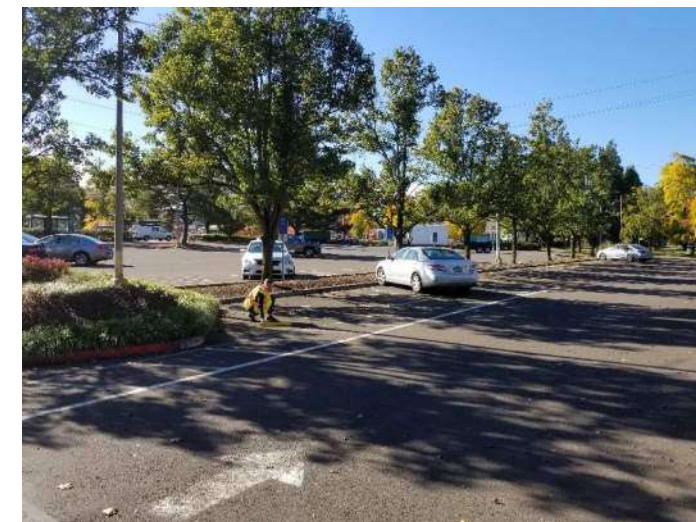
**Metro 12**S1, A1, S2, S3 - [Table 26](#)

Stall/ Aisle Number	Compliant ADA sign?	Compliant Slopes ?*	Comments
S1	No	Yes	<a href="#">Photo: Metro 12</a>
A1	-	2.7	<a href="#">Photo: Metro 12</a>
S2	No	2.6	<a href="#">Photo: Metro 12</a>
S3	No	3.4	Missing aisle <a href="#">Photo: Metro 12</a>
S4	No	Yes	<a href="#">Photo: Metro 13</a>
A2	-	2.6	<a href="#">Photo: Metro 13</a>
S5	No	2.3	<a href="#">Photo: Metro 13</a>
S6	No	2.4	<a href="#">Photo: Metro 13</a>
A3	-	2.5	<a href="#">Photo: Metro 13</a>
S7	No	Yes	<a href="#">Photo: Metro 13</a>
A4	-	3.7	<a href="#">Photo: Metro 13</a>
S8	No	4.4	<a href="#">Photo: Metro 14</a>
A5	-	4.7	<a href="#">Photo: Metro 14</a>
S9	No	3.5	<a href="#">Photo: Metro 14</a>
S10	No	4.1	<a href="#">Photo: Metro 15</a>
A6	-	3.4	<a href="#">Photo: Metro 15</a>
S11	No	3.6	<a href="#">Photo: Metro 16</a>
S12	No	4.3	<a href="#">Photo: Metro 16</a>
A7	-	5.2	<a href="#">Photo: Metro 16</a>

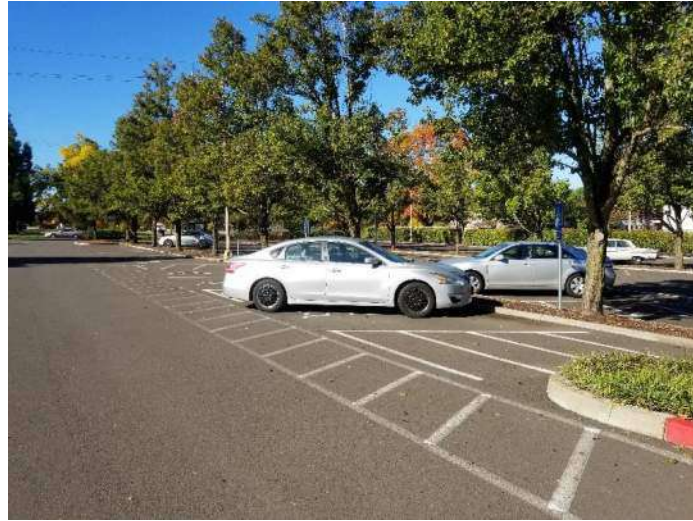
**Metro 13**

S4, A2, S5, S6, A3, S7, A4 - [Table 26](#)

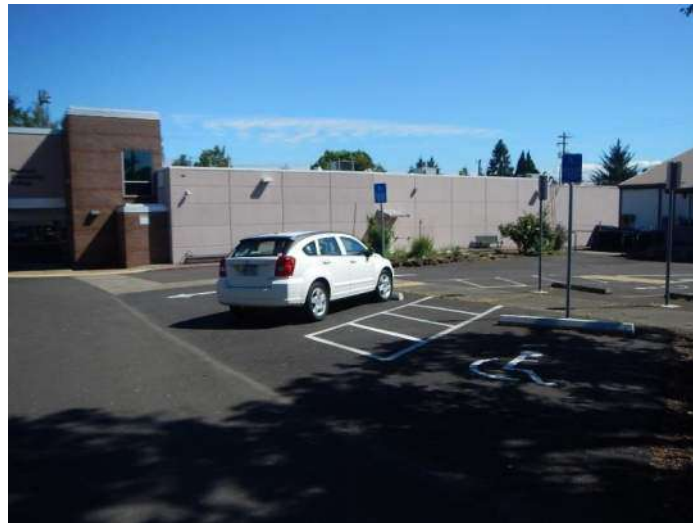
**Metro 14**

S8, A5, S9 - [Table 26](#)

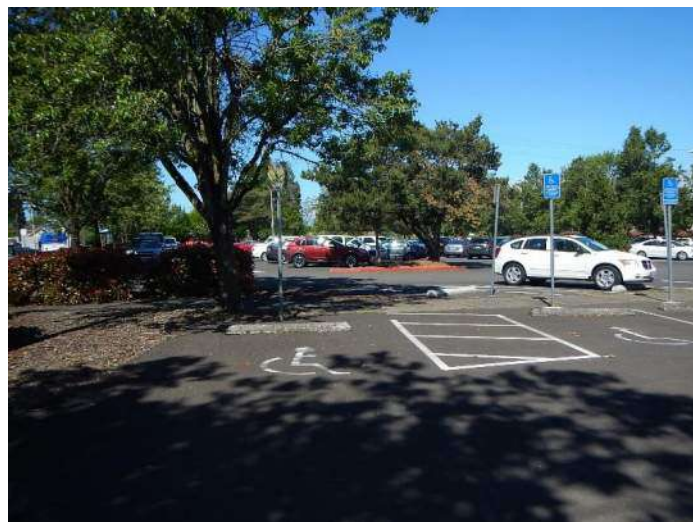
**Metro 15**

S10, A6 - [Table 26](#)

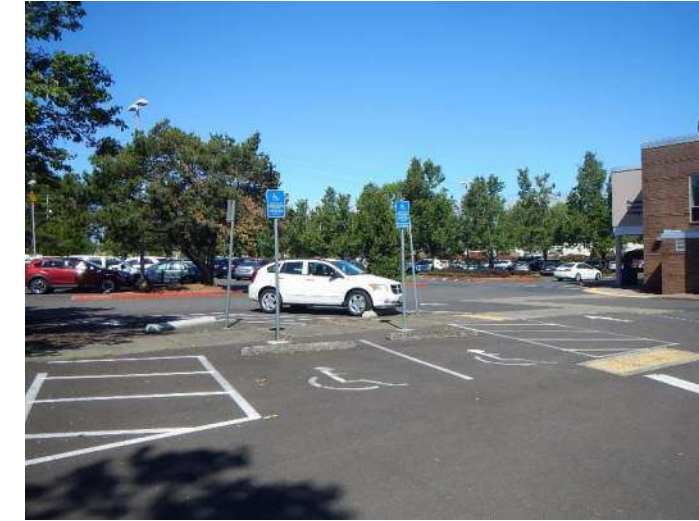
**Metro 16**

S11, S12, A7 - [Table 26](#)

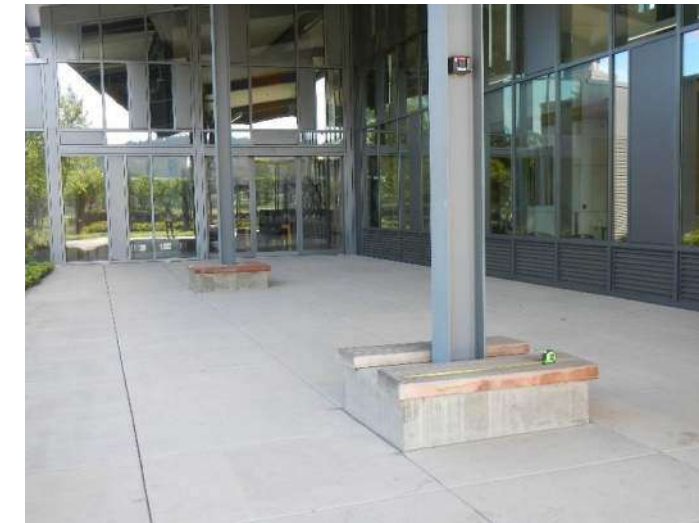
**Newberg 1**

Keynote 1 - [Table 27](#)

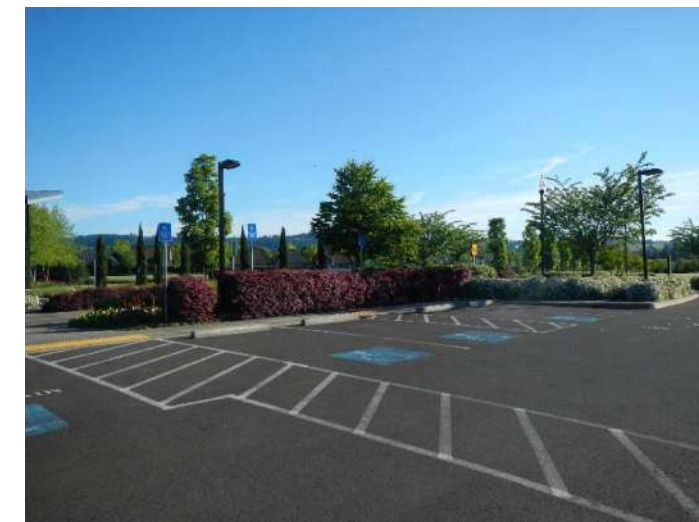
**Newberg 2**

S1, A1, S2, S3, A2 - [Table 28](#)

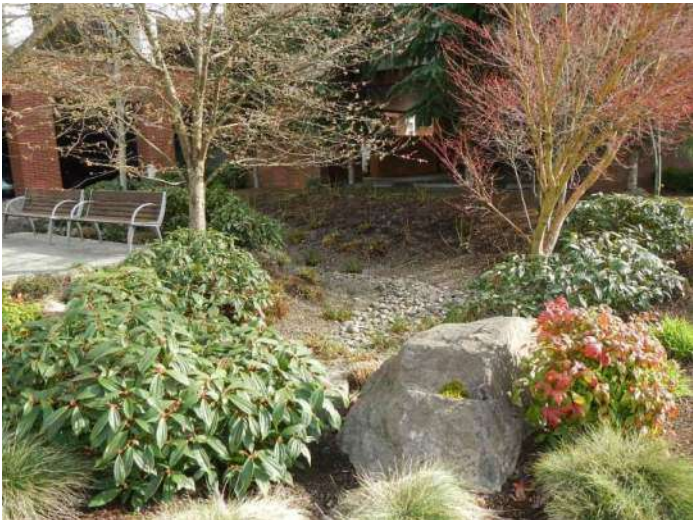
**Hillsboro WQ #1**  
[Table 6](#)

ID	TYPE	CONDITION	AGE	NOTES
WQ #1	Stormwater Infiltration Planter	Good	Constructed in 2009	<a href="#">Photo: Hillsboro WQ #1</a>
WQ #2	Stormwater Infiltration Planter	Good	Constructed in 2009	<a href="#">Photo: Hillsboro WQ #2</a>
WQ #3	Stormwater Infiltration Planter	Good	Constructed in 2009	<a href="#">Photo: Hillsboro WQ #3</a>

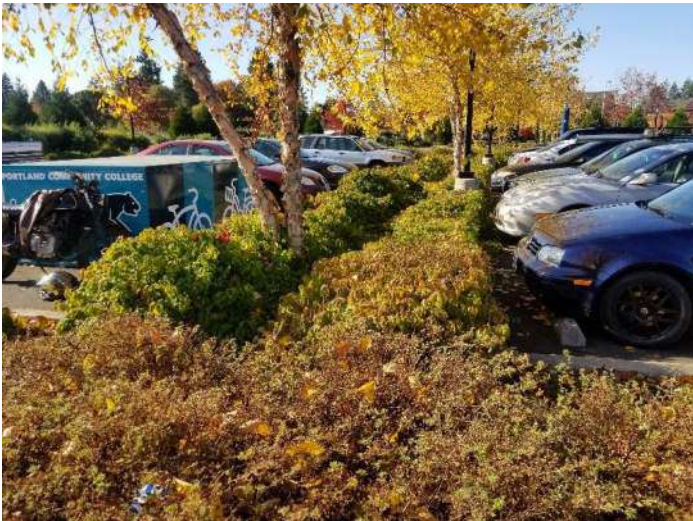
**Newberg WQ #1**  
[Table 7](#)

ID	TYPE	CONDITION	AGE	NOTES
WQ #1	Swale	Good	Constructed in 2009	Treats runoff from parking lot. <a href="#">Photo: Newberg WQ #1</a>
WQ #2	Swale	Good	Constructed in 2009	Treats runoff from parking lot. <a href="#">Photo: Newberg WQ #2</a>
WQ #2	Swale	Good	Constructed in 2009	<a href="#">Photo: Newberg WQ #3</a>

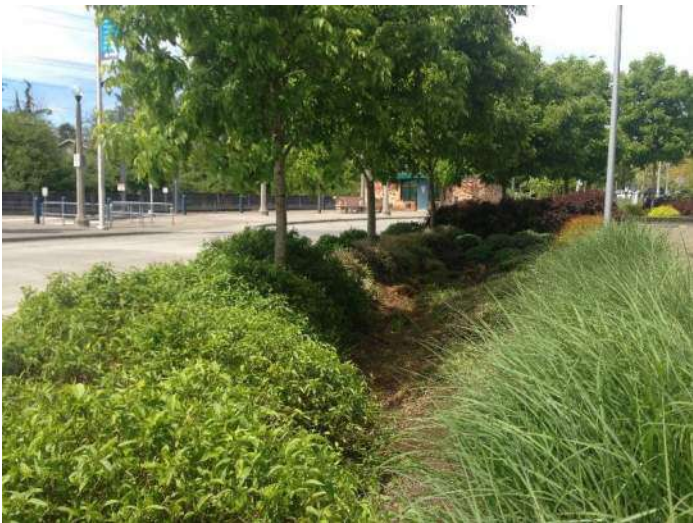
**Swan Island WQ #1**  
[Table 8](#)

ID	TYPE	CONDITION	AGE	NOTES
SW #1	Swale	Good	Constructed in 2013	<a href="#">Photo: Swan Island WQ #1</a>
